**Arboricultural Impact Assessment & Method Statement in accordance  
with BS5837:2012 '*Trees in relation to design, demolition and  
construction – Recommendations*'**

| Project name: | <b>Old Tollgate Hotel, Gravesend, DA11 8AB</b> | | |
| Project Ref: | 2496 Rev-02 | Date of report: | 14 March 2024 |

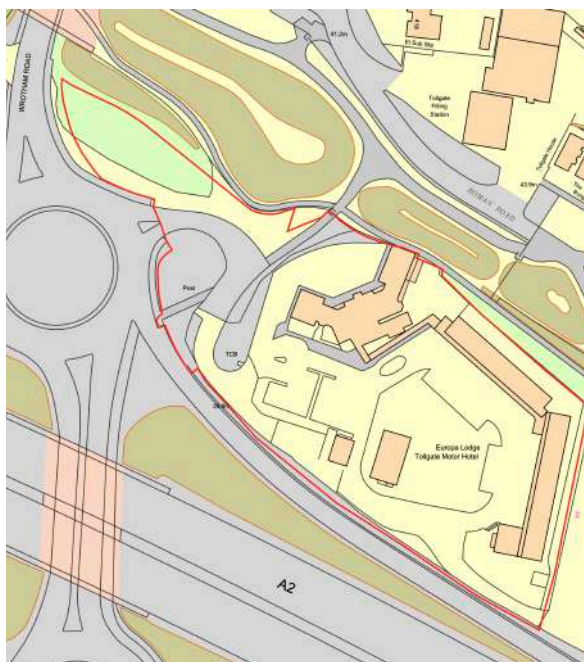
*Image 1: Existing site layout redline boundary provided by client.*

**2.2 Site description and layout:** This site as it was at the time of assessment consisted of a dilapidated and abandoned service station and hotel. Few trees exist within the compound with much of the original landscaping removed. A single, mature tree, T1 PA, was surveyed along with a section of vegetation along the northern boundary. The remainder of vegetation included in this assessment consists largely of highways style native planting in and around the verges surrounding the compound and the roundabout slip road. No trees of any real significant amenity or screening value exist within the site itself. Further information regarding trees recorded at the site can be found in the survey sheets located in appendix 2.

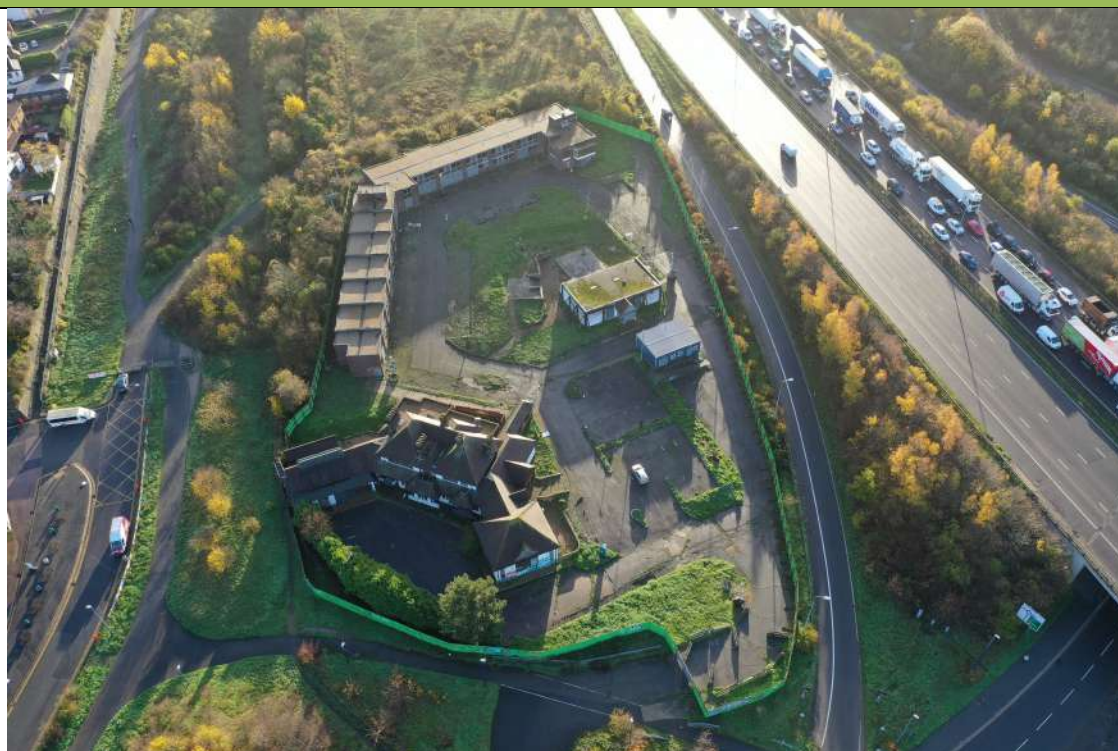
**Photo 1:** Aerial image showing extent of compound at the time of survey. T1 and H2 seen in lower left hand side inside existing site hoarding.

**3.2 Trees to be removed:** A single category B tree, (T1), and a single category C tree group, (G7), along with H2, are required to be removed to facilitate the proposed design. The removal of these trees does not, in my professional opinion, constitute a significant loss of arboricultural amenity assets and given the volume of landscape planting proposed across the site, this will be mitigated many times over.
