PROPOSED REMOVAL OF EXISTING SOIL AND SUBSEQUENT REPAIR AND REPLACEMENT OF THE STUCCO RENDER TO THE EXPOSED WALL.

AT: 4 CONSTITUTION CRESCENT, GRAVESEND, KENT. DA12, 1JS.

DRG No: 2021-05-01

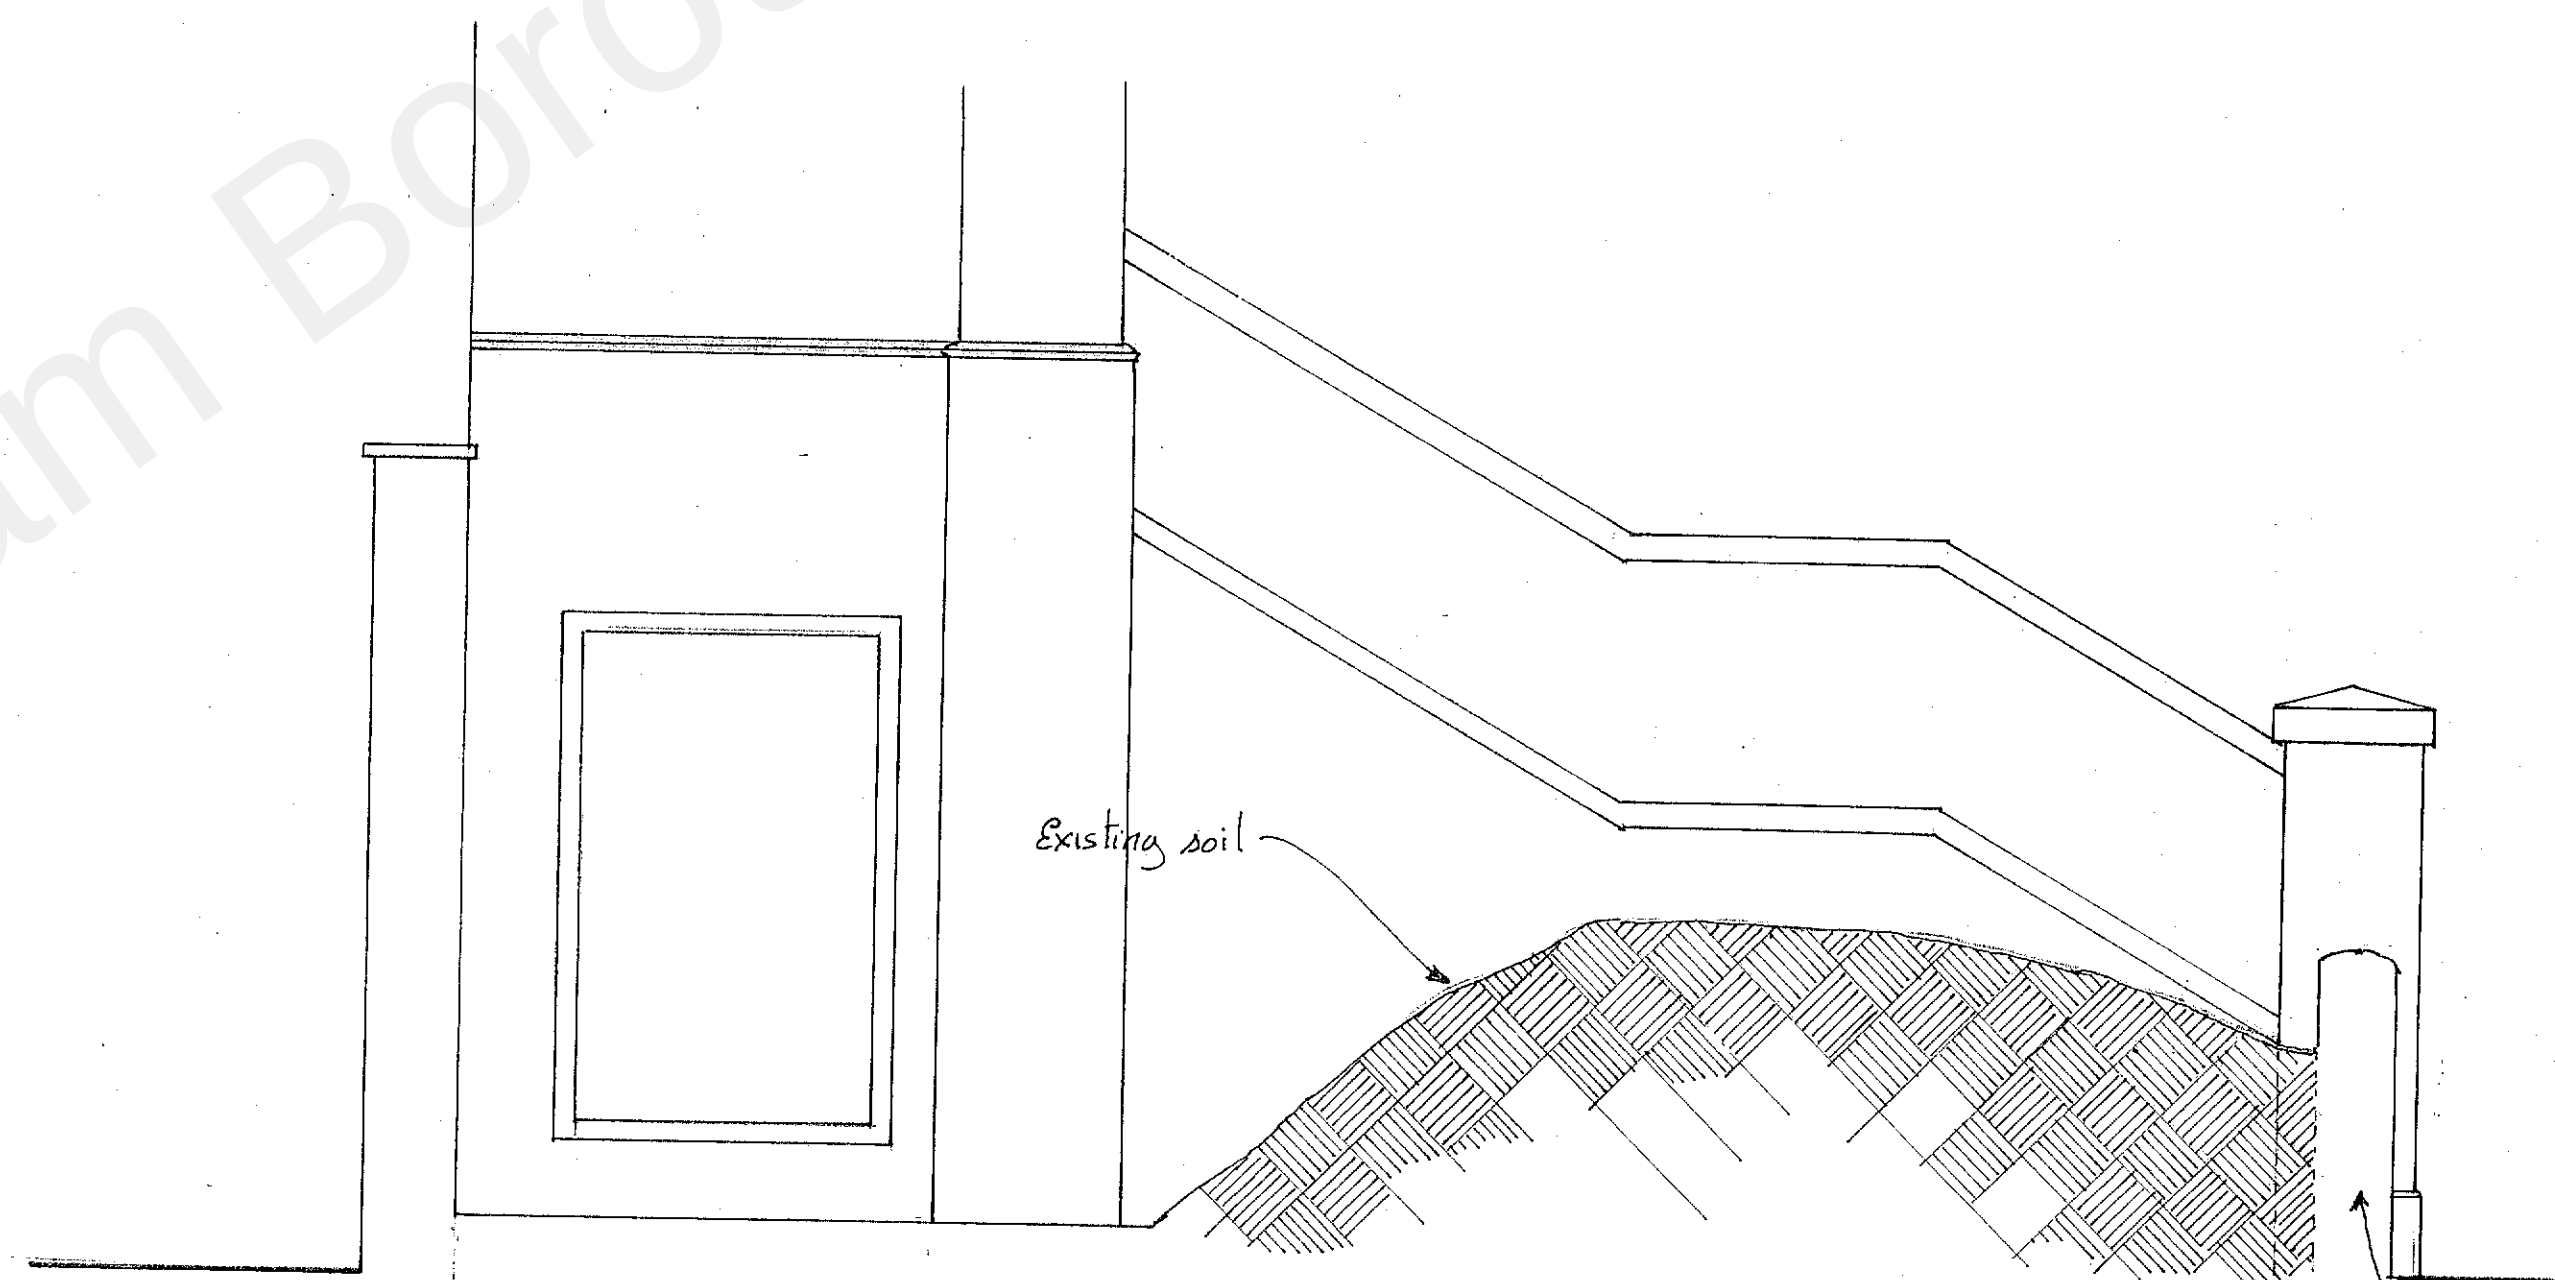
EXISTING FRONT STAIRCASE SECTION AND ELEVATION 1:20

Existing Flint wall to be removed
