PROPOSED REMOVAL OF EXISTING SOIL AND SUBSEQUENT REPAIR AND REPLACEMENT OF THE STUCCO RENDER TO THE EXPOSED WALL.

AT: 4 CONSTITUTION CRESCENT, GRAVESEND, KENT. DA12, 1JS.

DRG No: 2021-05-01

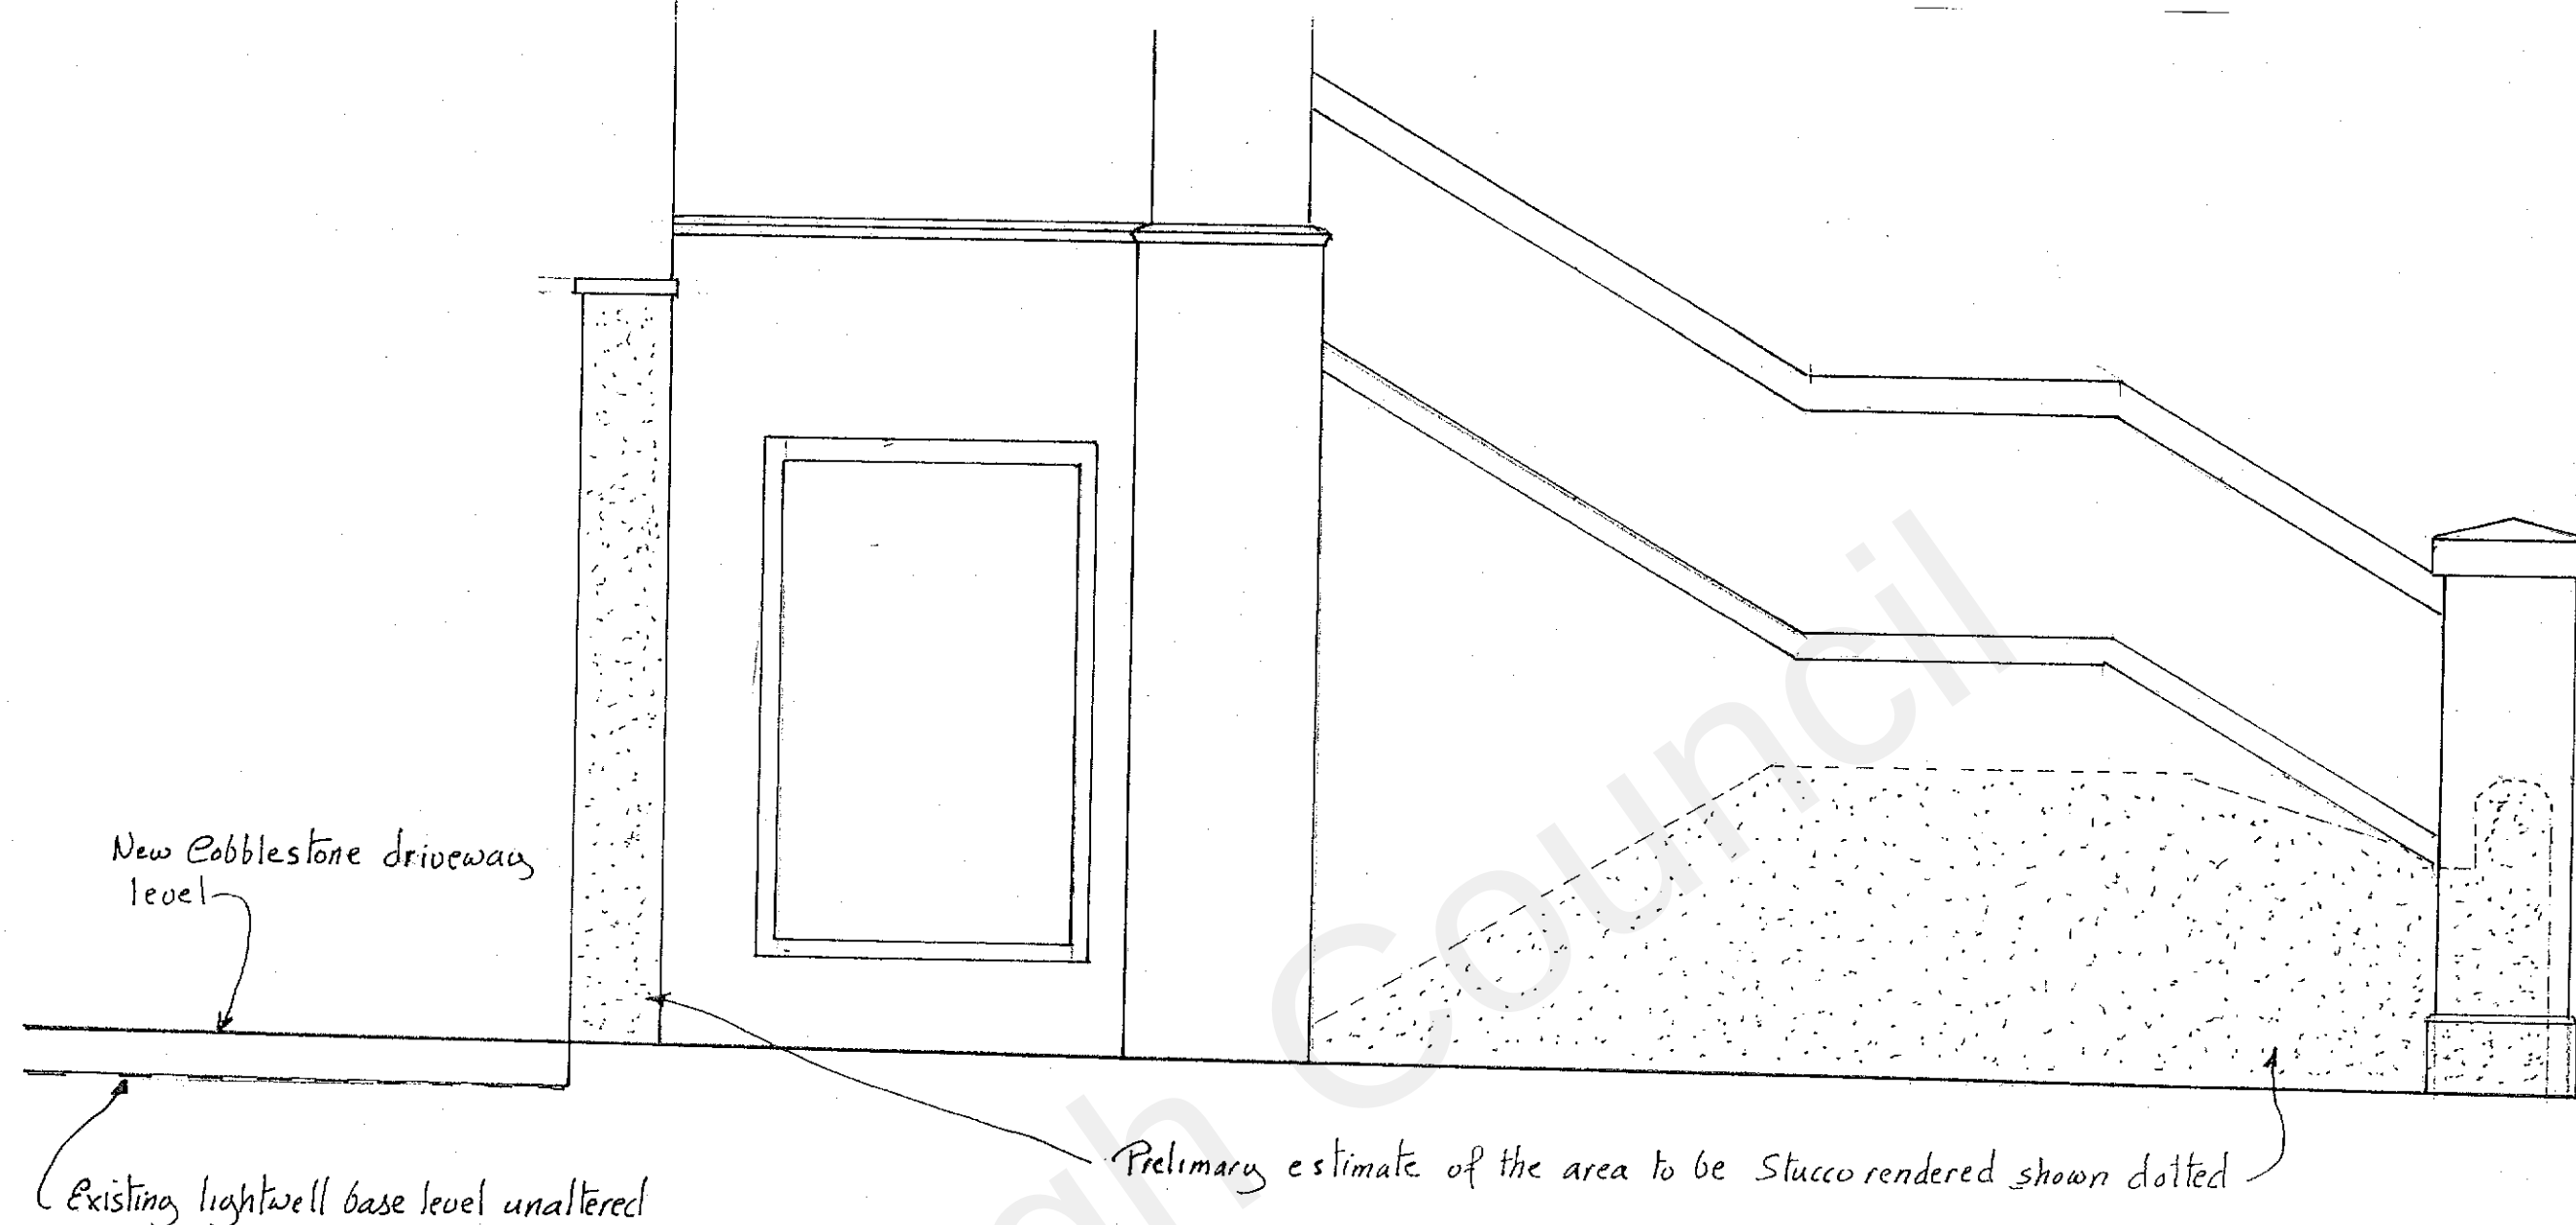
PROPOSED FRONT STAIRCASE ELEVATION 1:20

1. Dismantle the original flint and overburnt brick garden wall and set aside flints for re-use.
2. Carefully excavate the soil adjacent to the staircase wall and expose the original Stucco render.

3. Examine the condition of the original Stucco render and keep a photographic record of your findings.
4. Remove any loose cracked or debonded stucco back to the original substrate.

5. Brush away dust and loose debris then hose down to further remove any remaining dust.
6. Whilst wall is still damp apply a coat of Render (Cal RB) Lime render 10-20mm max thickness. In normal conditions the render should take about 4 days to calcify. In hot conditions do not let it dry too quickly or cracking will occur. Cover with damp hessian and protect from direct sunlight. In cold conditions protect from frost.

7. When base layer is set clampen down and apply a 2mm coat of Finish (Cal AC) followed by a second coat 2mm thick when the first coat has firmed up, normally on the same day. Protect from elements as in stage 6 until surface has fully set.

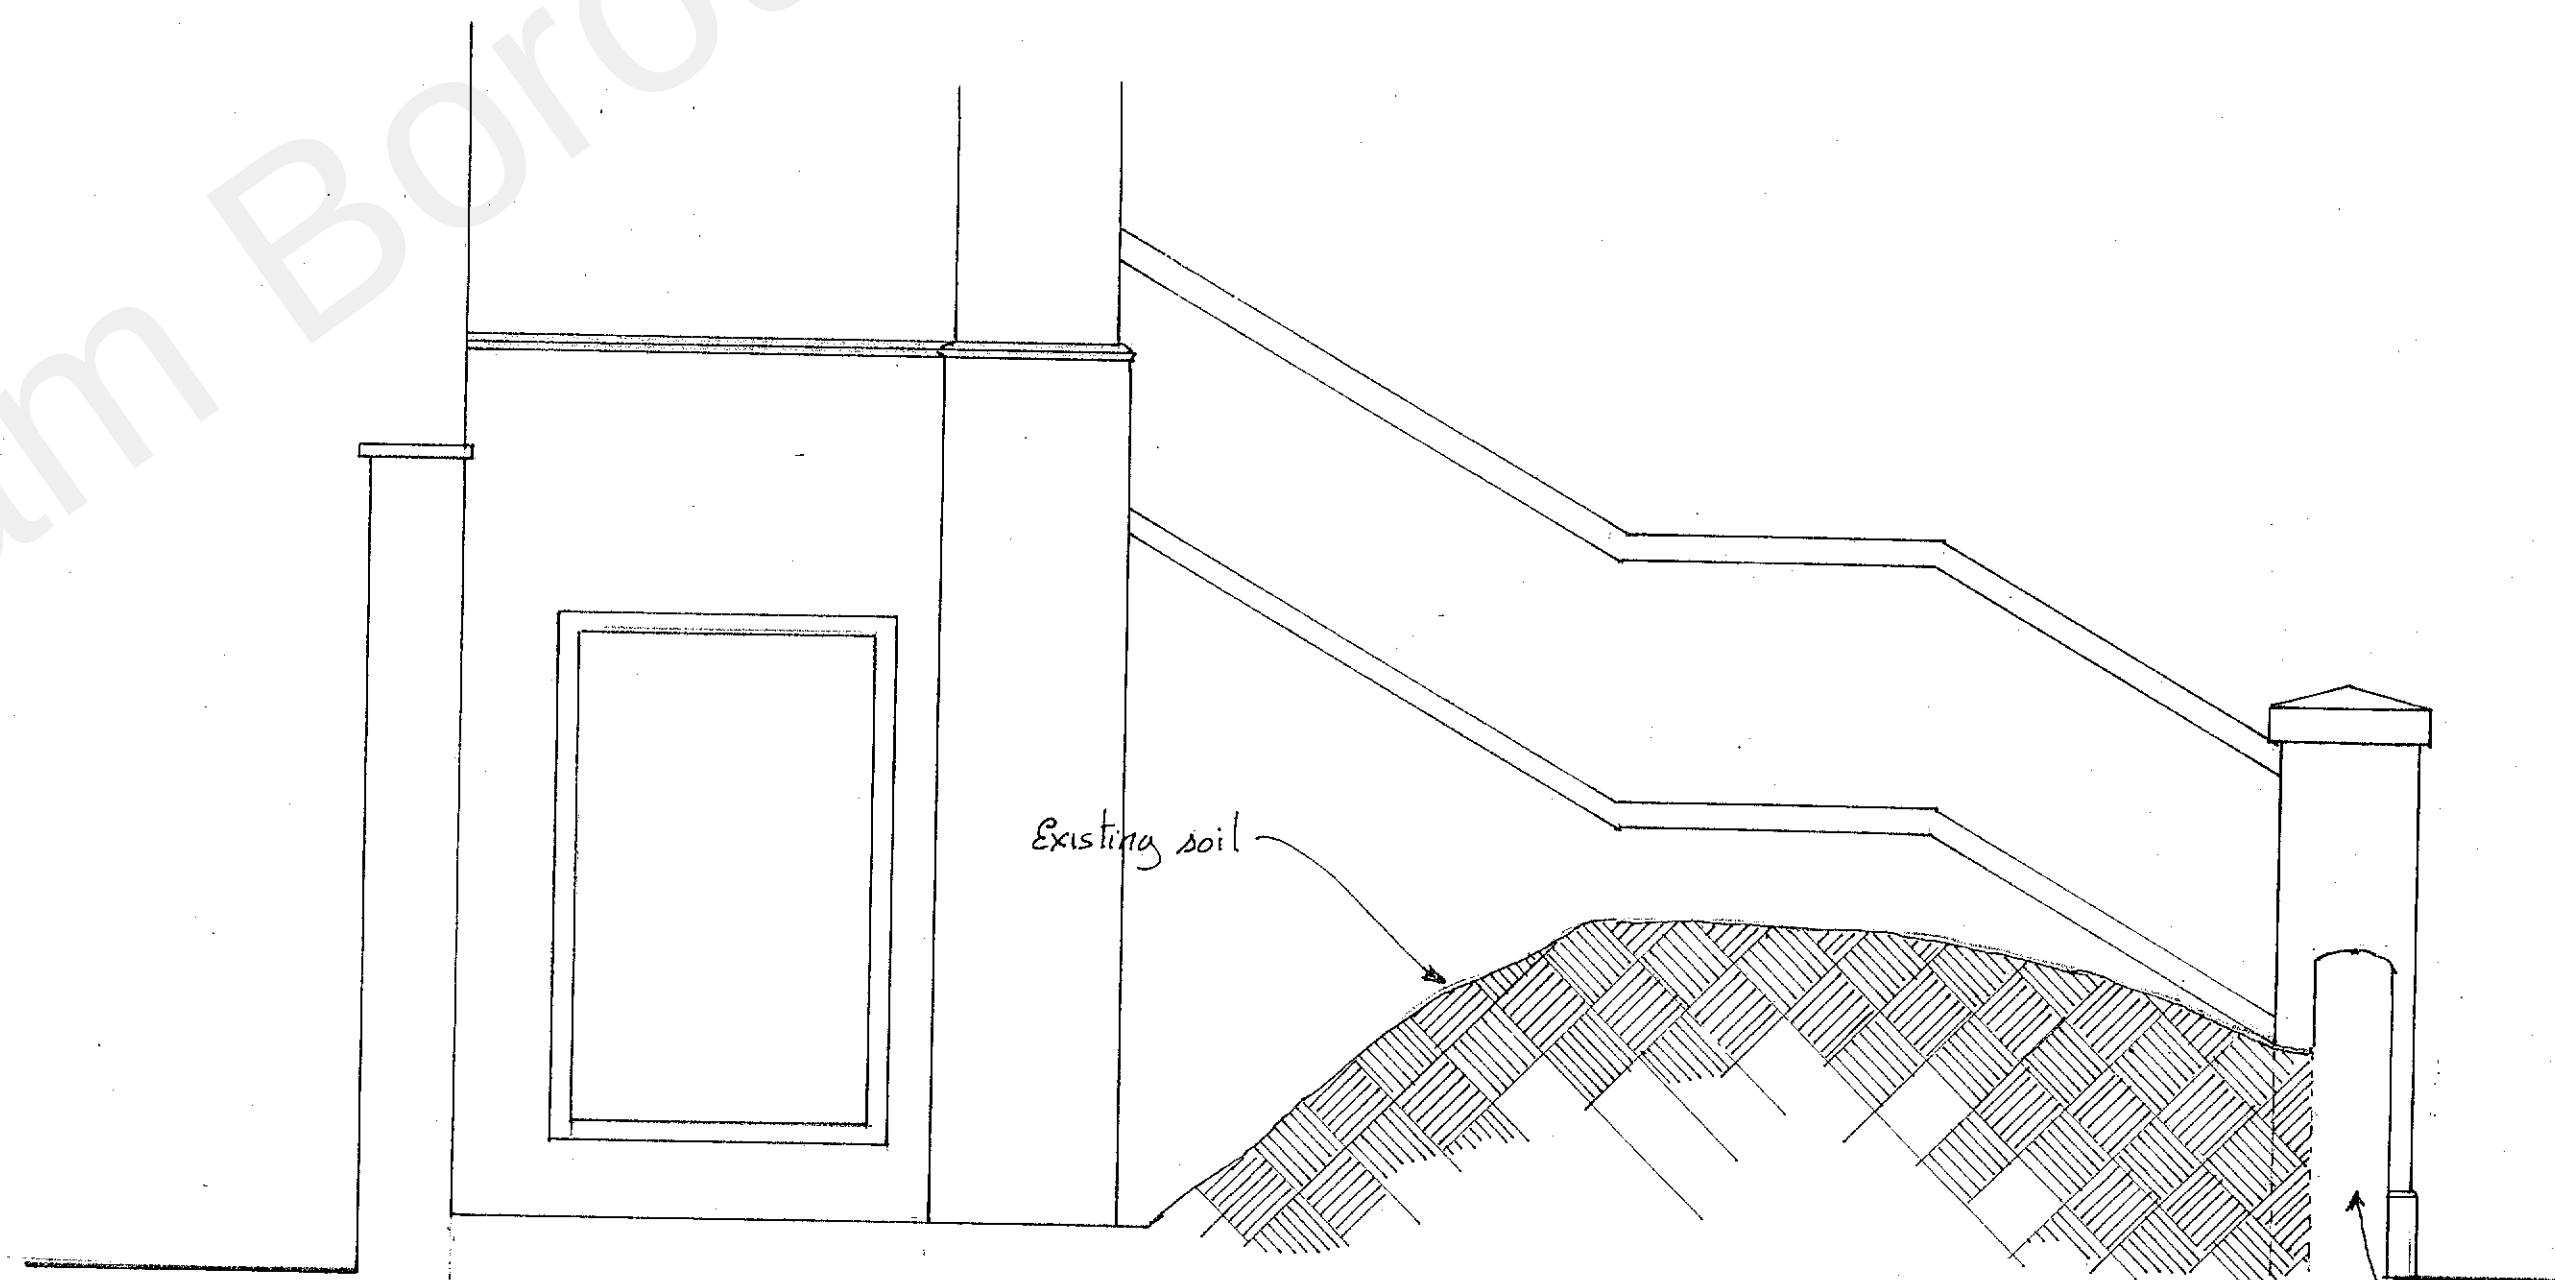
EXISTING FRONT STAIRCASE SECTION AND ELEVATION 1:20

Existing Flint wall to be removed
