This Arboricultural Impact Assessment was commissioned by Baily Garner LLP to accompany a planning application for residential development at Rose Avenue, Gravesend. A survey of the trees on site and within influencing distance of the boundaries was undertaken on the 14<sup>th</sup> of January of 2025 as part of a Preliminary Arboricultural Assessment to aid design and avoid unnecessary tree removal.

# Appendix B

# Appendix C

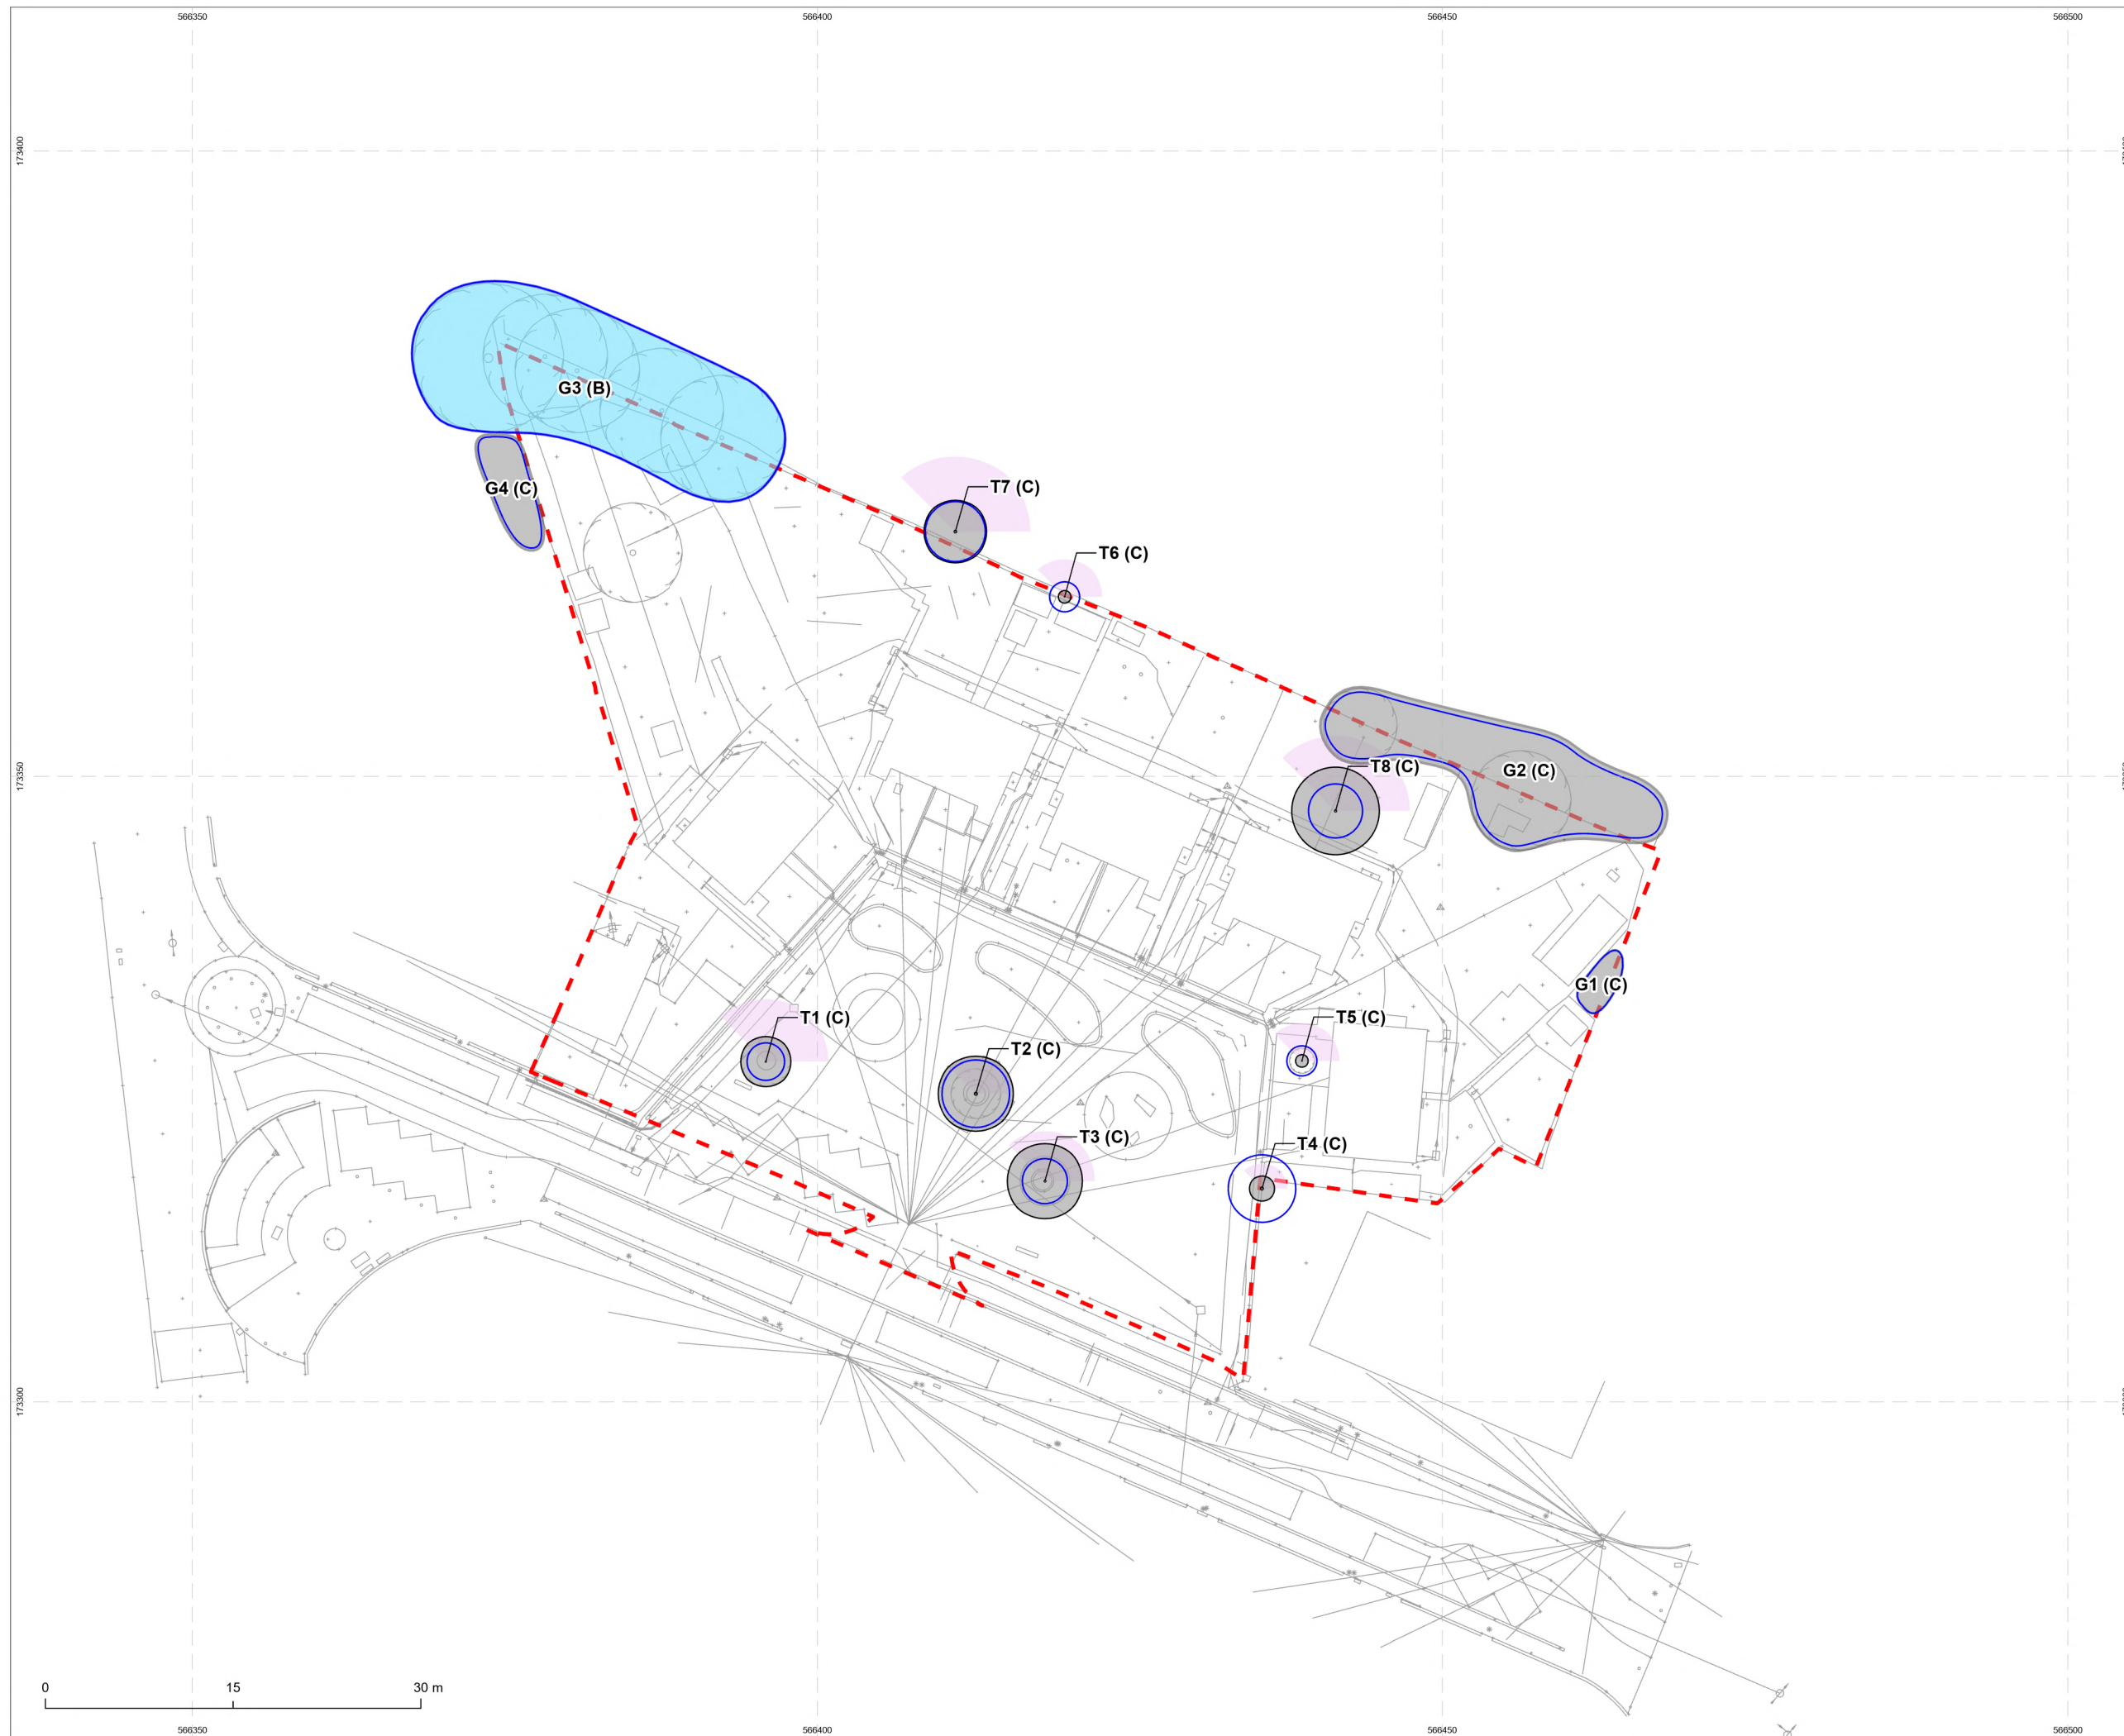
C181336-04-01-RevA

## Tree Survey Plan

| Attribute | Description |
|---|---|
| Appendices | Appendix A: Tree Schedule<br>Appendix B: Tree Survey Plan – C181336-04-01<br>Appendix C: Tree Retention Plan – C182248-05-01 |

The Preliminary Arboricultural Assessment report (prepared by Middlemarch environmental Ltd and supplied separately) identified 8 individual trees and 4 groups of trees, as detailed in the Tree Schedule (Appendix A) and Table 1.2 below.

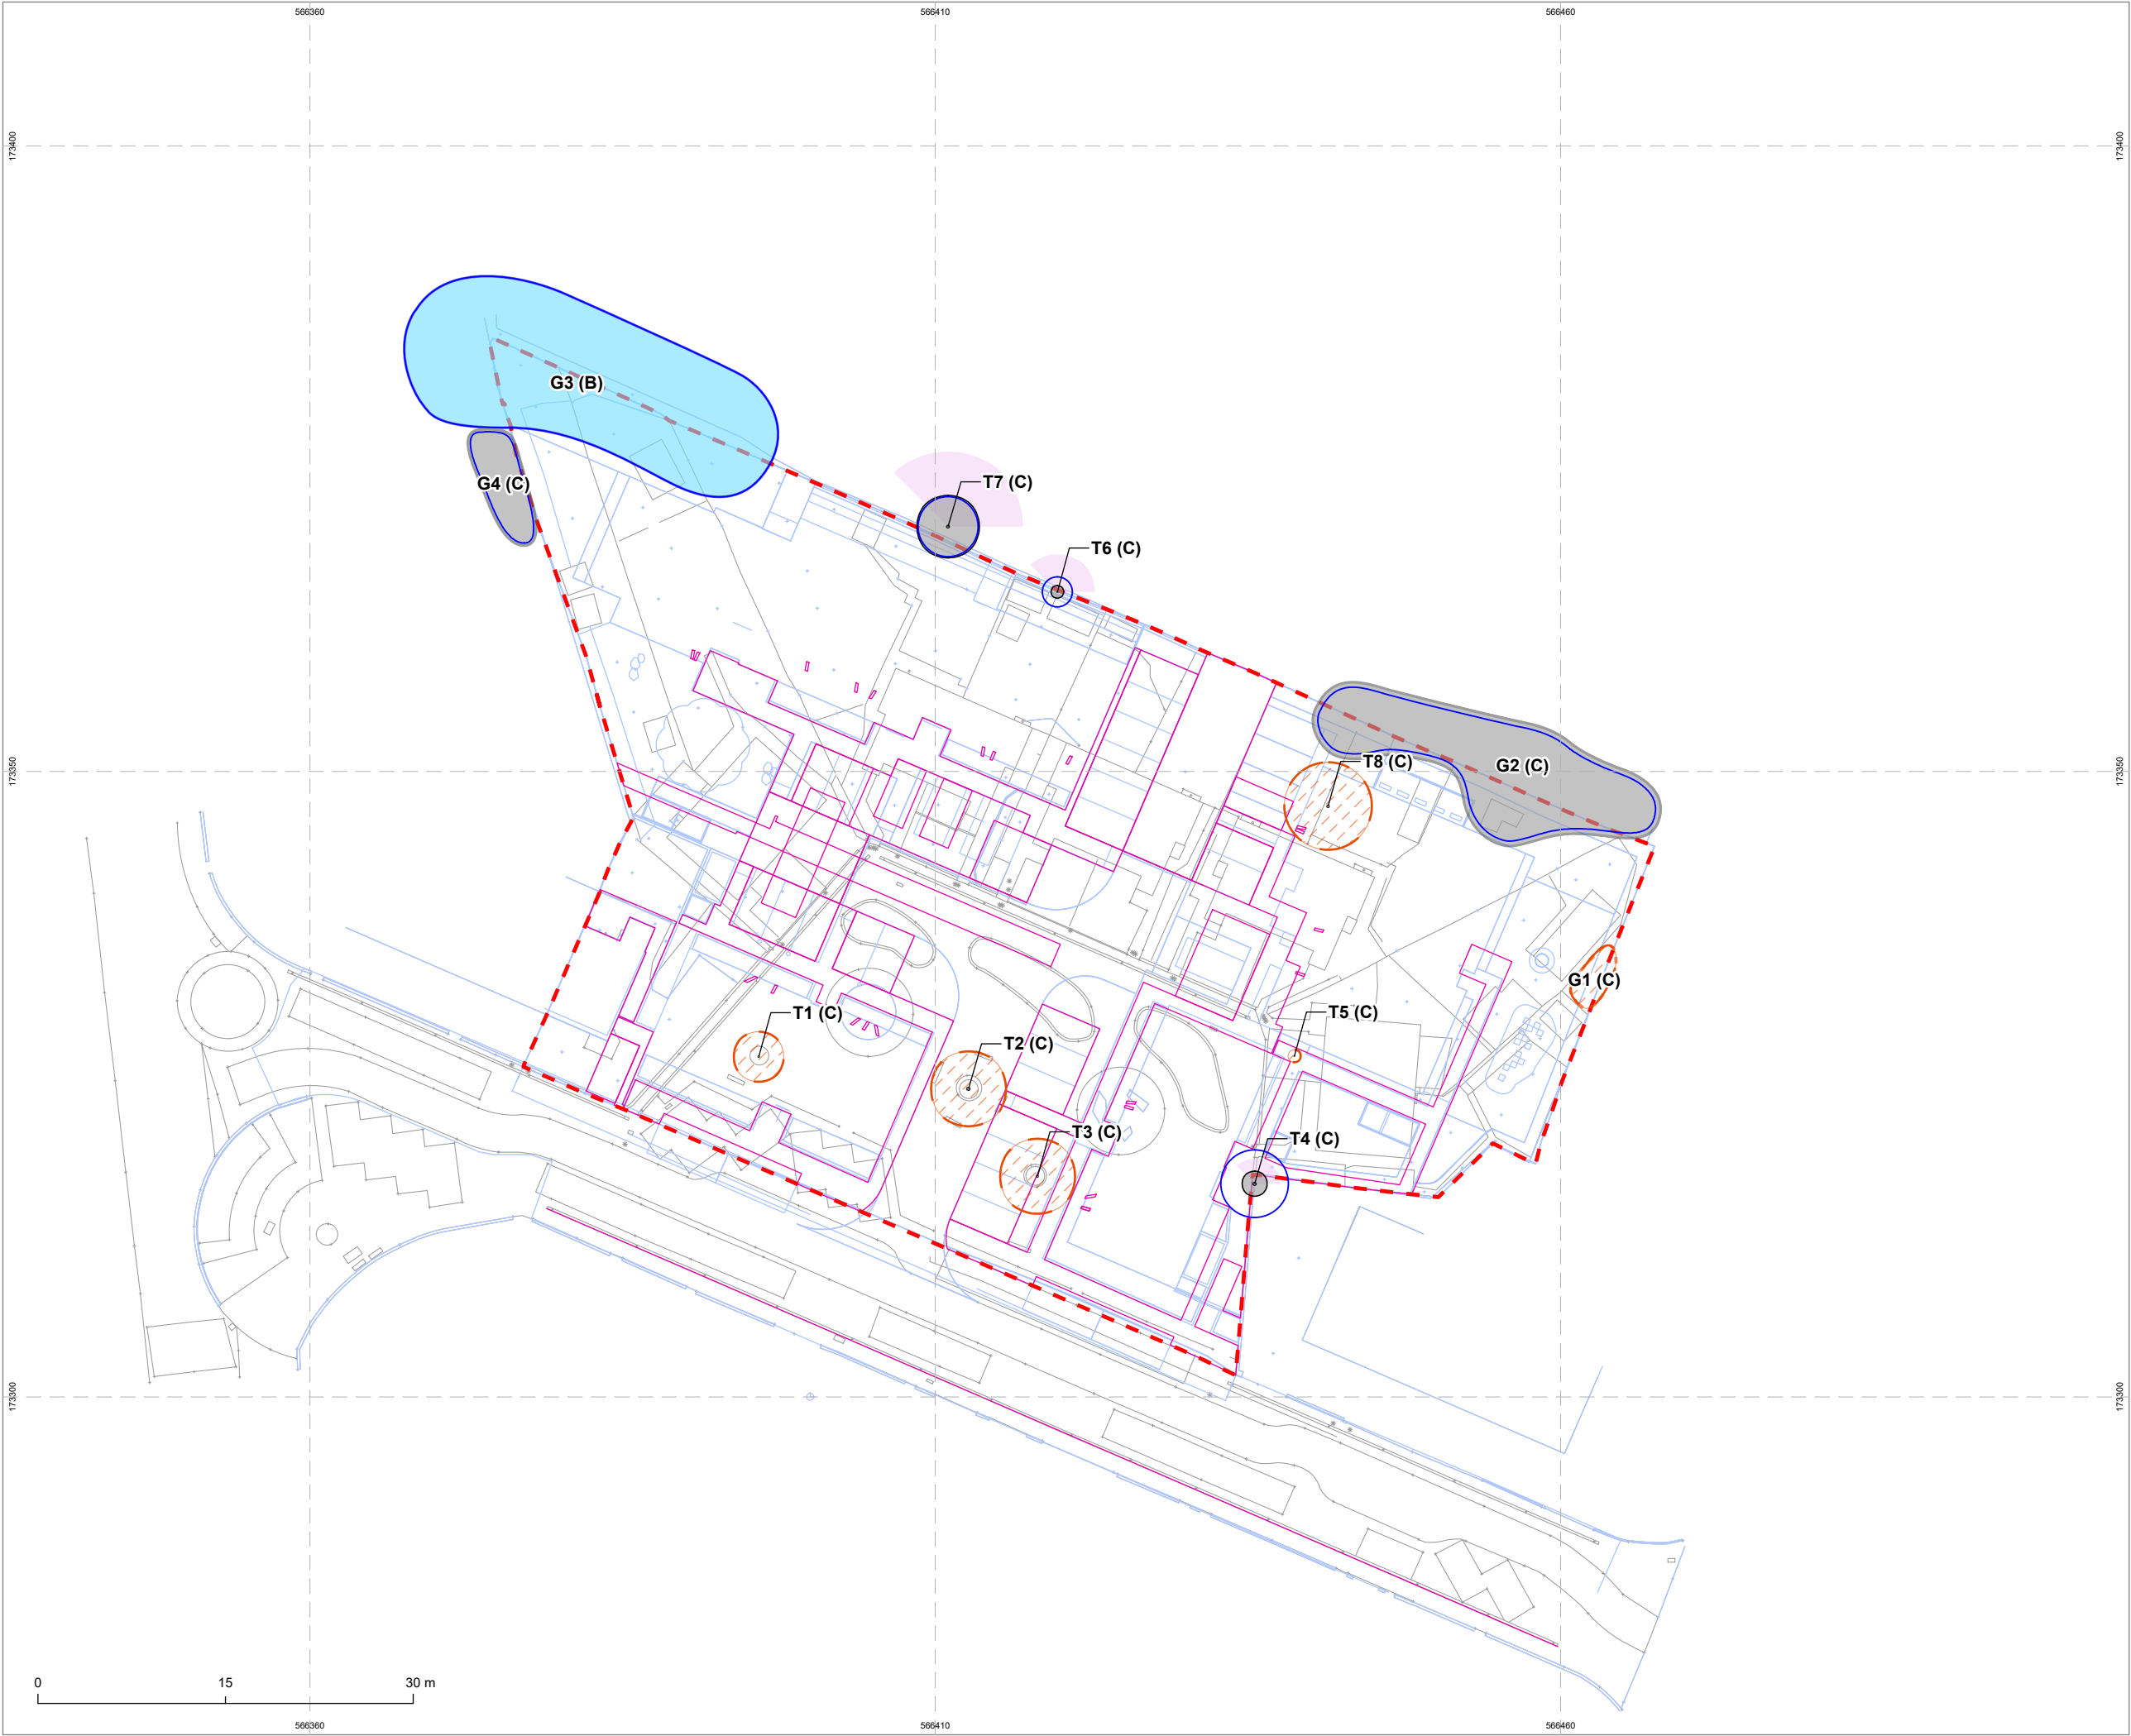
C181336-05-01

## Tree Removal and Retention Plan

The Tree Retention Plan (Appendix C) identifies which trees and hedgerows are to be retained and incorporated as part of the site development and which are to be removed.

The trees to be removed are detailed below and are identified on the Tree Retention Plan. All trees, groups and hedgerows *not* featured within the table below are to be retained within the proposed development.
