Bat Emergence and Re-Entry Surveys (BERS)

Hartshill Bungalow, Thong Lane, Gravesend, Kent, DA12 4AD

National Highways

17th July 2025

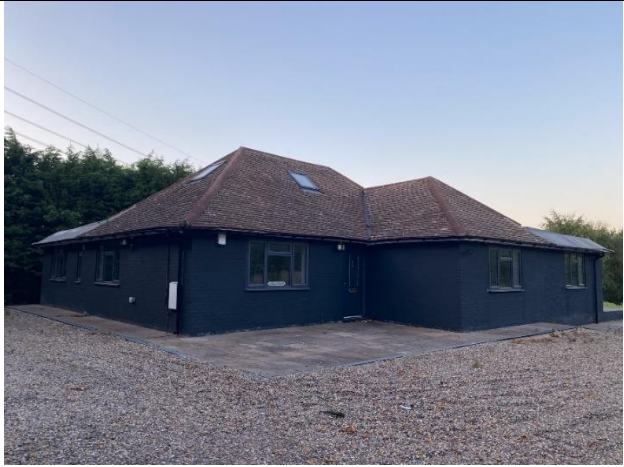
<p><i>IR position 1</i> 1x <i>Nightfox Whisker</i>, 1x <i>Nightfox XB5 PRO</i></p>	<p>Camera position: observing southwest elevation of building.</p> <p>No additional observations or bat activity recorded upon review.</p>

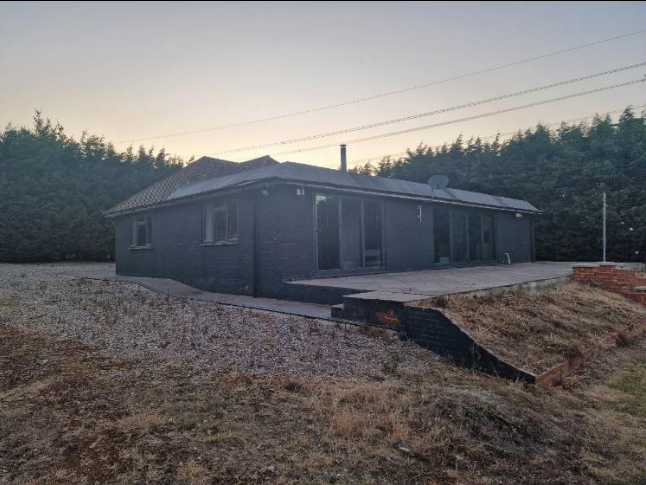
<p><i>IR position 2</i> 1x <i>Nightfox Whisker</i>, 1x <i>Nightfox XB5 PRO</i></p>	<p>Camera position: observing southeast elevation of building.</p> <p>No additional observations or bat activity recorded upon review.</p>

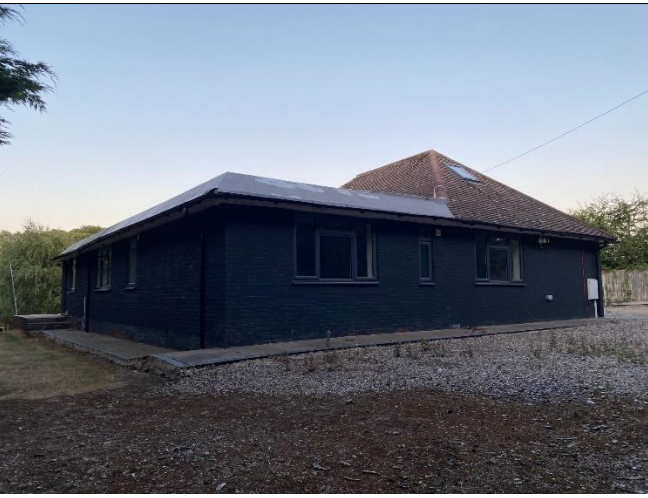
<p><i>IR position 3</i> <i>1x Nightfox Whisker,</i> <i>1x Nightfox XB5 PRO</i></p>	<p>Camera position: observing northwest elevation of building.</p> <p>No additional observations or bat activity recorded upon review.</p>
