**LUSTRE**  
CONSULTING

**2 VALE ROAD - NORTHFLEET**

**SUPPLEMENTARY PHASE 2 SITE INVESTIGATION**

| NON-TECHNICAL SUMMARY | |
|---|---|
| Site | Vale Road, Northfleet DA11 9RE |

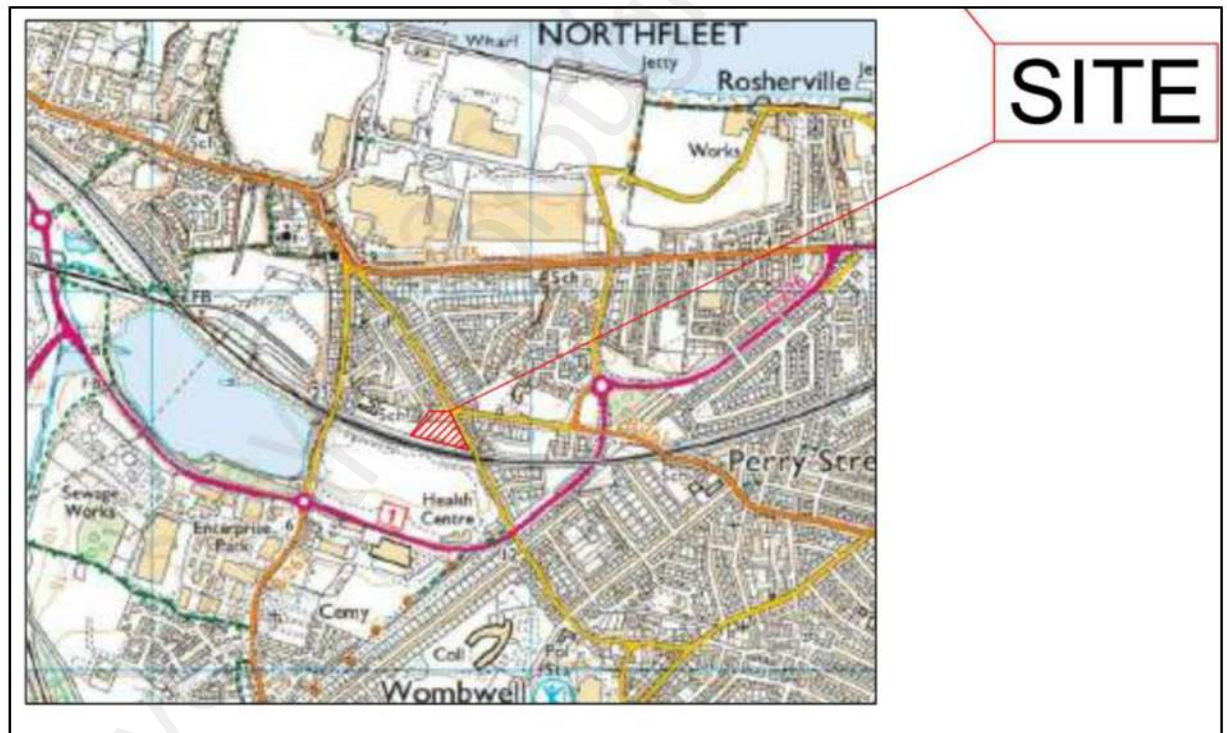
Figure 1: Extract from Desk Study Assessment Report undertaken by Brownfield Solutions Ltd showing wider site area owned by BRT Properties hashed in red

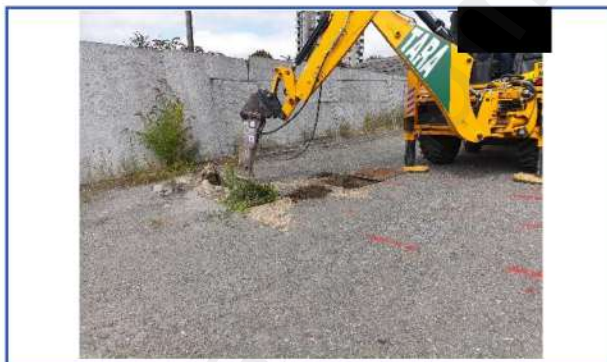
- 3.7 Excavation was then undertaken in a second area to the rear (west) of the former shop building to try and located the tanks (based on anecdotal evidence). This area was located **off-site**, adjacent to the west of the subject site boundary. A visual inspection of the area identified a manhole cover which when lifted contained infrastructure consistent with a UST fill point. A GPR survey was undertaken, however, no further information with respect to the presence of underground tanks could be ascertained.

*Manhole cover west of the subject site*

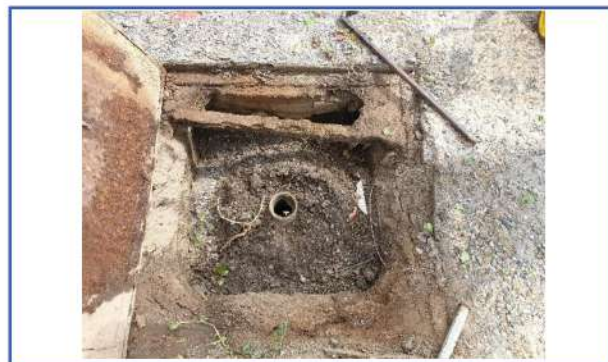
*Fill point infrastructure within manhole*

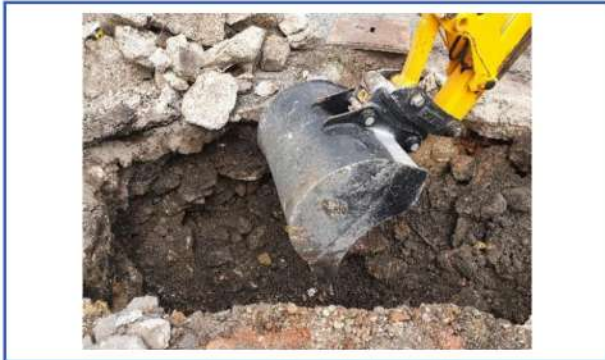
- 3.8 Two excavations (TP203 and TP204) were undertaken in the vicinity of the suspected fill point. TP203 was undertaken at the southern boundary of the tanks and TP204 was undertaken at the western boundary of the tanks. The ground surface at both locations was comprised of reinforced concrete to a depth of 0.2m bgl. This was underlain by Made Ground comprising silty sandy GRAVEL with moderate ash content to a depth of 1.3m bgl and was broadly consistent across the two locations. A concrete slab was then identified

extending 0.5m south from manhole cover in TP203 and 2m west of the manhole cover in TP204. Both excavations were laterally extended to allow for excavations to continue to assess soil conditions at a depth consistent with the suspected underside depth of any USTs.

- 3.9 Within TP203 ground conditions beyond the concrete slab (logged as side A) were consistent with anthropogenic fill material to a depth of 3.3m bgl. This comprised silty sand gravel with moderate ash content. Gravel was recorded as chalk, brick, glass, slate, concrete and brick. At 3.3m bgl ground conditions were recorded as yellowish brown and greyish brown silty slightly gravelly SAND with gravels comprising flint and chalk. This layer remained unproven to base of the excavation at 3.8m bgl.

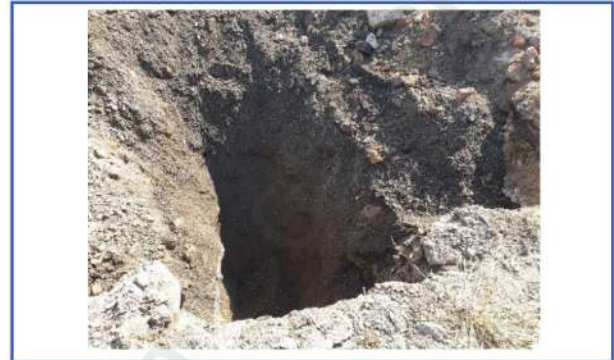
TP204

- 3.10 Within TP204, reworked natural soils broadly similar to those encountered in TP203 were identified from a depth of 1.3m bgl in the excavation undertaken adjacent to the concrete slab. The reworked natural soils were described as orangish brown sandy gravelly CLAY. Gravels comprised flint and chalk. This was underlain by natural soils comprising white structureless CHALK at depth of 2.5m to base of the excavation at 2.8m bgl.

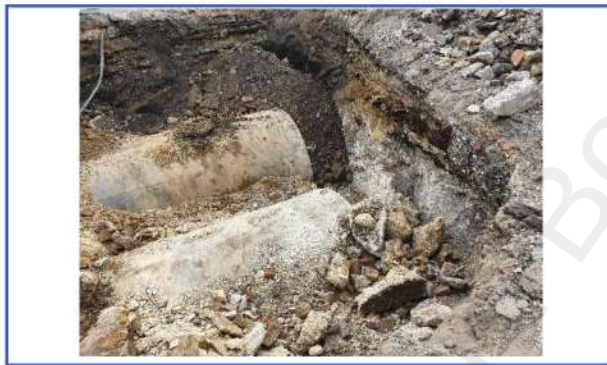
- 3.11 Further excavation was then undertaken through the concrete slab as this was suspected to be a protective cap above the USTs. Two cylindrical tanks were identified beneath the concrete. The fill point identified above related to the southern tank, with a second tank identified to the north which had a fill point at the opposite end of the tank. The excavation was progressed to expose the tanks on three sides (northern, southern and western); access constraints prevented the excavation from completely exposing eastern end of the tanks. Both tanks were orientated from east to west and measured approximately 1.8m in diameter and are estimated to be 10m in length. The depth to the top of the tank was estimated to be 1.7m bgl. It is noted that based on a 1.8m diameter, the base of the tanks would be at an approximately depth of 3.5m bgl. Excavations TP203 and TP204 would therefore have been deep enough to coincide with lower half of the tanks i.e. most likely area of soils to have been impacted by any leaks originating from tanks. Further excavation was then undertaken along the northern side of the tank (TP205). Ground conditions were consistent with reworked naturals encountered in TP204; however, these soils were identified to extend to the base of the hole at 4.6m bgl.

- 3.12 Both tanks appeared to be in good condition with **no evidence of corrosion, damage or loss of integrity**. No visual or olfactory evidence of hydrocarbon contamination associated with tanks was observed. However, a small area of staining (no odour or elevated PID readings) possibly representing a minor historical spill from surface was identified along the northern side of the tanks extending to a depth of approximately 2.4m bgl. As noted above the USTs are located immediately off-site, rather than within the planning boundary.
- 3.13 The excavation around the tanks has been temporarily re-instated pending arrangement of tank decommissioning and removal at a future date. This comprised backfilling with arisings and sealing of the surface with concrete to prevent infiltration of surface water.

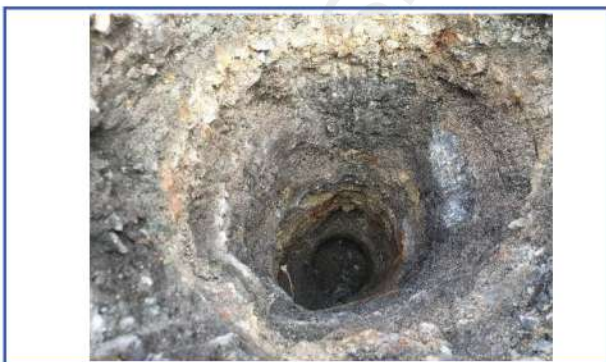
- 4.3 Made Ground was encountered from a depth of 0.15m bgl to a depth of 18.8m bgl and comprised a mixture of both granular and cohesive material.
- 4.4 Granular Made Ground was encountered to a depth of 2.7m bgl which was broadly similar to Made Ground encountered within trial pit excavations undertaken both in the former forecourt of the petrol filling station and offsite adjacent to the west of the former shop footprint. However, slight hydrocarbon odour was noted from 0.15 to 0.6m bgl likely associated with coal tar within bituminous materials.

*BH201 – hand pit*

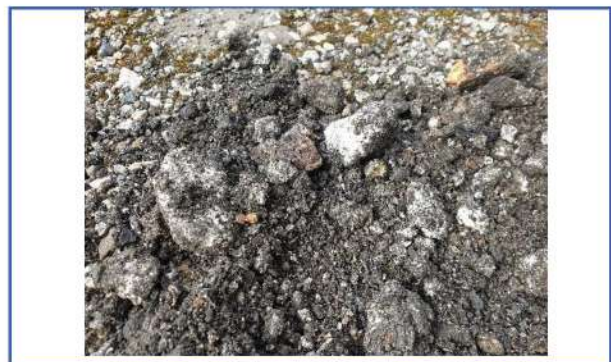
*BH201 arising to 2.7m bgl*

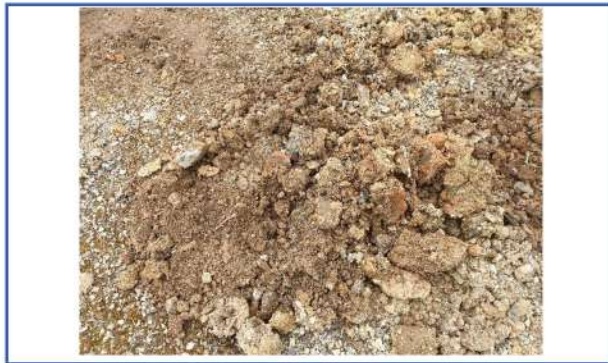
- 4.5 This was underlain by predominantly cohesive Made Ground to a depth of 10.3m bgl. Cohesive Made Ground comprised slightly sandy gravelly silty CLAY with varying amounts

and types of anthropogenic constituents. Localised high proportions of metal were encountered throughout the cohesive Made Ground as well as occasional coarse gravel size fragments of coal tar with an accompanying slight hydrocarbon odour. Suspected ACM cement was encountered from 4.7m to 6.5m bgl. Organic clay and inclusions of wood were encountered within cohesive Made Ground from 7.9m bgl to 9.3m bgl.

*BH201 representative arisings 2.7-6.5m*

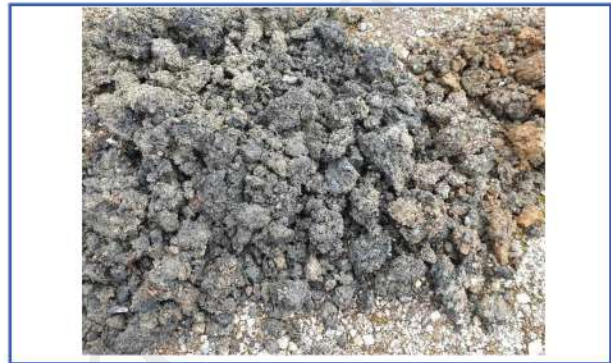
*BH201 representative arisings 7.9 – 9.3m bgl*

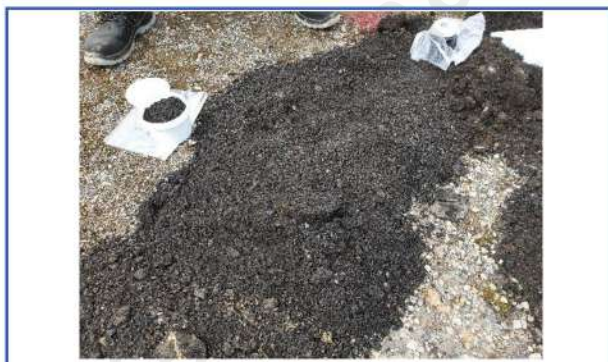
- 4.6 From a depth of 10.3m bgl to base of Made Ground at 18.8m bgl Made Ground was granular and predominantly comprised black silty sand GRAVEL with high ash content. This material was considered to be consistent with bottom ash. Other anthropogenic materials in minor quantities included metal, brick, wood and slate. Suspected ACM cement was encountered at a depth of 11m bgl. From 18m to 18.8m bgl materials appeared to comprise demolition rubble and included degraded coal tar likely from felt roofing as well as brick, slate and concrete.

*BH201 – representative arisings 10.3-18m bgl*

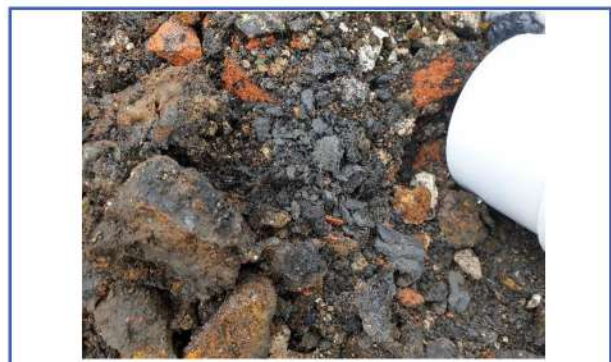
*BH201 – representative arisings 18-18.8m bgl*

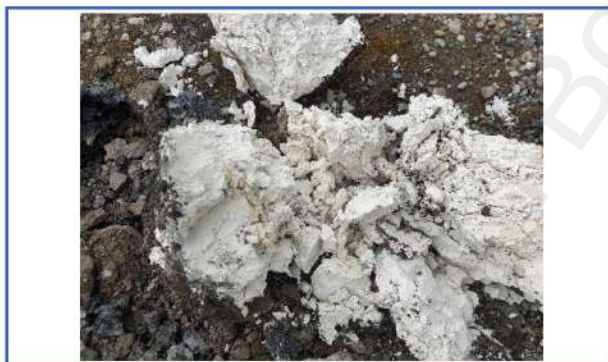
- 4.8 Chalk arisings were encountered from a depth of 18.8m bgl. These became damp from approximately 20m bgl and were recovered as silty water from below the water strike at 21m bgl. A band of flint was encountered from 25 to 25.3m bgl.
- 4.9 It appears from early recovery of arisings that chalk is likely structured at this depth, however, recovery was limited and became structureless in appearance when damp. Chalk arisings were therefore described as structureless chalk composed of cream slightly gravelly SILT. Gravel is medium density and white with rare inclusions of flint gravel.
- 4.10 No visual or olfactory evidence of hydrocarbon or solvent contamination was identified. No elevated concentrations were identified from in-situ PID headspace readings.

BH201 – Chalk arisings 18.8 to 20m bgl

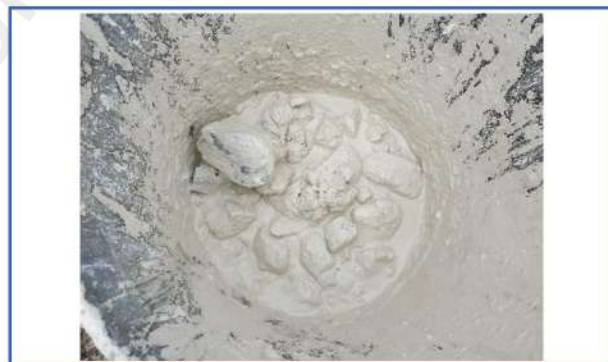
BH201 – chalk arisings circa 25m bgl

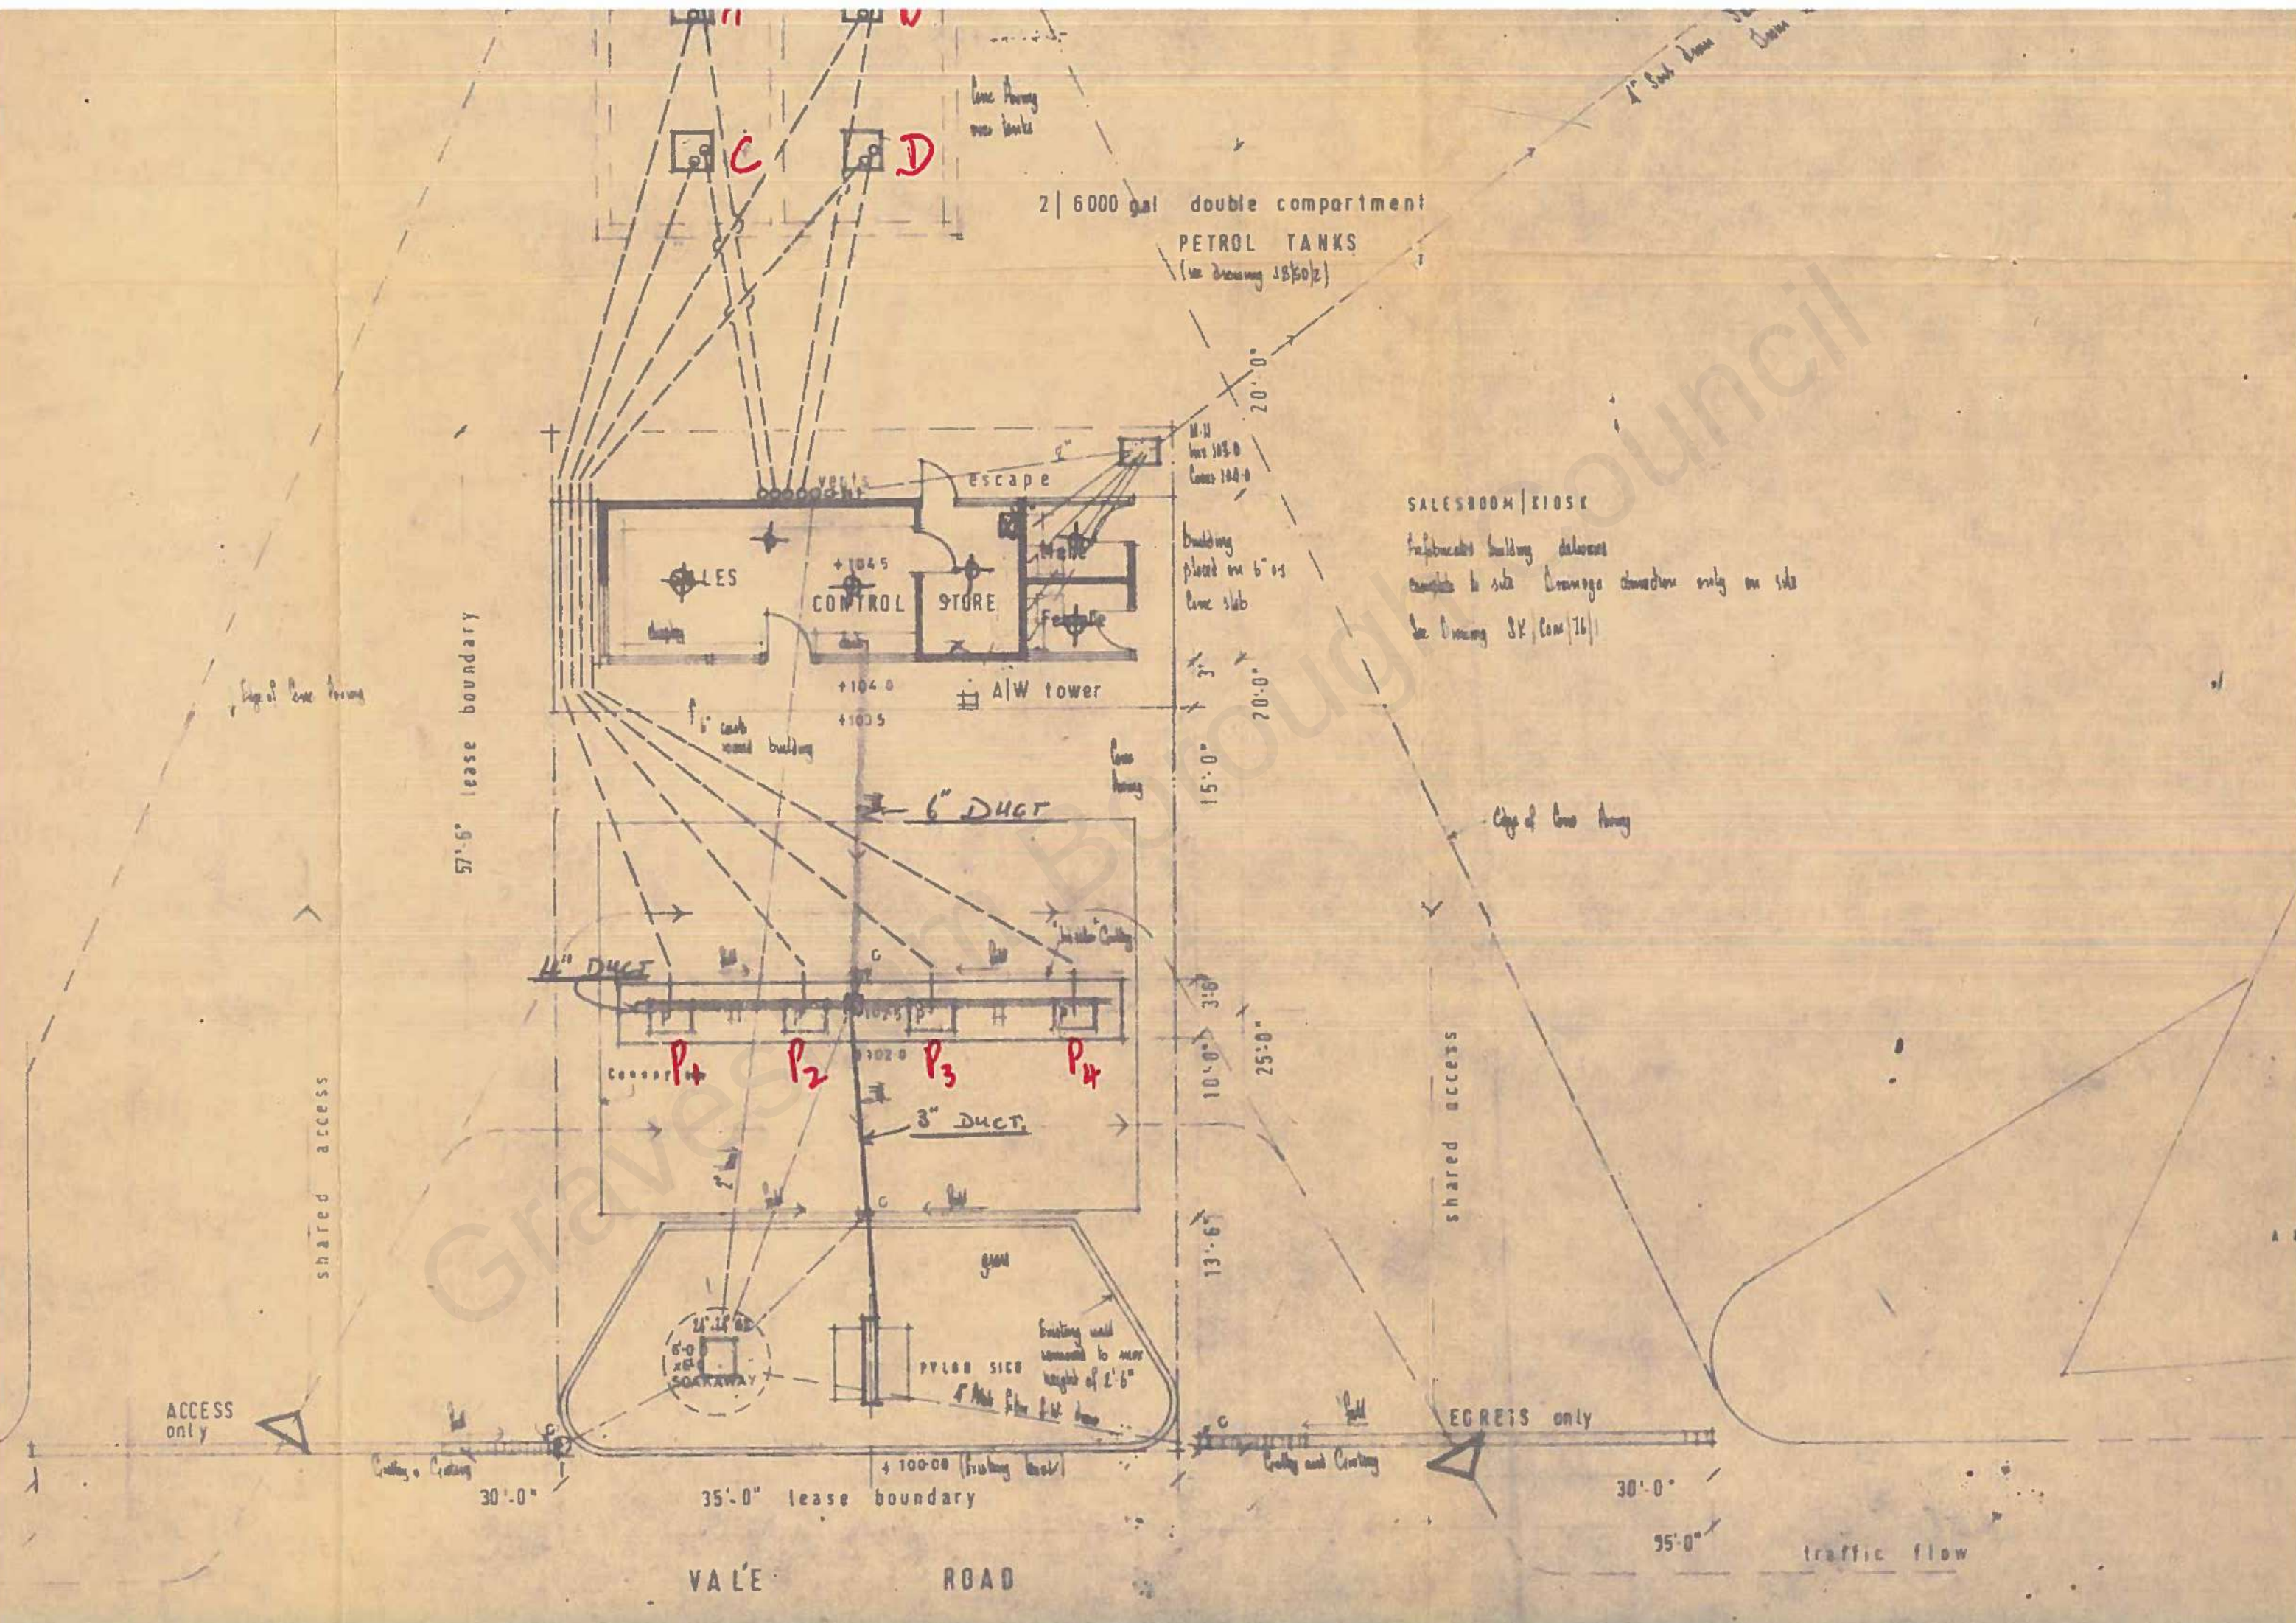
2 | 6000 gal double compartment  
PETROL TANKS  
(see drawing 18/50/2)

SALESROOM/KIOSK  
fabricated building delivered  
complete to site. Dimensions shown only on site  
see drawing 38/16/1
