MILTON MOUNT CHURCH,  
CLARENCE PLACE, GRAVESEND,  
KENT, DA12 1LD

LEVEL 3 HISTORIC BUILDING RECORD  
WRITTEN SCHEME OF INVESTIGATION

Prepared by HB Archaeology & Conservation Ltd  
Project No. 2023535  
September 2023

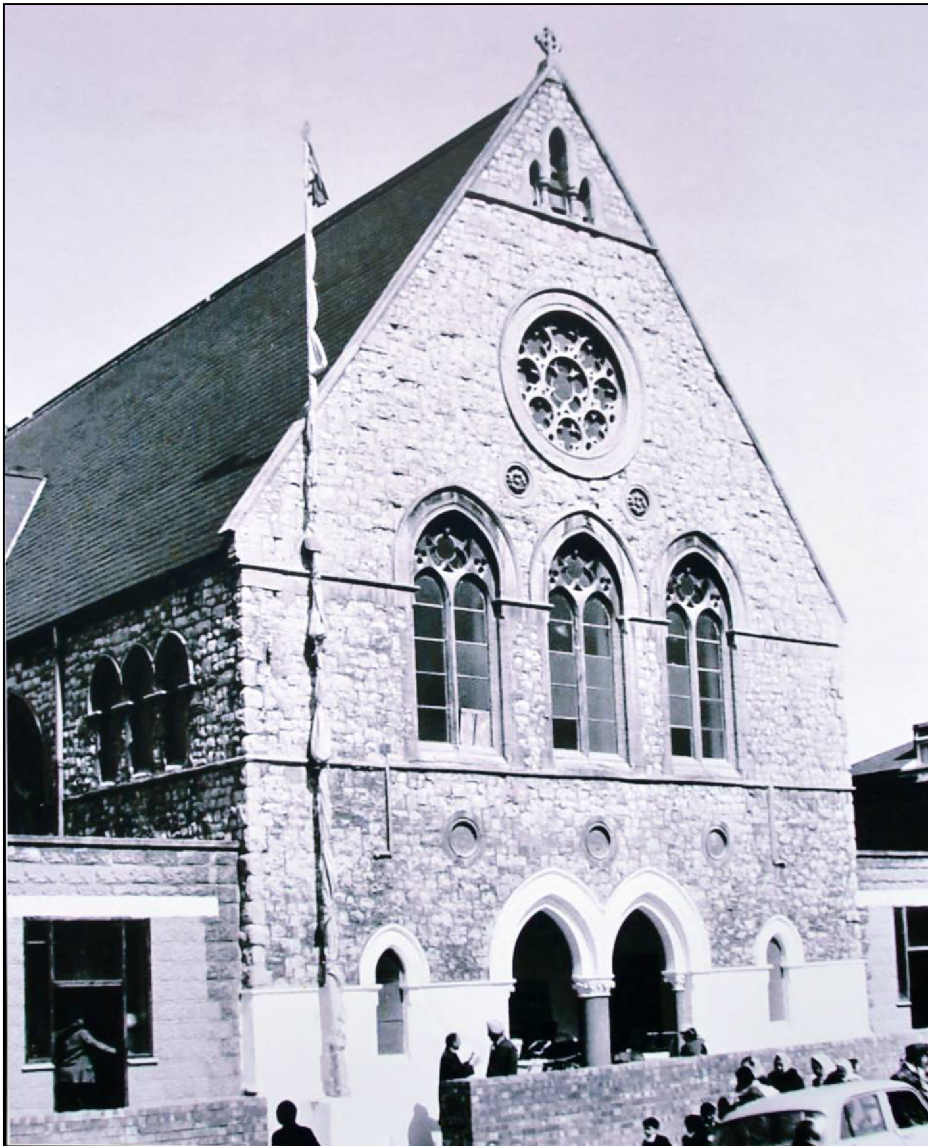
Plate 3: A view of the Clarence Place elevation showing the two loading bay extensions added in 1955 *in situ*, converted to cloakrooms in 1968

- 6.1.17 The first extensions to the group were the southern additions to the two aisles: these were added by Wholesale Trading Supplies Ltd in 1955 as loading bays. The loading bays were converted to cloakrooms in 1968 as part of the Sikh temple facilities, soon after they took ownership of the site in 1967. Extracts of the planning proposals show the layout and the associated alterations to the ends of the aisles to accommodate them (Plate 3).

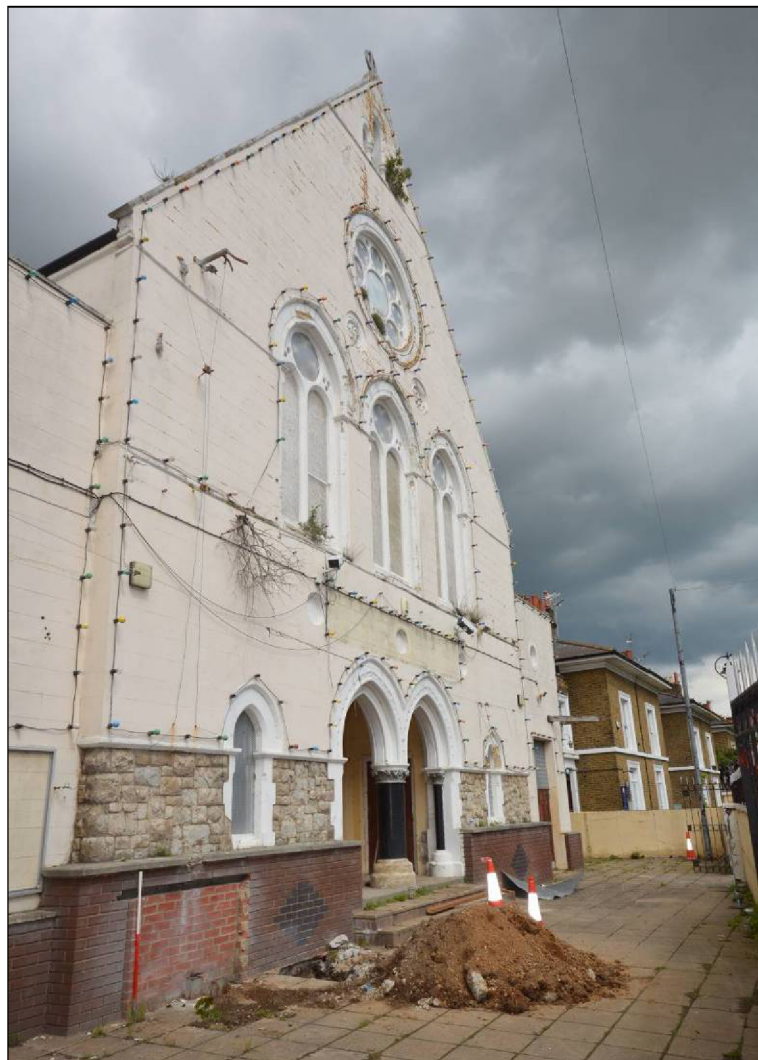
- 6.2.1 The south elevation of the building is the gabled end of the church, fronting onto Clarence Place. The centre of the elevation at ground floor level comprises the arcaded entrance: two pointed-arched openings raised above external ground level and accessed via a short flight of steps (Plate 9). The entrance arcade includes a central pillar and side shafts of red Aberdeen granite, the arrangement is flanked by a pair of single-light, pointed arch-headed windows that light the lobbies within the entrance area (Plate 9; Figure 2).
- 6.2.2 The original ragstone rubble masonry walls are partially exposed, concealed from the window sill level to the ground surface by applied brick plinths of 20<sup>th</sup> century origin (Plate 9). The remainder of the elevation is under render, except the Bath stone dressings to the openings.

Plate 9: The front (south) elevation of the church looking northeast (scale 1.00 metres)

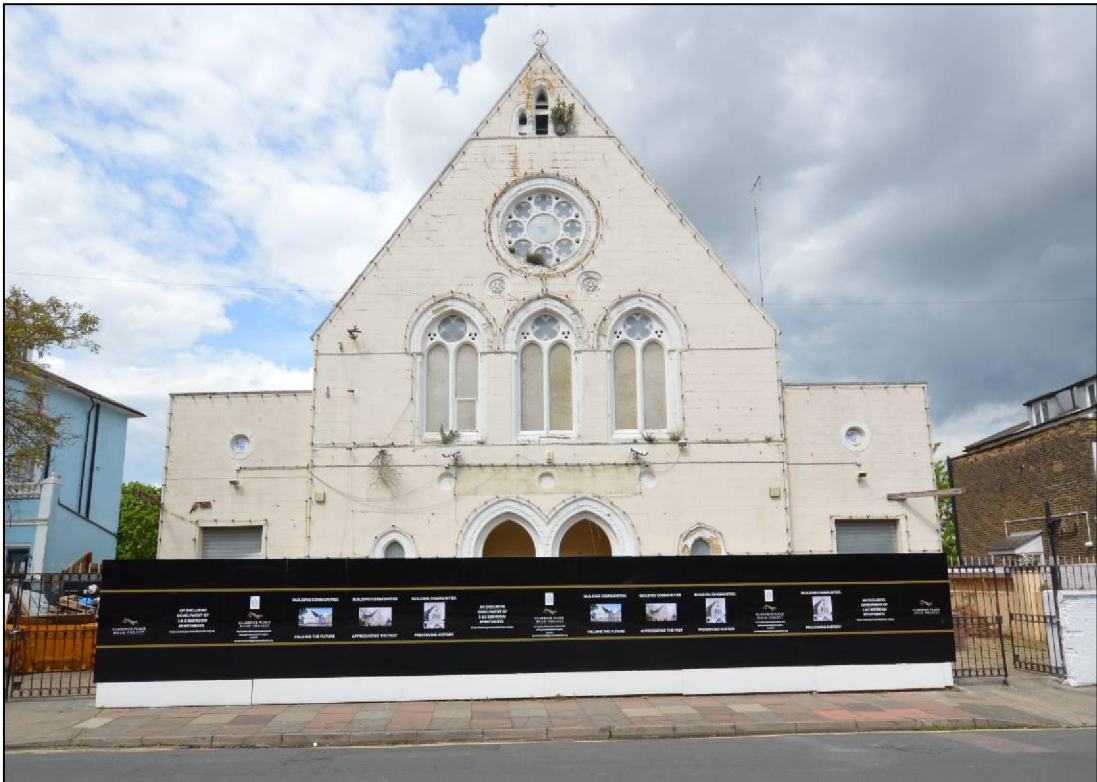
Plate 10: The feature front, the south elevation of the church fronting onto Clarence Place

- 6.2.3 The first floor part of the elevation comprises a tripartite feature window, a group of three pointed arch-headed openings each of two lights surmounted by quatrefoil tracery (Plate 10).. The tripartite window is in turn surmounted by a large circular

'rose' window. Two round plaques with carved motifs sit between the base of the rose window and the arched heads below and a further three round recessed plaques of plainer design are situated between the base of the tripartite arched window and the entrance arcade (Plate 10). Further embellishments are included at the apex of the gable: this comprises another tripartite opening, a ventilator comprising a taller central pointed-arch flanked by a lower pair, the parts separated by carved columns (Plate 10). The finial currently *in situ* replaced the original carved cross when the building was converted to its temple function.

6.2.5 The two extensions are set back from flush to the principal south elevation of the church. The additions are box-like with flat roofs and a rendered finish embellished by incised ashlar lines. Both extensions have wide central doorways surmounted by simple circular windows (Plate 10). The base of the additions have plinths of brown brick laid in stretcher bond (Plate 9: this continues onto the base of the church elevation indicating that the intervention occurred when the extensions were altered to their current form during the late 20<sup>th</sup> century.

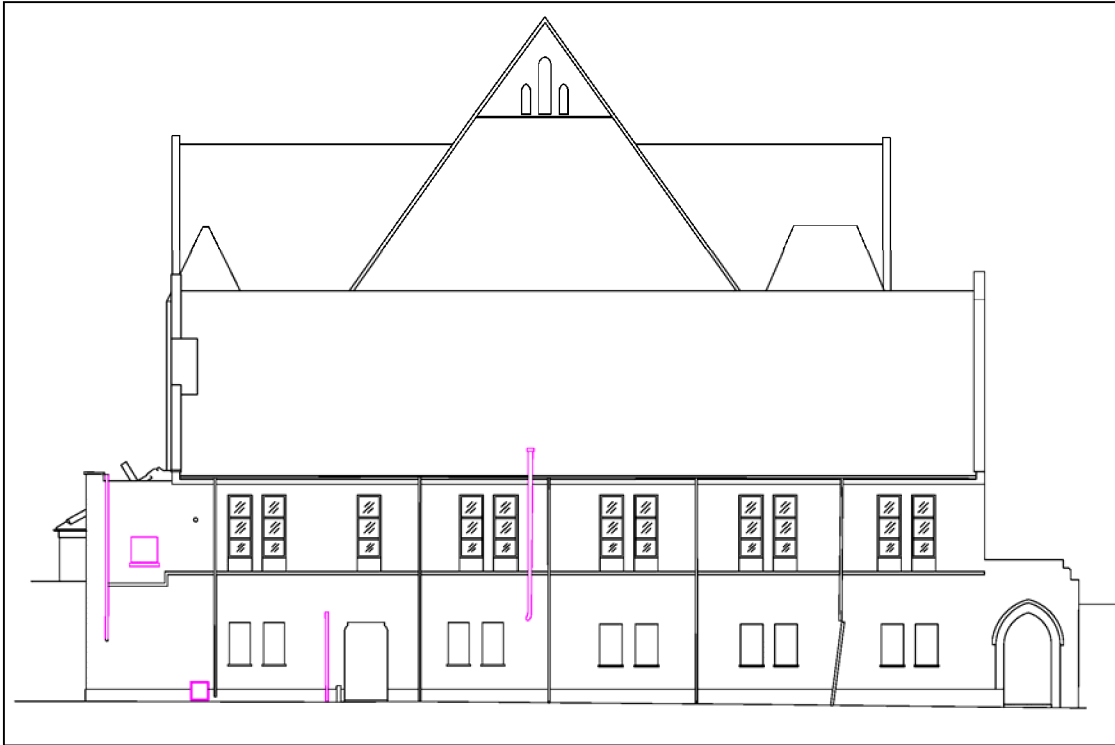
6.2.6 The north elevation of the property fronts onto William Street and comprises the side elevation of the former purpose-built school building. The school, at two storeys in height, had a substantially lower ridge-line in comparison to the church proper, emphasising the hierarchy and different functions of the two ranges (Plate 11).

Plate 11: The north elevation (based on the drawings prepared by Survey and Engineering Services Ltd for Haskins Designs)

- 6.2.8 The final features on the north side of the group is the pointed arched opening at the eastern end of the building: this is an external entrance leading to the narrow courtyard on the western side of the church. A single modern window is situated at the western end of the building: this lights the interior of the WC facilities in that location, concealed behind a parapet effect on the north side of the group (Plate 11).

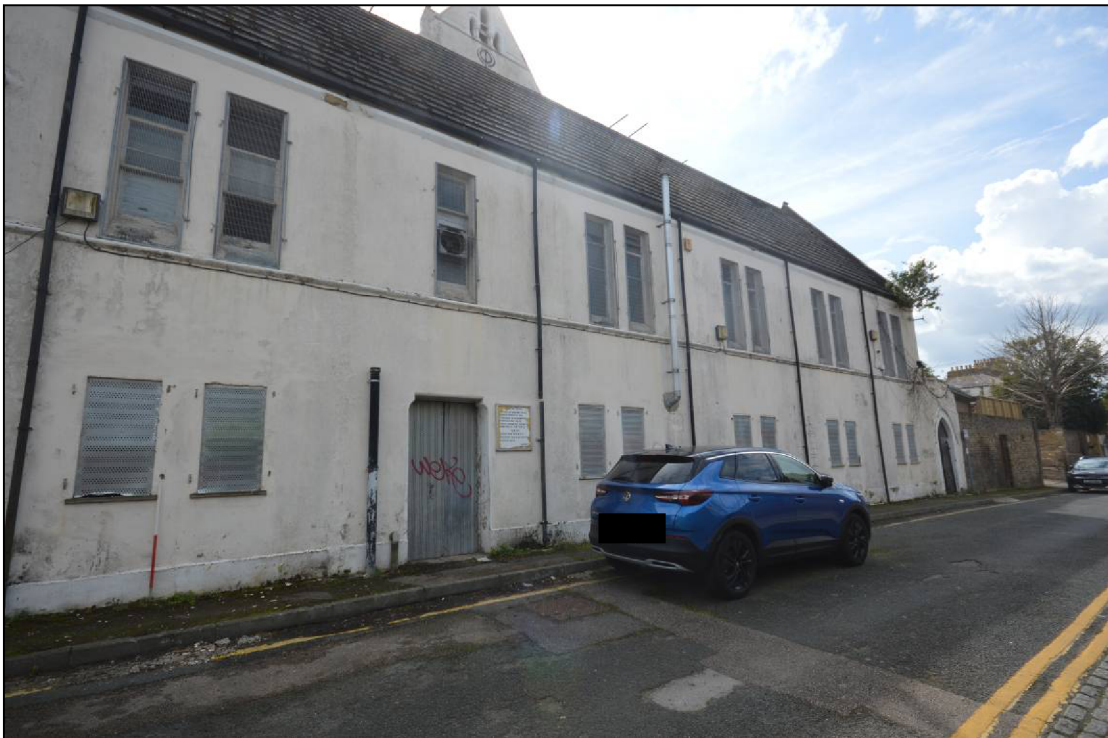
Plate 12: An oblique view of the north elevation as existing in 2023

- 6.2.7 The north elevation comprises a single entrance with a shouldered-arch head, situated towards the eastern end of the range: this leads to the lower ground floor and the stair hall (Figure 2). The remainder of the elevation comprises windows arranged in pairs at regular intervals. The fenestration for the upper ground floor is laid out to

match that of the floor below, with an additional single-light window over the entrance (Plates 11 and 12). The subtle embellishments to the elevation comprise a moulded string course at the base of the upper ground floor windows and a moulded cornice. The roof is gabled at each terminal and is under a cover of slate.

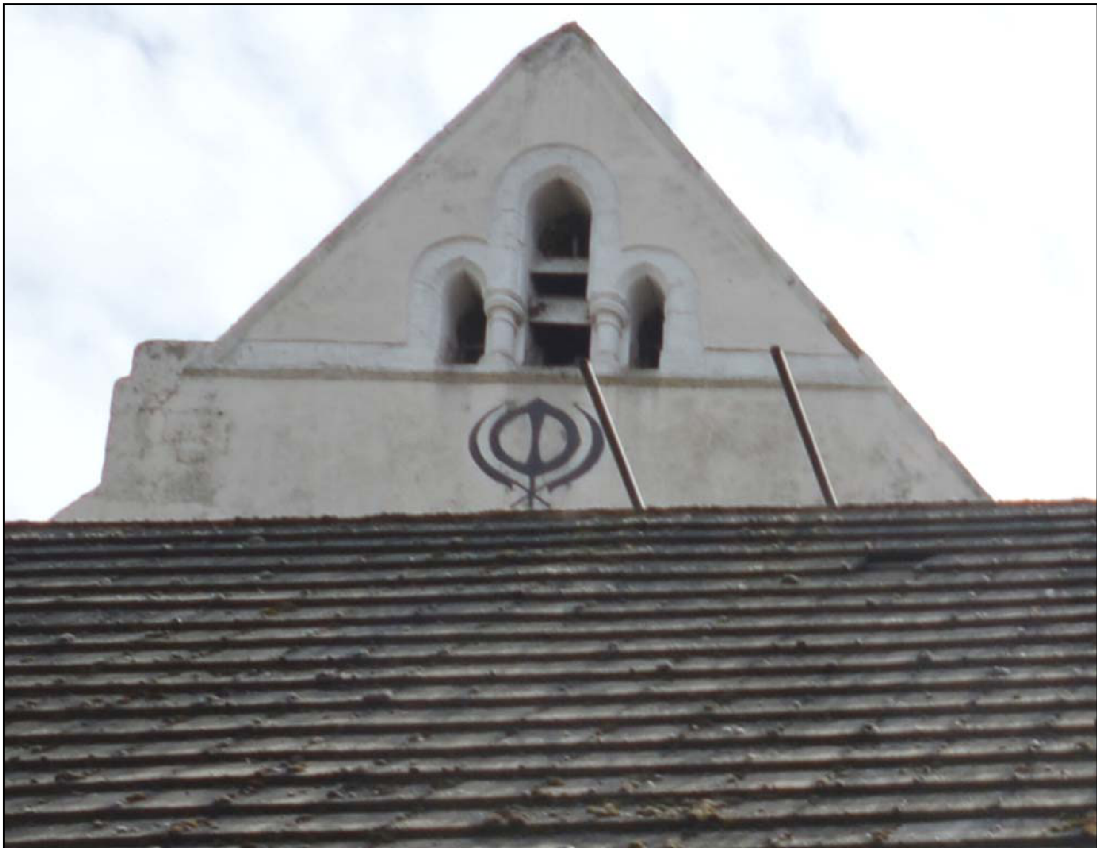
Plate 13: The north gable of the church

- 6.2.9 The north gable of the church rises above the roof-line of the former school building. The gable is pierced by another tripartite ventilator to match that *in situ* at the front of the church (compare Plates 10 and 13). A decorative band defines the base of the windows and extends to the slopes of the roof: this steps out to the east side in the location of the former (now truncated) chimney stack that had served the fireplace in the minister's vestry at the northern end of the east aisle. The painted motif below the ventilator relates to the temple function of the property.

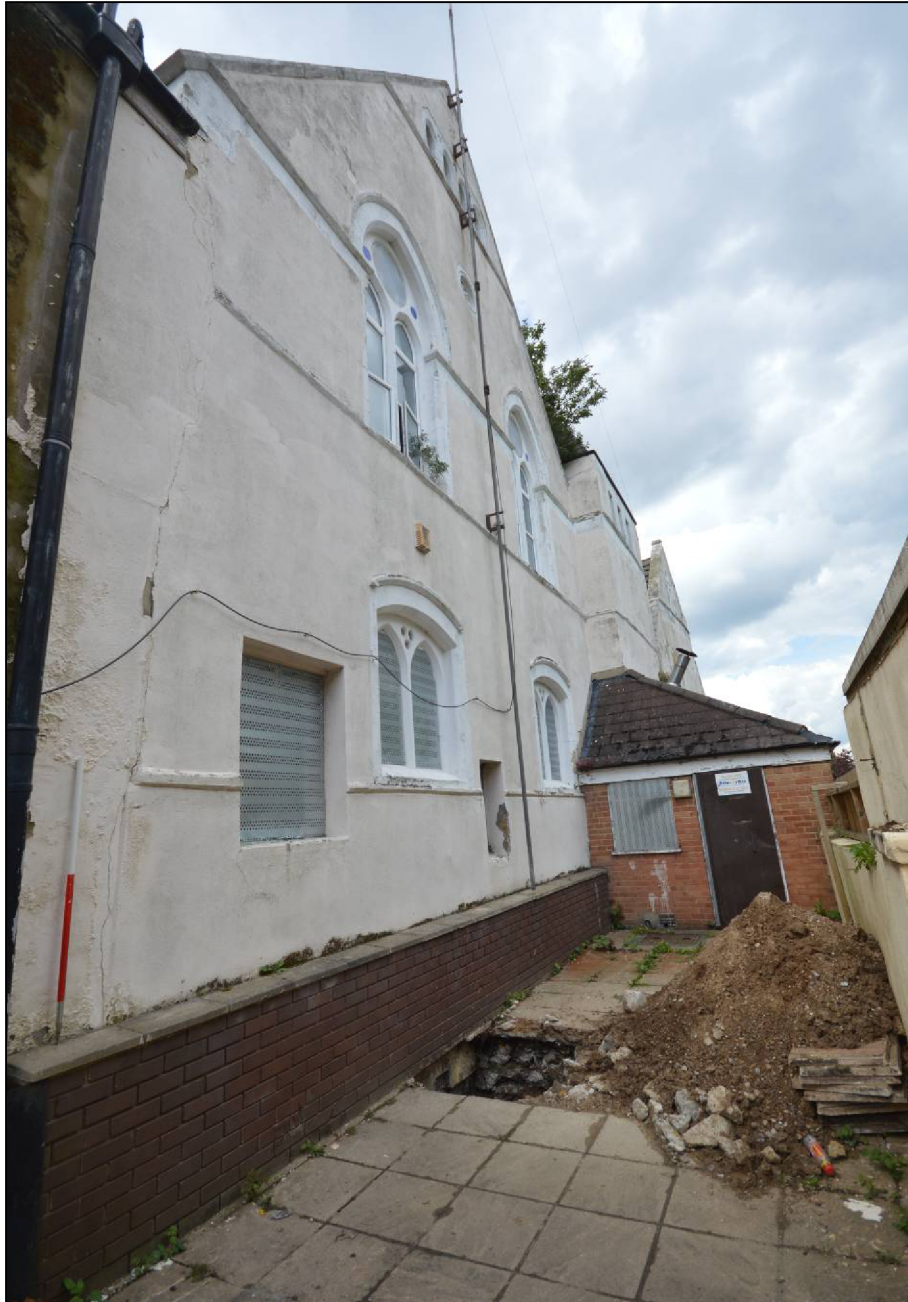
- 6.2.16 Two modern windows have been inserted into the wall at ground floor level: these are plain rectangular openings that interrupt the string course in that location. The applied brick plinth described above for the south elevation and the 20<sup>th</sup> century extensions has been continued along the length of the east elevation (Plate 16).

Plate 16: The east elevation and the porch added in 1982

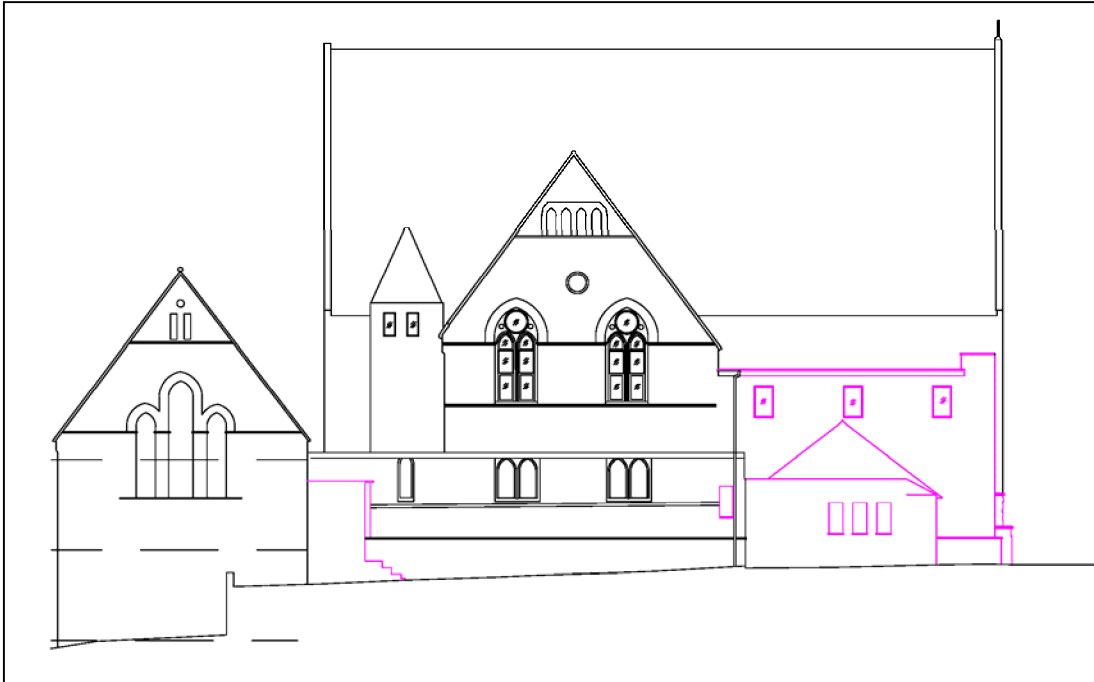
Plate 17: The west elevation (based on the drawings prepared by Survey and Engineering Services Ltd for Haskins Designs)

- 6.2.18 The west elevation of the school building comprises a feature tripartite window that lights the interior of the original school room on the upper ground floor (Plate 17). A doorway had been situated at ground floor window: this has since been blocked on the interior and there was no external access to the small courtyard in front of the doorway at the date the survey was undertaken.

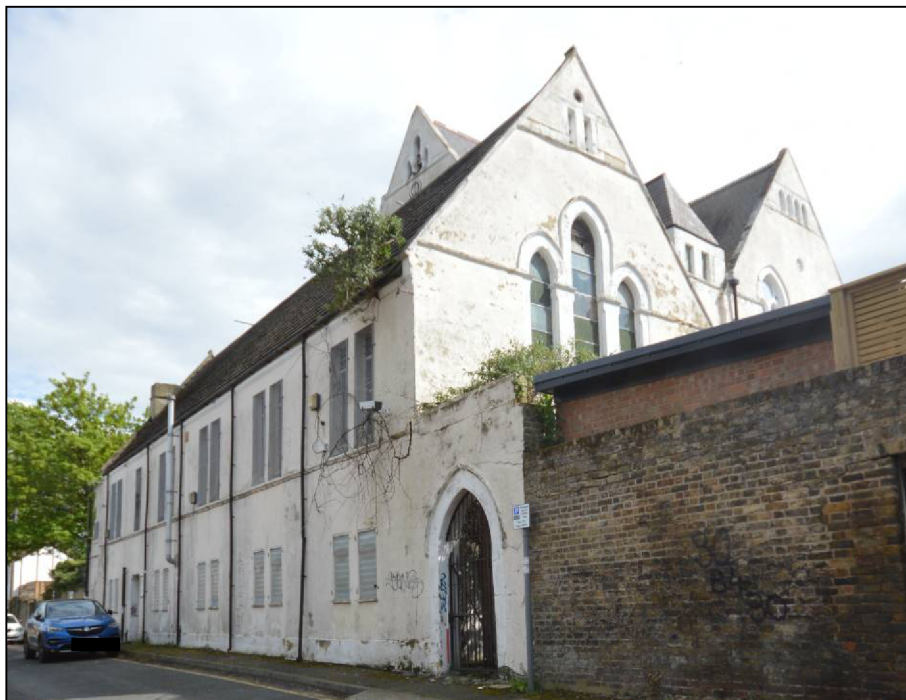
Plate 18: The west end elevation of the school, stair turret and west aisle from William Street

- 6.2.19 The gabled end of the school is under render: the capping to the eaves is moulded and there are two visible moulded string courses with at least one further course anticipated at the base of the tripartite window. The two extant string courses are situated at the springing point on the window and at the base of a two-light ventilator at the apex of the roof.
- 6.2.20 The tripartite window includes a tall central light flanked by a pair of lower lights, all with pointed arched heads. The string course is punctuated by the openings yet picked up again on the columns that separate each light (Plates 17 and 18).
- 6.2.21 The ventilators match those *in situ* at the eastern end of the school range, surmounted once again by a circular opening (Plate 18).

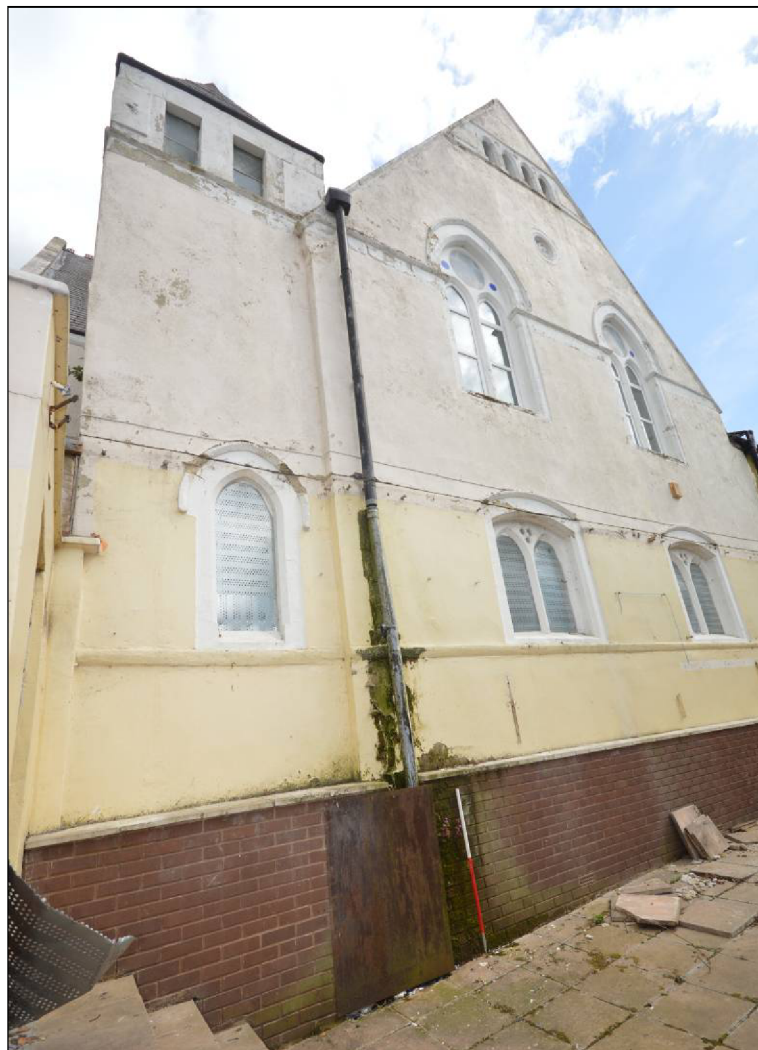
Plate 19: The west side of the building showing the stair turret and west aisle

- 6.2.23 The ground floor window is a single light one with chamfered leading edges and a prominent moulding that is almost more of a hood-moulding in this instance (Plate 19). The two plain rectangular openings at the eaves do not sit well within the tower and it is possible that they had been altered in the 20<sup>th</sup> century to the current form (Plate 19).
- 6.2.24 As before, the applied brown brick plinth continues along the entirety of the west elevation excepting the location of the WC facilities added in 1982 and removed by the date of this survey.

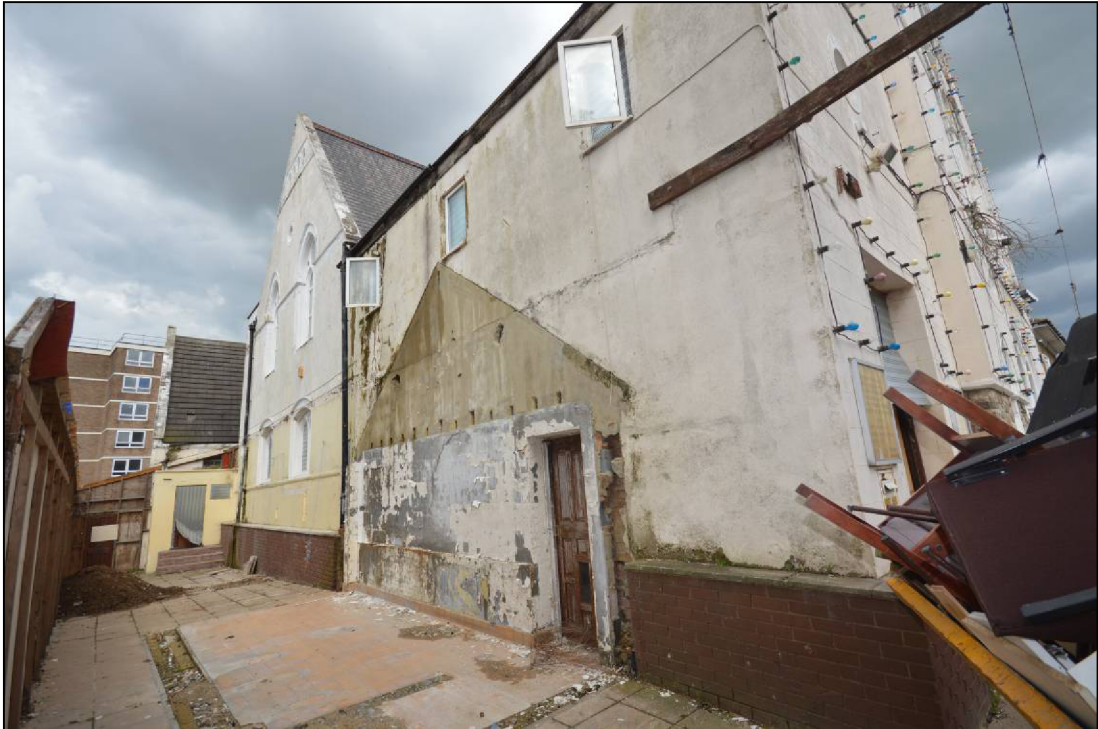
Plate 21: The southwest extension and the scars left by the addition made in 1982 to accommodate new WC facilities

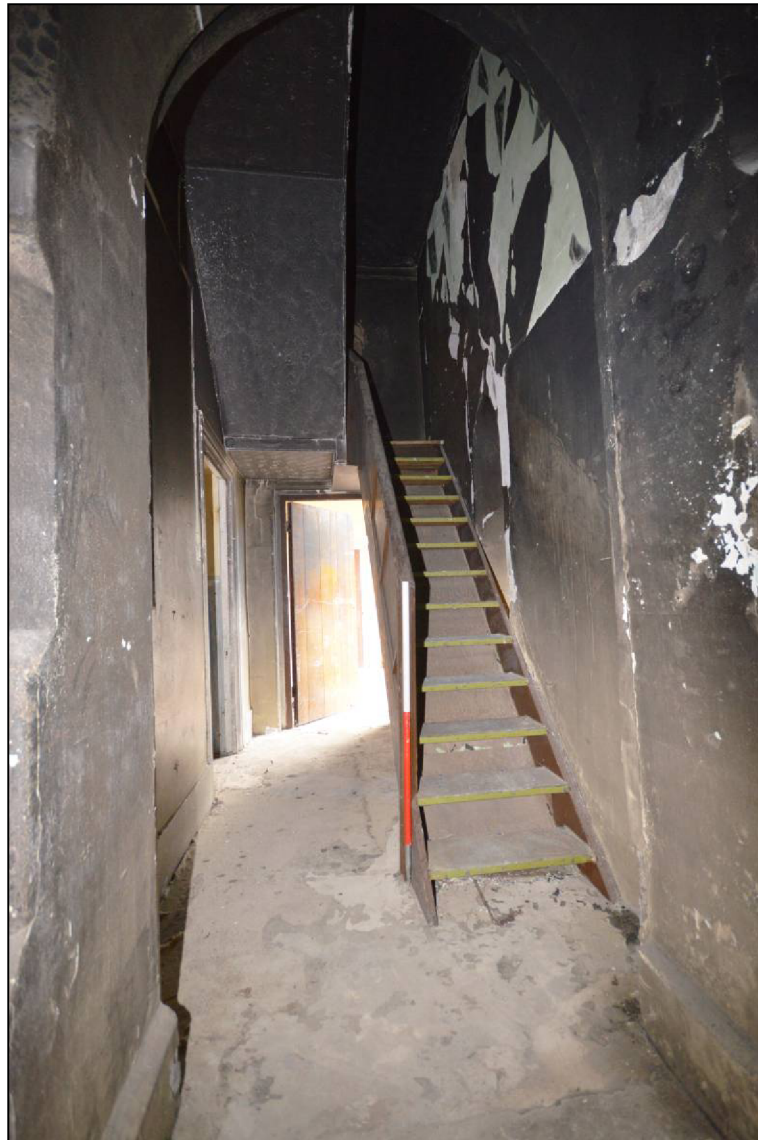
Plate 24: Interior of the west lobby and staircase leading to the south gallery

- 6.3.3 The west lobby has rendered walls, a concrete floor and an under-plastered ceiling. The staircase rising to the south gallery is a plain and very basic straight flight of stairs that overly the southwest window. A pointed arch-headed entrance, with its door removed, is situated to the west side of the lobby providing external access in the first instance, later utilised to link the lobby to its southwestern extension. A further doorway leads from the west lobby to the interior of the church: the door is no longer *in situ*.

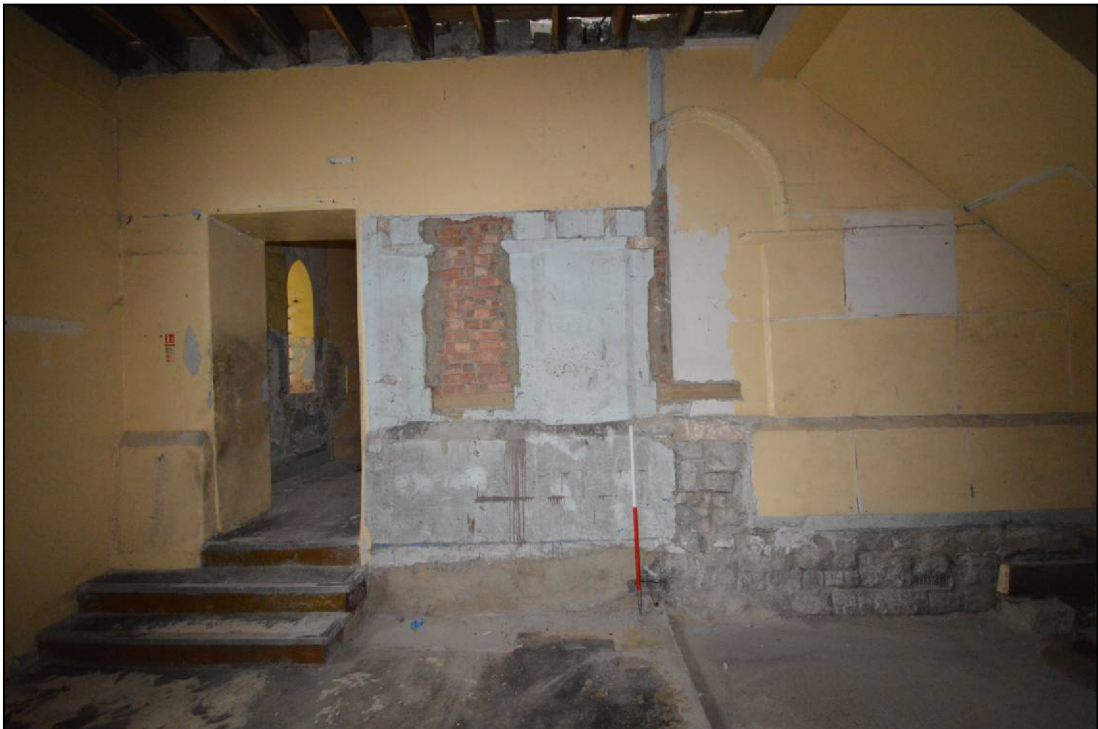
- 6.3.4 The east lobby matches the west lobby in terms of finishes: the plain flat-arched head to the entrance in the east elevation indicates that it was a later alteration to the building, added to access the extension.

Plate 26: the inserted doorway in the east elevation of the east lobby, viewed from the extension added in 1955

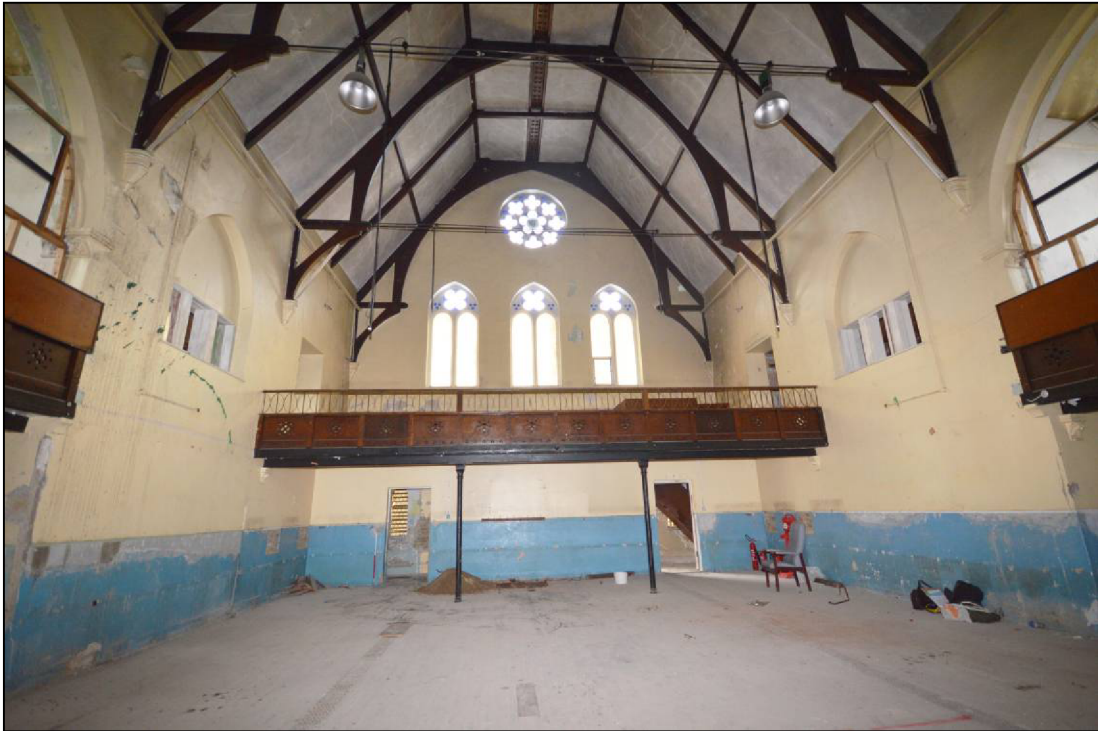
Plate 27: The nave looking south towards the gallery and entrance areas

- 6.3.6 The nave, excepting its south gallery, was full height, entirely open to its hammer-beam roof (Plate 27). The north end of the room had included a raised platform as shown on the 1874 plan (Plate 1). The platform was raised in front of a tall pointed-arch-headed recess in the wall (Plate 28): this had framed the organ and created a strong focal point of the group at the northern end of the nave where the minister would have led his congregation.
- 6.3.7 The walls of the church are under render, the floor is a suspended timber one comprising floorboards at 160 mm wide by 30 mm thick raised over joists that are 50 mm wide by 80 mm thick, set at 400 mm centres.

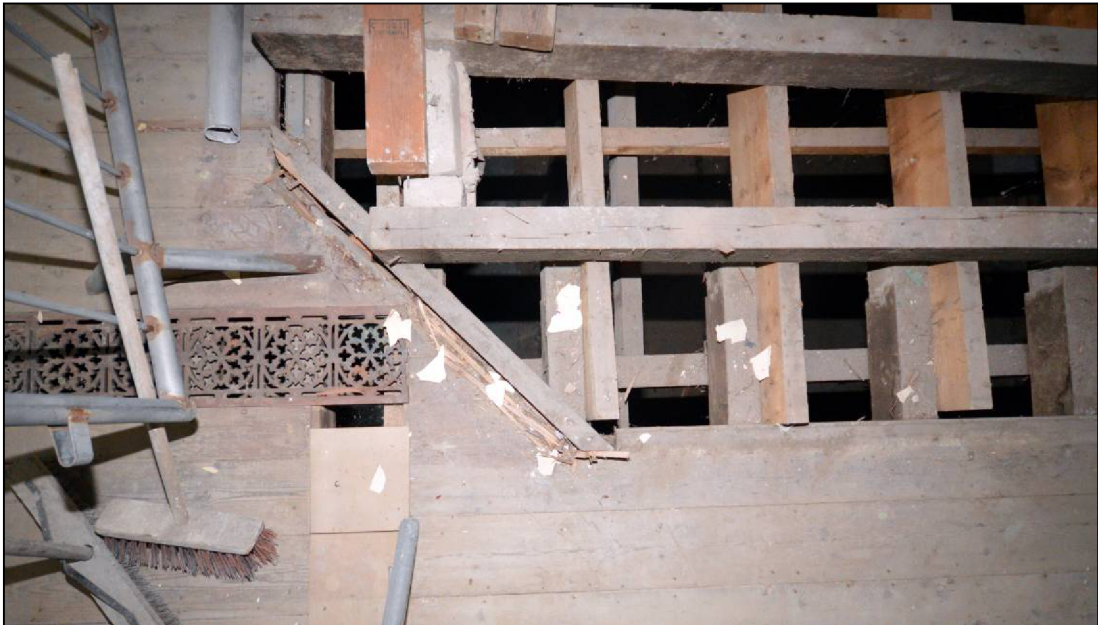
Plate 29: Detail of the canted southwest corner of the dais platform, the joist arrangement and the integral grilles, part of the heating system

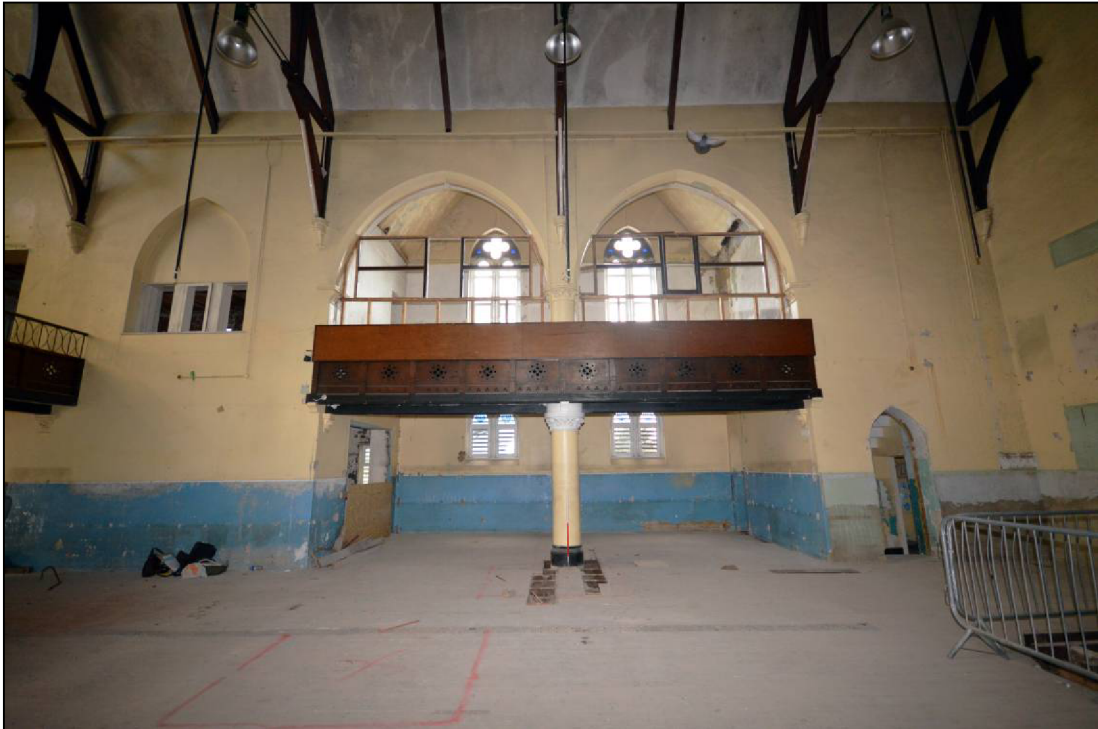
Plate 30: The west aisle arcade and the blocked high-set window to the south of it illustrating the extent of natural light that would have suffused the church at the date of construction

- 6.3.9 The nave is lit by the tripartite and rose windows set within the south elevation: additional light was not doubt provided by virtue of two high-set arch-headed windows just north of the south gallery (Plate 30), in addition to the tripartite groups that lit the south gallery prior to the addition of extensions in 1975. The south group included windows below and above the gallery in that location: all are now blocked.

- 6.3.10 The northern end of the nave no doubt benefitted from the borrowed light derived from the four windows in each side elevation of the aisles; two to each floor as described above (Plate 30).

- 6.3.13 The consistent pointed-arch theme was continued into the arcades that defined the boundary between nave and aisle (Plate 30). A tall graceful pair of arched openings separated by columns with floral carved capitals dominated the side elevations of the nave between the south gallery and dais (Plate 30).
- 6.3.14 The south gallery is simpler in style, the structure supported on two slim columns with moulded capitals. In all cases, the plate supported by the columns is in turn supported by carved corbels with floral detail (Plate 31).
- 6.3.15 All three galleries are defined by low timber balustrades: these are panelled and each panel is embellished with a pierced motif that picks up on external window details.

- 6.3.11 A group of three doorways with pointed arch-heads were situated at the north end of the nave: one each to the two stair turrets and a third leading from the northeast corner of the nave into the school building (Figure 2; Plates 28 and 30).
- 6.3.12 At the south end of the nave, below the gallery, two plain doorways provide access to the lobbies and entrance area; their plain, functional form emphasising the hierarchy within the church, access to the south and a focal point for worship to the north (Plates 27 and 28).

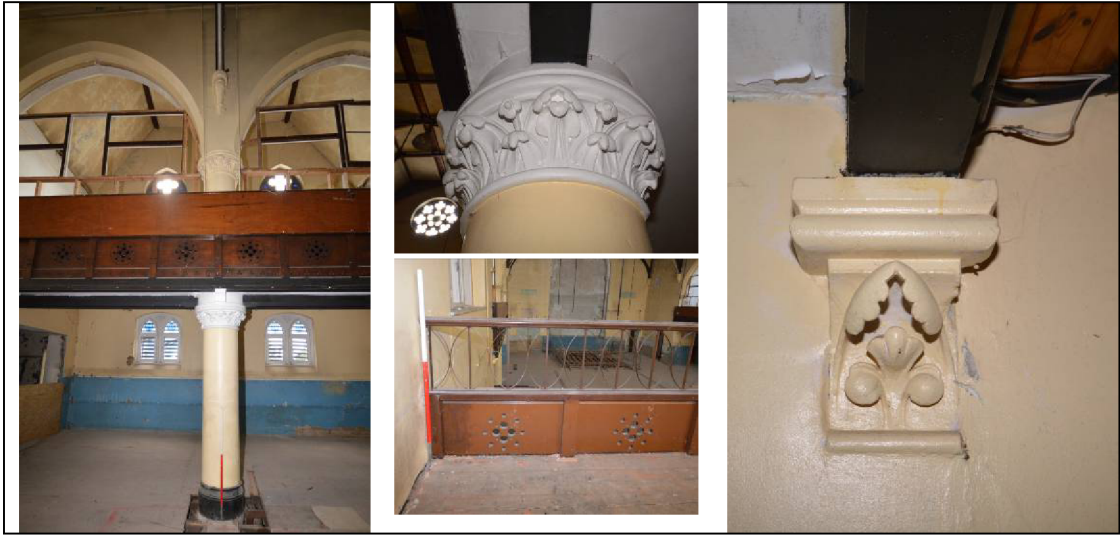
Plate 31: Decorative detail in the aisle and gallery construction

The pierced element comprises a series of groups of three circles (representing the Holy Trinity) surmounted by a recessed centrally situated circle, in turn embellished by further pierced detail (Plate 31). The south gallery balustrade includes a low timber-framed extension that borders decorative metal detail, intended to raise the height to a safer level at a later date in the building's evolution. The two aisle gallery balustrades have been raised by adding plain hardboard panels (Plates 27, 30 and 31).

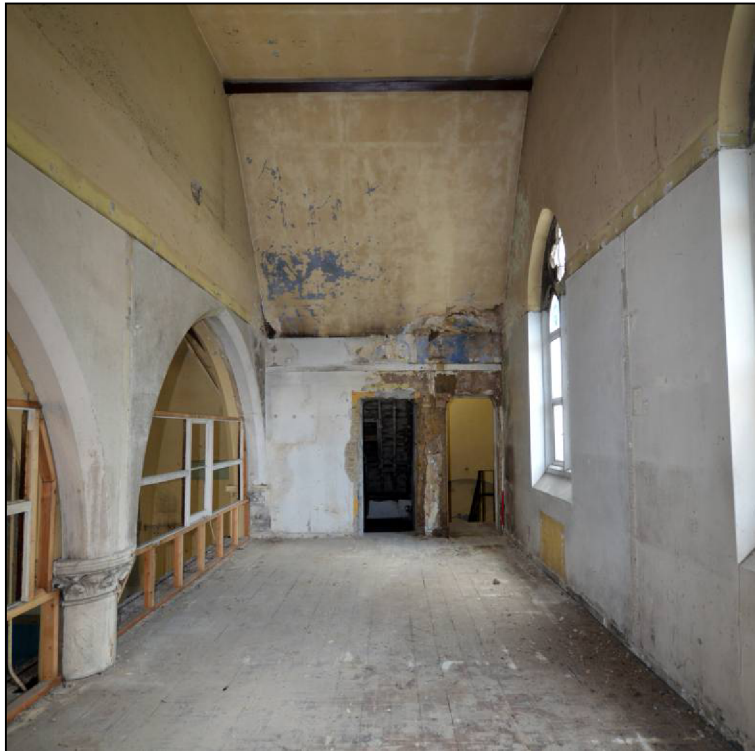
Plate 32: The north end of the east gallery showing the interior, the later in-fill of the arcade and the access to the stair turret

- 6.3.16 The first floor of each aisle gallery has been much altered, the arcade enclosed and fitted with modern windows (Plate 32). The suspended timber floors remain *in situ*, the walls rendered and the ceilings and skeelings under-drawn (Plate 32).
- 6.3.17 In both aisles, access was via the neighbouring integral stair turret: on the eastern side of the church, a small ante-chamber had been included within the turret, accessed from the gallery (discussed below). The doorway access from the turrets to the galleries were plain flat-arched openings (Plate 32).
- 6.3.18 Later inserted openings at the south end of the west aisle provided access to the first floor extension made to the southwest corner of the church in 1975 (Plate 33).

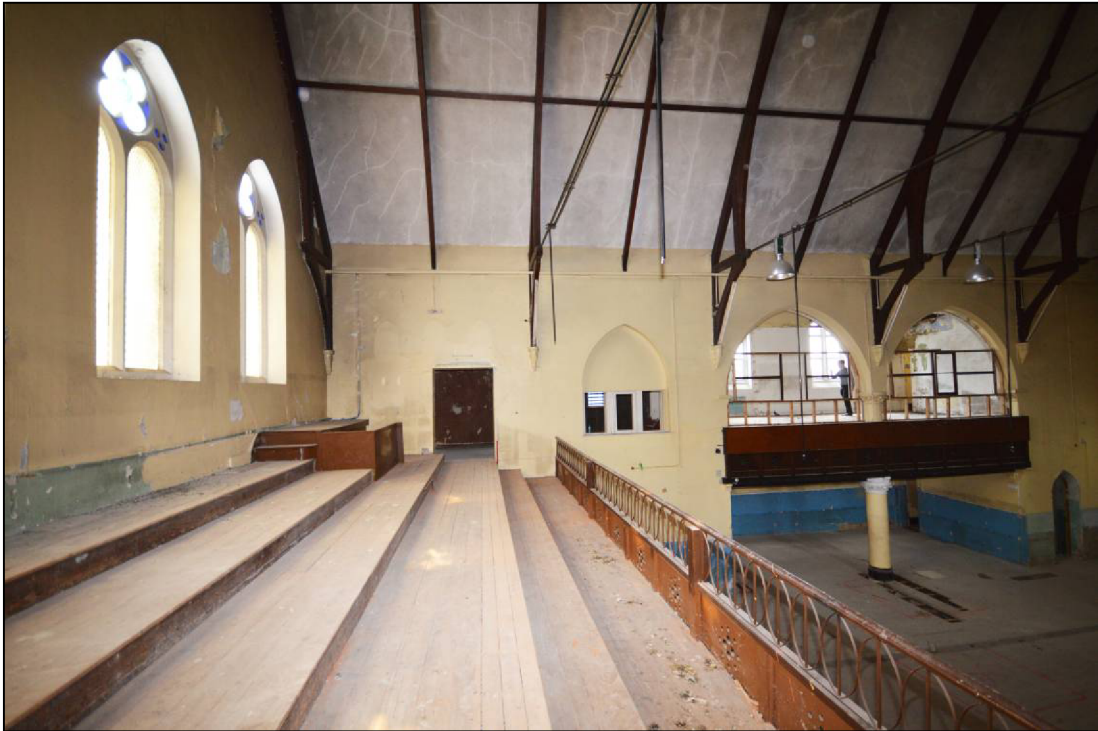
Plate 34: The west side of the south gallery showing the staircase and the entrance inserted into the west wall to link the aisle to the first floor extension added in 1975

- 6.3.19 The south gallery includes a series of wide steps rising from the balustrade to the south elevation, intended to raise the seating levels (Plate 34). The staircase occupies the southwest corner of the gallery, enclosed by a plain timber balustrade. A further raised platform is situated to the rear of the staircase enclosure (Plate 34).
- 6.3.20 Access to the gallery had initially been via the staircase in the southwest corner, the extensions made to the southwest and southeast corners of the church at first floor level in 1975 were carried out in conjunction with the insertion of two plain, flat-arched entrances flanking the gallery: these replaced the original tripartite window arrangements (Plate 3).

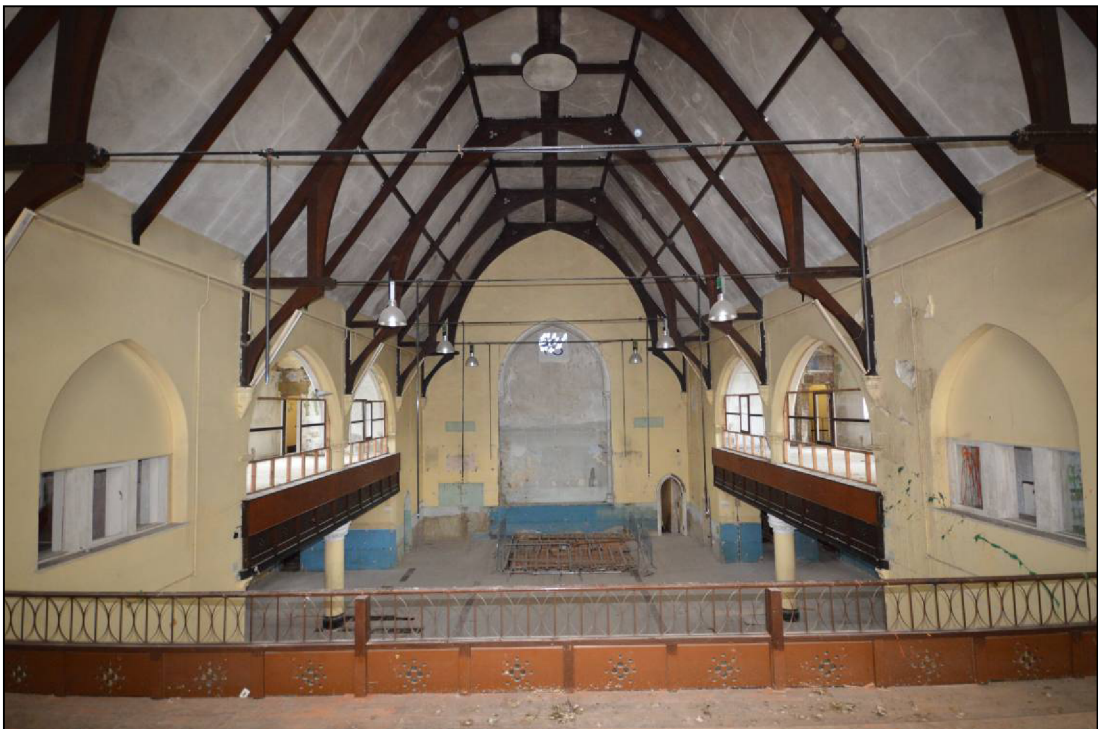
Plate 35: The interior of the church showing the galleries and the roof and ceiling construction

- 6.3.21 The roof of the nave comprises a series of six graceful hammer-beam trusses raised over moulded corbels, simpler intermediate trusses carry the structure over the remainder of the roof. The skeelings and ceilings, the latter set above collar level, are

under-drawn concealing the remainder of the roof structure (Plate 33). The enclosed apex of the roof is well ventilated by virtue of the gable ventilators visible on the exterior of the building as described above.

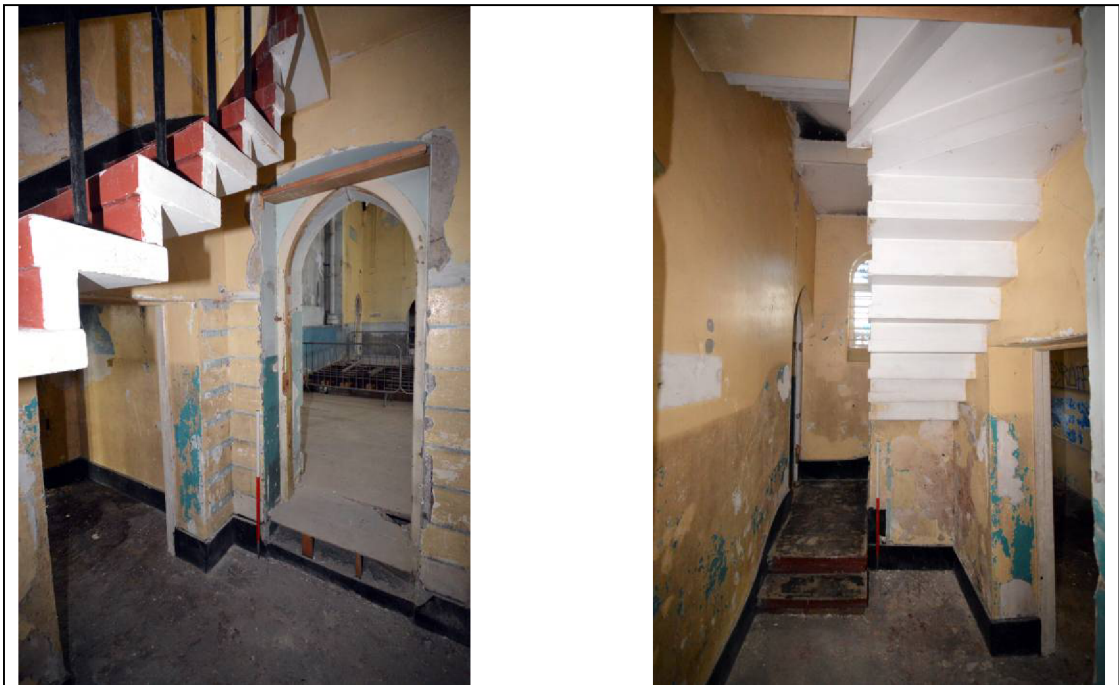
Plate 37: Details of the stair turret staircases

- 6.3.22 The two stair turrets include simple cantilevered staircases with plain metal balustrade and handrails (Plate 36). Despite the simplicity of the stair stylistically, the cantilevered form and purpose-built staircase enclosure with pointed arched windows and high-set groups of plain lights at the eaves lend an elegance to the construction (Plate 37).

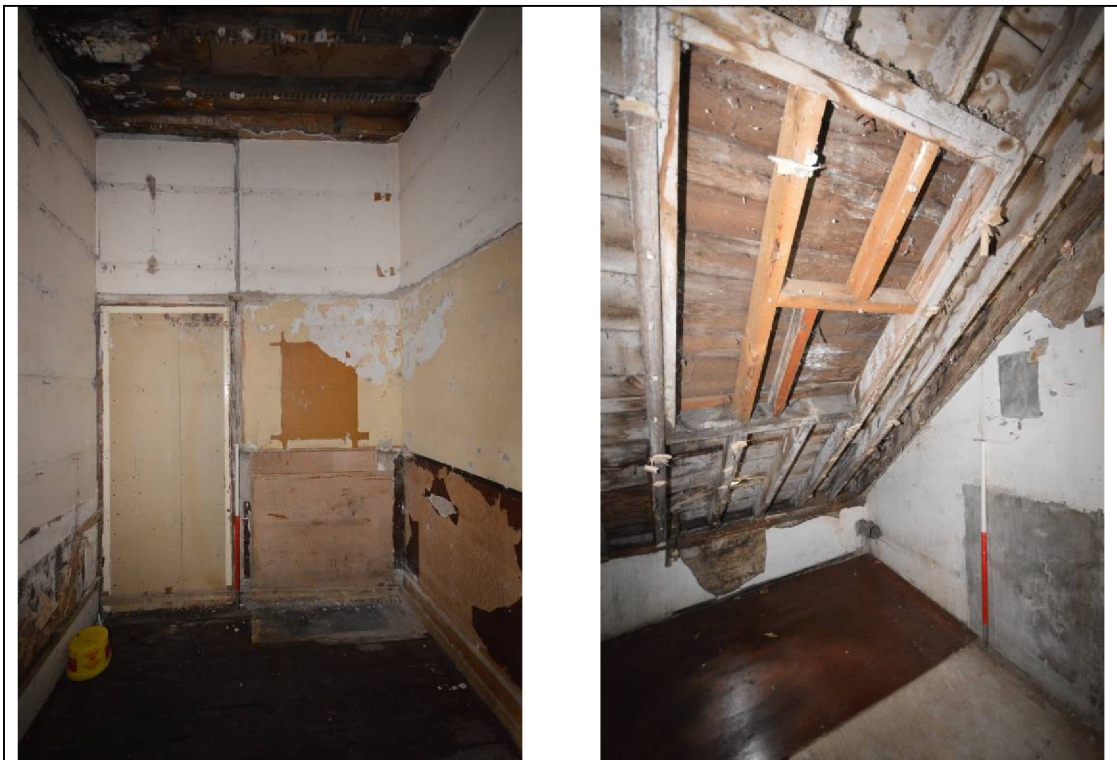
Plate 38: The blocked fireplace in the north wall of the former minister's vestry at the base of the east stair turret and the blocked rooflight in the chamber above

- 6.3.24 The eastern ante-chamber at ground floor level had been intended as the minister's vestry (Plate 1); with access directly to the dais platform at the north end of the church in addition to separate access into the school. A fireplace had been included within the north wall of the room (Plate 38). The fireplace has been blocked, any surround removed, the hearth remaining *in situ* to indicate its original location (Plate)

- 6.3.25 The first floor room over the former vestry had been lit by an integral rooflight : this has since been blocked (Plate 38). The original function of the first floor room is unknown.
