MILTON MOUNT CHURCH,  
CLARENCE PLACE, GRAVESEND,  
KENT, DA12 1LD

LEVEL 3 HISTORIC BUILDING RECORD  
WRITTEN SCHEME OF INVESTIGATION

Prepared by HB Archaeology & Conservation Ltd  
Project No. 2023535  
September 2023

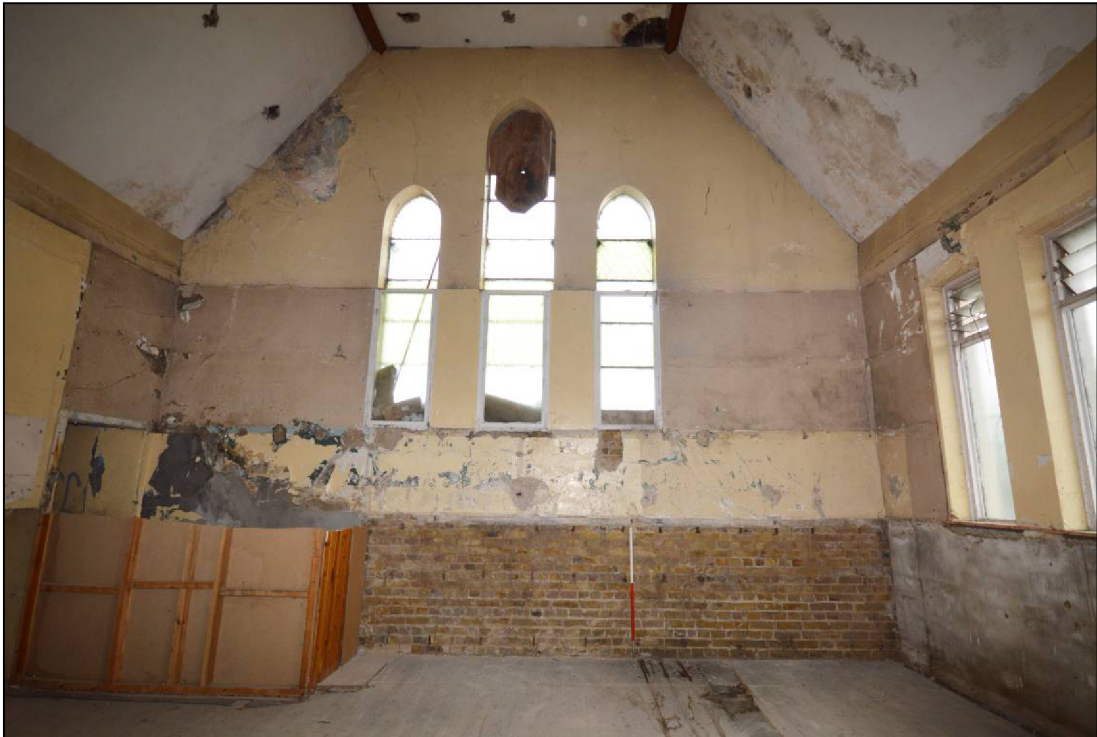
Plate 39: The tripartite feature window at the west end of the school room on the upper ground floor, contrasting with the plain window openings in the north elevation

- 6.4.1 The upper ground floor includes the original large classroom and lecture theatre: this room remains open-plan, accessed from the lobby at the north end of the west stair turret and from the stair hall at the eastern end of the group (Figure 2). A third doorway provided a link to the Deacon's rooms and vestry at the eastern end of the classroom: this has been partially blocked. One final doorway is situated in the southwest corner of the room: this leads to the inserted staircase and is the result of later alterations to the building (Figure 2).
- 6.4.2 The room and the building that accommodates it is simple in style, contrasting with the more elaborate treatment visible within the church. All doorways and windows are flat-arched excepting the tripartite arrangement at the western end of the range (Plate 39).

- 6.4.3 The walls are under render, excepting the exposed yellow English bond brickwork at the west end of the room: small sockets at the top of the exposed brick indicate some form of dado panelling, since removed (Plate 39).
- 6.4.4 The floor is a suspended timber one, the ceilings and ceilings are under-drawn. There are three recesses within the south wall of the room (Figure 2). It is unclear if the recesses had been integral to the building's construction as storage facilities, or to include a hearth; all have been modified in line with the changes in use (Plate 40).

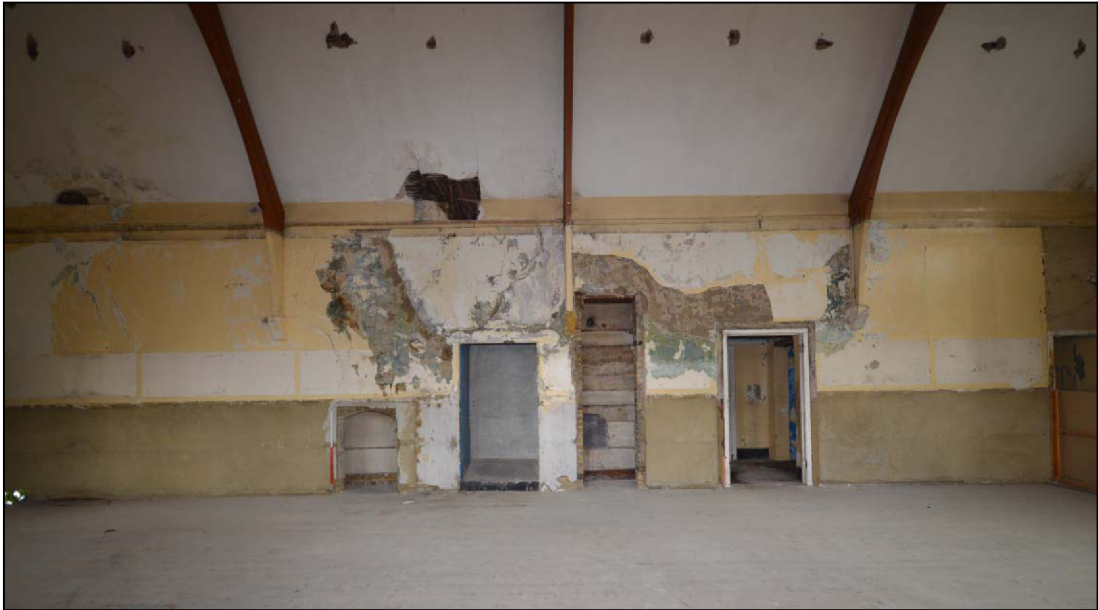
Plate 40: The three recesses on the west side of the school house and the doorway leading to the lobby linked to the west stair turret

The recessed features are accommodated within a thick wedge-shaped boundary between the school and the church: this is interpreted as a result of aligning the north and south elevations to their respective street-frontages (Figure 2).

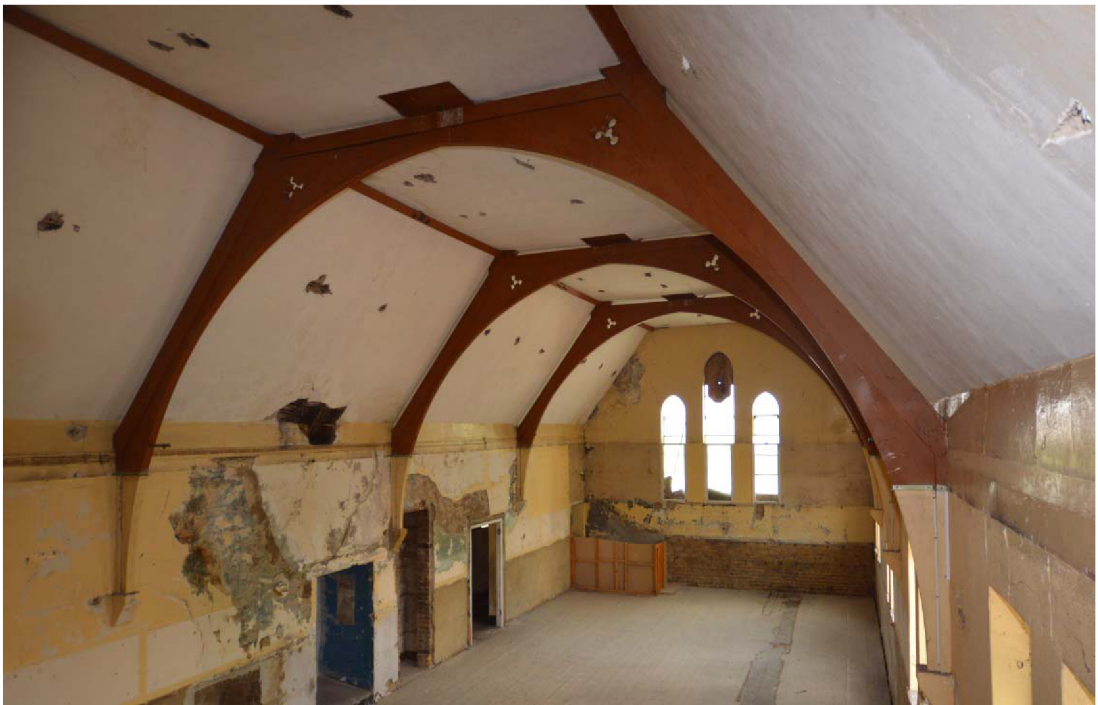
Plate 41: The roof structure over the school classroom on the upper ground floor looking towards the west end of the range

- 6.4.6 The school room is open to its roof: this comprises three trusses raised on chamfered corbels: the braces of each truss create a pointed-arch, the spandrels embellished by pierced detail (Plate 41).

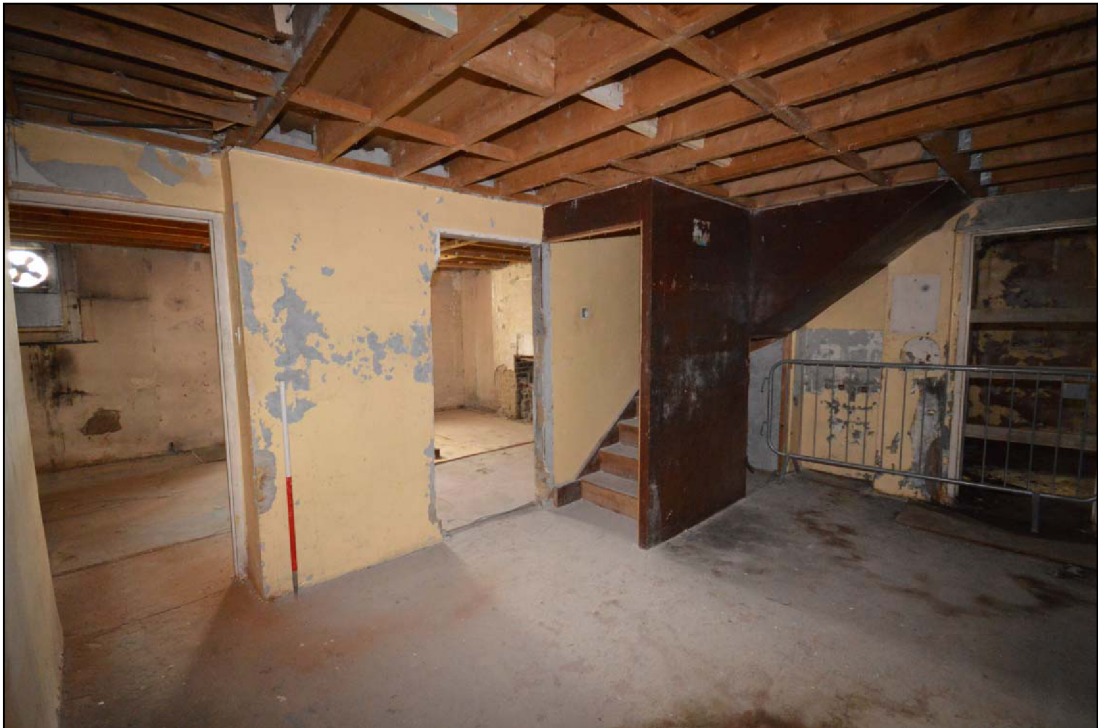
Plate 42: The interior of the eastern group at the end of the school house: the doorway to the west is in the location of the original; the partition adjacent, doorway, staircase and ceiling structure are the result of 20<sup>th</sup> century alterations

- 6.4.7 The eastern end of the upper ground floor accommodates its original staircase linking the accommodation to the facilities on the floor below that front onto and are level with William Street. The remainder of the group at the eastern end is the result of 20<sup>th</sup> century alterations, now set out to provide a pair of rooms to the north and a stair hall to the south (Figure 2; Plate 42).

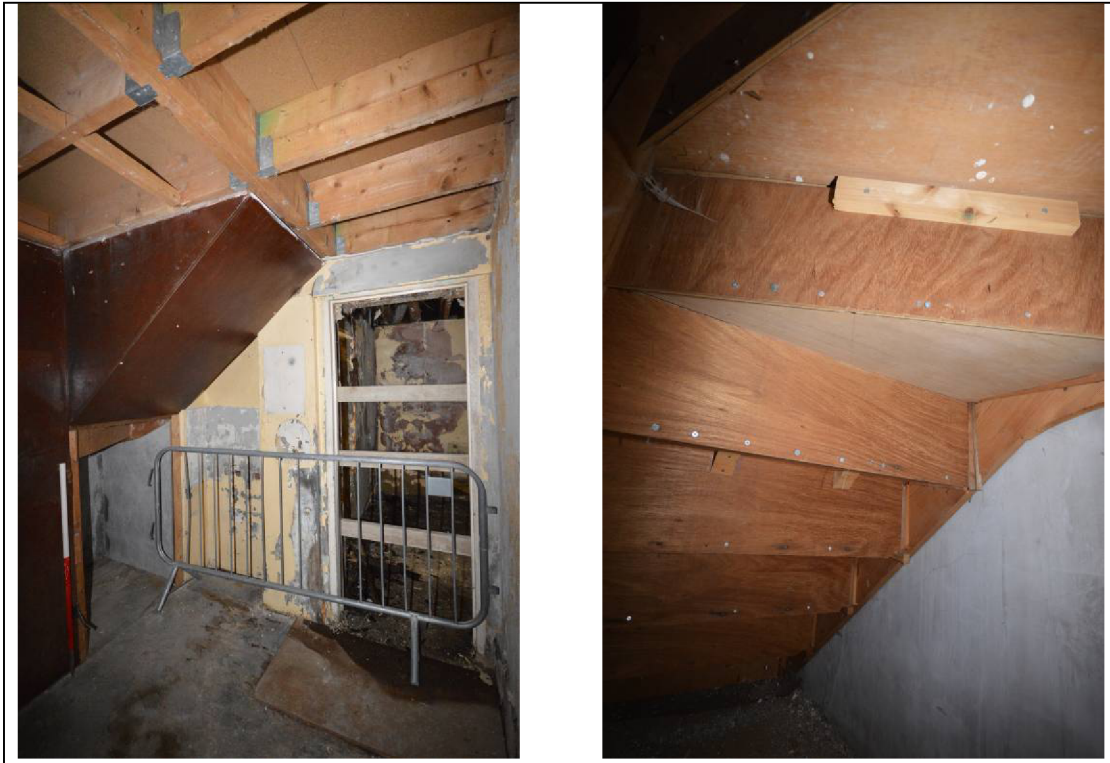
Plate 43: Detail of the inserted floor and the staircase structure and a doorway that had led into the neighbouring single storey utility lean-to

- 6.4.8 The stair hall provides access to the altered eastern layout and the neighbouring ranges: the inserted staircase links the accommodation to the floor above: both are 20<sup>th</sup> century modifications.

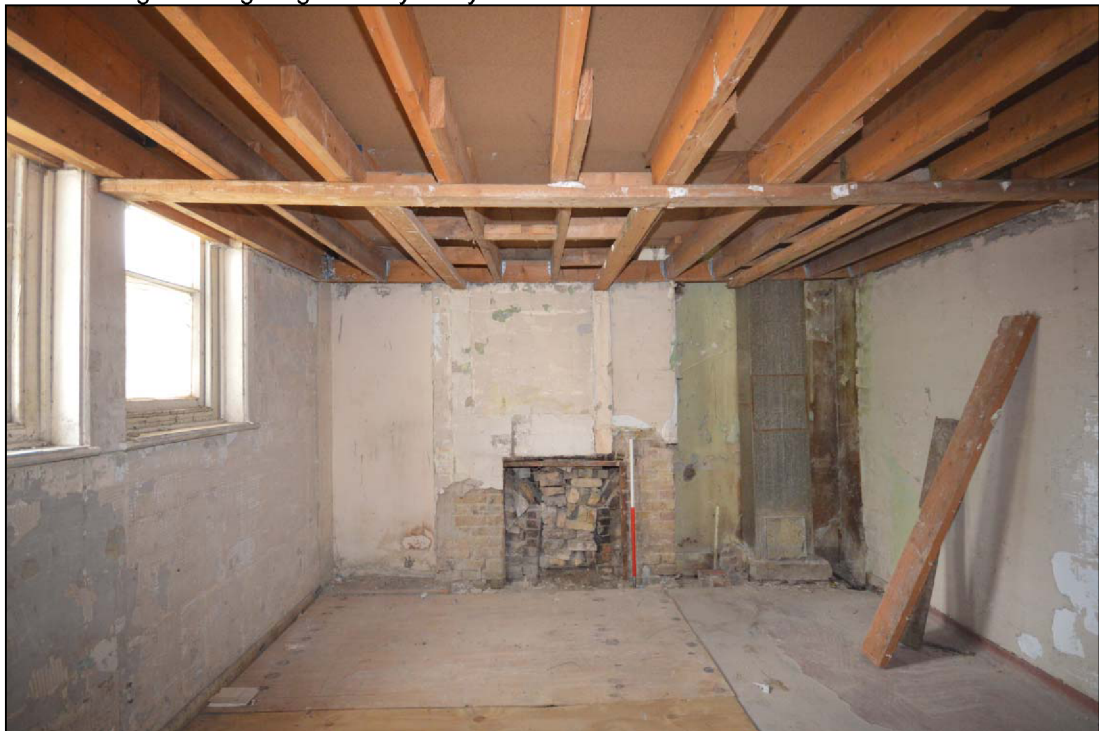
Plate 44: The northeastern room of the school house with its fireplace and windows bisected by the inserted floor structure

- 6.4.9 The eastern of the two rooms on the north side of the inserted stair hall includes the remains of its original fireplace (Plate 44). The first floor inserted into the stair hall continues across the remainder of the eastern rooms, bisecting the windows in the north elevation (Plates 44 and 45).

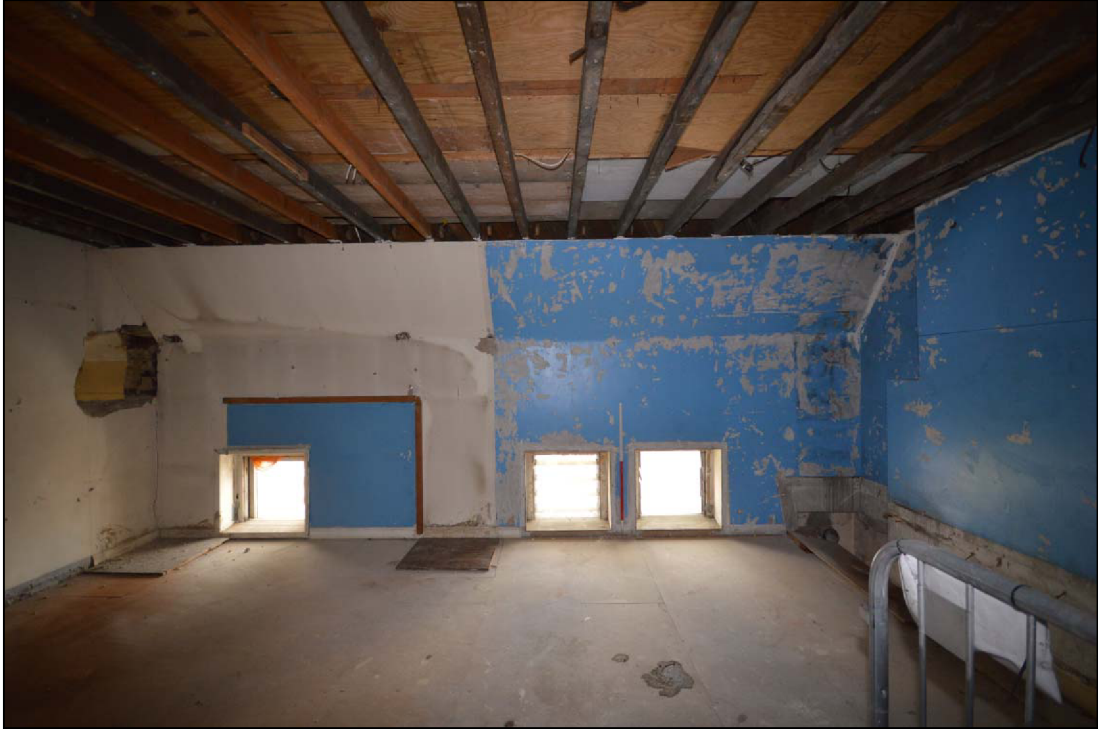
Plate 45: The north wall of the first floor accommodation at the east end of the school house created in recent years

- 6.4.10 The upper parts of the north windows, bisected by the inserted first floor remain extant on the upper floor for natural light (Plate 45). The ceilings and skeelings had been under-drawn; lath and plaster in the first instance as evidenced by striped pressure marks on the collars. Timber sarking boards can be seen on the roof slope above the rafters on the south side of the building (Plate 46).

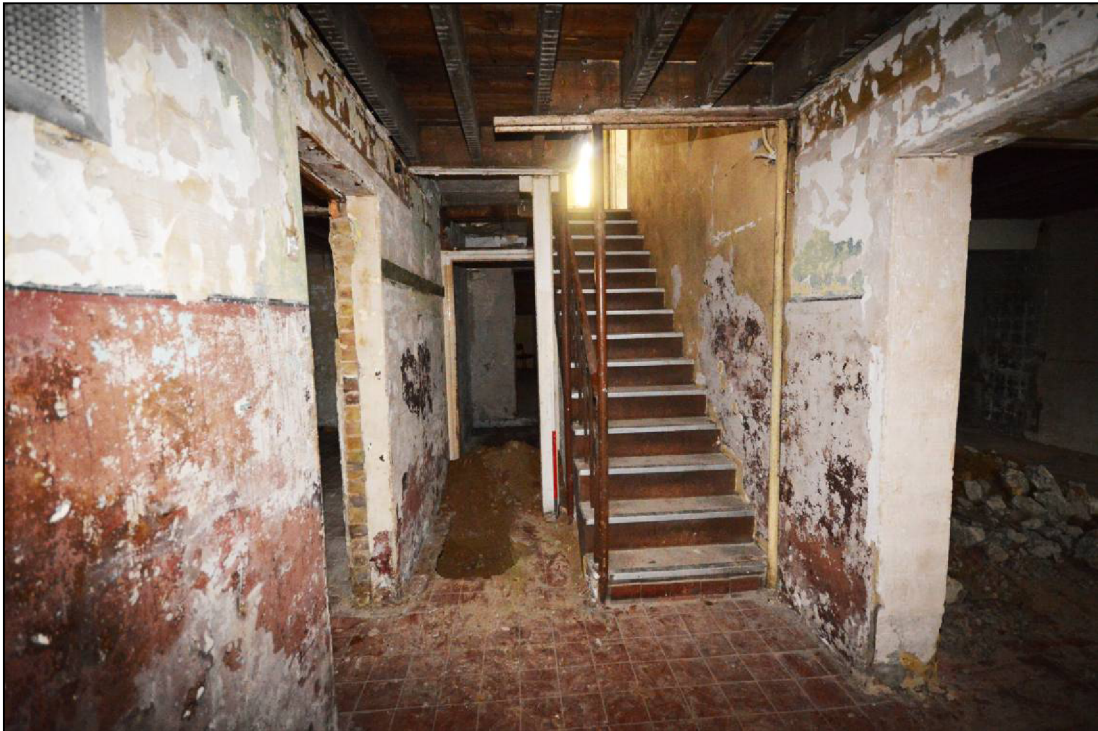
Plate 47: The interior of the stair hall looking south

- 6.4.11 The lower ground floor layout is better preserved than its upper ground floor counterpart: the eastern end of the range includes the central stair hall accessed directly from William Street and in turn providing access to the other three rooms in the group (Figure 2; Plate 47). There are clear signs of alteration during the 20<sup>th</sup> century, however the original proportions of the classroom at the western end of the range remains intact (Figure 2; Plate 48).

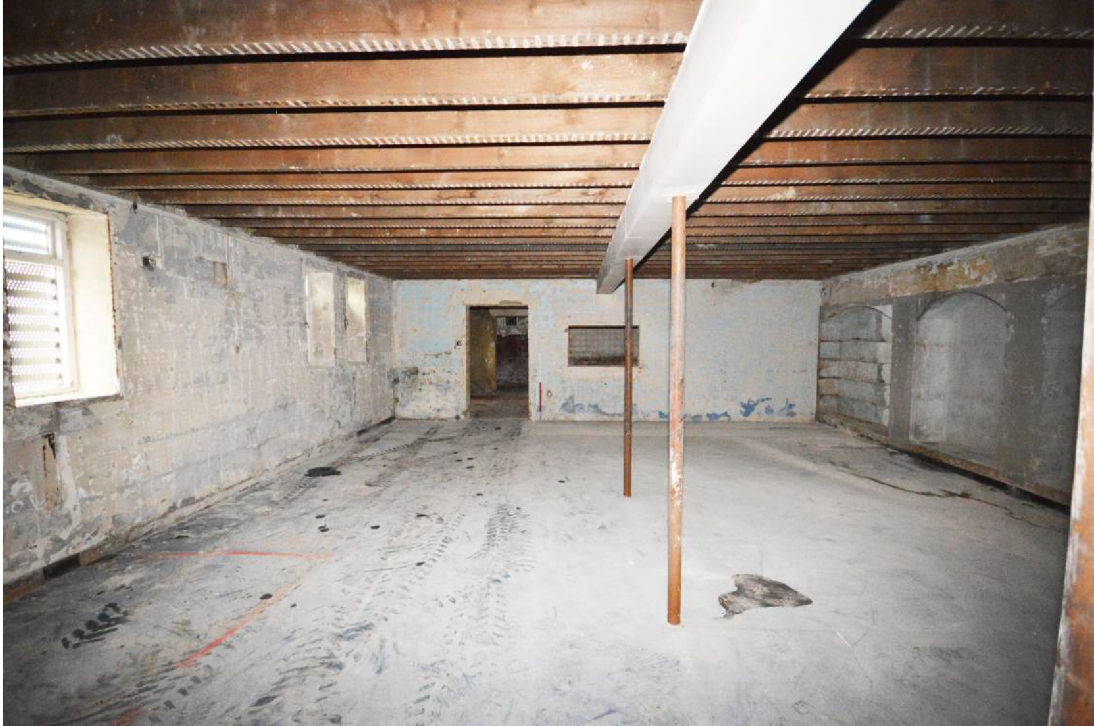
Plate 48: The lower ground floor classroom at the west end of the range looking east

- 6.4.12 The former classroom had been lit by pairs of windows on the north side of the room. The walls are rendered and the floor is concrete. The ceiling had been lath and plastered: this has since been removed, evidenced by the pressure marks on the soffits of the joists (Plate 48). The upper ground floor structure is supported by an east – west oriented girder, now boxed-in, in turn supported on a series of columns: these appear to be the result of later intervention intended to stabilise the building (Plate 48).

- 6.4.14 Later modifications to the main classroom comprise the creation of a window-type opening in its eastern elevation, part of the servery facilities when used as a dining room and the insertion of the staircase into the southwest corner of the room (Plates 48 and 50). The western doorway to the courtyard outside the building has been blocked (Plate 51).

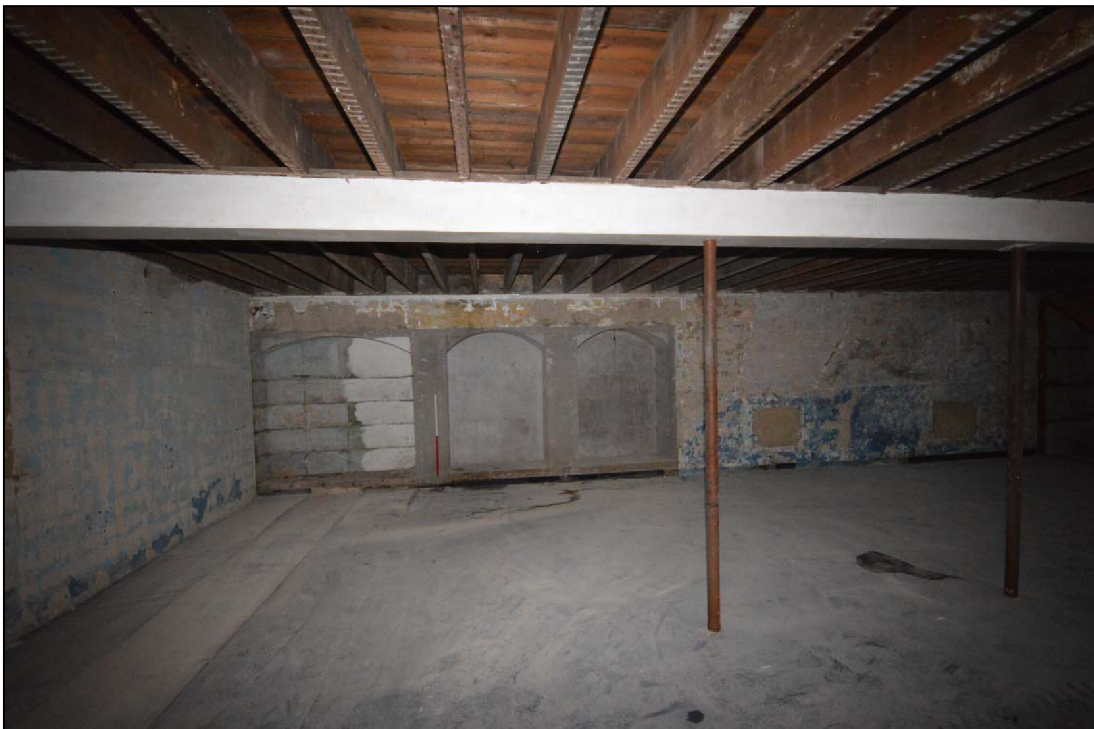
Plate 49: The lower ground floor west classroom looking south showing the series of niches integral to the wall in that location

- 6.4.13 A series of niches are situated within the south elevation of the room at its eastern end (Plate 49). The niches all include segmental arched soffits: suggesting that they had been an original part of the building's construction, again accommodated within the wedge-shaped boundary between the two main ranges (Figure 2).

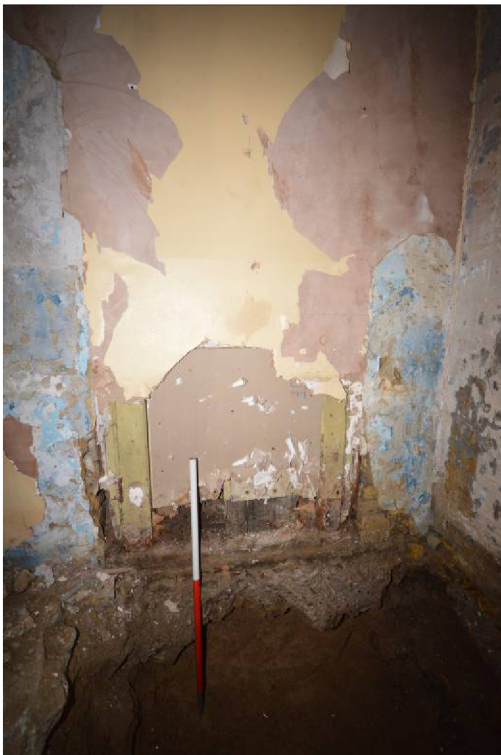
Plate 51: Detail of the blocked doorway showing the timber-frame *in situ*

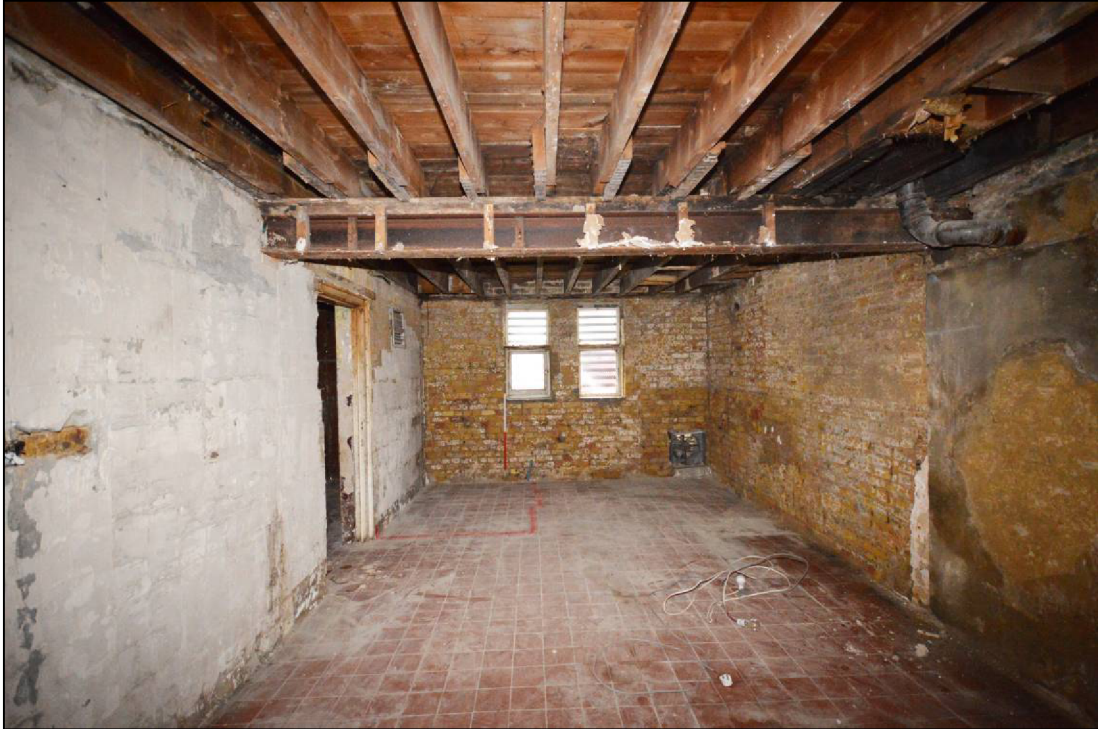
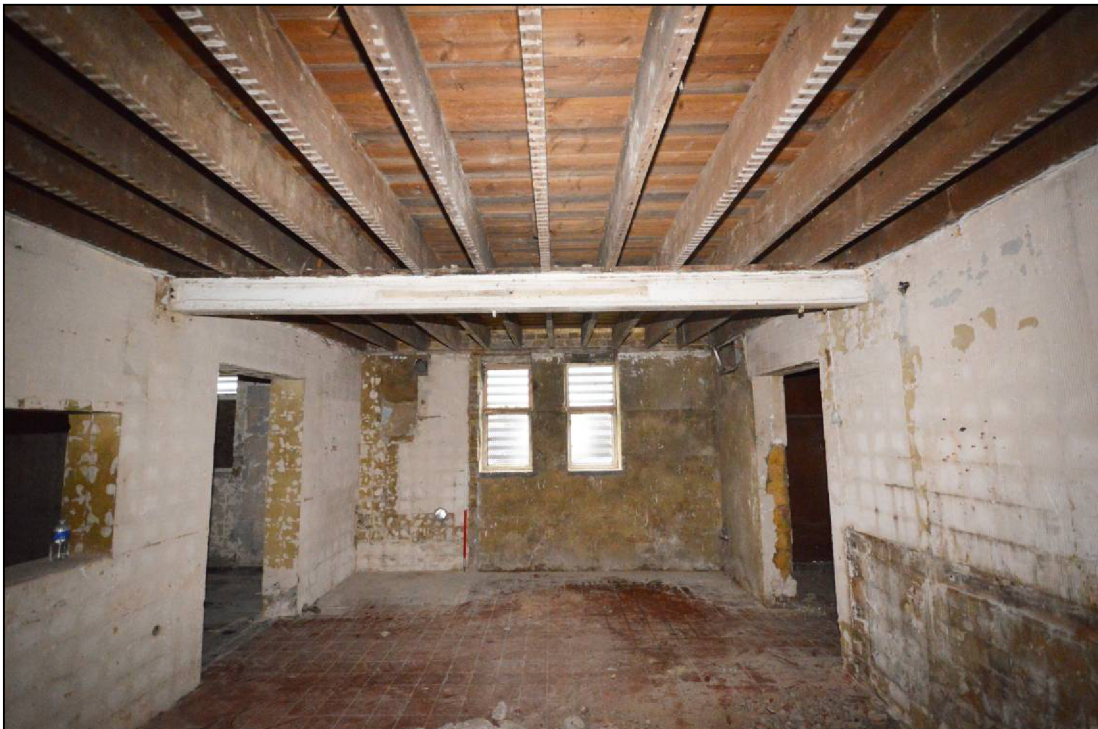
- 6.4.15 The former infant's classroom may have been situated within either of the two rooms flanking the stair hall. Both rooms now extend across the full width of the building, each had included lath and plaster ceilings, rendered floor finishes and tiled floors, although the latter may have been the result of later alterations (Plates 52 and 53).

Plate 52: The eastern room on the lower ground floor, looking north towards William Street

Plate 53: The western of the two rooms flanking the stair hall at the east end of the school looking north towards William Street

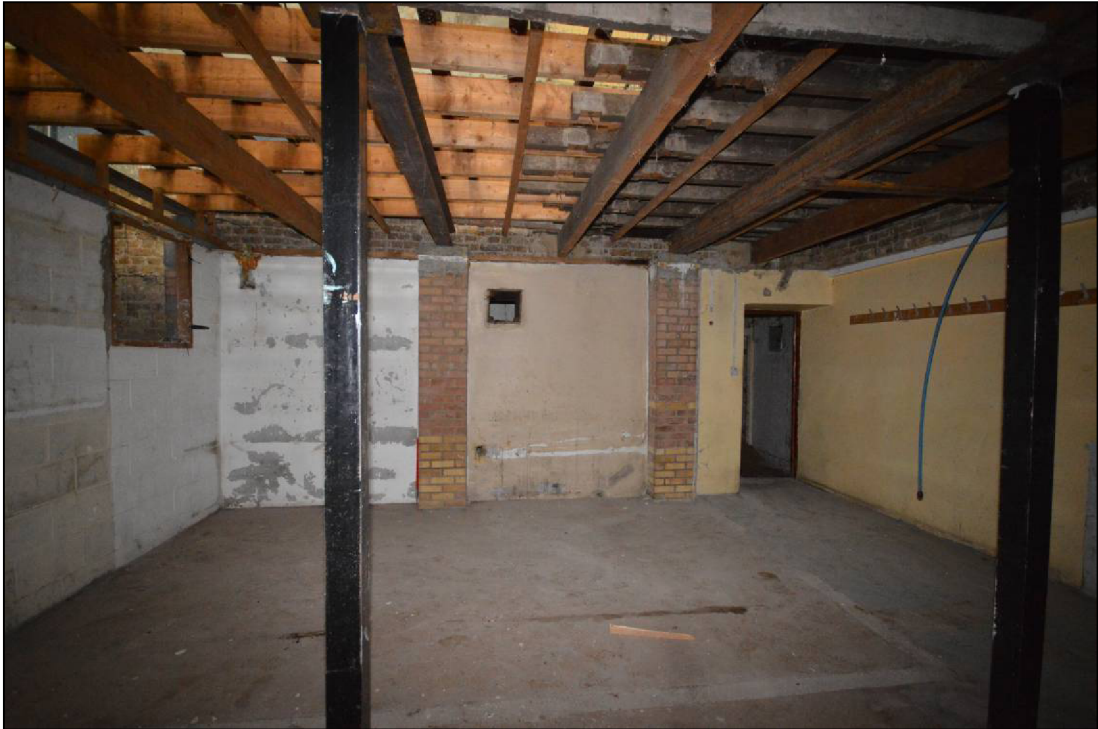
Plate 54: The room below the northeast corner of the nave looking north towards the doorway leading to the stair hall at the east end of the school

- 6.4.16 One final room is situated at lower ground floor level: this is located below the northeast corner of the nave (Figure 2). The room below the church had been partitioned to include a separate enclosure, since removed (Plate 54). The room has a concrete floor, rendered walls and had included an under-drawn ceiling, since removed. There is clear evidence of intervention historically to strengthen the floor structure, indicated by the insertion of I-beams and posts (Plate 54).

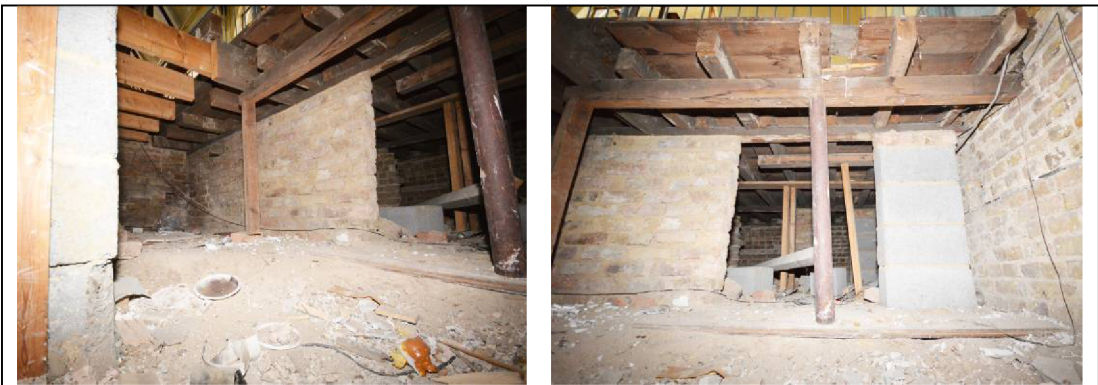
Plate 55: Two access hatched leading from the room under the northeast corner of the nave to the remainder of the floor of the church the later joists and block-work indicate intervention for stability in response to the changing use of the building from the second half of the 20<sup>th</sup> century

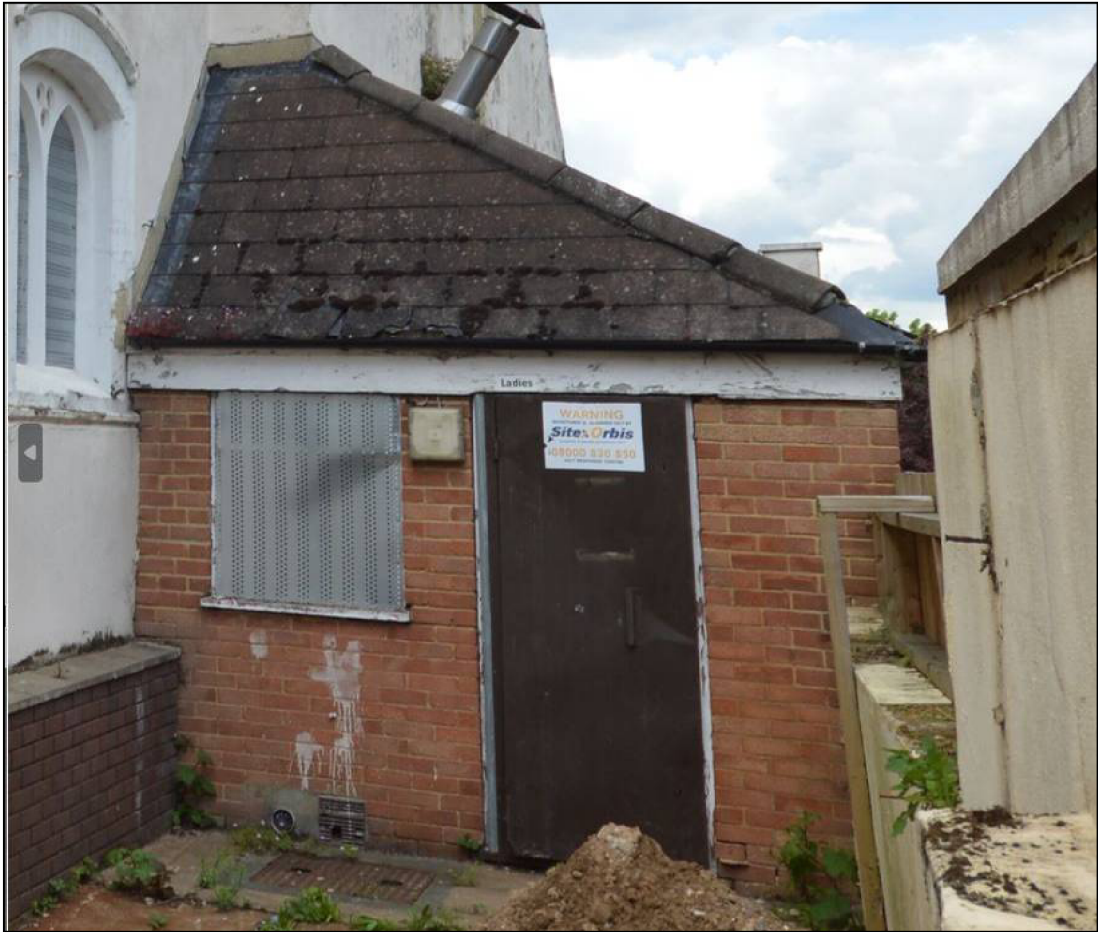
Plate 56: The south elevation of the porch added in 1982

- 6.4.18 There was no access to the WC or porch at the eastern end of the school house during the survey due to health and safety concerns. From the exterior, the porch, added in 1982, was constructed in brick laid in Flemish bond: this may represent cladding on a block-work skin. A single doorway and window adjacent adorned the south elevation of the structure. The roof was under slate, sloping in a single lean-to pitch back to the main body of the church (Plate 56).
- 6.4.19 A keyhole view of the interior of the addition looking south through the doorway in the east elevation of the school indicates a simple plasterboard finish to the walls and ceilings (Plate 57).

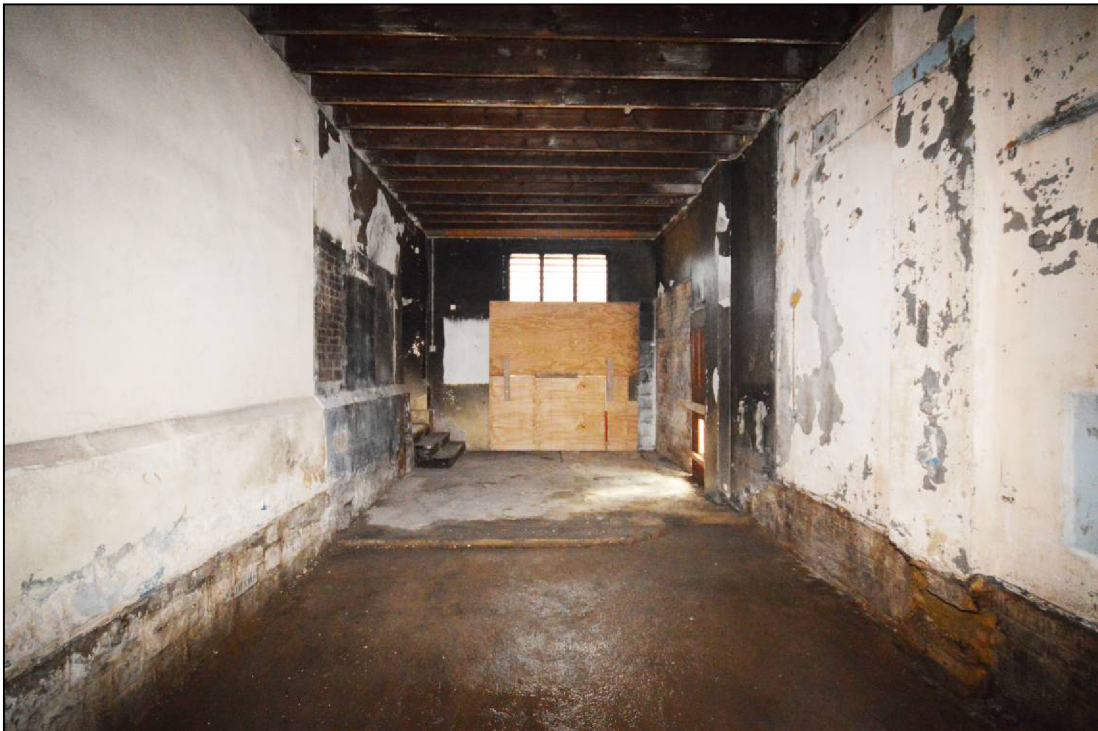
Plate 58: The interior of the southwest extension on the ground floor, looking south

- 6.4.20 The two additions made to the south ends of the aisles in 1955, extended by the addition of first floors in 1975 are simple in form, comprising box-like rooms on each floor with rendered walls to the ground floor and plaster-board to the first floors. All ceilings were finished in plaster-board (Plates 58 to 62).

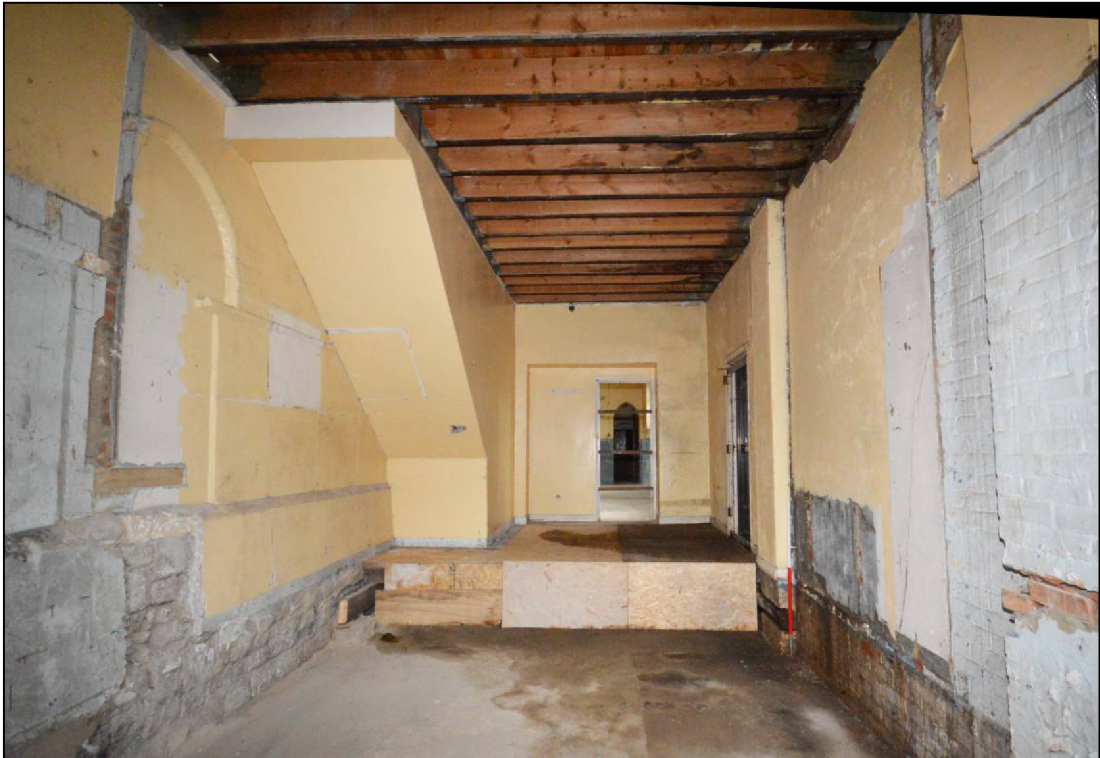
Plate 59: The interior of the southeast extension looking north towards the staircase accessed from within the aisle. Note the blocked pointed-arch-headed window in the west wall

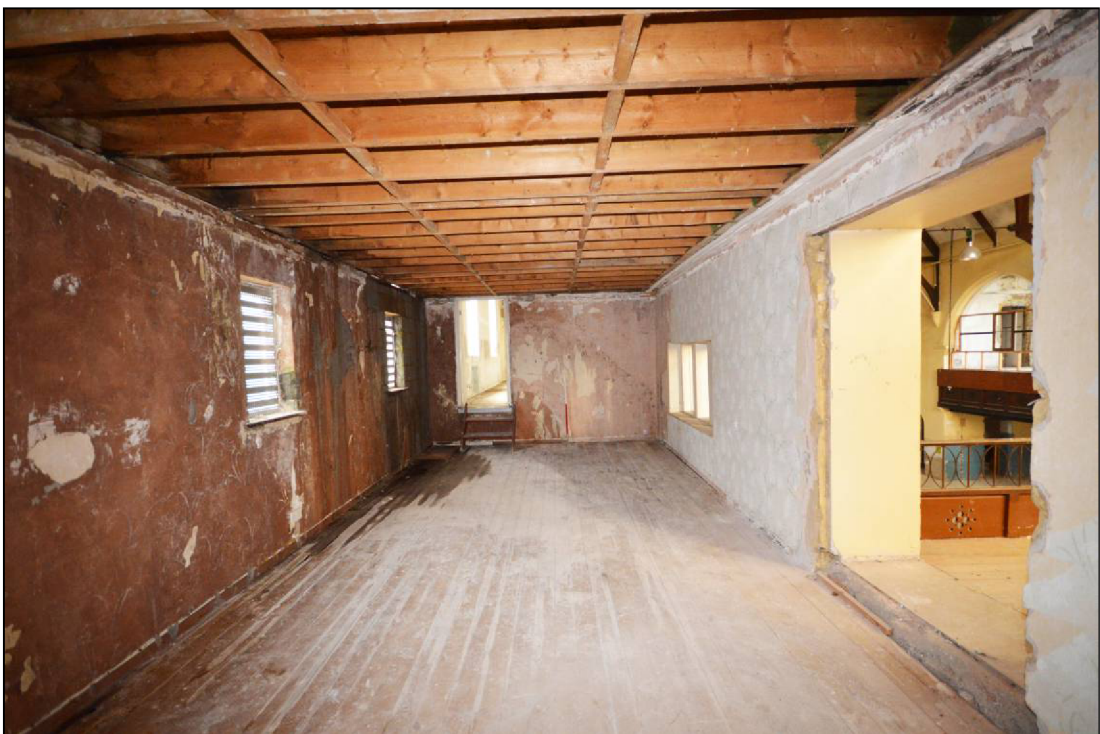
Plate 60: The interior of the southwest extension looking north towards the doorway created in the south wall of the west aisle to link the two parts

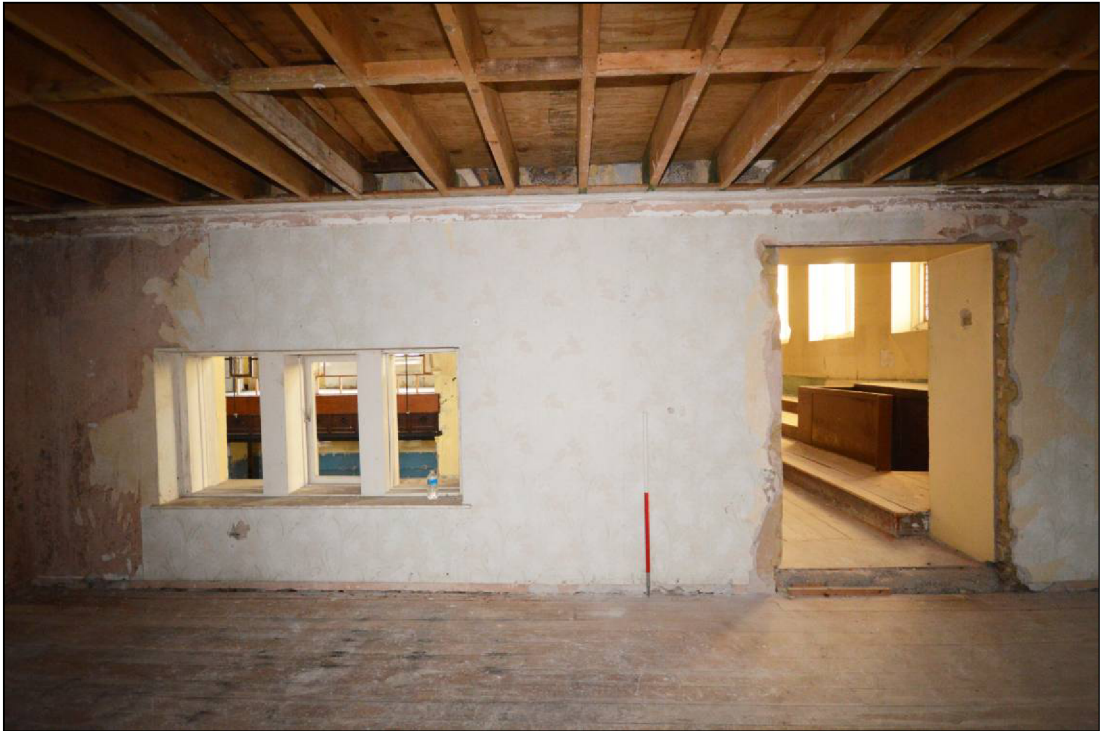
Plate 61: The east wall of the southwest extension; the three-light window is within infill of an original larger high-set pointed-arch-headed window lighting the nave to the north of the south gallery. The doorway was inserted, replacing part of the tripartite window that had occupied that position prior to extension

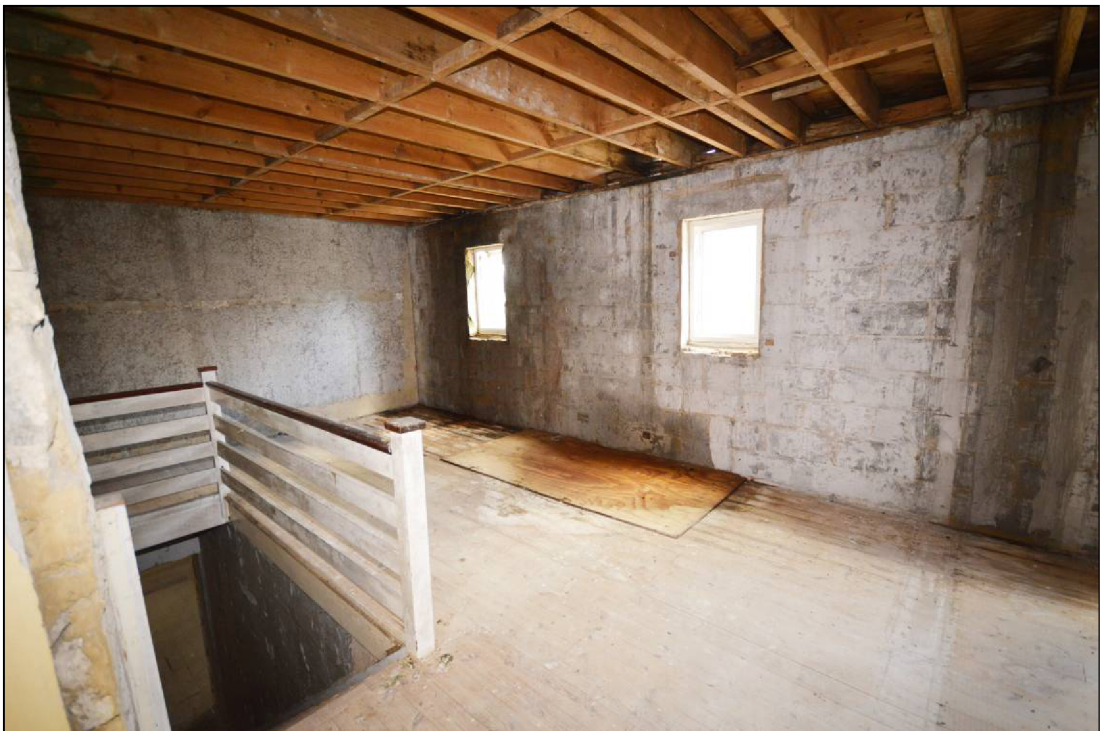
Plate 62: The interior of the southeast extension with its integral staircase in the northwest corner

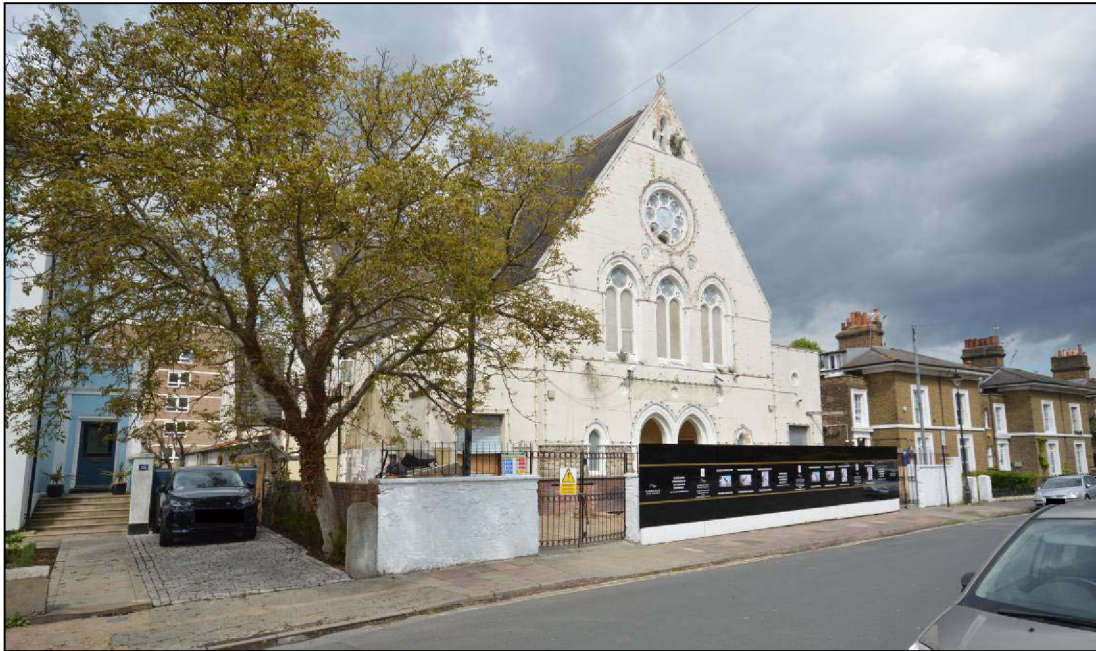
Plate 63: The setting of the property on the Clarence Place side of the group

- 8.2.2 The wider setting of the property on the Clarence Place side of the group has retained its historic character, acknowledged within the Windmill Hill Conservation Area. The William Street side of the group has been subject to a higher degree of more recent modern intervention. The former church and school buildings no doubt form a focal point on both sides of the group contrasting strongly with the domestic architecture that surrounds the site.
