## BRT PROPERTIES LIMITED

Vale Road, Northfleet, Gravesend

Desk Study Assessment Report

BM/C3476/6655

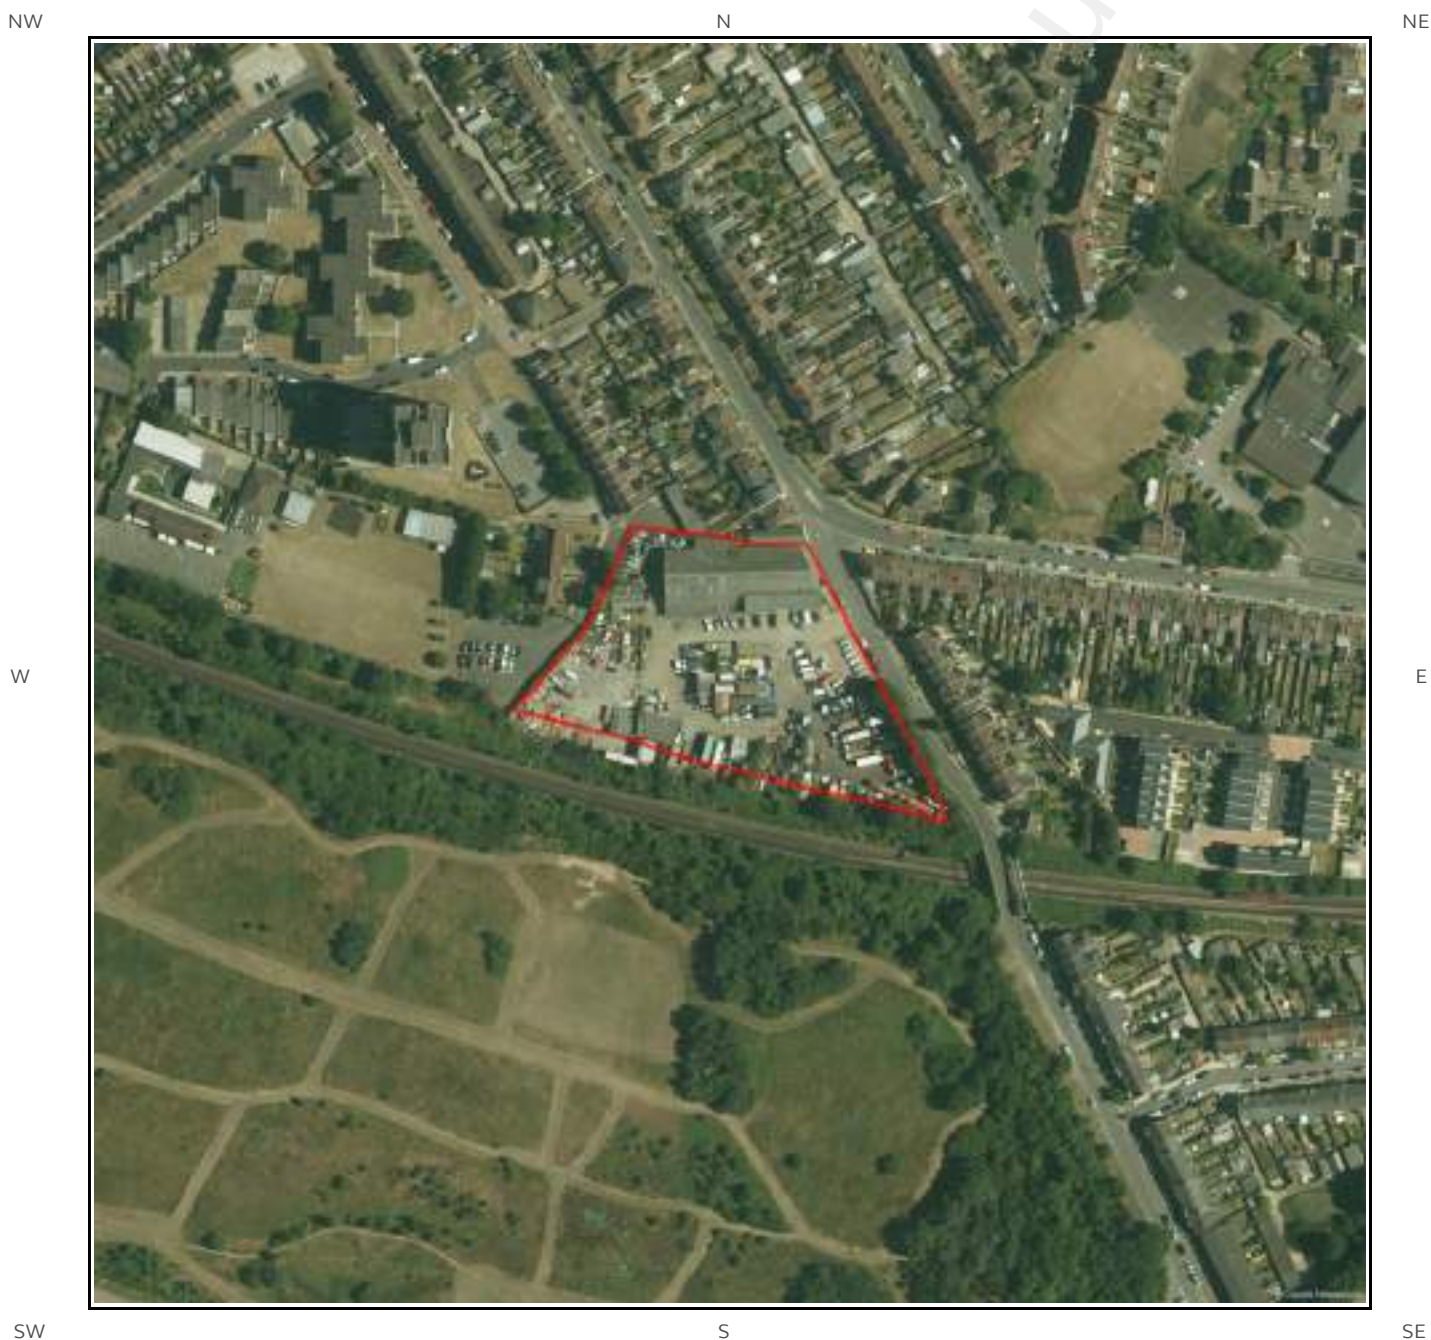
Aerial Photograph Capture date: 30-Jun-2015  
Grid Reference: 562763,173634  
Site Size: 0.88ha
