## BRT PROPERTIES (KENT) LTD

Vale Road, Northfleet

Geo-Environmental Assessment Report

PD/C3476/8382 Rev A

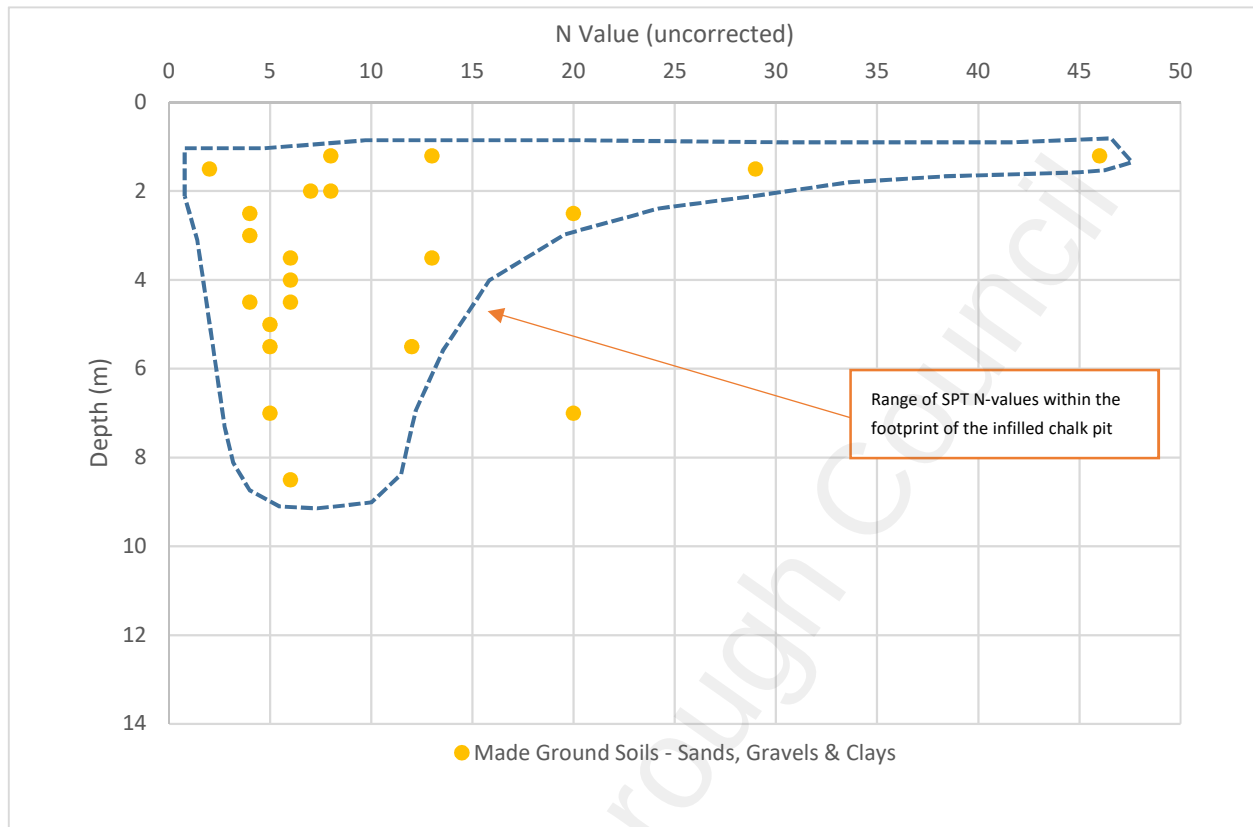
### Made Ground

The SPT vs Depth graphs show that there is a large variation in the strength/density of the made ground deposits within the footprint of the infilled chalk pit. Between 1.20m and 1.50m bgl. the corresponding N-values ranged between 4 and 46, with an average of 17, whilst between 2.00m and 2.5m bgl the corresponding N-values ranged between 2 and 20, with an average of 8. Generally, the strength/density of the made ground soils decreases with depth, with the majority of the N-values being less than 10.

The test results have been evaluated to derive geotechnical soil parameters for the site. Depth vs SPT N-value graphs for the made ground and chalk bedrock are provided separately below to provide a profile of the ground conditions underlying the site.

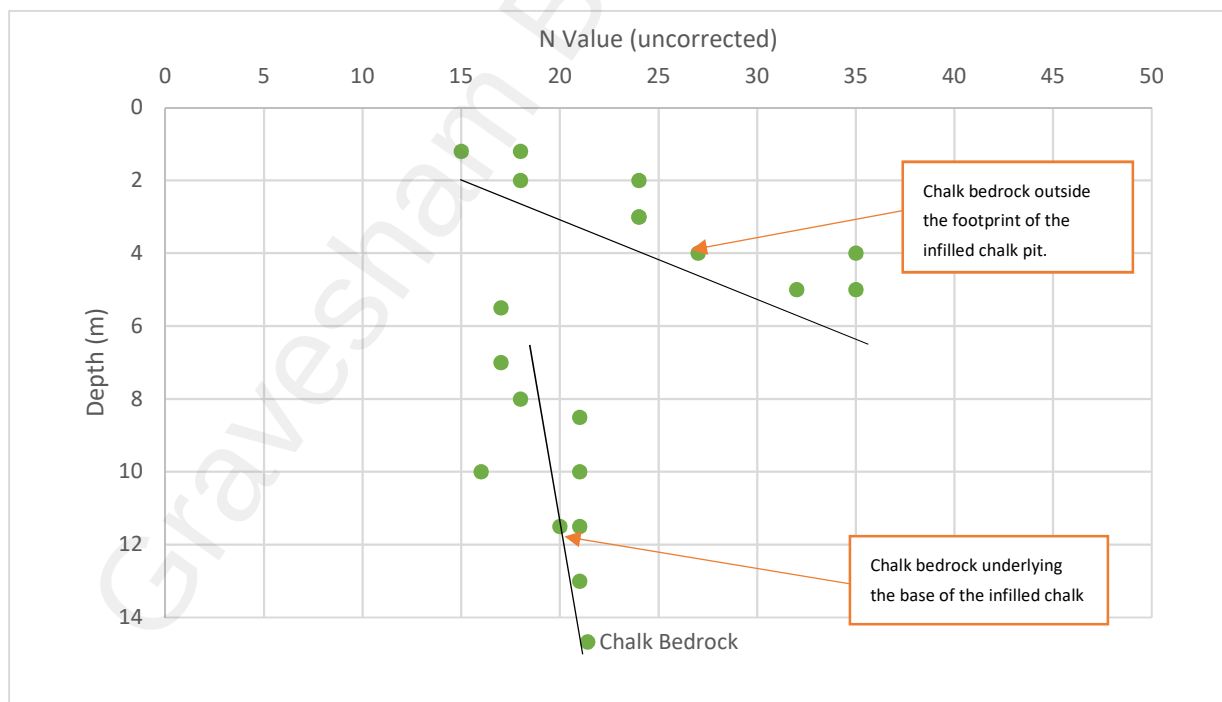
### Chalk Bedrock

The depth of the Seaford Chalk Formation and Newhaven Chalk Formation bedrock underlying the site is clearly identifiable by the sharp increase in the N-values. One made ground anomaly lies within this data set (BH1 at 7.00 – 7.45m bgl); although the strata predominantly comprised chalk with rare brick fragments and is likely to be the reworked base of the chalk pit between 7.10m and 8.50m bgl.

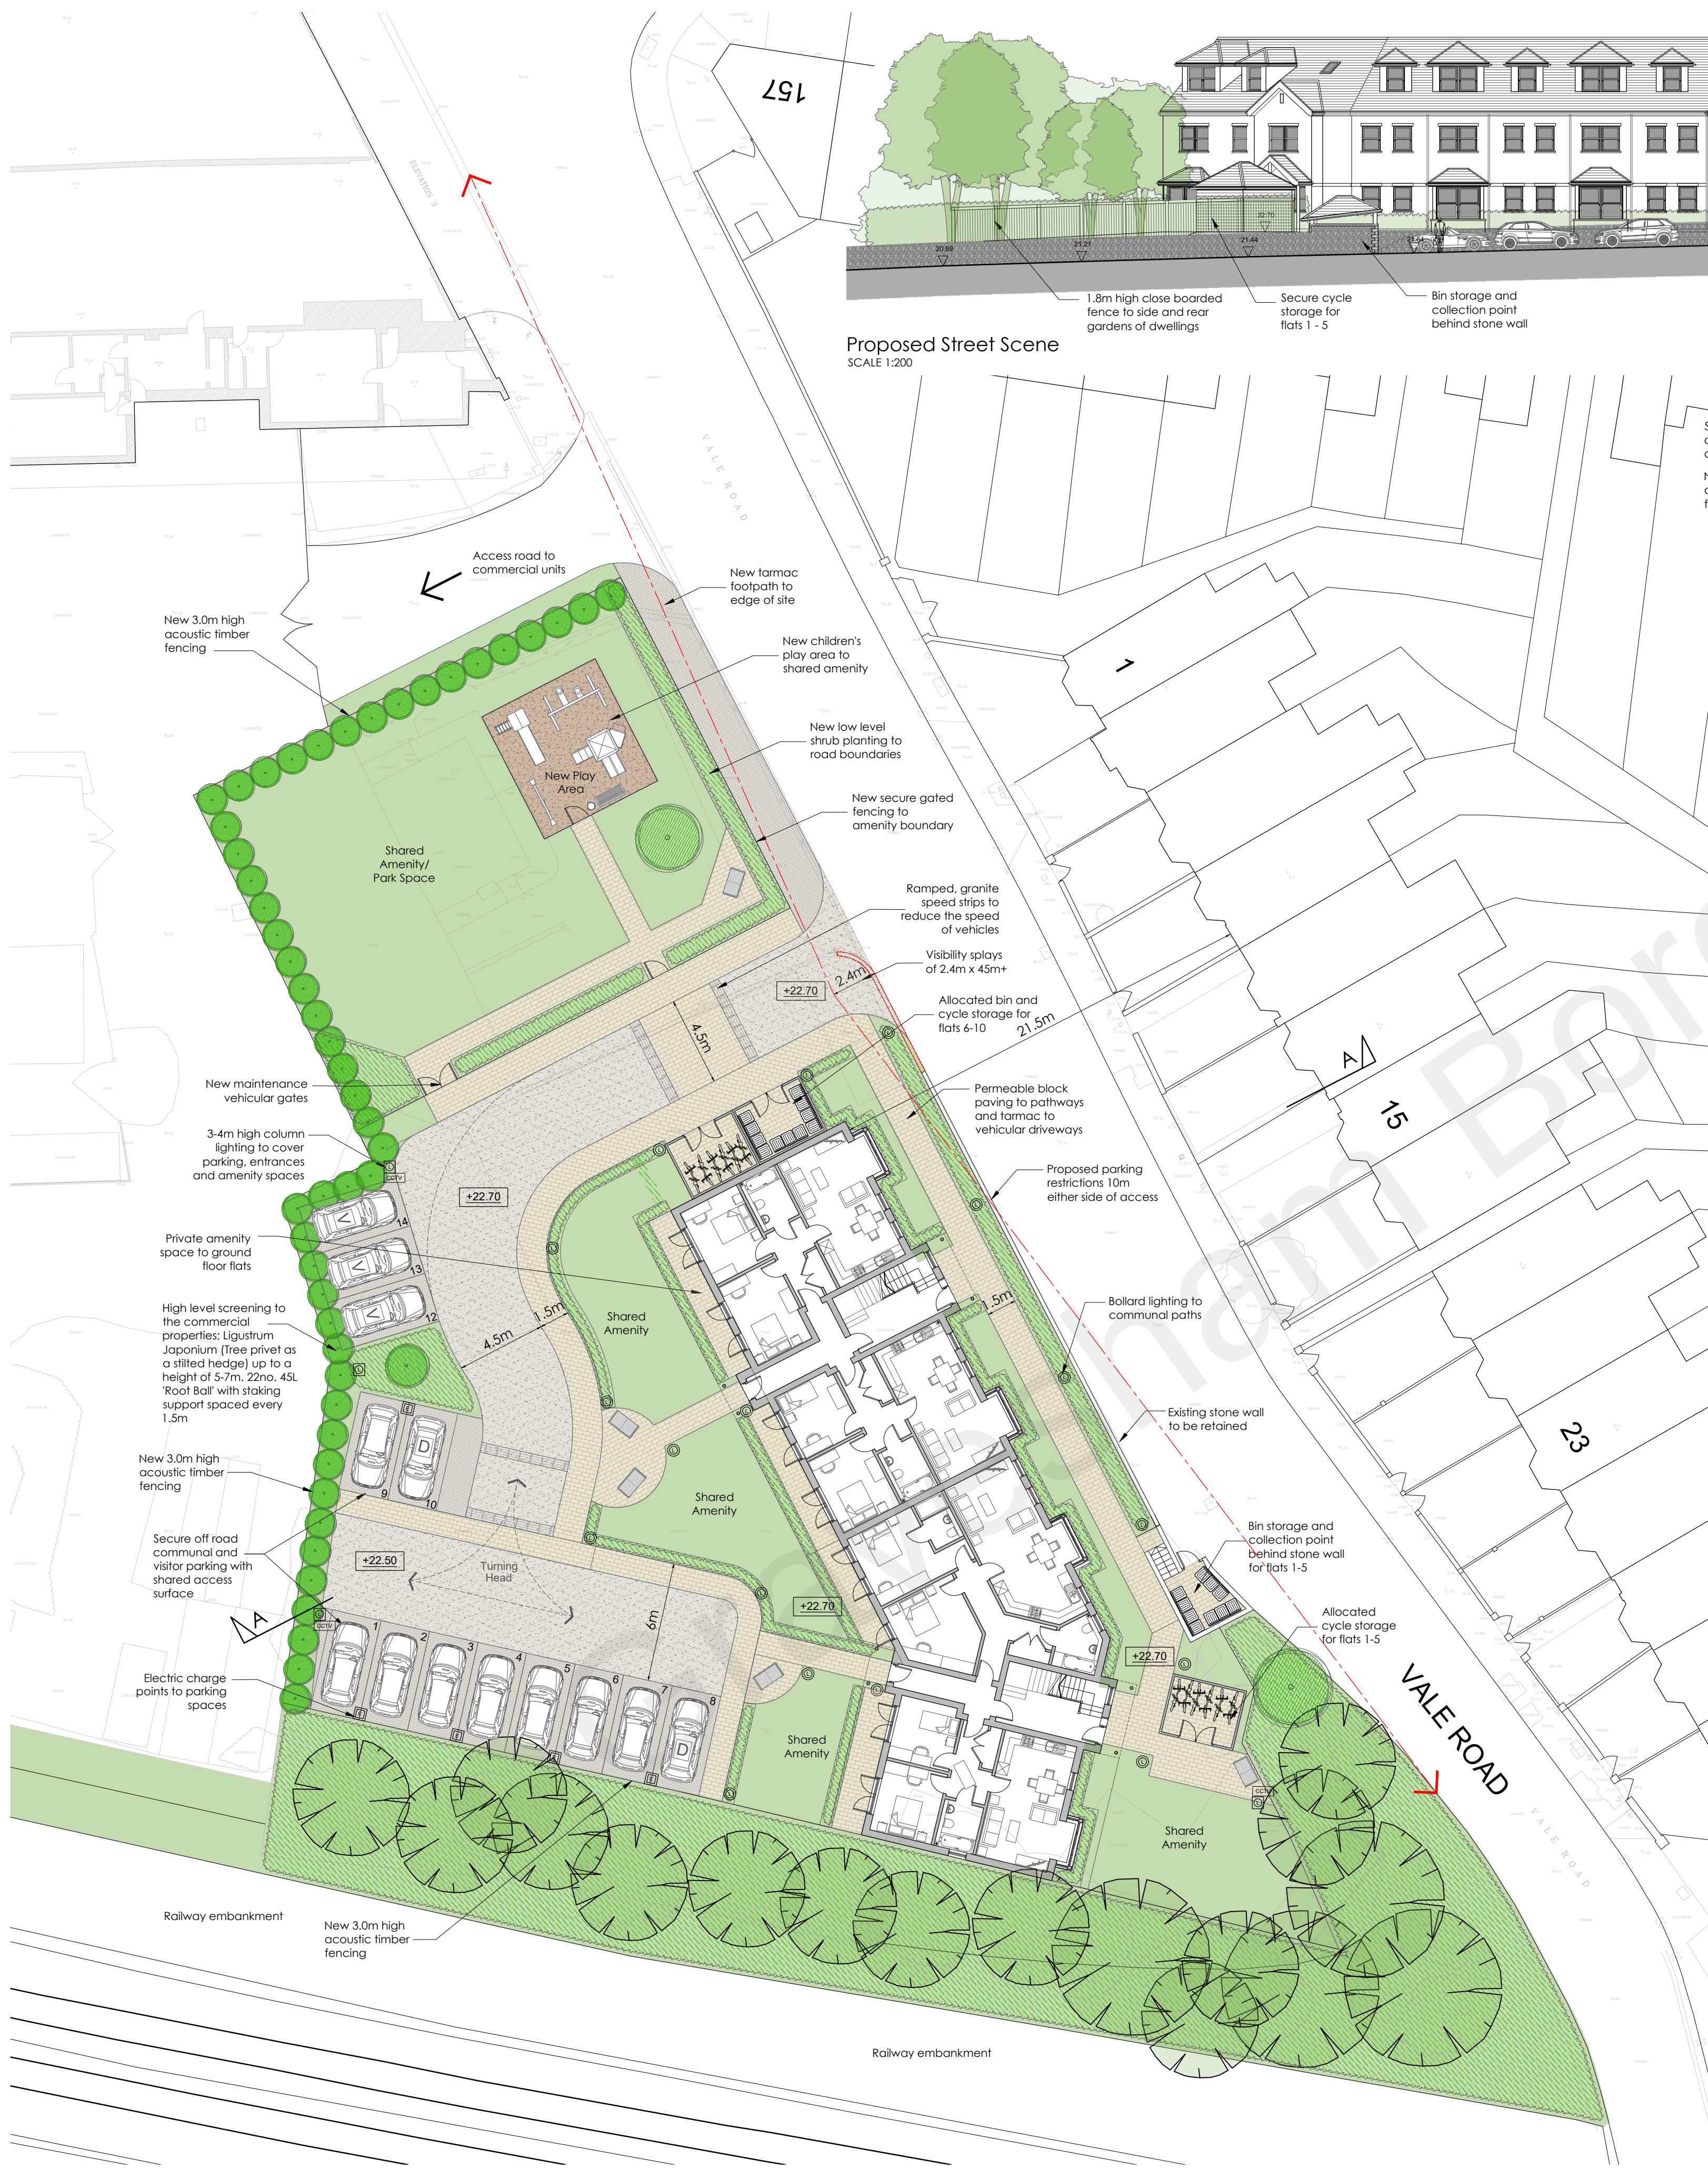
Proposed Street Scene  
SCALE 1:200

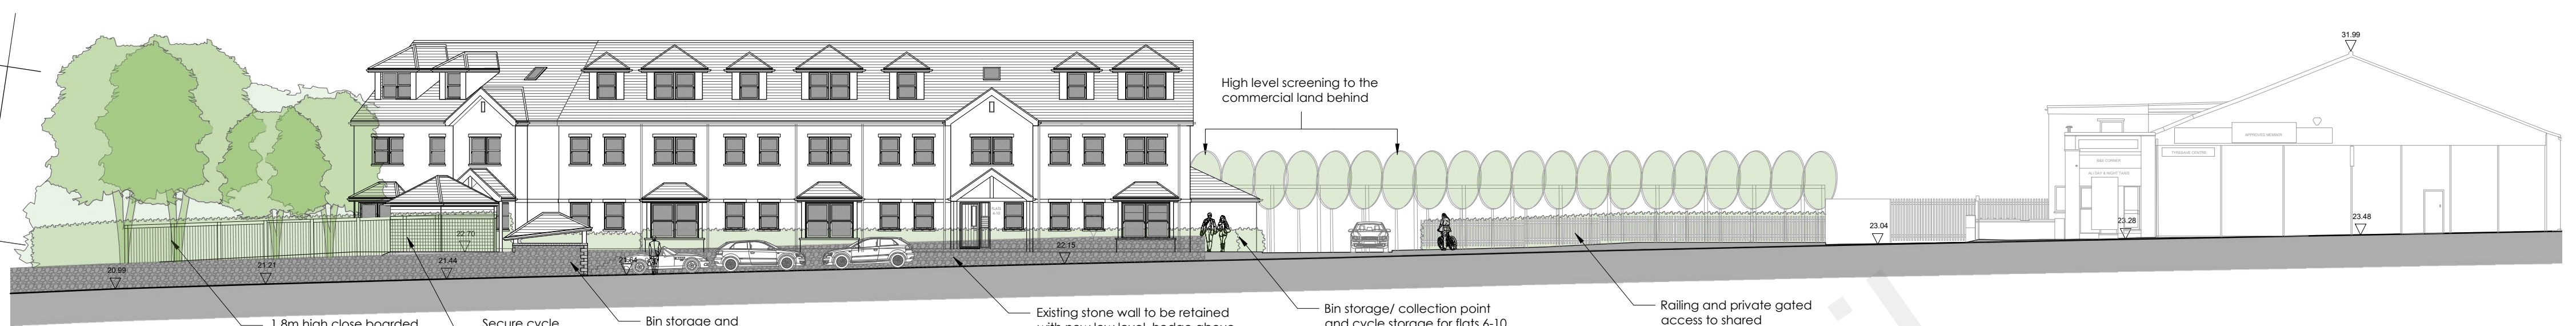
Proposed Site Section A-A  
SCALE 1:200

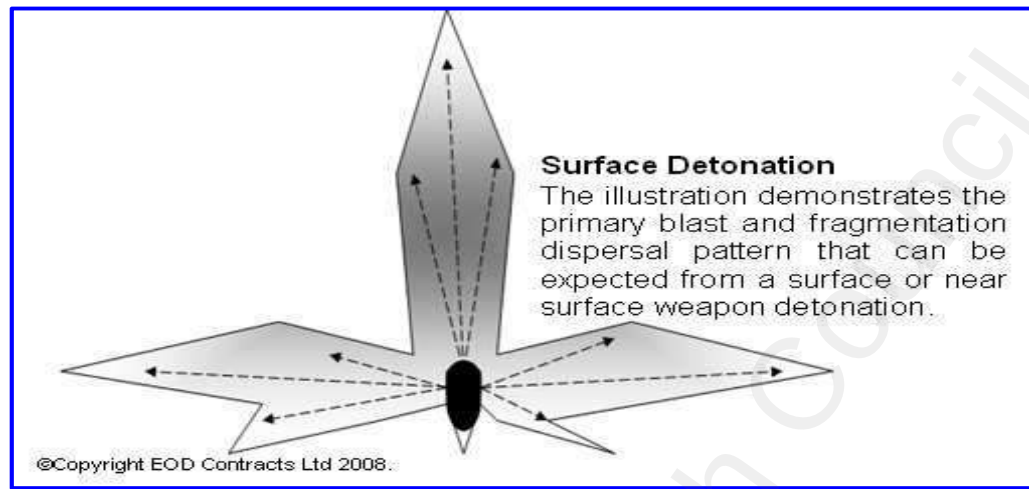
Figure 6.1: Primary Blast & Fragmentation on Land

**Blast and fragmentation dispersal.**

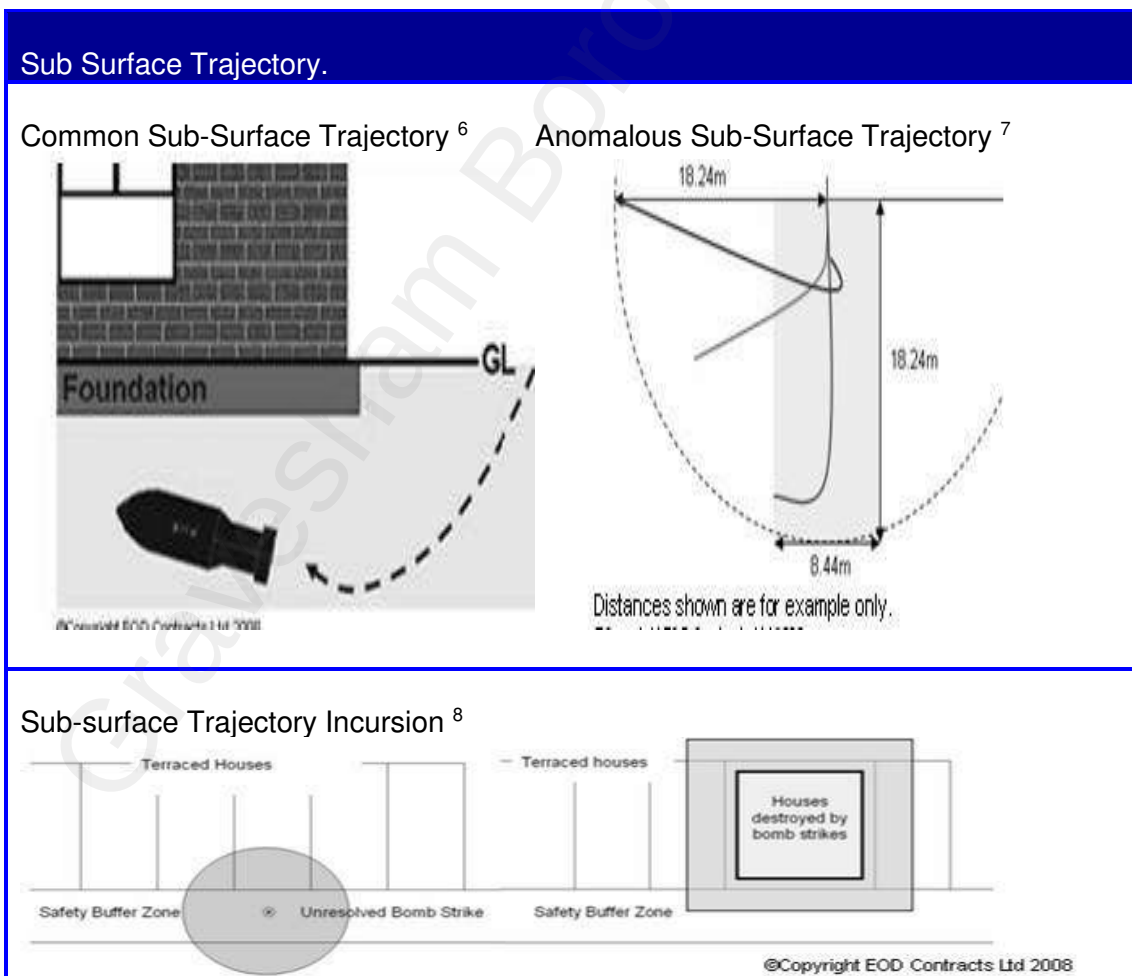
**Figure 1: Sub-Surface Trajectories & Safety Buffers**

*Note; the common sub-surface trajectory will follow a path best described as a 'J' curve. The curve can result in a weapon coming to rest some distance from its impact point. The distance from impact point to resting place is referred to as the "Off set Distance and is normally considered to be 1/3 of the depth. This mechanism can permit a weapon to strike outside a building and travel below ground finally coming to rest within the building footprint. Where a strike is known to have occurred close to a building or structure such as a dock wall, a danger zone should be considered to exist around the area of the strike of sufficient size to accommodate the likely sub-surface travel distance for the weapon.*

*Note; the typical offset distance is shown as the shaded area, on rare occasions a near surface deflection of the weapon can occur and the offset distance can be substantially increased up to 5/4 of the penetration depth. This mechanism does however reduce the penetration depth considerably with the net result that while the offset is increased the overall travel distance is for the most part unaffected.*

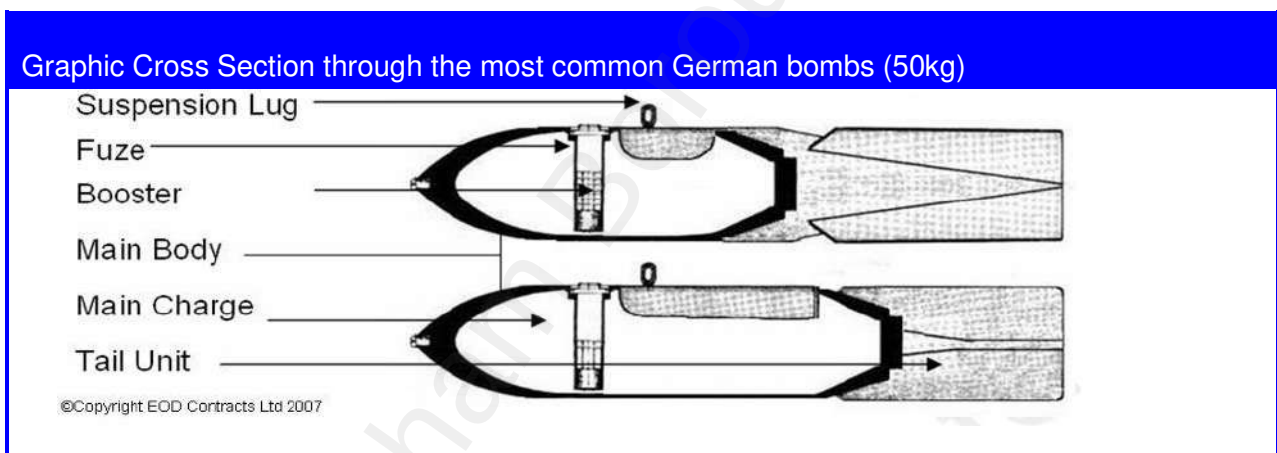
Figure 2: Generic German Bomb Design.

*Note; the diagram shows that there can be a significant difference in the quantity of High Explosive contained within bombs of similar size and shape; the Grade 1 bomb on the bottom having 30% more HE than the Grade 2 shown at the top. This serves to demonstrate the importance of an accurate identification of any item of UXO.*

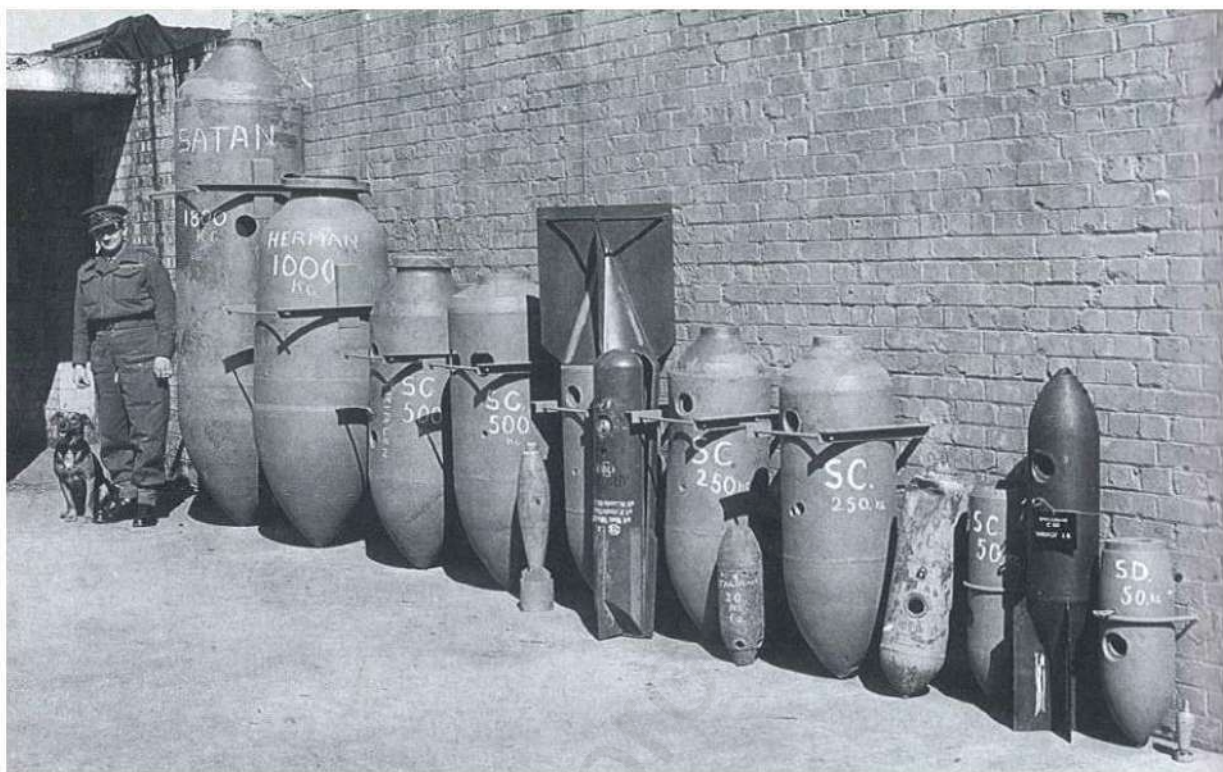
Figure 4: Range of HE bombs dropped on the United Kingdom.

*NOTE: The smaller sub-munitions (Bomblets) seen to the right, ranged in size between 1 and 3kg, were dropped in large numbers and were intended as incendiary bombs, anti-personnel bombs or as bombs filling both roles. The smaller bomblets were dropped in larger container bombs designed to hold between 360 and 620 of the bomblets. The containers were designed to burst open at a predetermined height above ground level, dispersing the bomblets over a wide area. Air raid damage was far greater by using both incendiary, and HE bombs on a single raid. The fires started by the incendiaries being rapidly spread by the blast waves from the HE bomb. This scenario was shown to devastating effect on the 14<sup>th</sup> February 1945 in the German city of Dresden. Where fires started and spread by the bombing increased to a point where the oxygen was being sucked into the flames at such a high speed that the fire became a "Fire Storm". At the time the city's population had increased due to a high number of refugees fleeing the Russian advance to the east, the exact civilian death toll from fire and suffocation will never be known, but is considered to be somewhere between 25,000 and 100,000.*

**High Explosive (HE) Bomb.** Some of the most common type of ordnance to be dropped on the United Kingdom, HE bombs are often the type encountered as UXBs. Relatively thick cased, they are still recovered in remarkably good condition. Ranging in size from 50 to 1700 kg, their typical release height (1,500m) allowed them to penetrate deep into the ground as a result of design or flaw. Towards the end of the bombing campaign, as steel became scarce the German Engineers produced a range of bombs that used steel reinforced concrete as the bomb body. Figure 4 shows the range of steel HE bombs dropped on the UK.

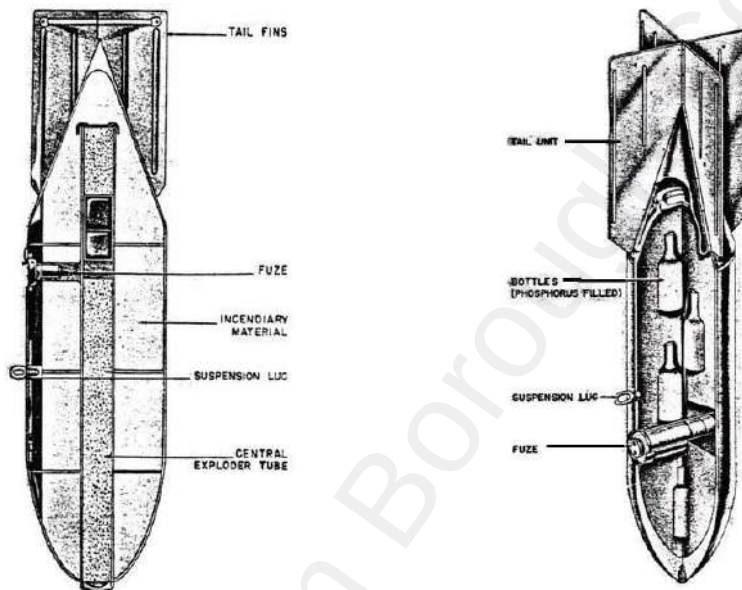
250 mm  
Above 1kg incendiary bomblet, below left the larger 500kg incendiary bomb Below right a 50kg incendiary bomb containing bottles of white phosphorus.

*Note; Incendiary bomblets were made of a flammable alloy similar in appearance to aluminium, which resists corrosion well. The tail unit was made of thin tin-plate steel and is more prone to have rusted away. Some Incendiary models were fitted with a High Explosive (HE) steel nose. With the tail and explosive nose attached the bomb was 480mm long.*

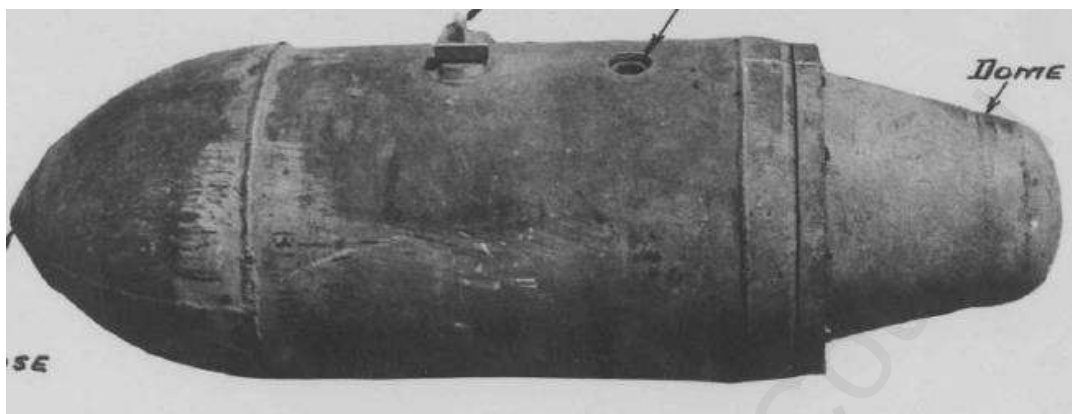
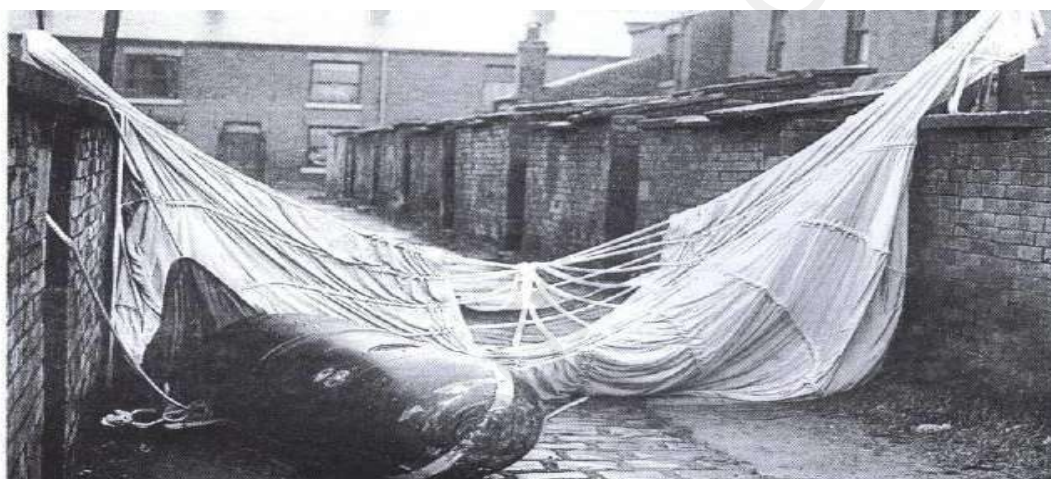
### Parachute & Ground Mines

**Blast Bomb / Parachute Mine.** The parachute mine was extensively used on land and at sea and was fitted with specialist fuzes designed to trigger the weapon at a predetermined altitude, water depth or to switch on other magnetic influence mechanisms to trigger the weapon when a ship approached (Magnetic or Acoustic influence). While early versions were based on the standard 1000kg SD Bomb case others were specially designed and manufactured with an aluminium body, making them extremely difficult to detect using magnetometers. The thin cased versions would normally disintegrate on impact on land and are normally considered to pose little threat to work on land based projects, but the risk increases significantly on projects over water or in marshland. Thicker cased versions however will survive impact and pose a significant risk regardless of the local ground conditions. (See Figure 6)

*Note; all mine fuzes were designed to arm after deployment from the ship, submarine or aircraft, some fuze designs incorporated anti-removal booby traps. Unexploded mines found today are the result of a failure within the arming mechanism or procedure whereby the mine never fully armed. Sudden shock or jarring of a weapon in this state has the potential to complete the arming sequence and could result in the mine detonating with lethal consequences.*

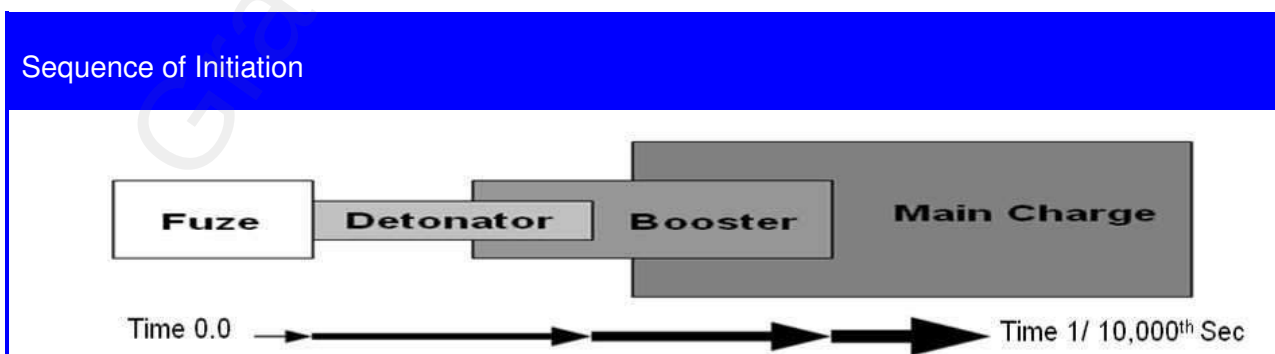
Figure 9: Explosive Ordnance Initiation Train.

**Initiation Train.** This is a means by which, once the safety features have been switched off or removed, a chain reaction occurs through the weapon. Starting within the fusing system as a small ignition or spark, causing a detonator to explode, which in turn causes the booster charge to detonate with a greater energy and ending in the full detonation of the main explosive filling. Each part of the process has in-built safety features to prevent an unintended detonation. A failure in any of the components within the Initiation Train can result in a UXO. In the case of a UXB; the chain reaction has broken down and the Initiation Train is brought to a halt, albeit, a temporary one. There are a number of ways that sufficient energy could be introduced to the otherwise stable UXB / UXO that may allow the Initiation Train to set off once more, overcoming the initial reason for failure. In addition to subjecting the weapon to excessive heat, such as a fire, the most common methods to bring about an explosive detonation in such items are considered to be:

**Initiation of Unexploded Ordnance.** Explosive Ordnance is highly unlikely to spontaneously explode. The energetic chemical compounds, (Explosives) used in weapon manufacture are chosen to be as stable as possible and they all require a significant application of additional energy to create the right conditions for detonation to occur. If stored correctly, most explosive materials are designed to remain stable for the duration of their expected lifespan (typically 20 years). During this time, the correct functioning of the weapon is achieved by means of the 'Initiation Train' (See Figure 9).
