# National Grid Cable Tunnel Replacement Project

## Arboricultural Impact Assessment (AIA) Part 1

December 2023

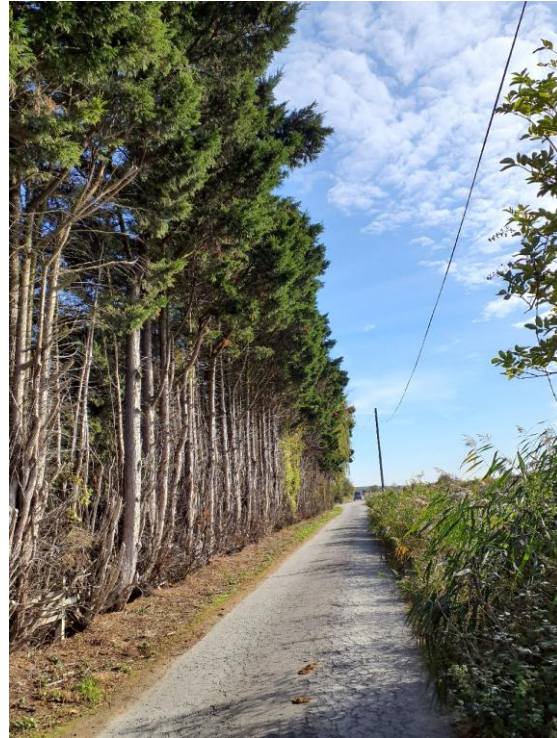
**Figure 2: G213, a row of previously crown lifted Leyland cypress**

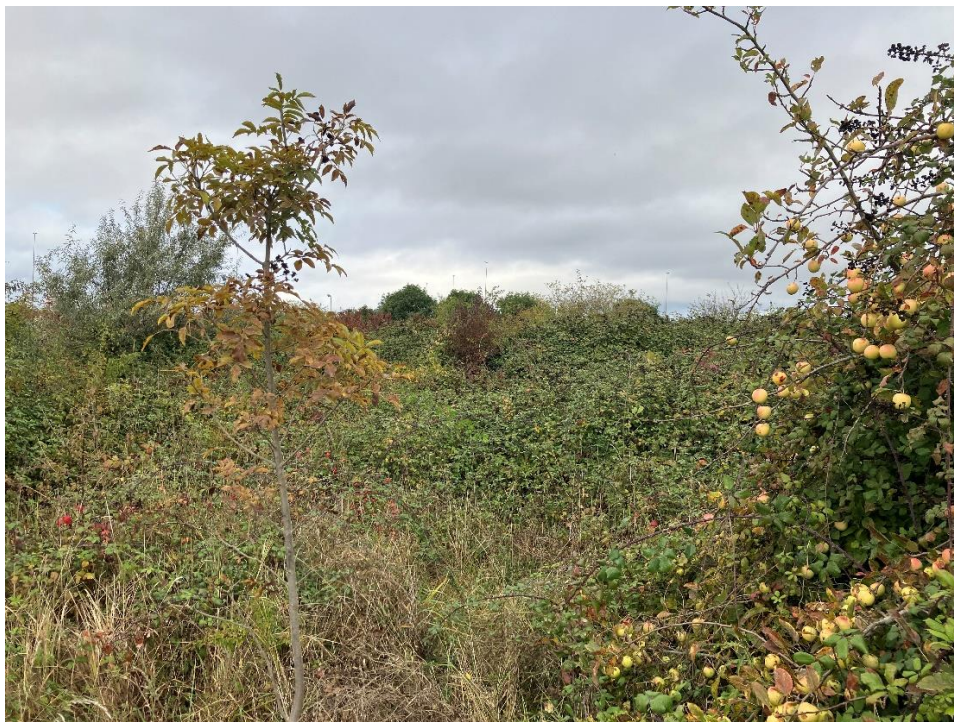
**Figure 3: A view within G95, a largely inaccessible area dominated by bramble and rose**
