## **Meopham Windmill – Heritage Statement and Assessment of Significance.**

Version 2-February 2025

Martin Ingham, Conservation Officer, Heritage Conservation Team KCC.

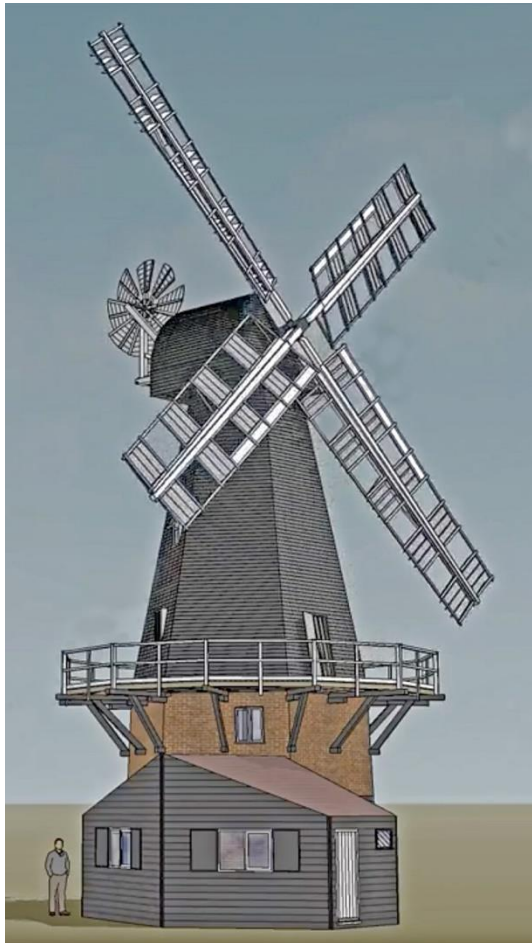
The structure of the mill comprises a tapering six-sided timber-framed tower with four levels standing on a brick base of two storeys. The walls of the base have a less pronounced taper than those of the wooden tower above. The smock tower is framed using a combination of oak, elm and softwood.

The top of the tower supports a circular wooden curb ring, above which rests a four-sided cap roof with a central ridge. The rafters of the cap are gently curved to create the recognisable form of 'waggon-shaped' or hooded roof favoured by Kent millwrights. The front wall of the cap is curved in plan and slopes backwards slightly; the rear wall is flat and vertical.

Both the cap and the smock tower are clad with a double layer of feather-edged weatherboarding, painted white to exclude the weather. The red brick base is lime washed internally.

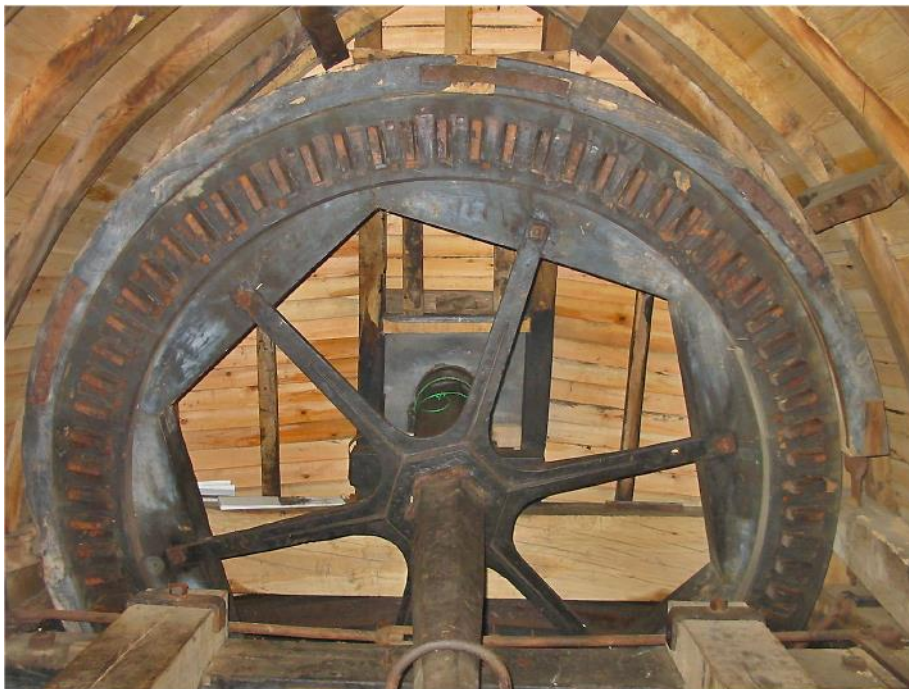
The machinery of the mill comprises two pairs of 'patent' sweeps, with adjustable shutters, driving three pairs of millstones in total: two on the third floor and a third pair, added late in the mill's working life, on the second or meal floor. This pair could alternatively be driven from below by the auxiliary engine located in the adjoining shed. The engine drive gearing remains in position, suspended below the second floor.

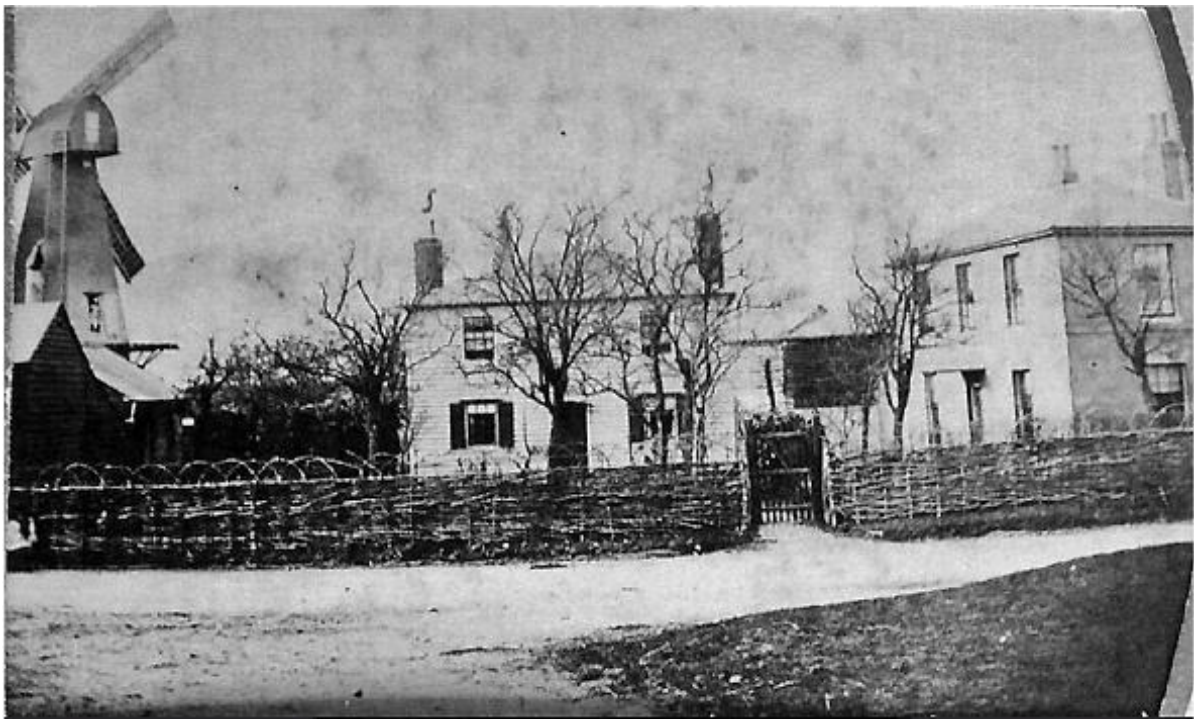
**An early photo of the mill, taken during the Killick family's ownership. The fantail has not yet been fitted, and one pair of sweeps is canvas-covered. (Rob Cumming Collection)**

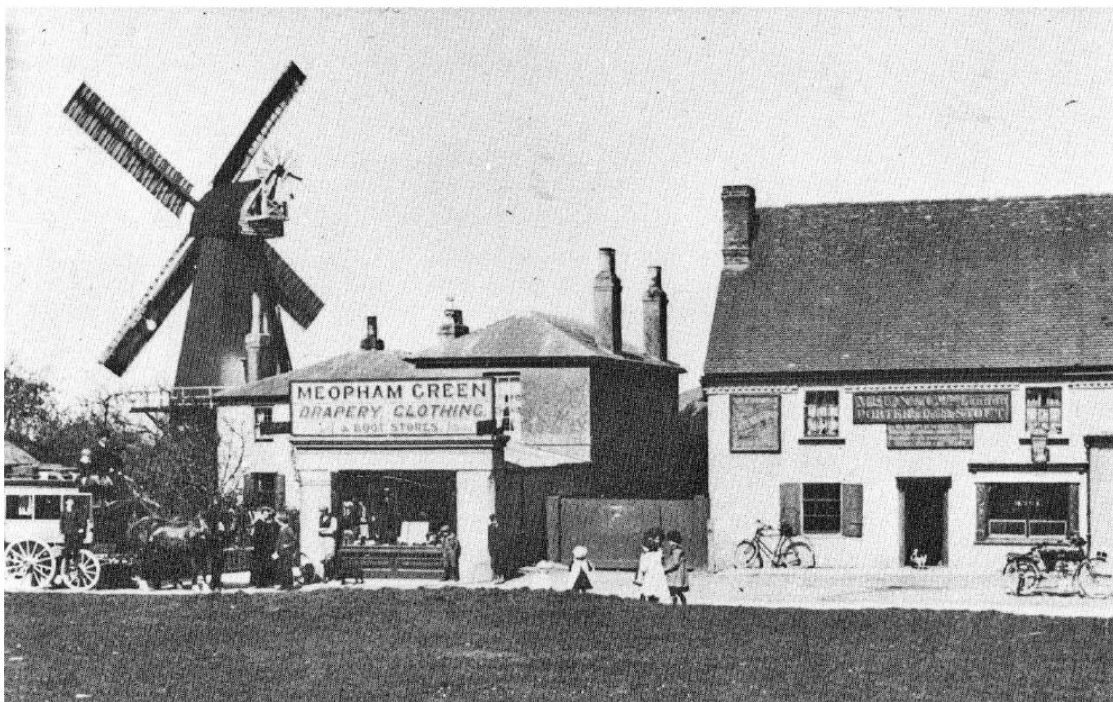
**Meopham Mill, c1905, at work with one pair of common sweeps and one pair of shuttered sweeps. A fantail has now been fitted and the rear wall of the cap has been painted white. (MWT Collection)**

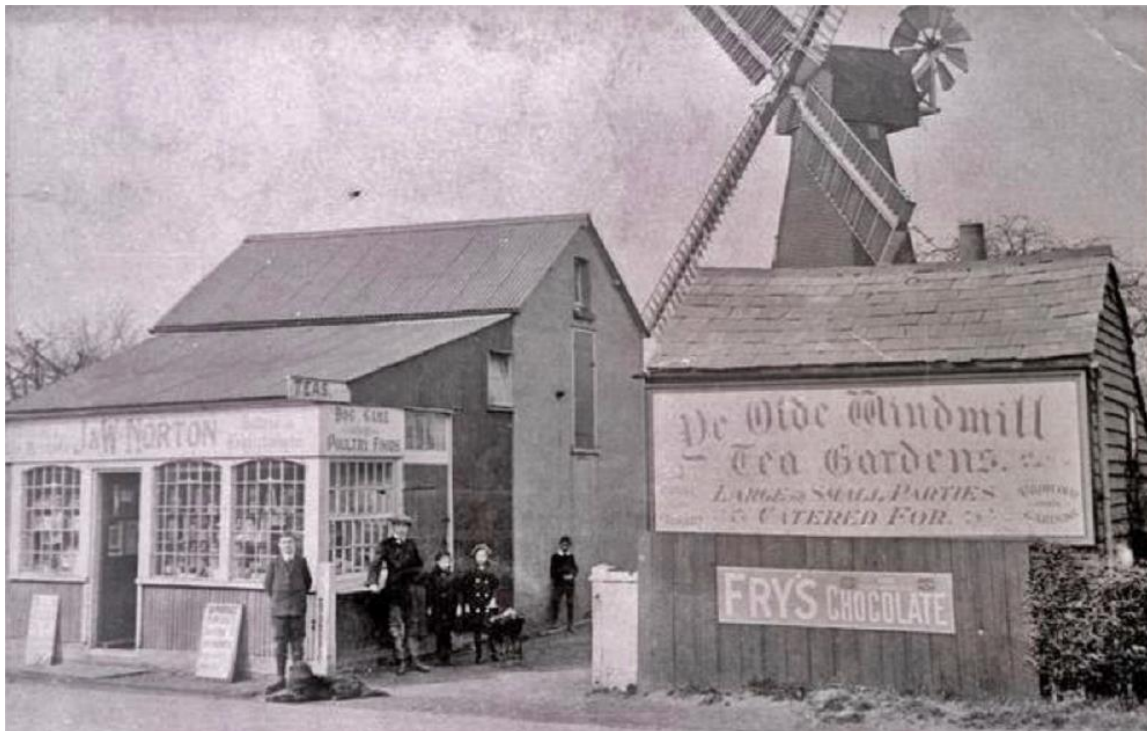
**Meopham Mill, c1918, showing the Norton's shop and a large advert for the tea gardens. The mill now has four shuttered sails. (MWT Collection)**

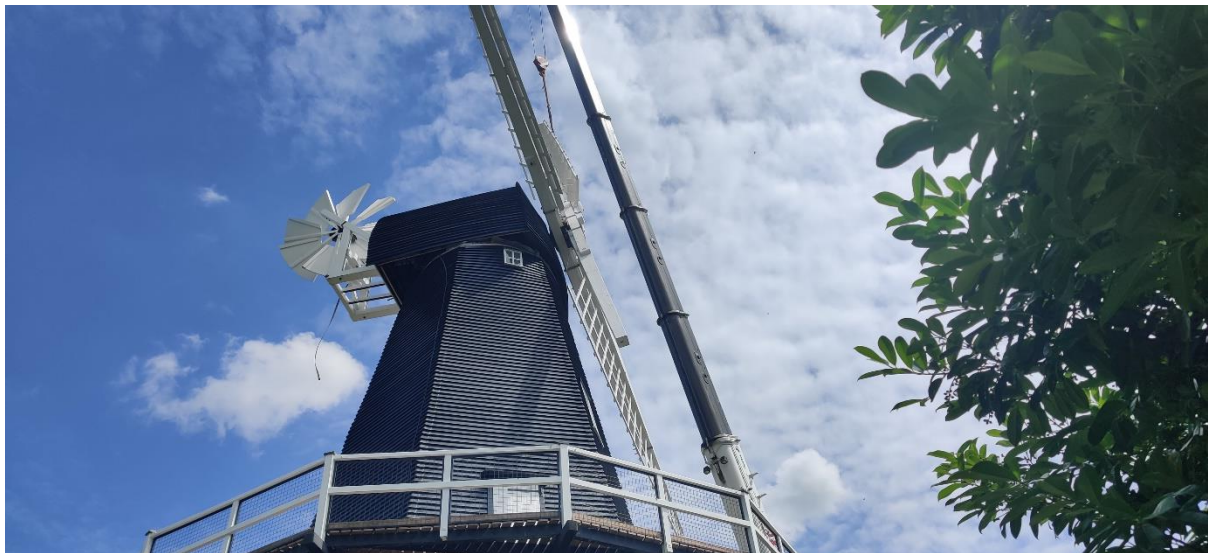
- A fan stage of ‘Medway’ pattern. The arrangement of timbers that supports the fantail could formerly be seen at other smock mills in the area that no longer exist. These include those located in and around Rochester and on the Hoo Peninsula.
