# Preliminary Bat Roost Assessment

Vale Road, Gravesham

**Frankham Projects**

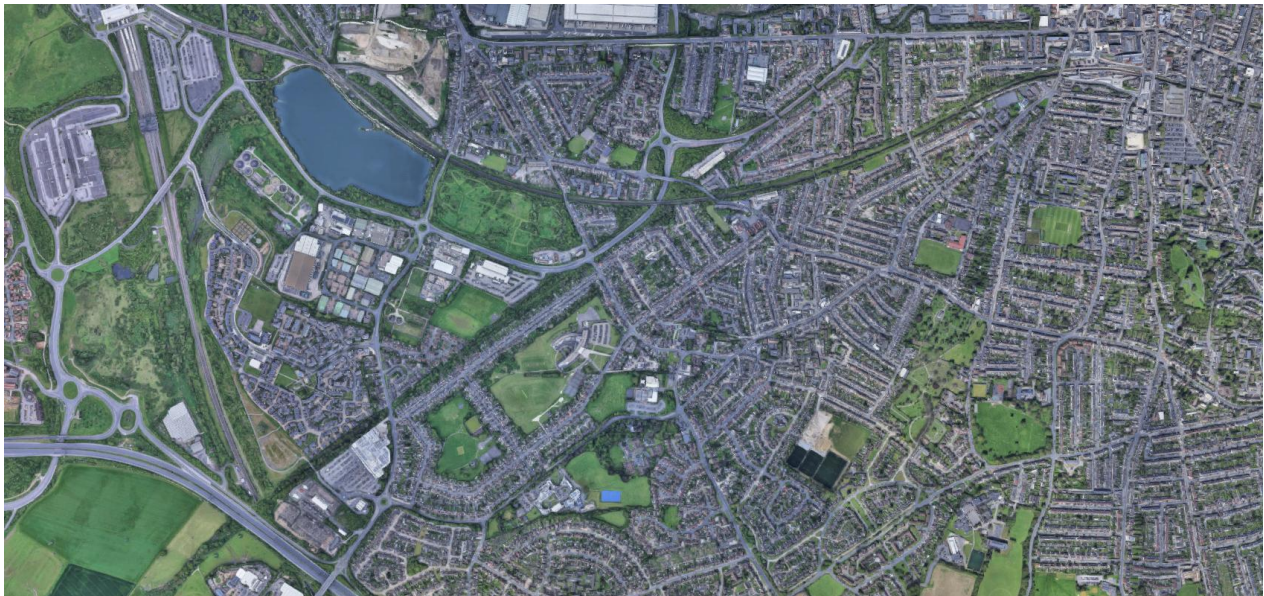
**FIGURE 1: AERIAL PHOTOGRAPH OF THE SITE SHOWING SURROUNDING LANDSCAPE STRUCTURE**

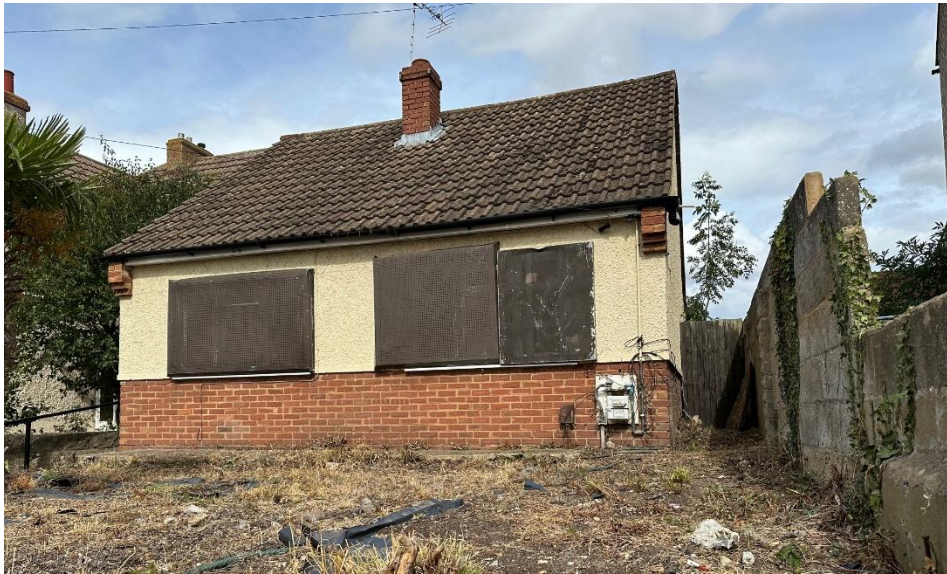
The survey building is a detached single storey small bungalow of masonry construction with a pebble dash render. The building has a dual pitched roof with interlocking concrete tiles. All of the windows were covered with perforated metal coverings. There was a small vegetated front garden that had been recently cut back with an individual palm tree, and an overgrown vegetated rear garden.

FIGURE 2 – FRONT ELEVATION OF THE BUILDING

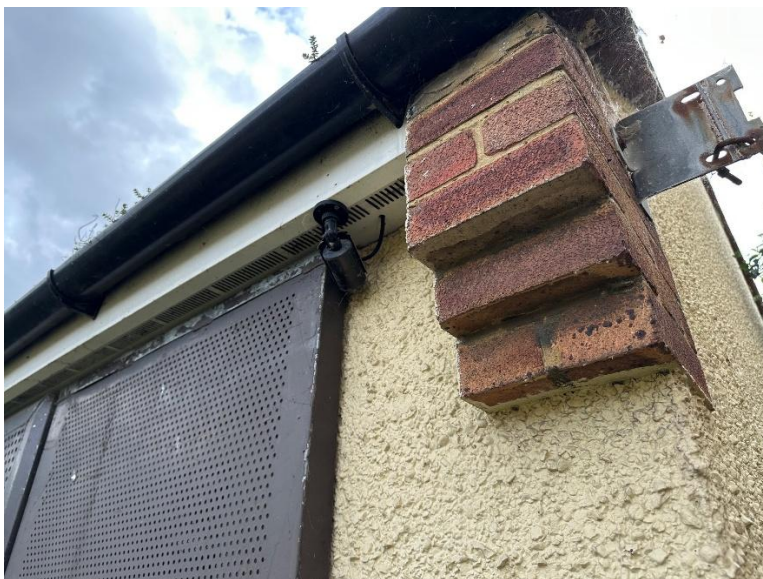
The roof tiles were all in a reasonable condition with a few small gaps or slipped slates which could allow bats to roost. Similarly, the soffits and external walls were in a slightly deteriorated condition with several cracks and gaps that could be used by bats to gain access into the building for roosting.

FIGURE 3 – SOFFIT & CORNER OF THE BUILDING

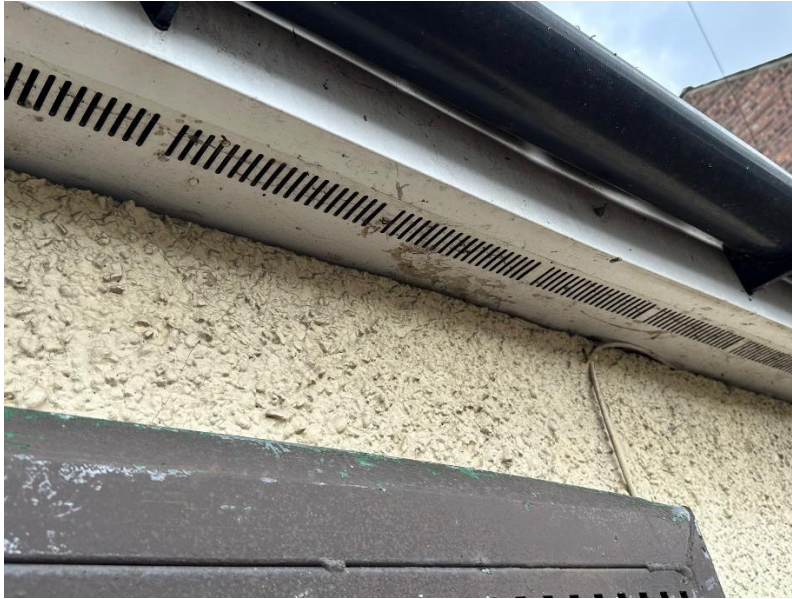
**FIGURE 4 – UNDERSIDE OF THE SOFFIT ILLUSTRATING GAPS**

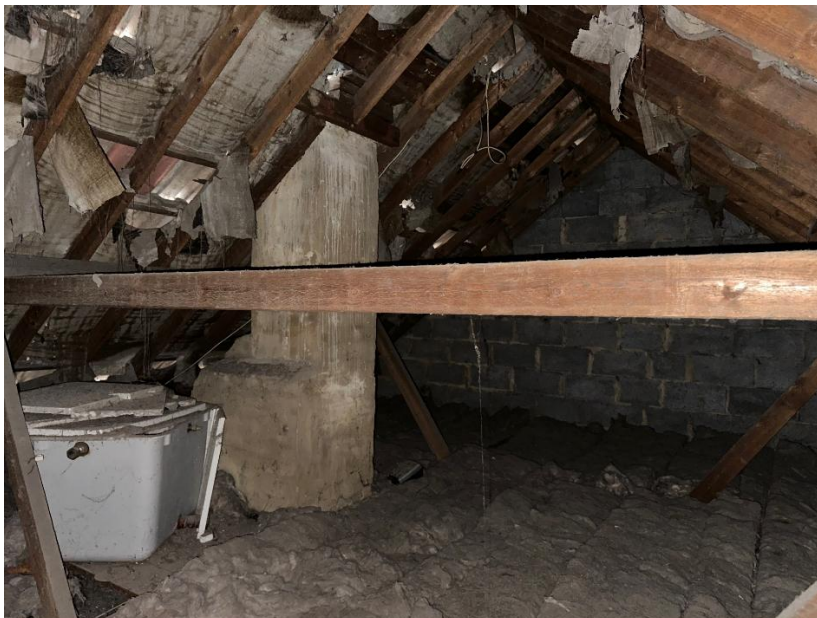
The under lining of the roof in the attic space was torn and in poor condition with the underside of the concrete tiles and gaps exposed across the whole roof. This indicates that the roof is likely to strongly fluctuate in temperatures across day and night, which would deter bats looking to for a maternity or hibernation roost location.

**FIGURE 5 – UNDER LINING OF THE ROOF IN POOR CONDITION**

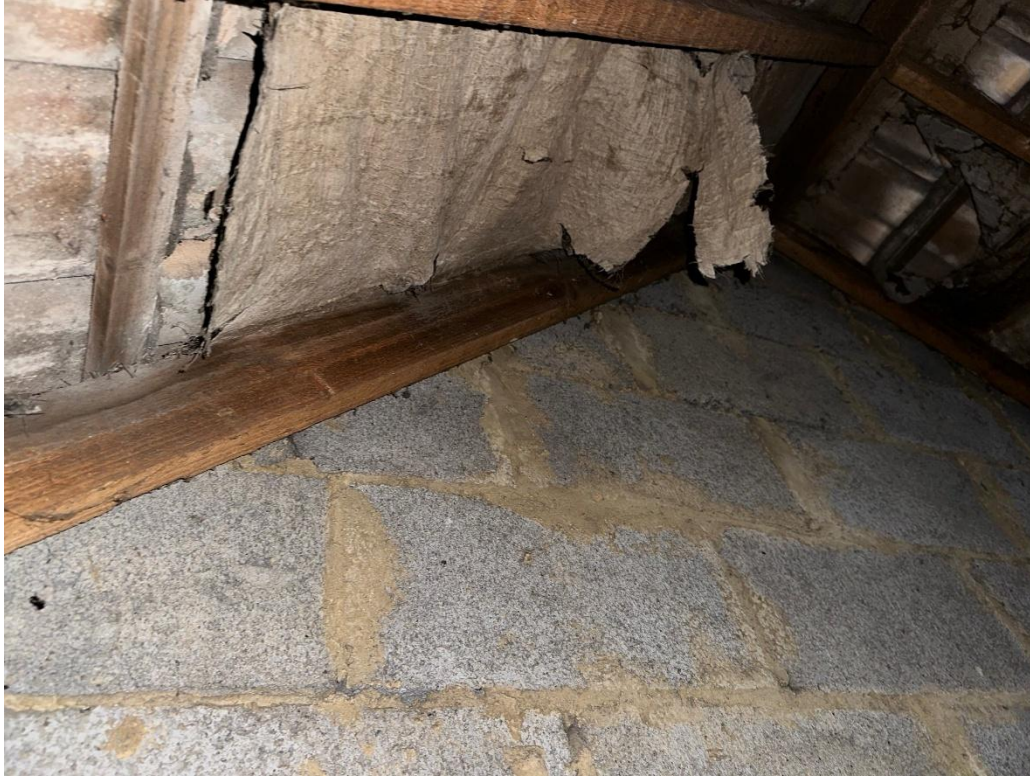
The inside of the building, in particular the attic space, was comprehensively surveyed to ascertain whether any signs of bat activity could be identified. No signs of bat activity were noted.

**FIGURE 6 – CONCRETE BLOCKS WITHIN THE ATTIC ILLUSTRATING ABSENCE OF BAT ACTIVITY**
