## **BROWNFIELD SOLUTIONS LTD**

### **BRT PROPERTIES (KENT) LTD**

Vale Road, Northfleet

Geo-Environmental Assessment Report

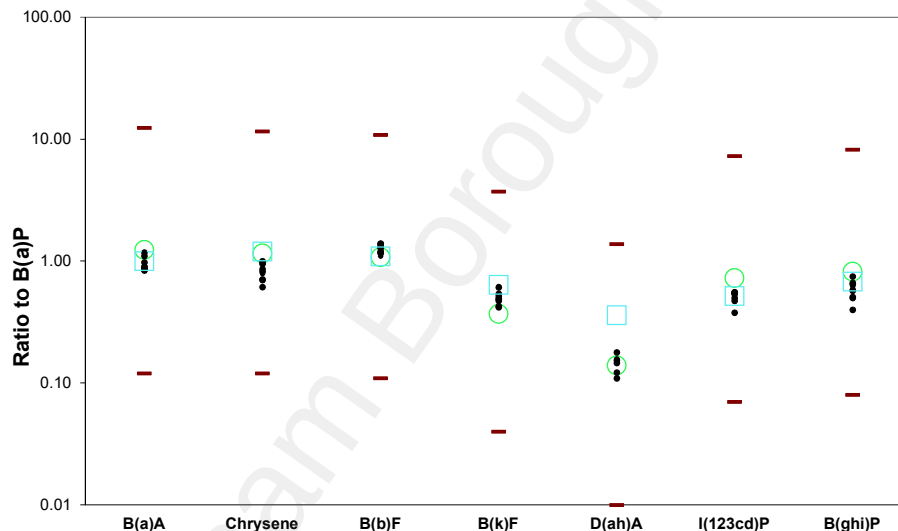
The graph summarises the study site data with respect to how the ratios of carcinogenic PAHs relate to B(a)P, within the confidence limits provided in the HPA documents.

BSL considered the main drivers for PAHs to be benzo(a)pyrene and naphthalene. This is as a result of B(a)P possessing carcinogenic properties and thus being the most toxic of the PAHs, and naphthalene the most volatile and soluble. Based on the above assumption for PAHs, BSL have undertaken an assessment of the data for the site with regards to using B(a)P as a surrogate marker for carcinogenic PAHs as per HPA and CL:AIRE guidelines.

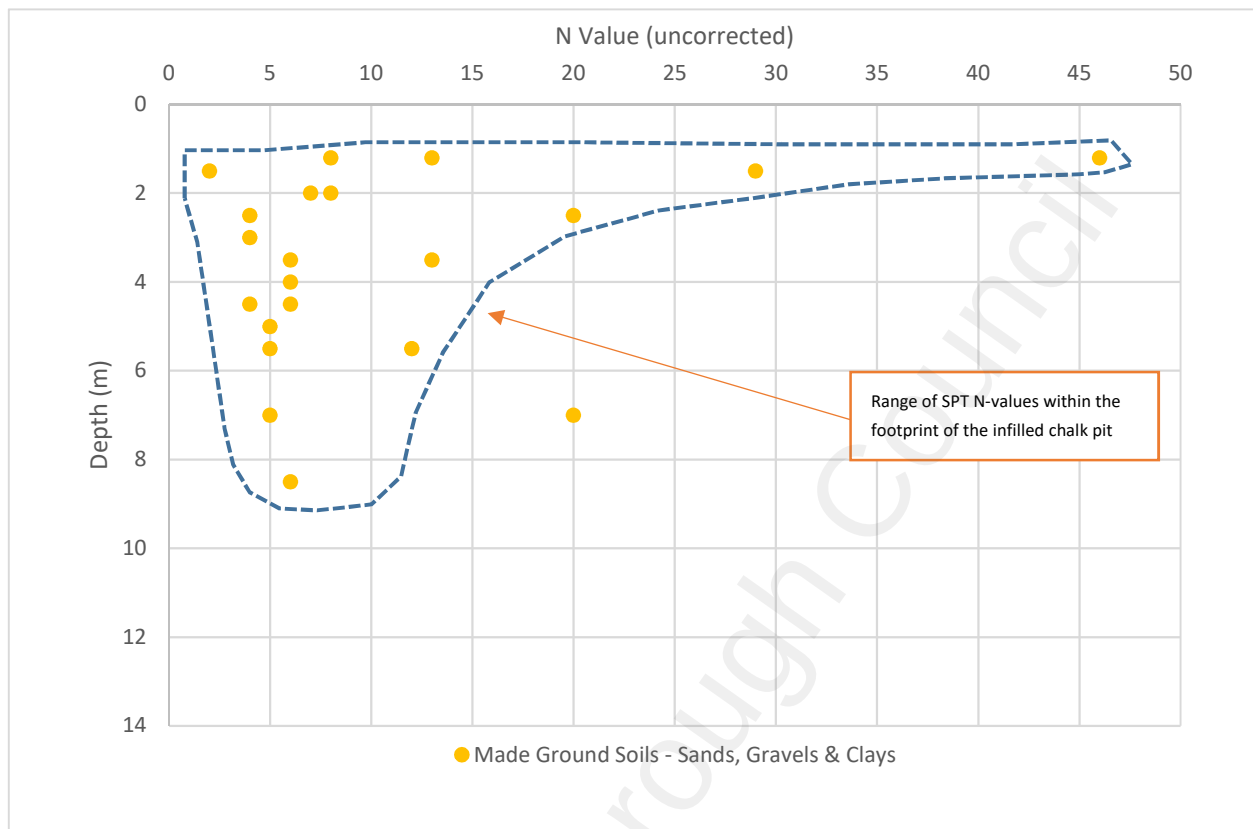
## Made Ground

The test results have been evaluated to derive geotechnical soil parameters for the site. Depth vs SPT N-value graphs for the made ground and chalk bedrock are provided separately below to provide a profile of the ground conditions underlying the site.

The SPT vs Depth graphs show that there is a large variation in the strength/density of the made ground deposits within the footprint of the infilled chalk pit. Between 1.20m and 1.50m bgl. the corresponding N-values ranged between 4 and 46, with an average of 17, whilst between 2.00m and 2.5m bgl the corresponding N-values ranged between 2 and 20, with an average of 8. Generally, the strength/density of the made ground soils decreases with depth, with the majority of the N-values being less than 10.

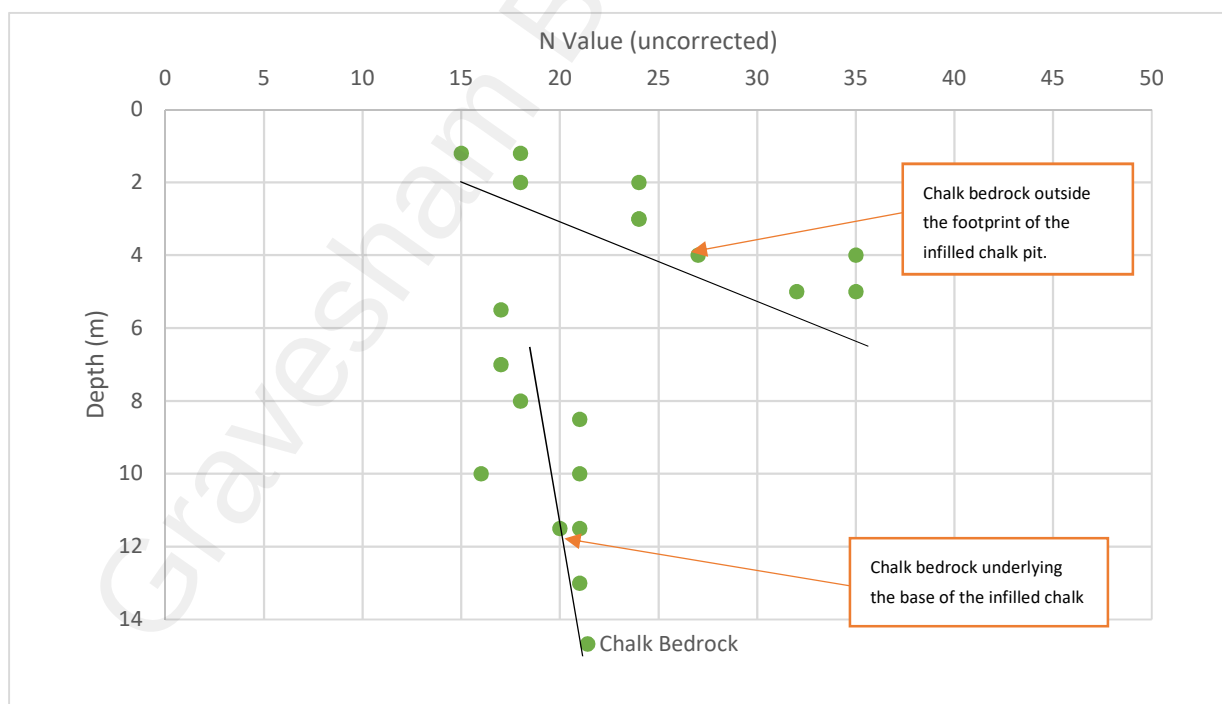
## Chalk Bedrock

The depth of the Seaford Chalk Formation and Newhaven Chalk Formation bedrock underlying the site is clearly identifiable by the sharp increase in the N-values. One made ground anomaly lies within this data set (BH1 at 7.00 – 7.45m bgl); although the strata predominantly comprised chalk with rare brick fragments and is likely to be the reworked base of the chalk pit between 7.10m and 8.50m bgl.

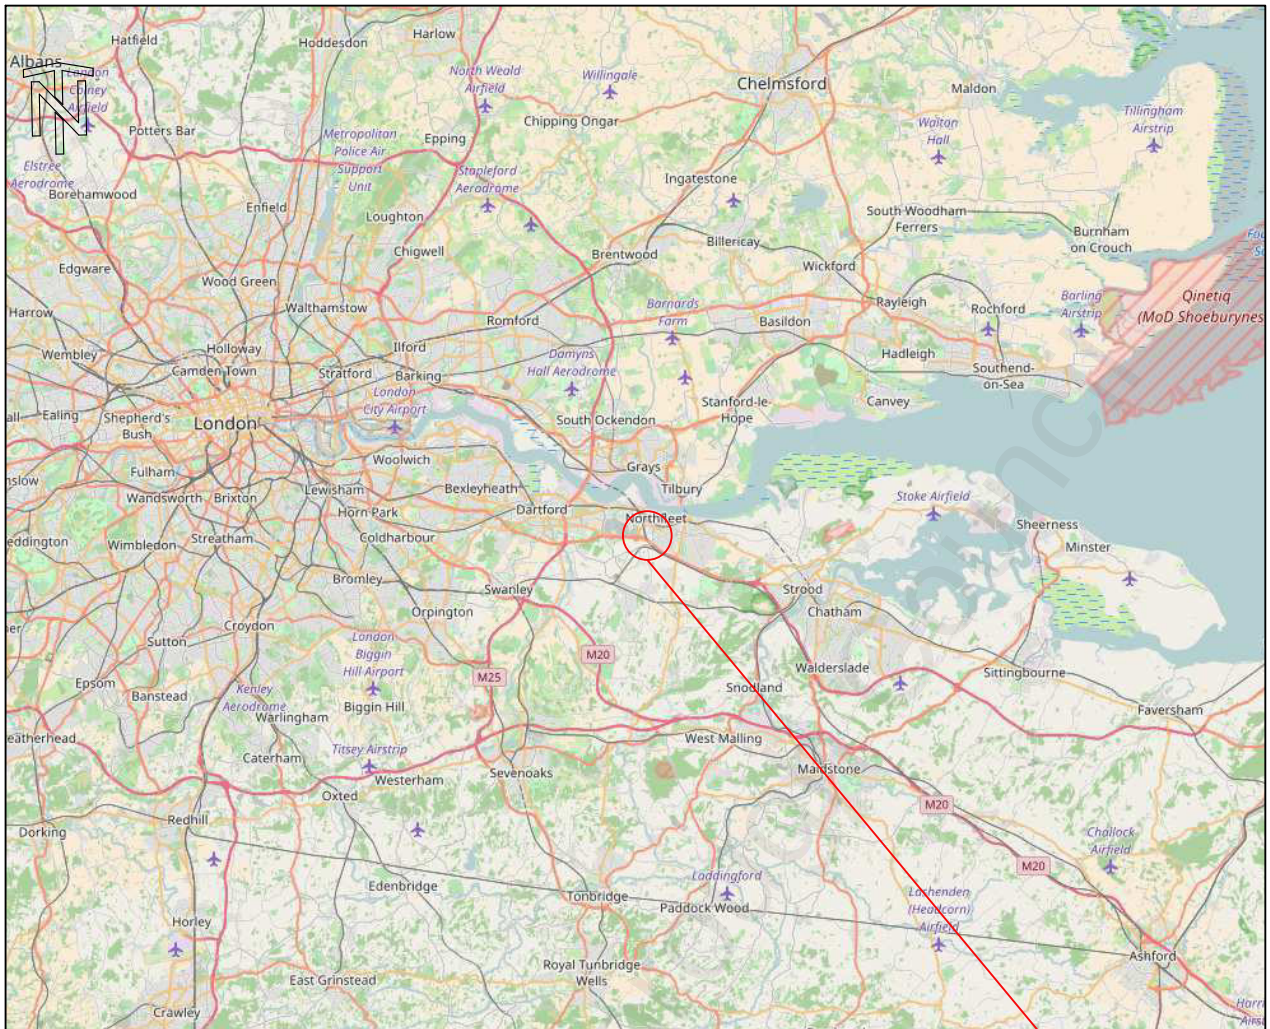
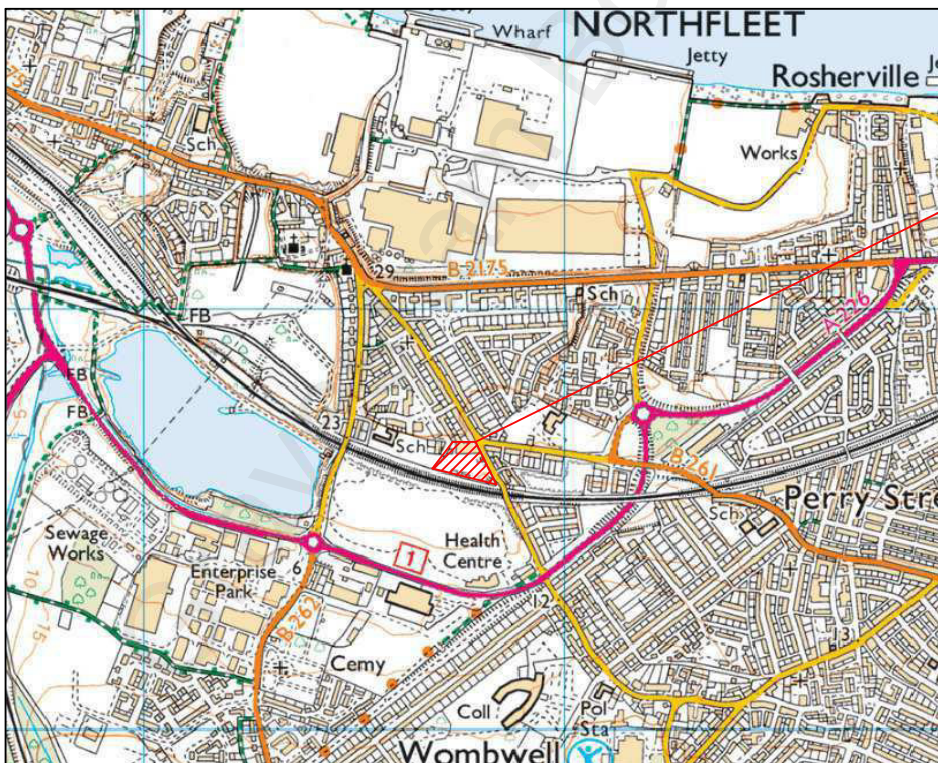
| CLIENT<br>BRT PROPERTIES LIMITED | | DRAWING DETAIL<br>SITE LOCATION PLAN | | <div>BROWNFIELD<br/>SOLUTIONS LTD<br/><small>GEO-ENVIRONMENTAL ENGINEERING EXCELLENCE</small></div> | |

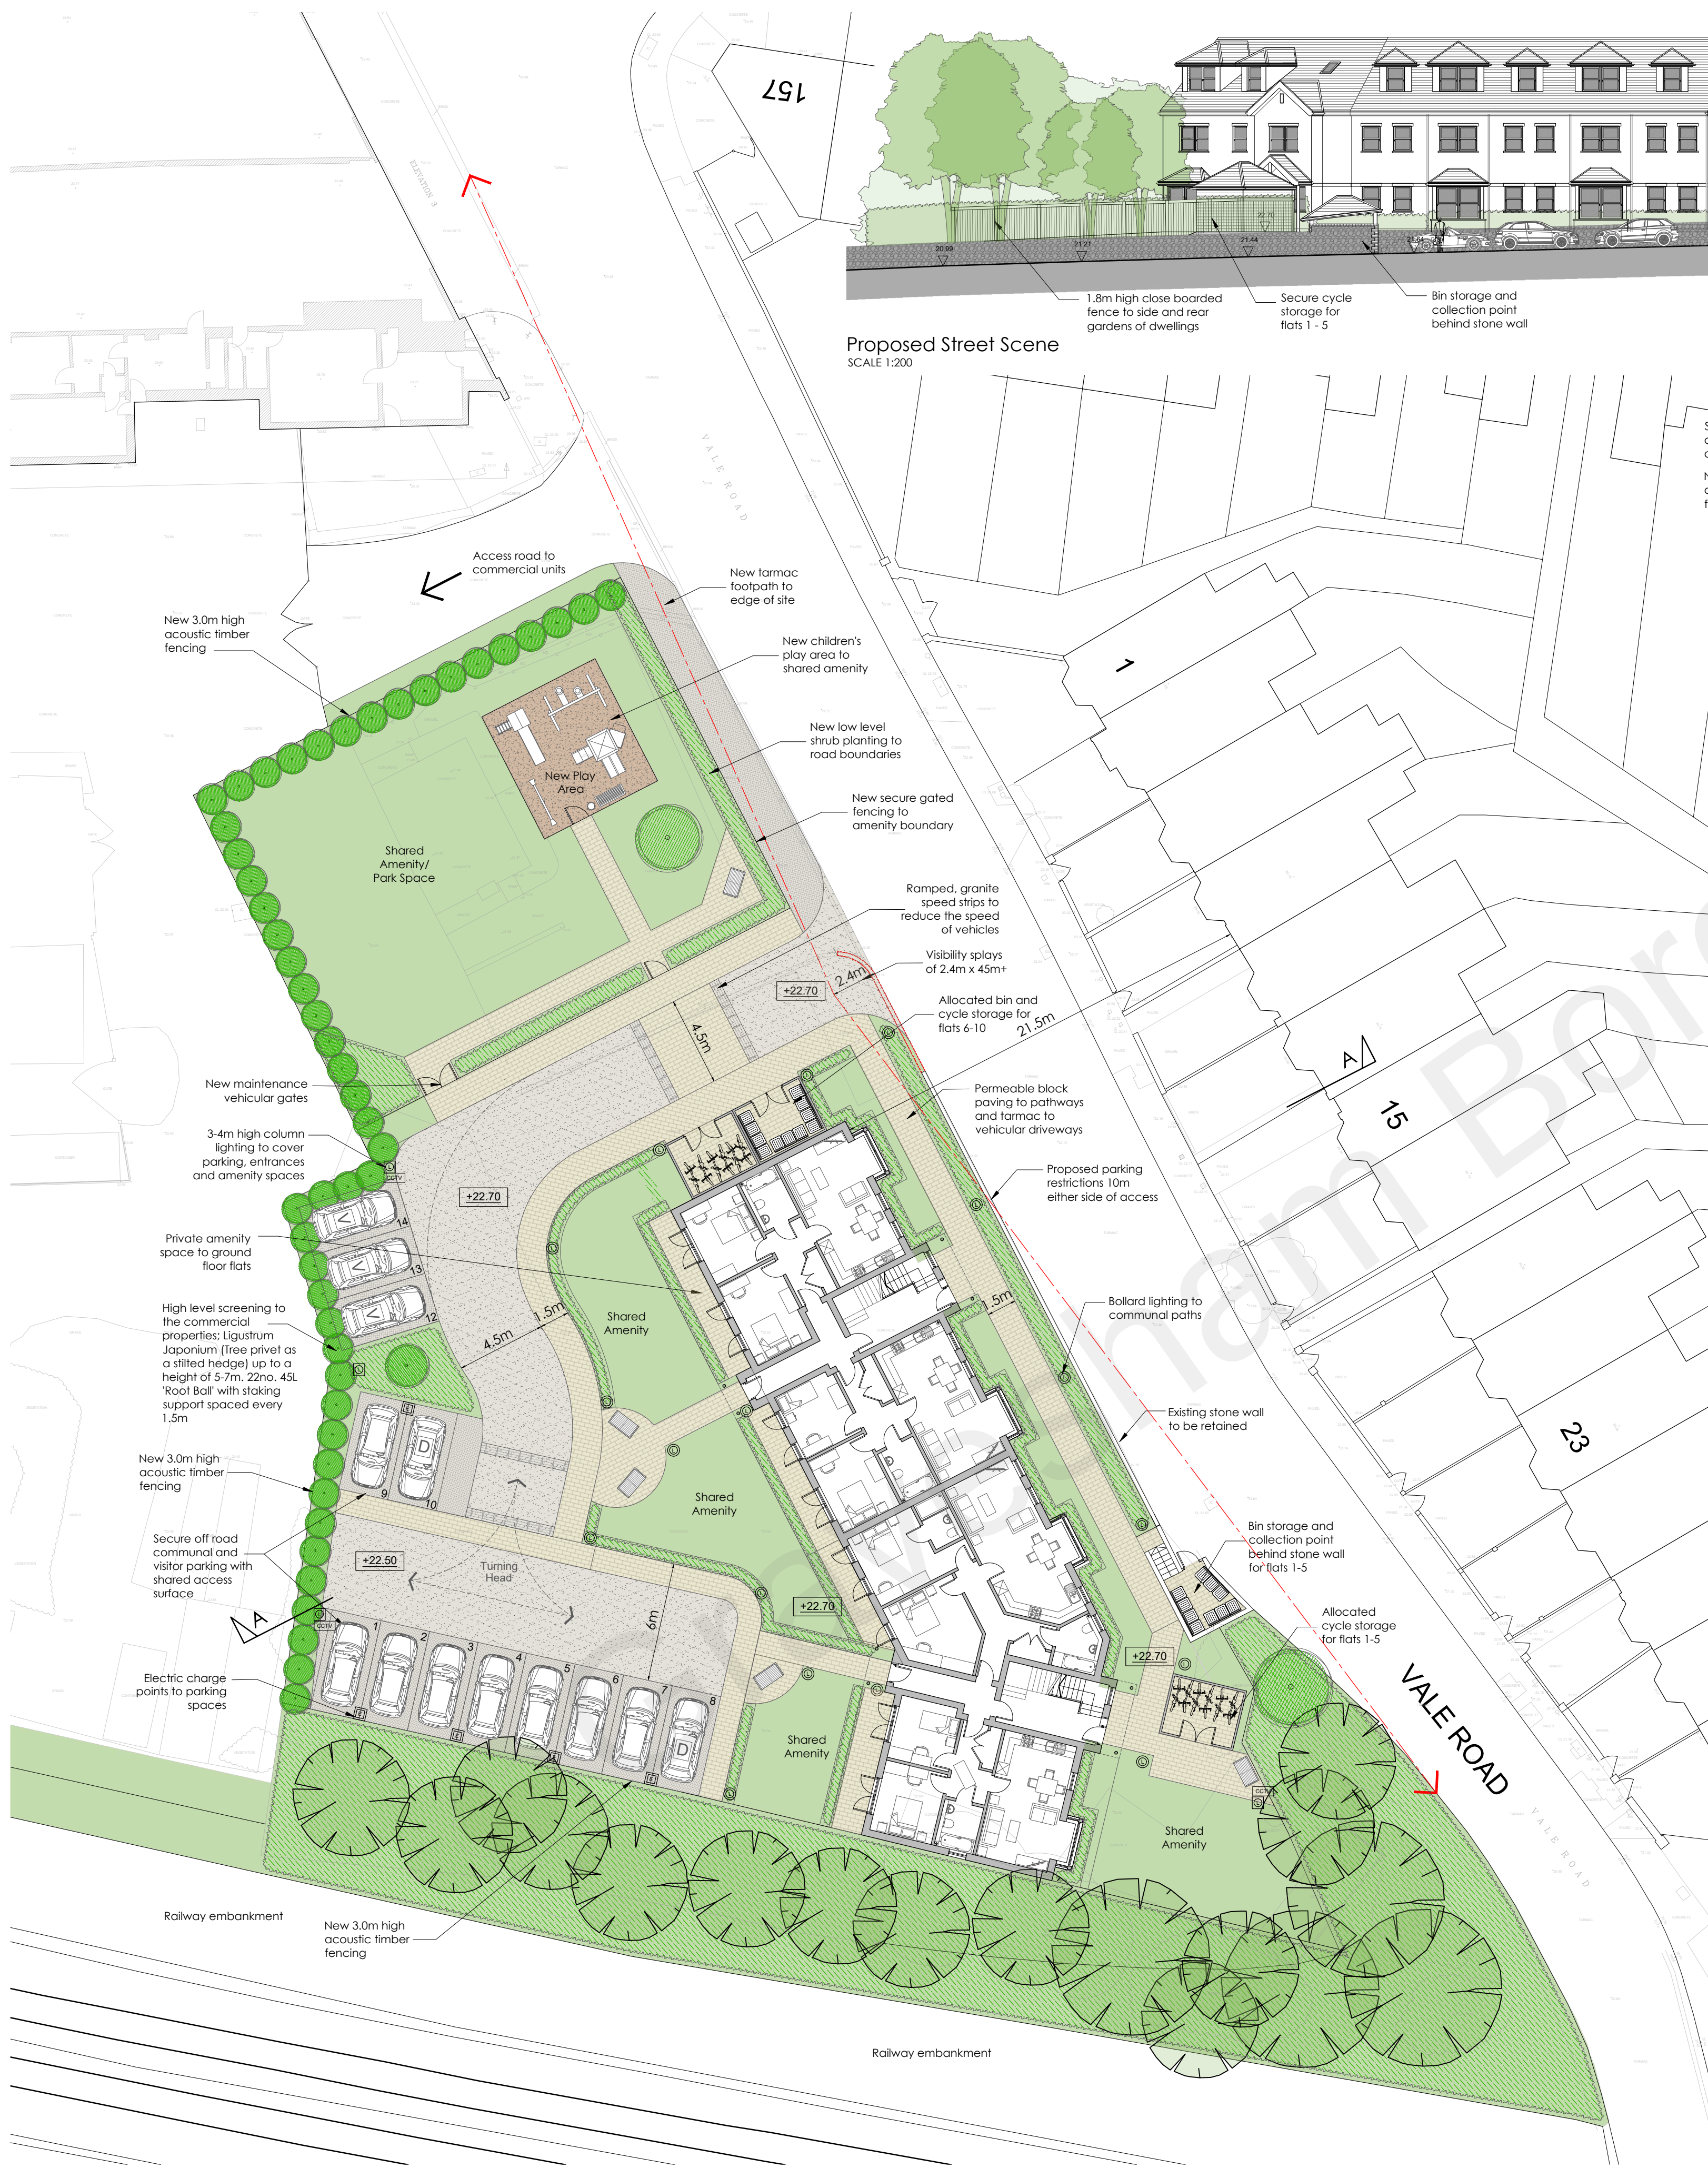
Proposed Street Scene  
SCALE 1:200

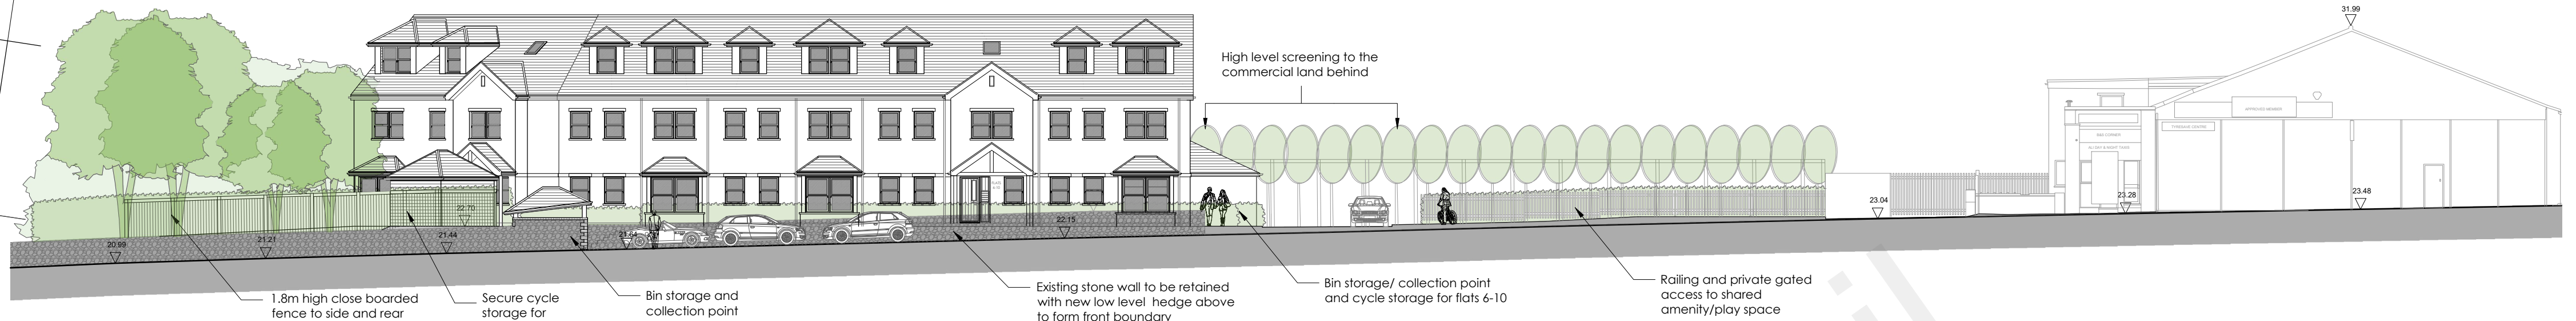
Proposed Site Section A-A  
SCALE 1:200

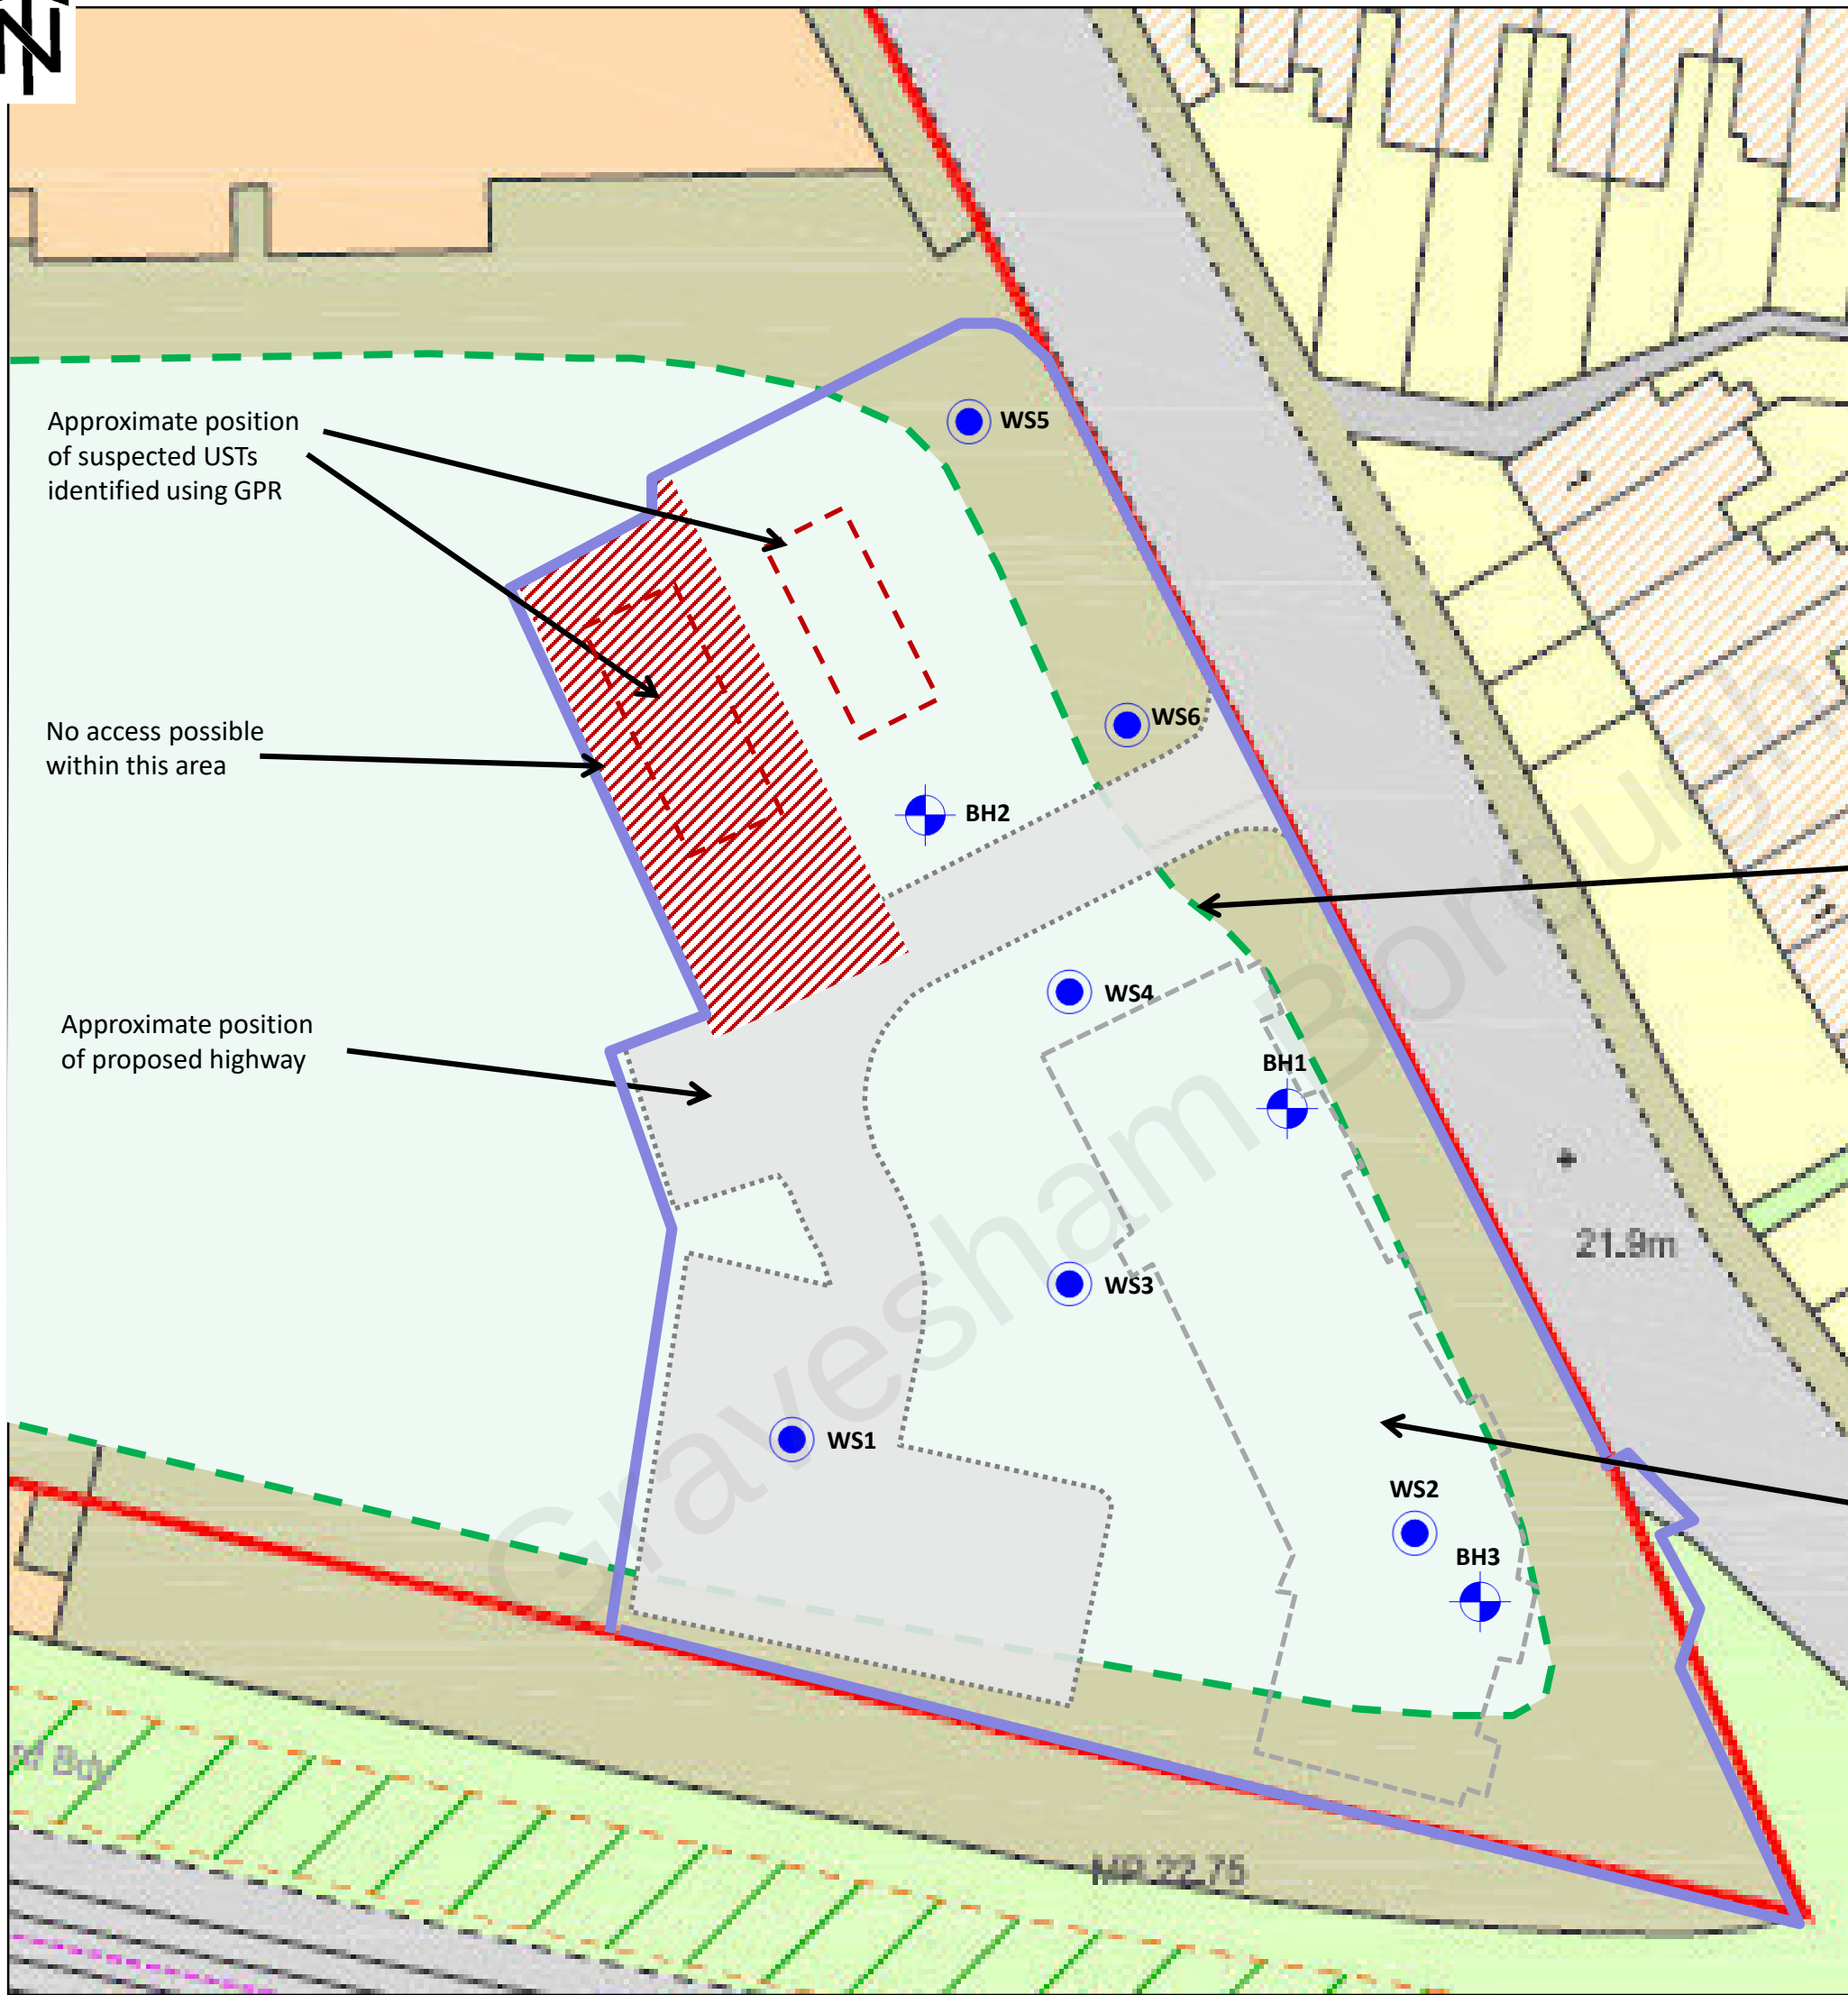
| DRAWING No.<br>C3467/03 | REVISION<br>- | SCALE<br>NTS | DATE<br>18/02/19 |

WS1 Window Sample Borehole

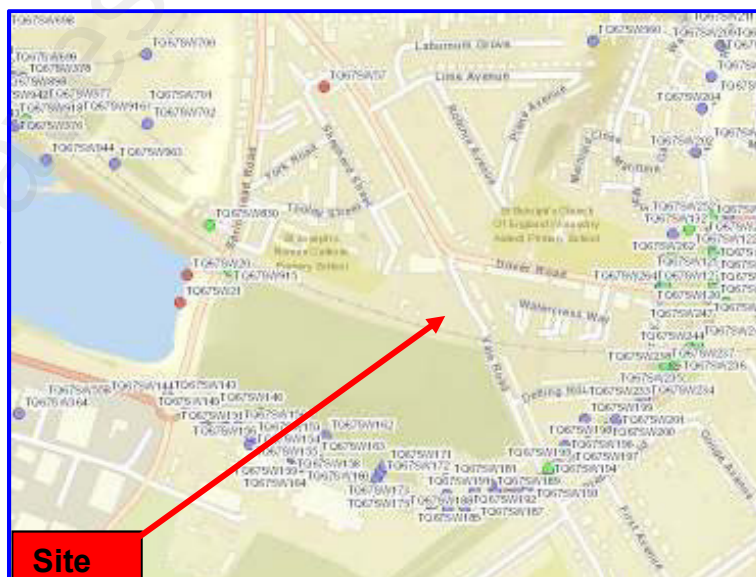
Figure 3.1 Borehole Location

BGS (British Geological Survey) nearest borehole see Figure 3.1 indicates the following geology:

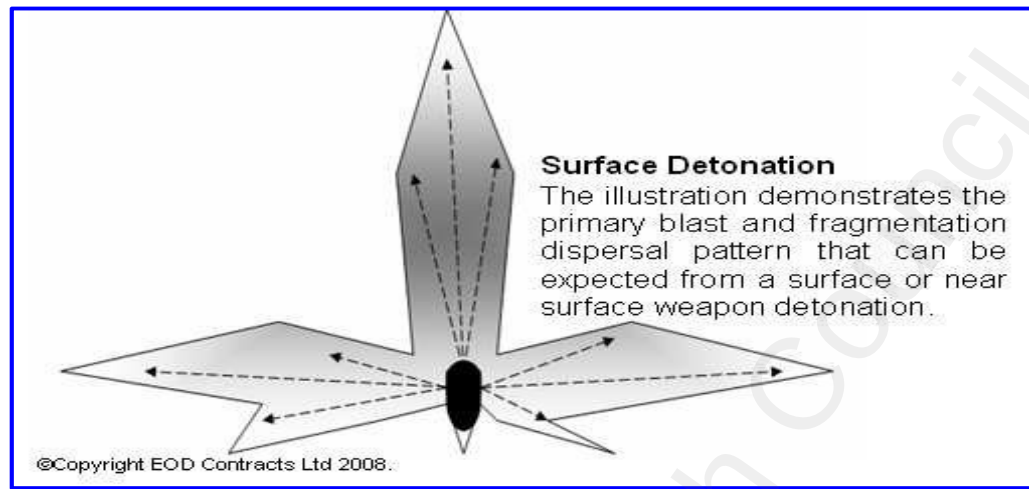
Figure 6.1: Primary Blast &amp; Fragmentation on Land

**Blast and fragmentation dispersal.**

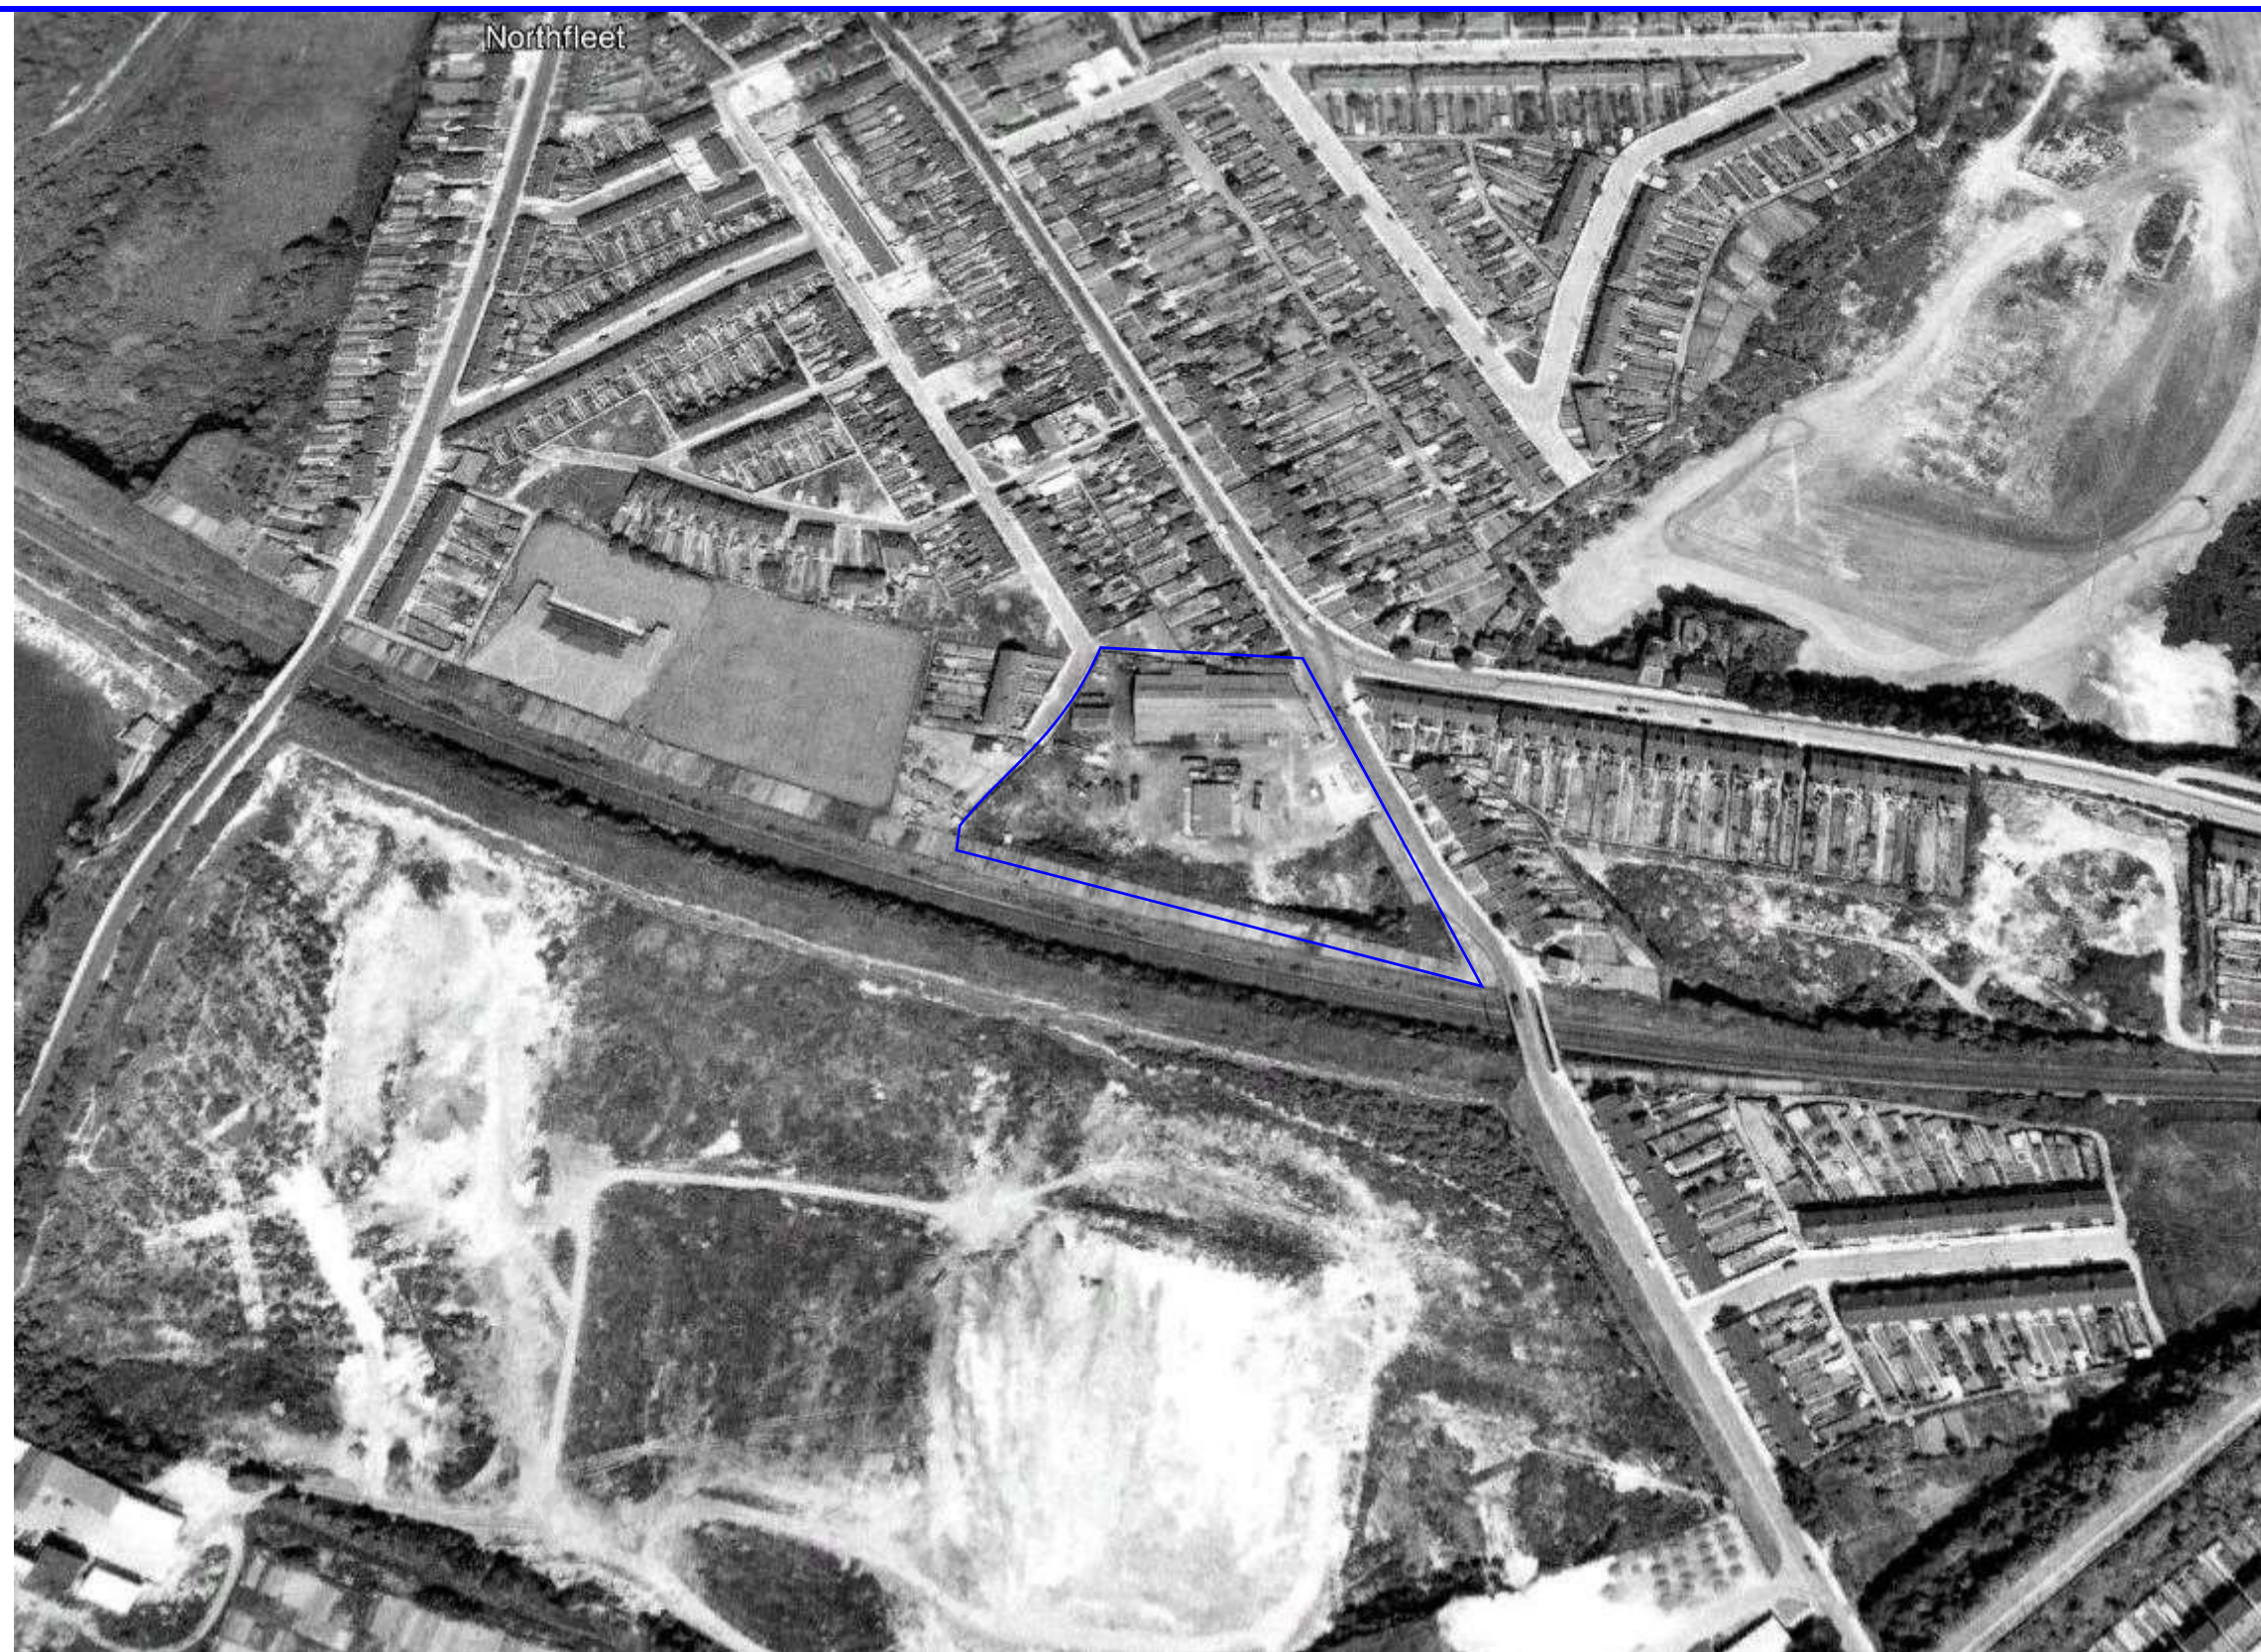
| Page No. | Date | Scale | Description/Remarks |
|---|---|---|---|
| B-6 | 1960 | NA | Aerial Photograph. Site appears to have buildings in the north quadrant and in the centre, the remainder appears to be open ground, partially excavated |

### AERIAL PHOTOGRAPH

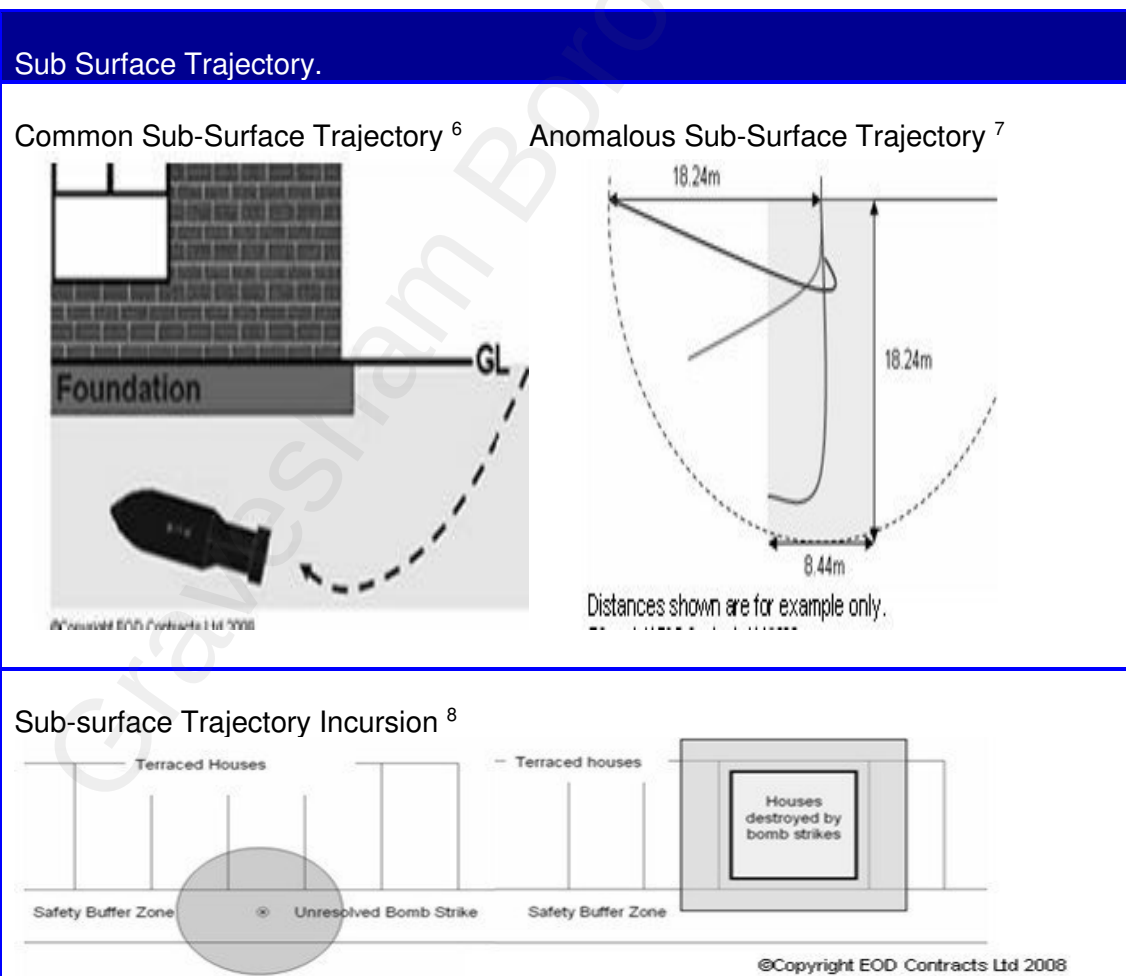
Figure 1: Sub-Surface Trajectories & Safety Buffers

*Note; the common sub-surface trajectory will follow a path best described as a 'J' curve. The curve can result in a weapon coming to rest some distance from its impact point. The distance from impact point to resting place is referred to as the "Off set Distance and is normally considered to be 1/3 of the depth. This mechanism can permit a weapon to strike outside a building and travel below ground finally coming to rest within the building footprint. Where a strike is known to have occurred close to a building or structure such as a dock wall, a danger zone should be considered to exist around the area of the strike of sufficient size to accommodate the likely sub-surface travel distance for the weapon.*

*Note; the typical offset distance is shown as the shaded area, on rare occasions a near surface deflection of the weapon can occur and the offset distance can be substantially increased up to 5/4 of the penetration depth. This mechanism does however reduce the penetration depth considerably with the net result that while the offset is increased the overall travel distance is for the most part unaffected.*

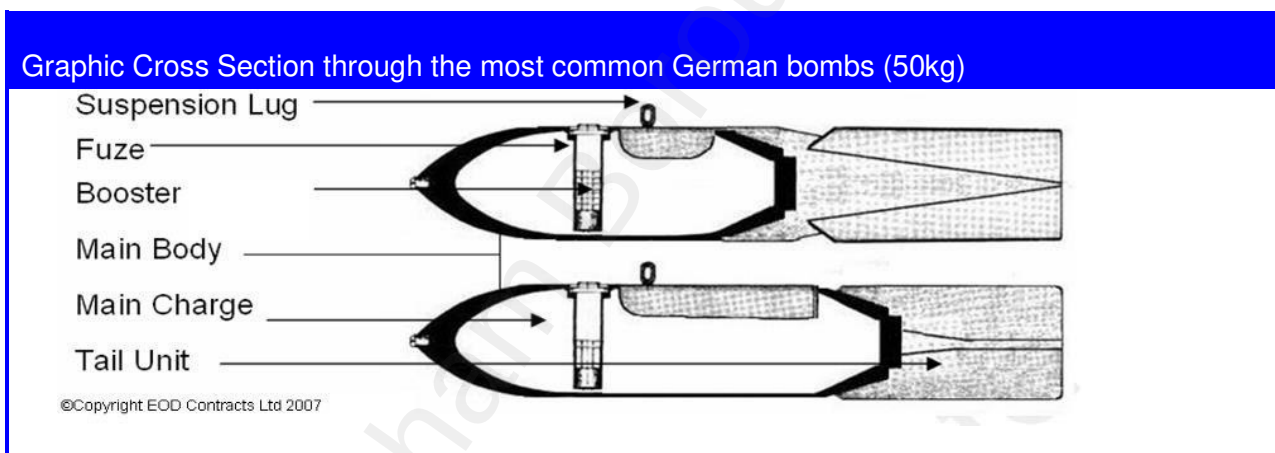
Figure 2: Generic German Bomb Design.

*Note; the diagram shows that there can be a significant difference in the quantity of High Explosive contained within bombs of similar size and shape; the Grade 1 bomb on the bottom having 30% more HE than the Grade 2 shown at the top. This serves to demonstrate the importance of an accurate identification of any item of UXO.*

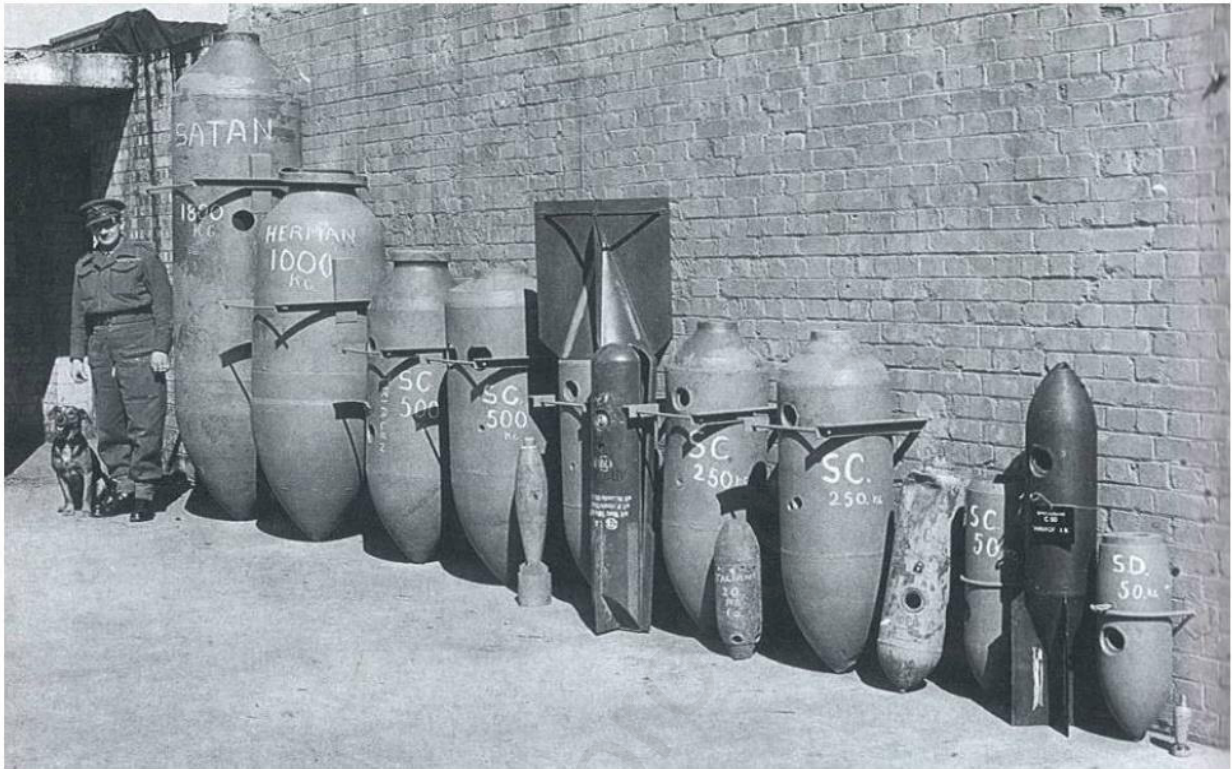
Figure 4: Range of HE bombs dropped on the United Kingdom.

*NOTE: The smaller sub-munitions (Bomblets) seen to the right, ranged in size between 1 and 3kg, were dropped in large numbers and were intended as incendiary bombs, anti-personnel bombs or as bombs filling both roles. The smaller bomblets were dropped in larger container bombs designed to hold between 360 and 620 of the bomblets. The containers were designed to burst open at a predetermined height above ground level, dispersing the bomblets over a wide area. Air raid damage was far greater by using both incendiary, and HE bombs on a single raid. The fires started by the incendiaries being rapidly spread by the blast waves from the HE bomb. This scenario was shown to devastating effect on the 14<sup>th</sup> February 1945 in the German city of Dresden. Where fires started and spread by the bombing increased to a point where the oxygen was being sucked into the flames at such a high speed that the fire became a "Fire Storm". At the time the city's population had increased due to a high number of refugees fleeing the Russian advance to the east, the exact civilian death toll from fire and suffocation will never be known, but is considered to be somewhere between 25,000 and 100,000.*

**High Explosive (HE) Bomb.** Some of the most common type of ordnance to be dropped on the United Kingdom, HE bombs are often the type encountered as UXBs. Relatively thick cased, they are still recovered in remarkably good condition. Ranging in size from 50 to 1700 kg, their typical release height (1,500m) allowed them to penetrate deep into the ground as a result of design or flaw. Towards the end of the bombing campaign, as steel became scarce the German Engineers produced a range of bombs that used steel reinforced concrete as the bomb body. Figure 4 shows the range of steel HE bombs dropped on the UK.

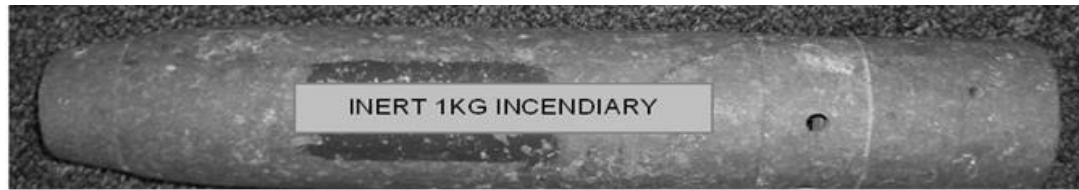
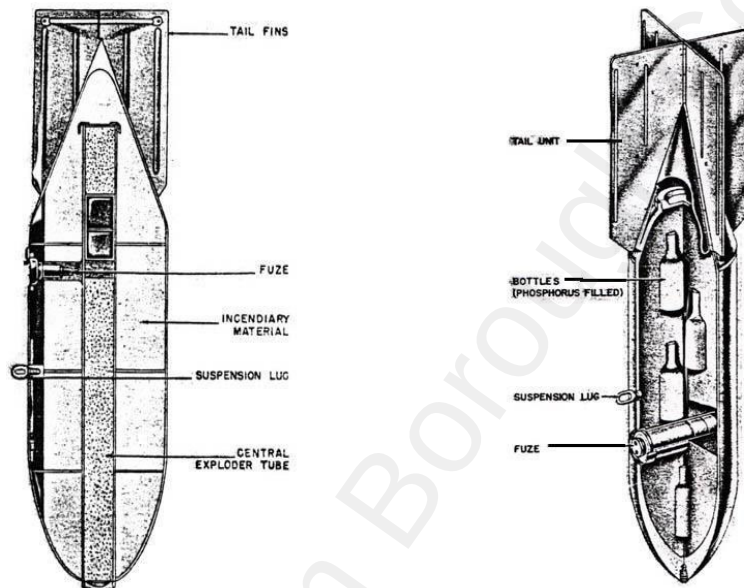
250 mm  
Above 1kg incendiary bomblet, below left the larger 500kg incendiary bomb Below right a 50kg incendiary bomb containing bottles of white phosphorus.

*Note; Incendiary bomblets were made of a flammable alloy similar in appearance to aluminium, which resists corrosion well. The tail unit was made of thin tin-plate steel and is more prone to have rusted away. Some Incendiary models were fitted with a High Explosive (HE) steel nose. With the tail and explosive nose attached the bomb was 480mm long.*
