## **BROWNFIELD SOLUTIONS LTD**

### **BRT PROPERTIES (KENT) LTD**

Vale Road, Northfleet

Geo-Environmental Assessment Report

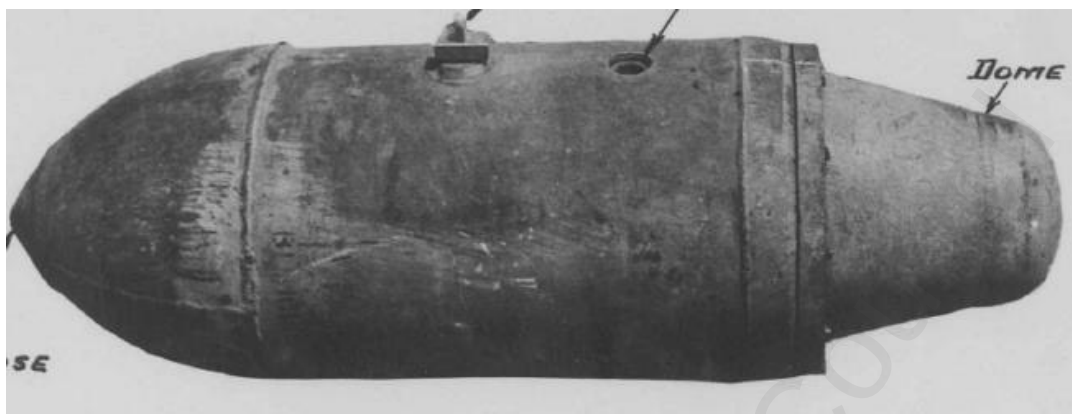
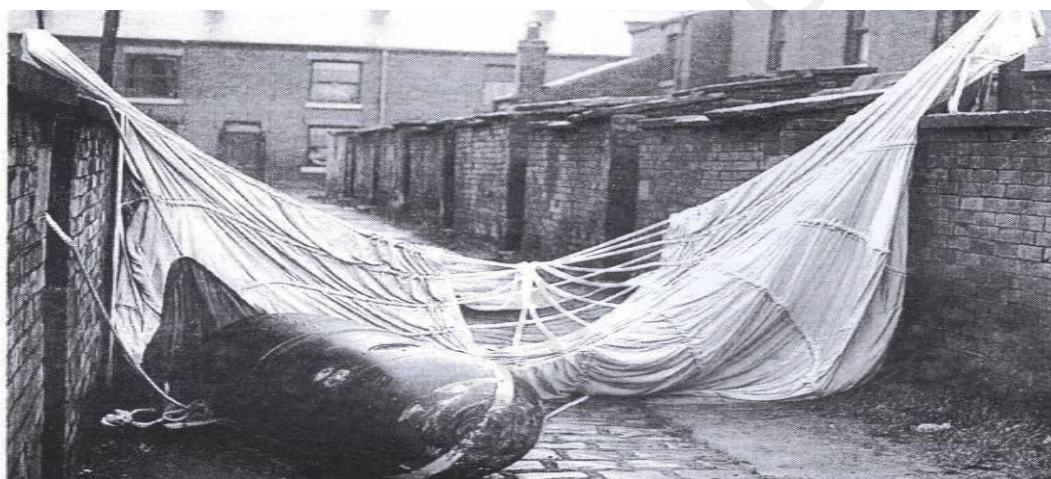
*Note; all mine fuzes were designed to arm after deployment from the ship, submarine or aircraft, some fuze designs incorporated anti-removal booby traps. Unexploded mines found today are the result of a failure within the arming mechanism or procedure whereby the mine never fully armed. Sudden shock or jarring of a weapon in this state has the potential to complete the arming sequence and could result in the mine detonating with lethal consequences.*

**Blast Bomb / Parachute Mine.** The parachute mine was extensively used on land and at sea and was fitted with specialist fuzes designed to trigger the weapon at a predetermined altitude, water depth or to switch on other magnetic influence mechanisms to trigger the weapon when a ship approached (Magnetic or Acoustic influence). While early versions were based on the standard 1000kg SD Bomb case others were specially designed and manufactured with an aluminium body, making them extremely difficult to detect using magnetometers. The thin cased versions would normally disintegrate on impact on land and are normally considered to pose little threat to work on land based projects, but the risk increases significantly on projects over water or in marshland. Thicker cased versions however will survive impact and pose a significant risk regardless of the local ground conditions. (See Figure 6)

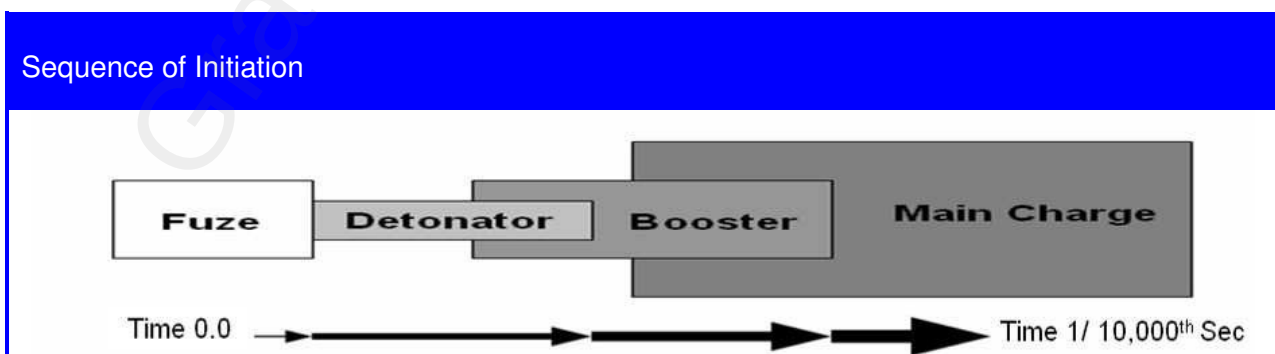
Figure 9: Explosive Ordnance Initiation Train.

**Initiation Train.** This is a means by which, once the safety features have been switched off or removed, a chain reaction occurs through the weapon. Starting within the fusing system as a small ignition or spark, causing a detonator to explode, which in turn causes the booster charge to detonate with a greater energy and ending in the full detonation of the main explosive filling. Each part of the process has in-built safety features to prevent an unintended detonation. A failure in any of the components within the Initiation Train can result in a UXO. In the case of a UXB; the chain reaction has broken down and the Initiation Train is brought to a halt, albeit, a temporary one. There are a number of ways that sufficient energy could be introduced to the otherwise stable UXB / UXO that may allow the Initiation Train to set off once more, overcoming the initial reason for failure. In addition to subjecting the weapon to excessive heat, such as a fire, the most common methods to bring about an explosive detonation in such items are considered to be:

**Initiation of Unexploded Ordnance.** Explosive Ordnance is highly unlikely to spontaneously explode. The energetic chemical compounds, (Explosives) used in weapon manufacture are chosen to be as stable as possible and they all require a significant application of additional energy to create the right conditions for detonation to occur. If stored correctly, most explosive materials are designed to remain stable for the duration of their expected lifespan (typically 20 years). During this time, the correct functioning of the weapon is achieved by means of the 'Initiation Train' (See Figure 9).

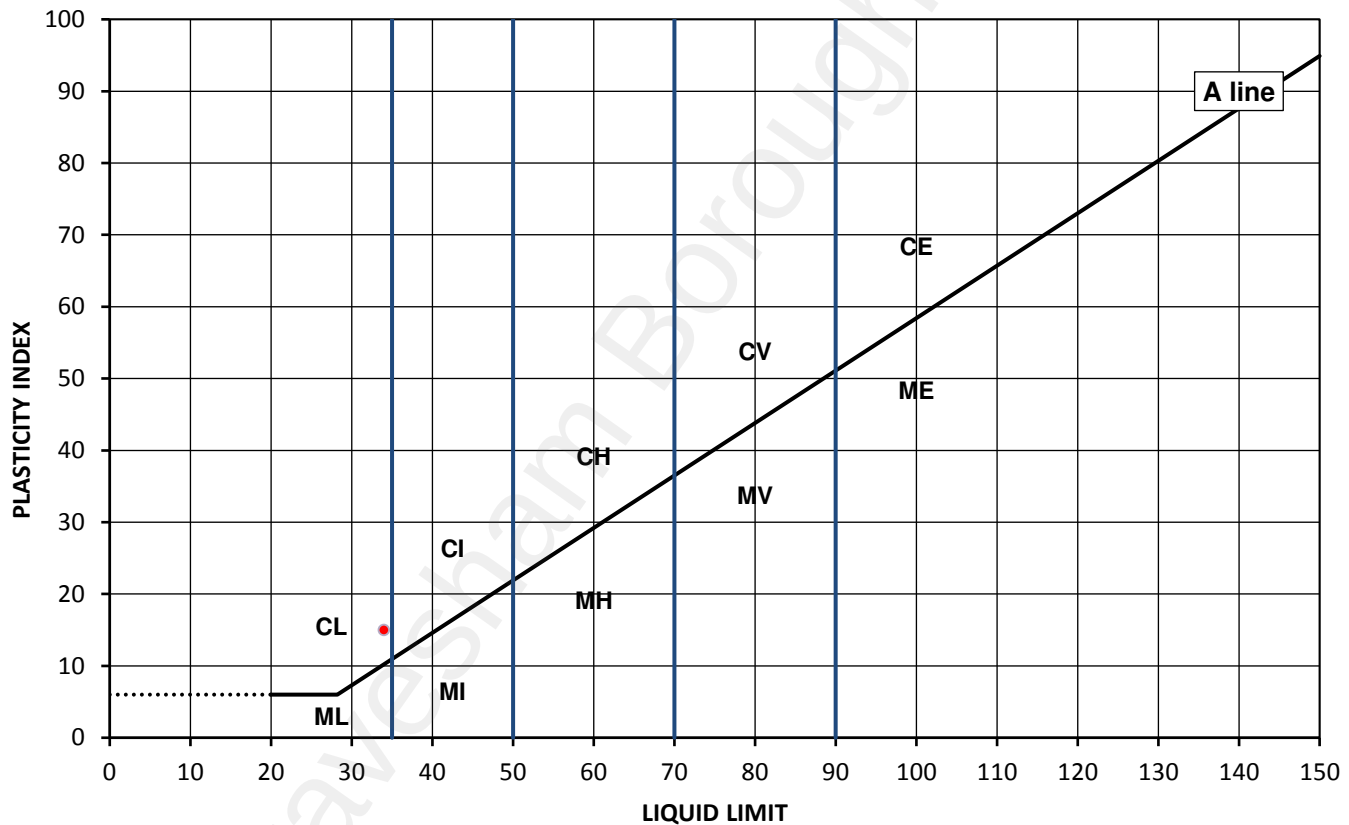
| As Received Moisture Content [%] | Liquid Limit [%] | Plastic Limit [%] | Plasticity Index [%] | % Passing 425µm BS Test Sieve |
| 15 | 34 | 19 | 15 | 81 |

Legend, based on BS 5930:2015 Code of practice for site investigations

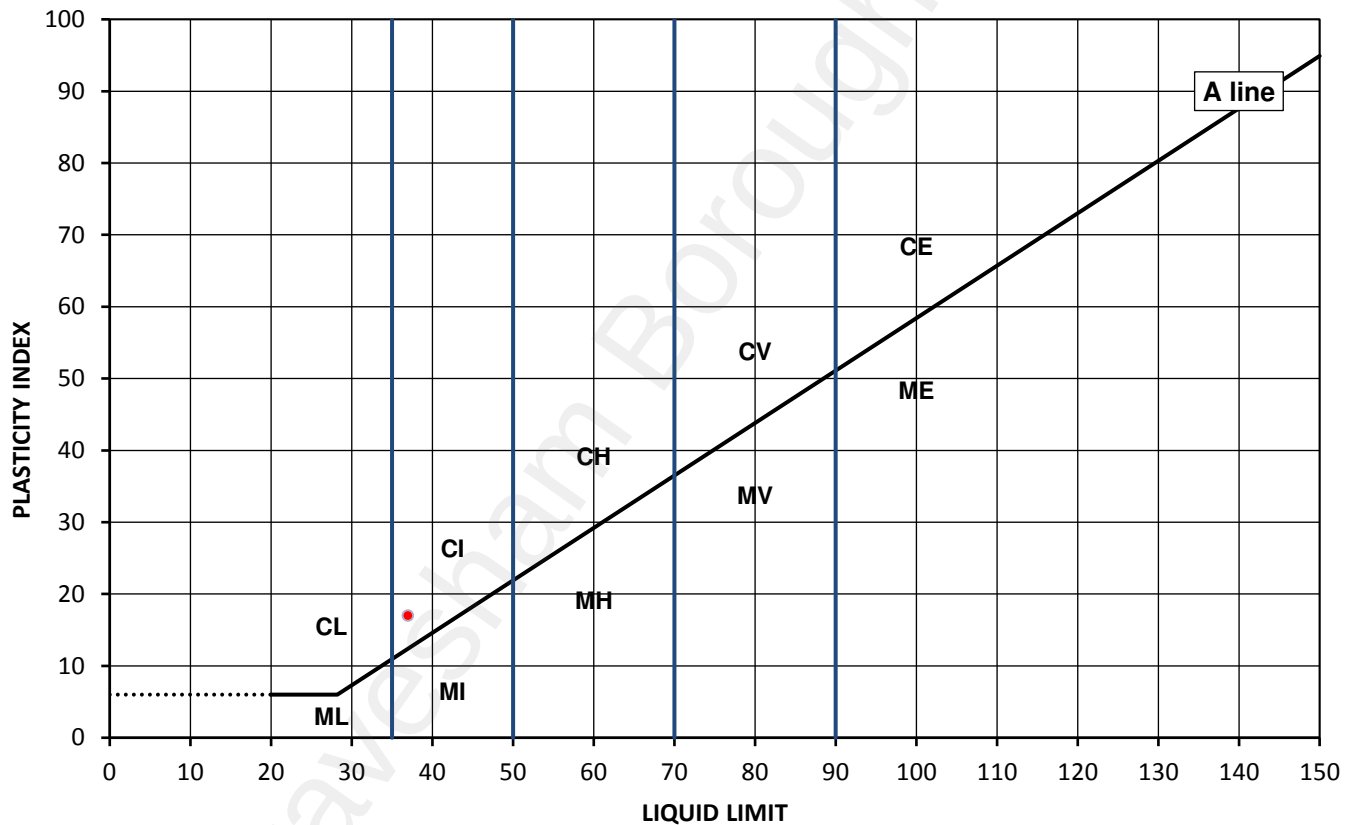
| As Received Moisture Content [%] | Liquid Limit [%] | Plastic Limit [%] | Plasticity Index [%] | % Passing 425µm BS Test Sieve |
| 20 | 37 | 20 | 17 | 96 |

Legend, based on BS 5930:2015 Code of practice for site investigations

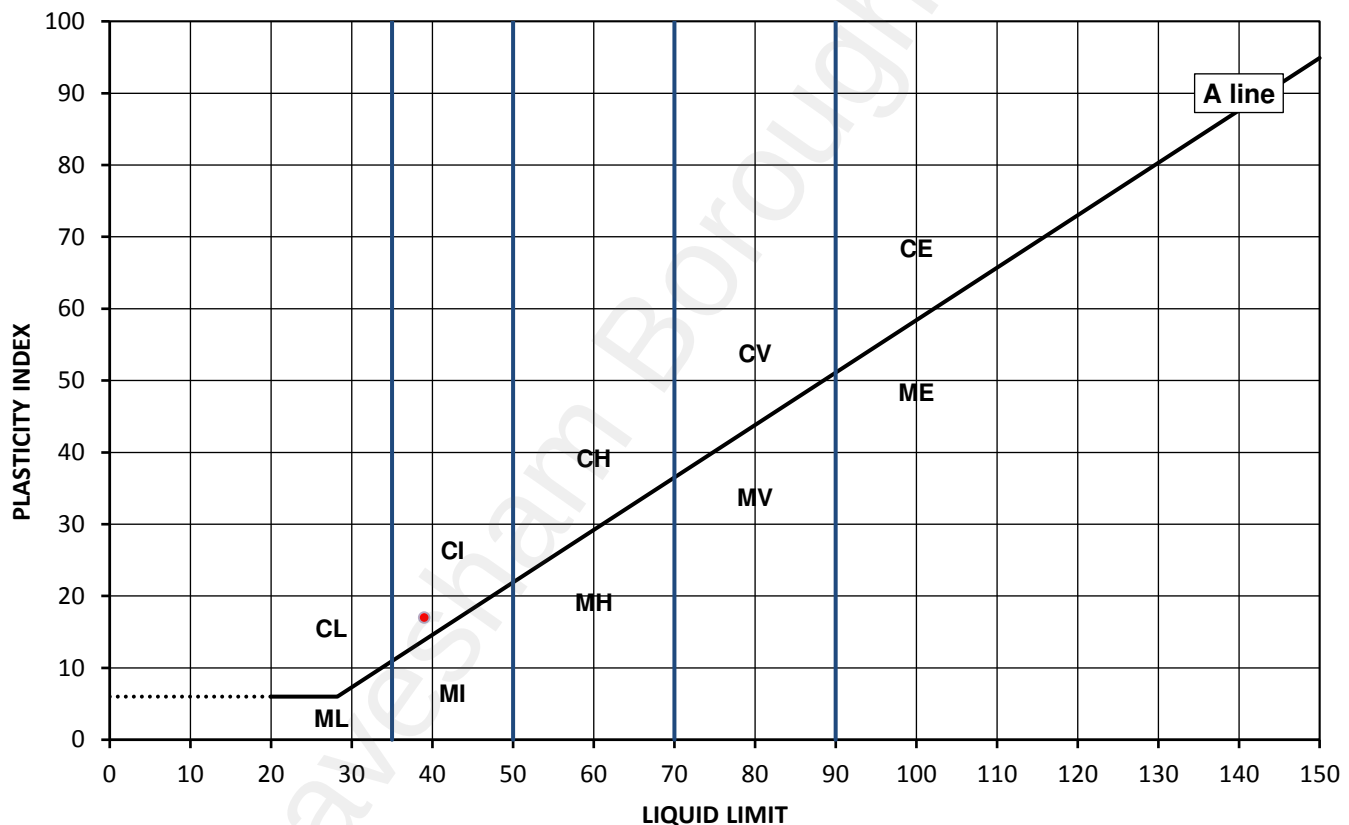
| As Received Moisture Content [%] | Liquid Limit [%] | Plastic Limit [%] | Plasticity Index [%] | % Passing 425µm BS Test Sieve |
| 29 | 39 | 22 | 17 | 85 |

Legend, based on BS 5930:2015 Code of practice for site investigations

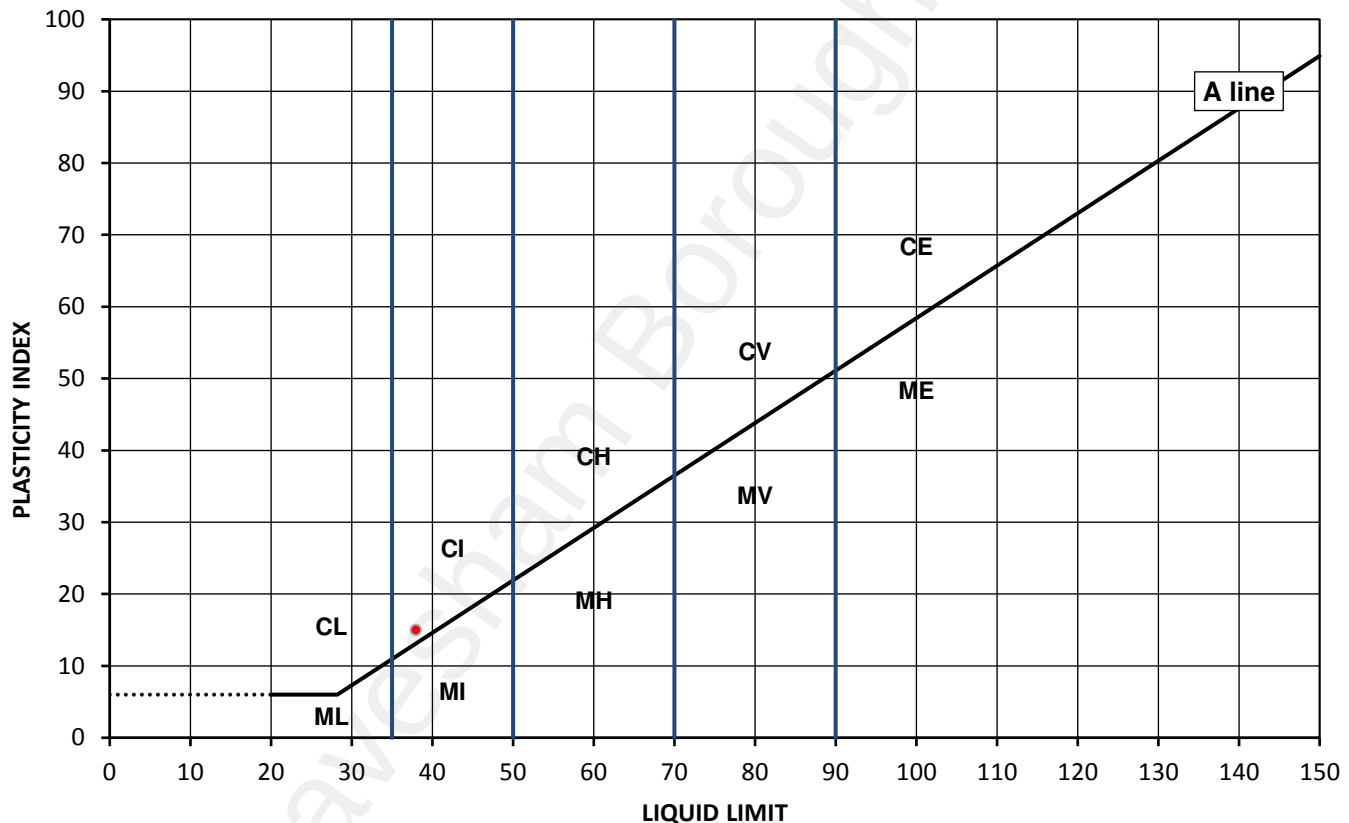
| As Received Moisture Content [%] | Liquid Limit [%] | Plastic Limit [%] | Plasticity Index [%] | % Passing 425µm BS Test Sieve |
| 26 | 38 | 23 | 15 | 87 |

Legend, based on BS 5930:2015 Code of practice for site investigations

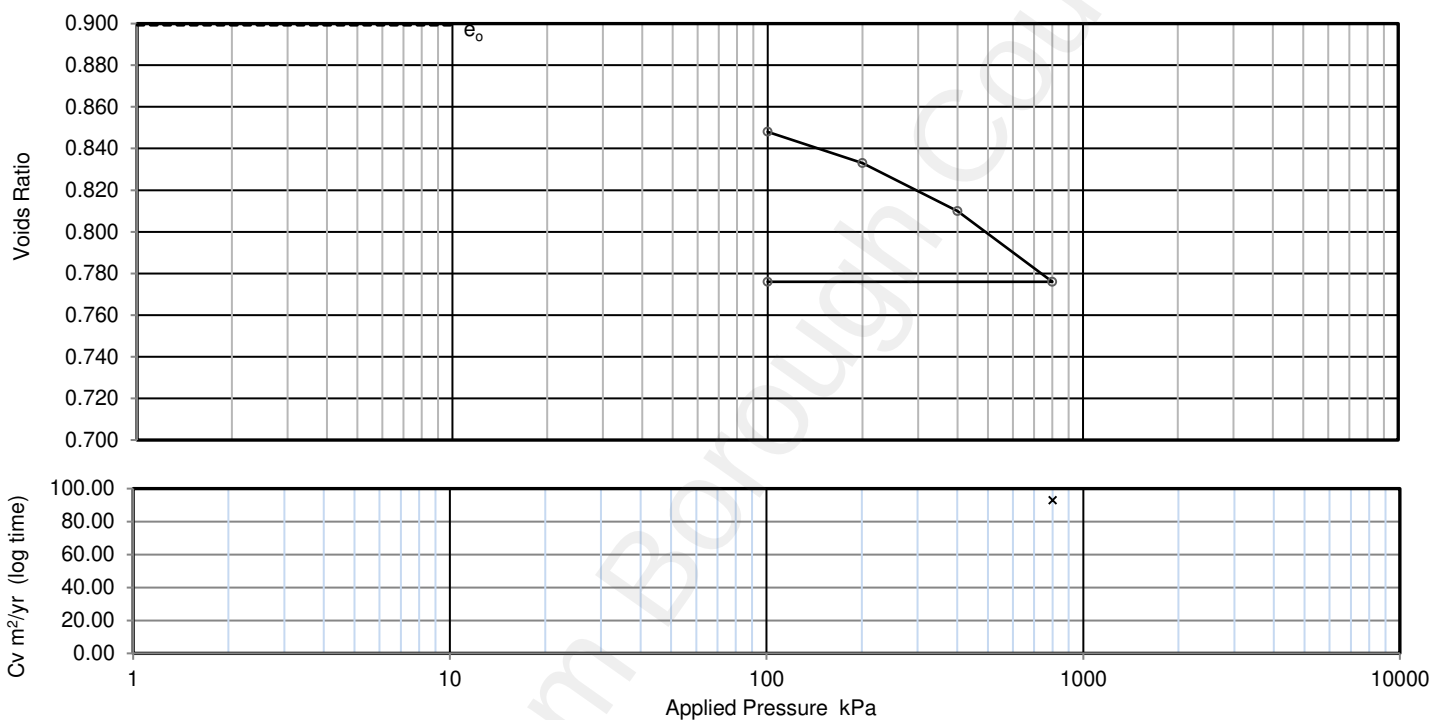
Laboratory Reference: 1159989  
Hole No.: BH2  
Sample Reference: Not Given  
Sample Description: White clayey CHALK

Depth Top [m]: 11.00  
Depth Base [m]: 11.45  
Sample Type: U

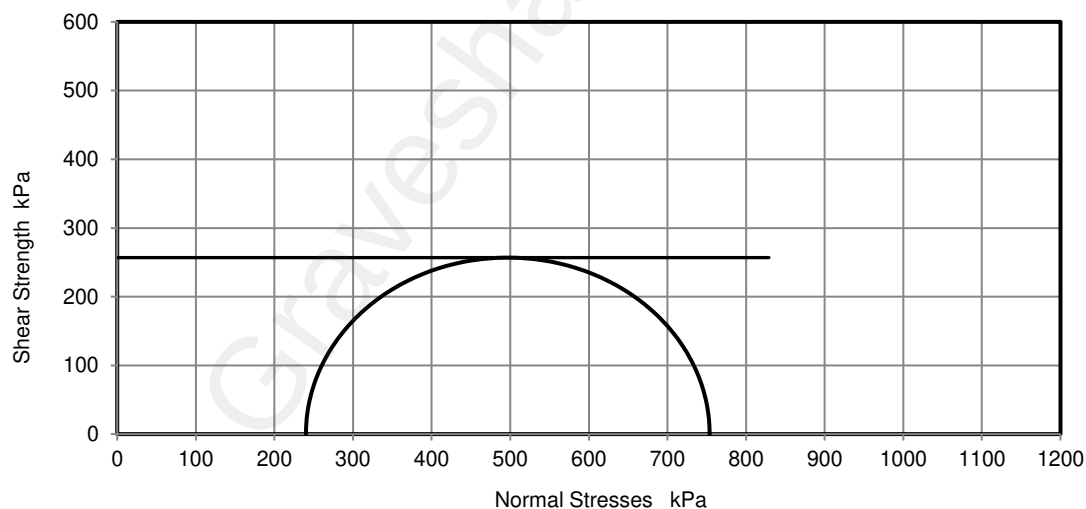
**Mohr Circles**
