## Ground Investigation Report

Proposed Residential Development  
Garages Rear of Osney Way Car Park

Site: Garages Rear of Osney Way Car Park  
Document Title: Ground Investigation Report  
Document no.: STU5768-R01 Rev B  
Date: October 2022  
Client: Stem Homes Ltd  
Issuing office: Soiltechnics Ltd  
Cedar Barn, White Lodge, Walgrave, Northampton. NN6 9PY  
Tel: 01604 781 877 E-mail: [mail@soiltechnics.net](mailto:mail@soiltechnics.net)

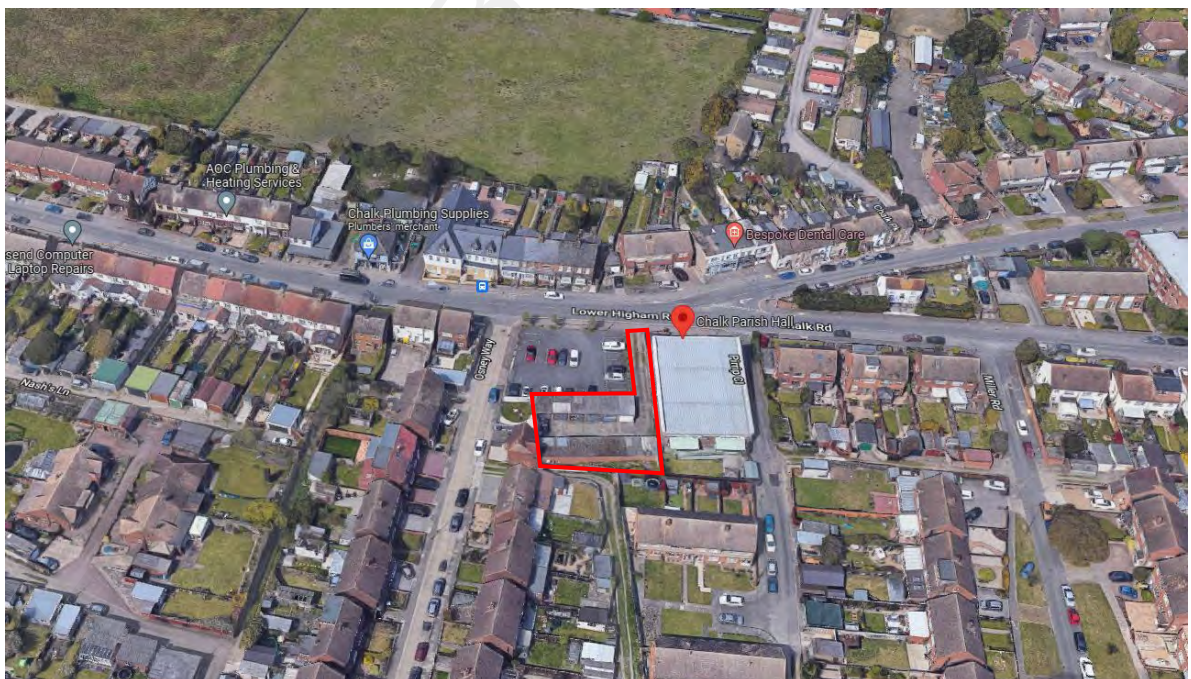
Figure 2-A: Aerial photograph and approximate site boundary

2.2.1 The site comprises 14 single domestic garages to the east of Gravesend. The main site is roughly rectangular with a steep single width access road extending northward from the garage, joining Lower Higham Road. The site is covered in hardstanding except for the base of the access track and a small area of scrub vegetation behind the garages. The base of the track is rough gravel and unfinished. North of the site is a public car park that is level with the road and ~0.8m lower than the garages.

2.2.2 An aerial image showing the approximate site boundary is presented below. A Site Plan is provided within Appendix A.

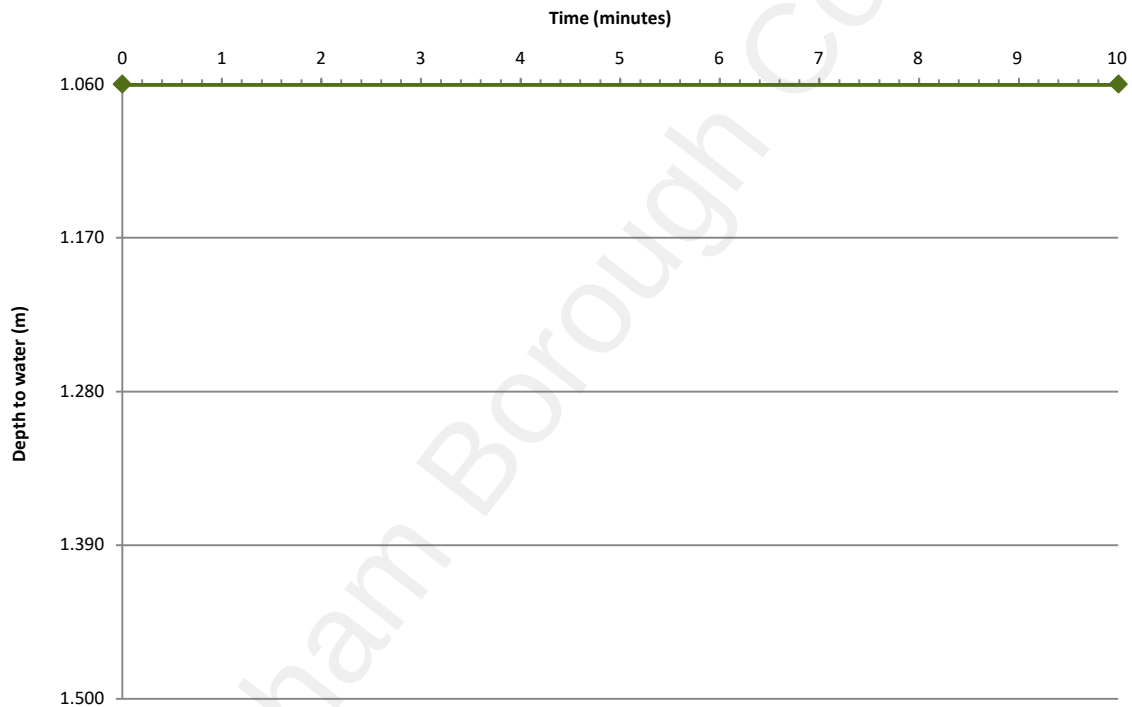
| Depth at start of test (m) | Groundwater observations (at time of excavation) |
|---|---|
| 1.06 | No groundwater encountered. |

Insufficient infiltration over 120 minutes of monitoring therefore unable to calculate soil infiltration rate.
