# **DETAILED UNEXPLODED ORDNANCE RISK ASSESSMENT**

**Lower Higham Road  
Gravesend, DA12 2ND**

**Prepared for: STEM Homes Ltd**

**Project Number: 7897**

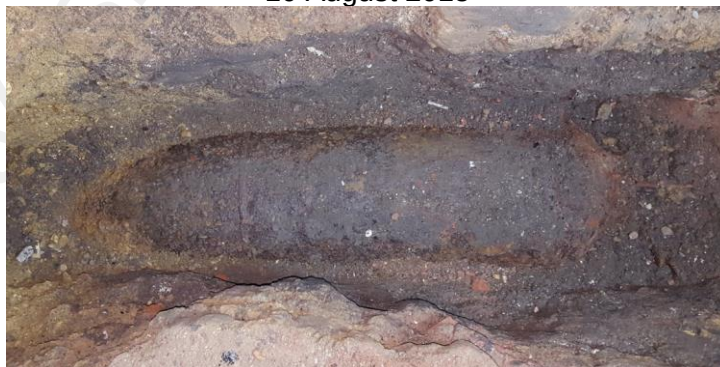
German 250kg Bomb found by MACC below a pre-war cellar floor in Bethnal Green London  
10 August 2015

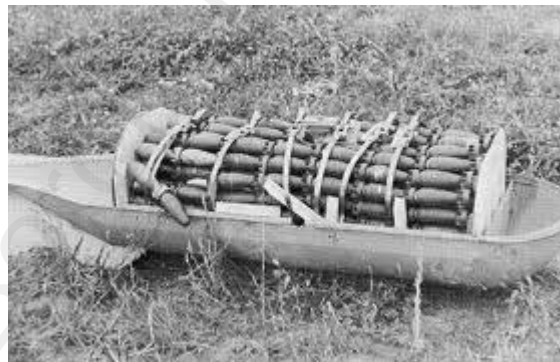
SD1 Anti-Personnel Bomblets

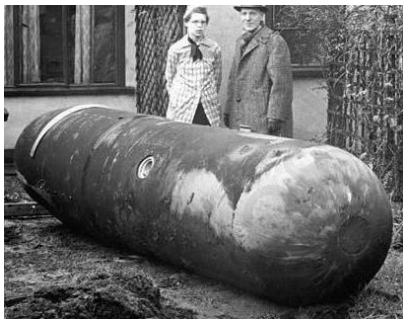
SD1 Container Bomb

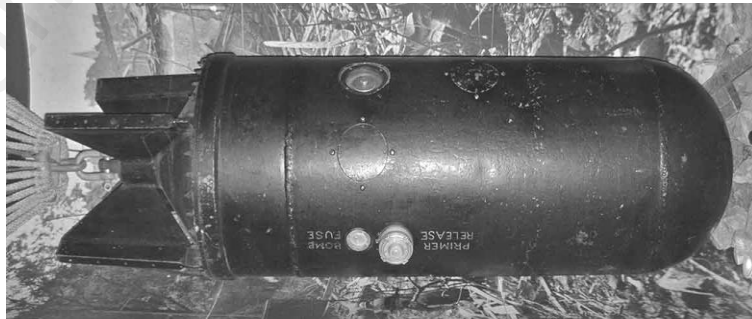
Parachute Mines
