# Report on a **PHASE 4 VALIDATION REPORT**

Ref: 26/41515 | Date: May 2026

**Seacon Terminals  
Lower Road  
Northfleet  
Kent DA1 9BD**

| <i>Document Type</i> | Report on a Phase 4 Validation |

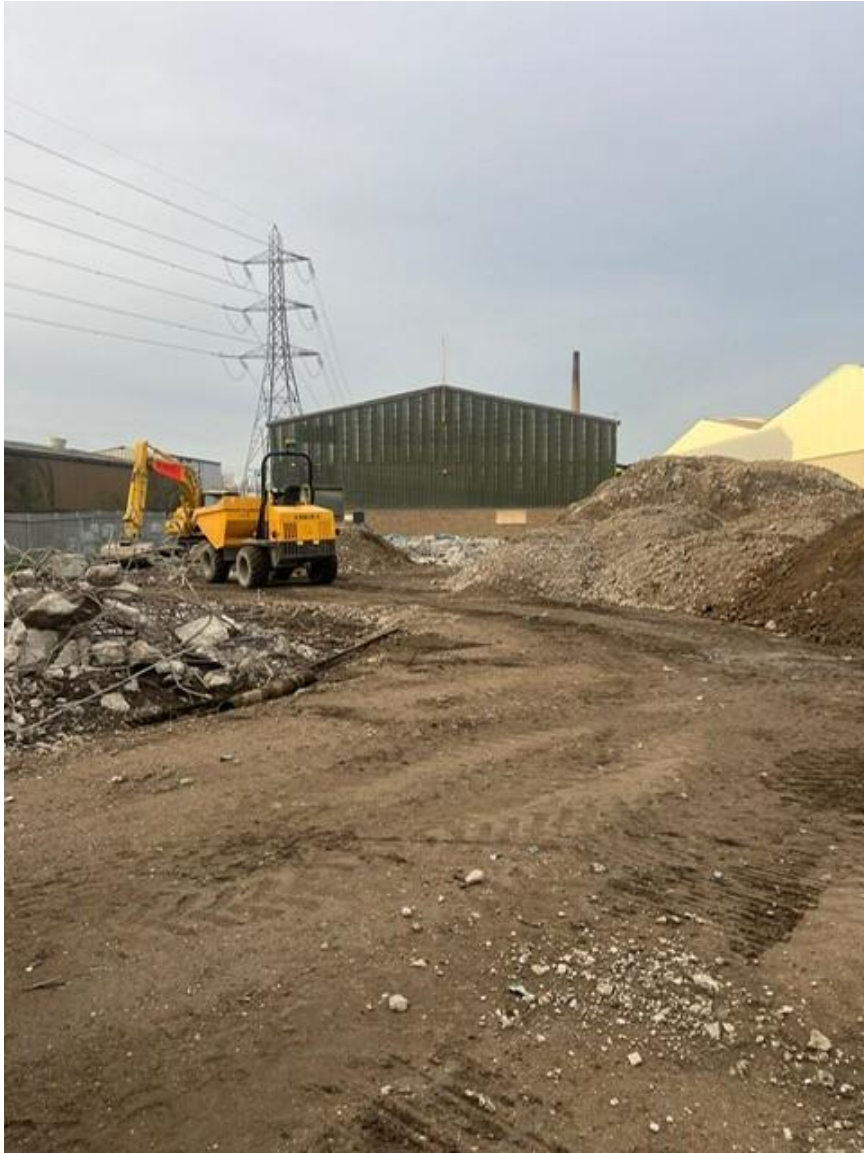
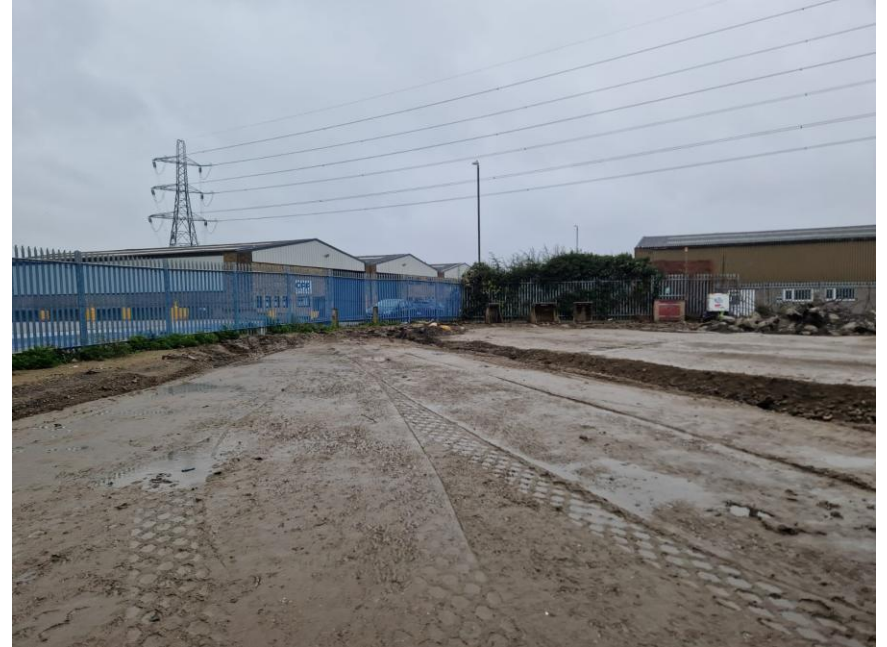
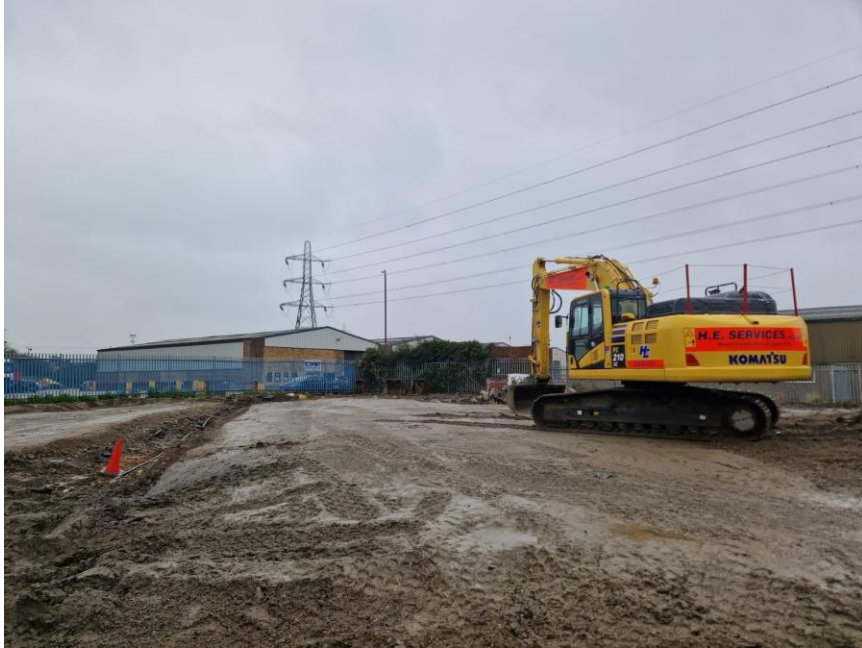
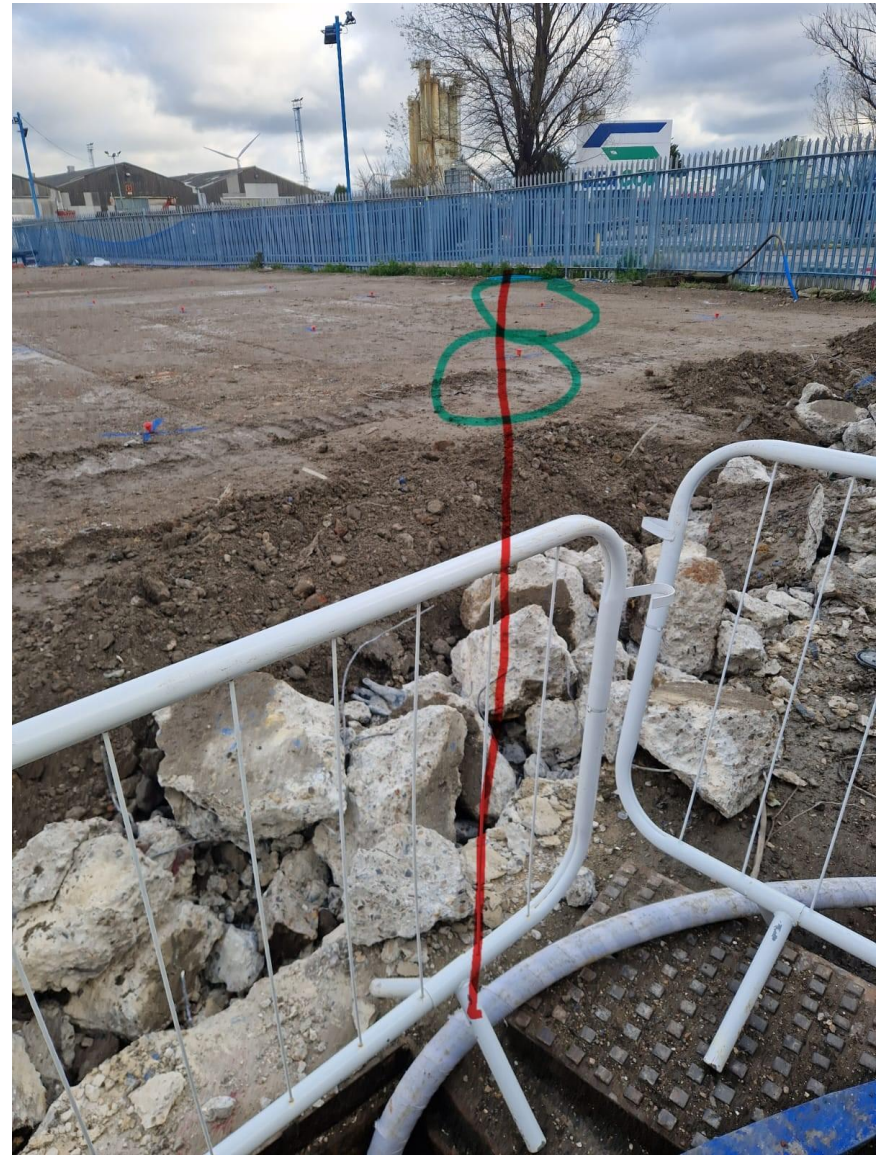
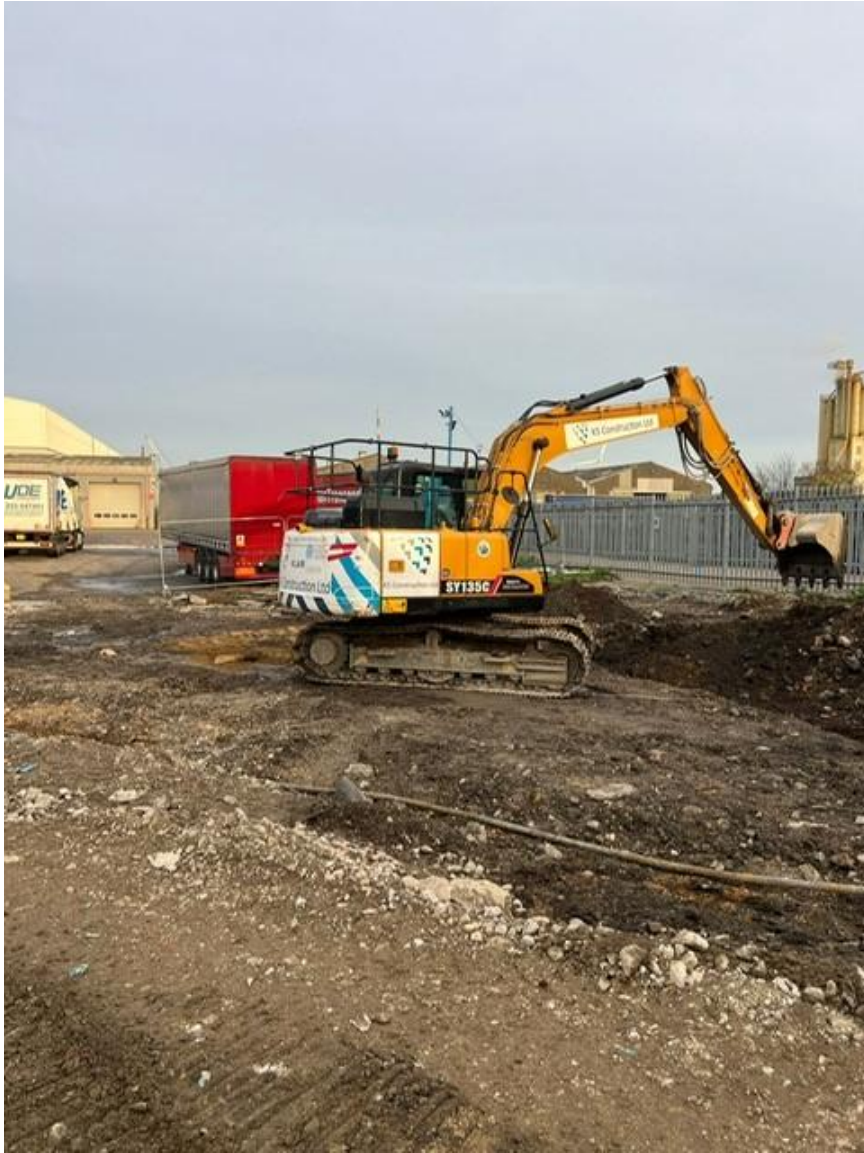
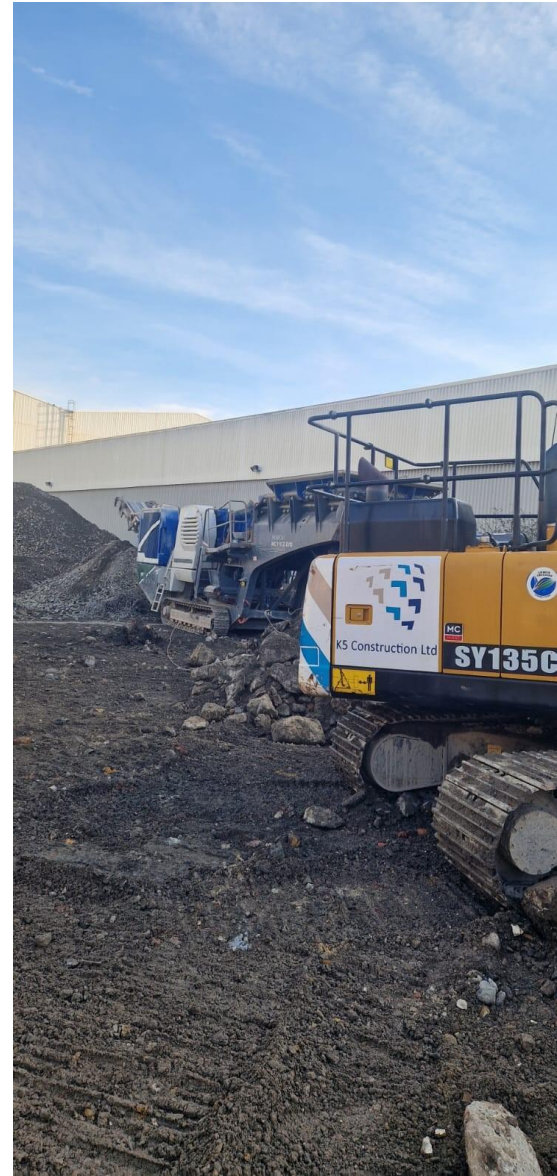
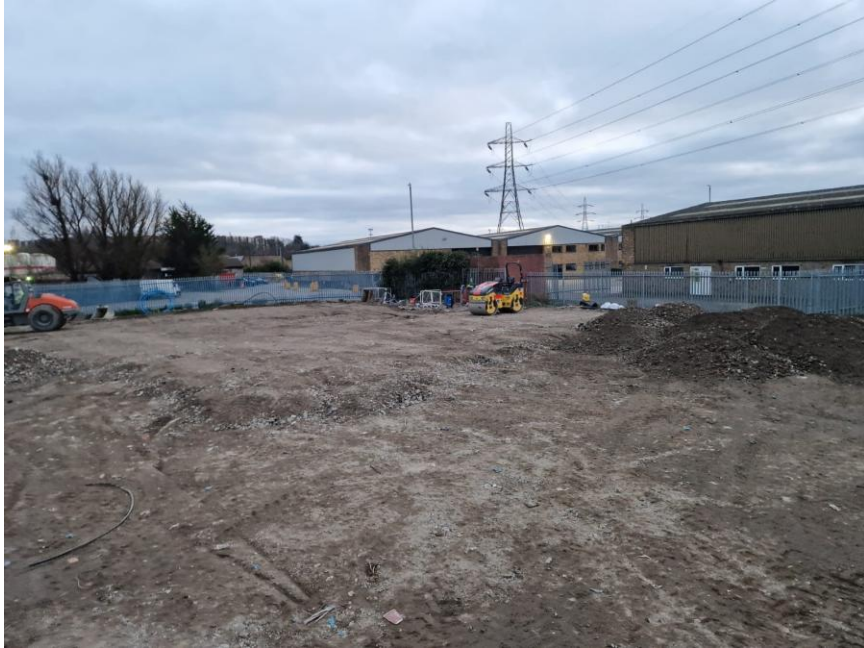
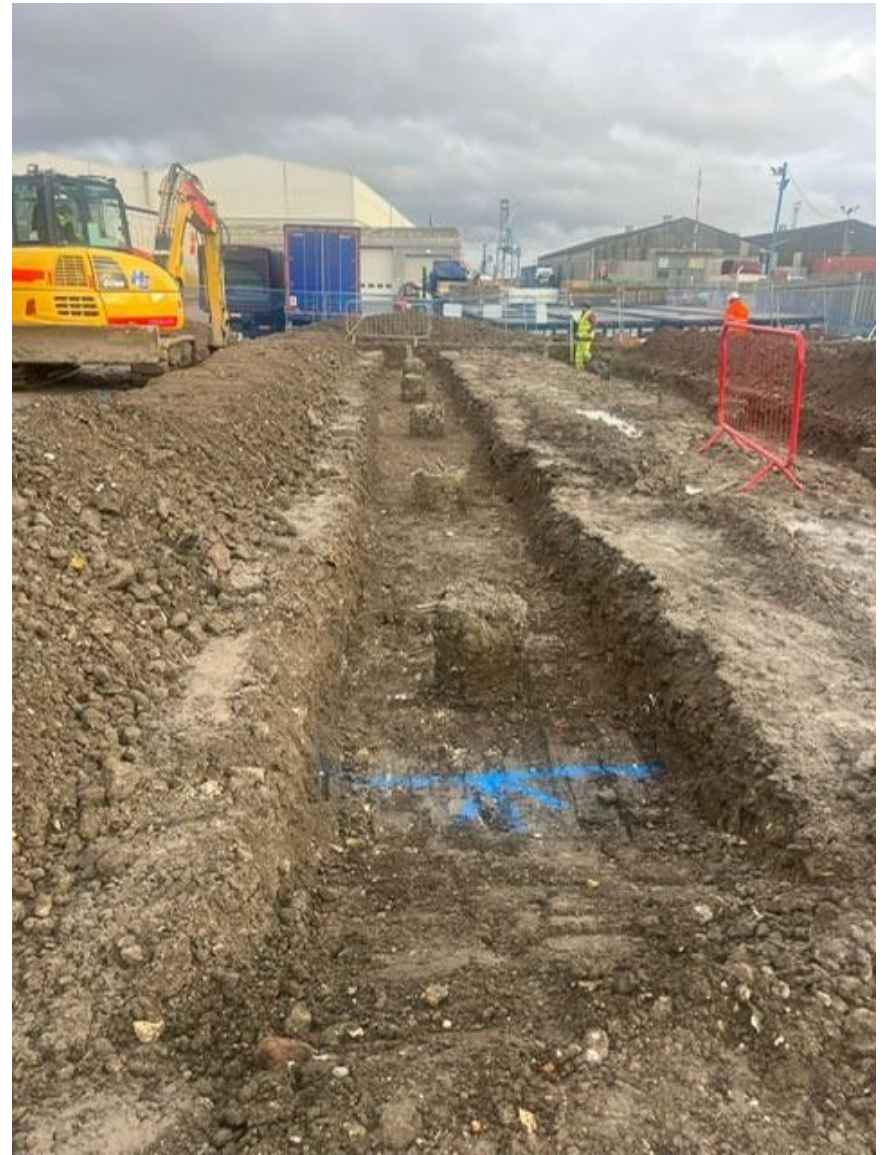
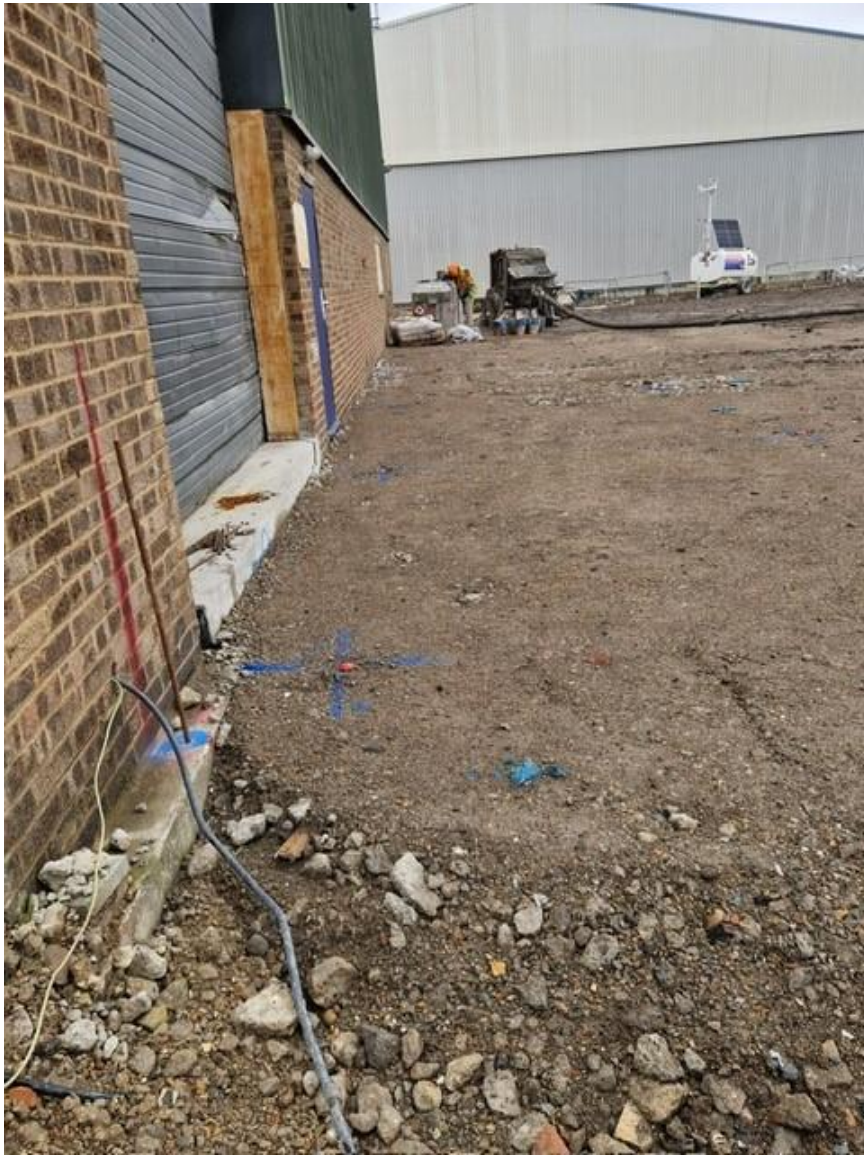
**Appendix B** – Photographs of Site Formation

As indicated above the site preparatory works involved the placing of site-won crushed concrete to create the development platform for the site. Photographs of the site formation works are presented in Appendix B.

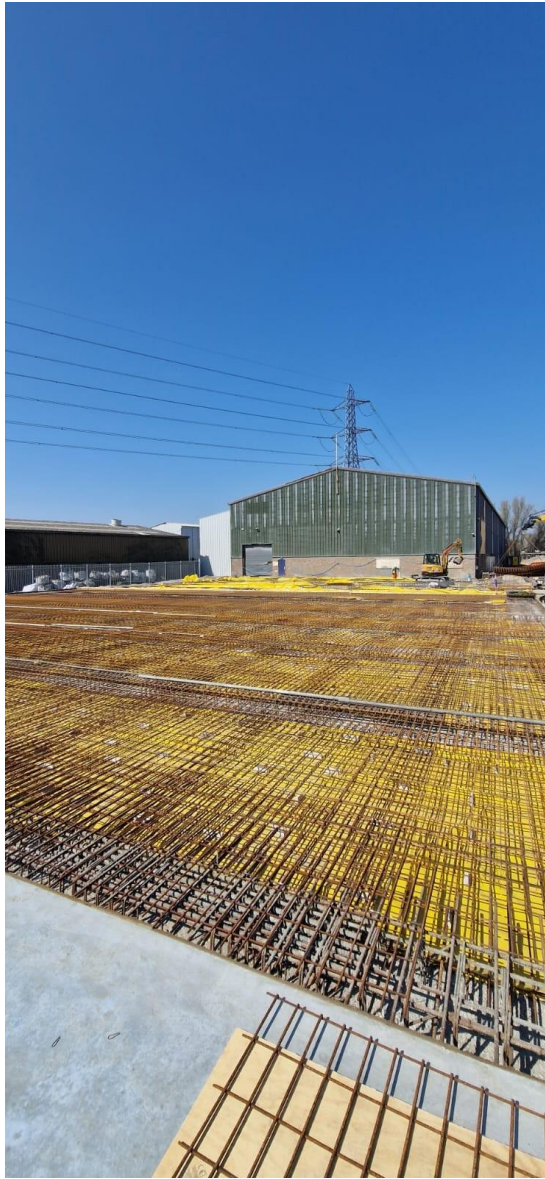
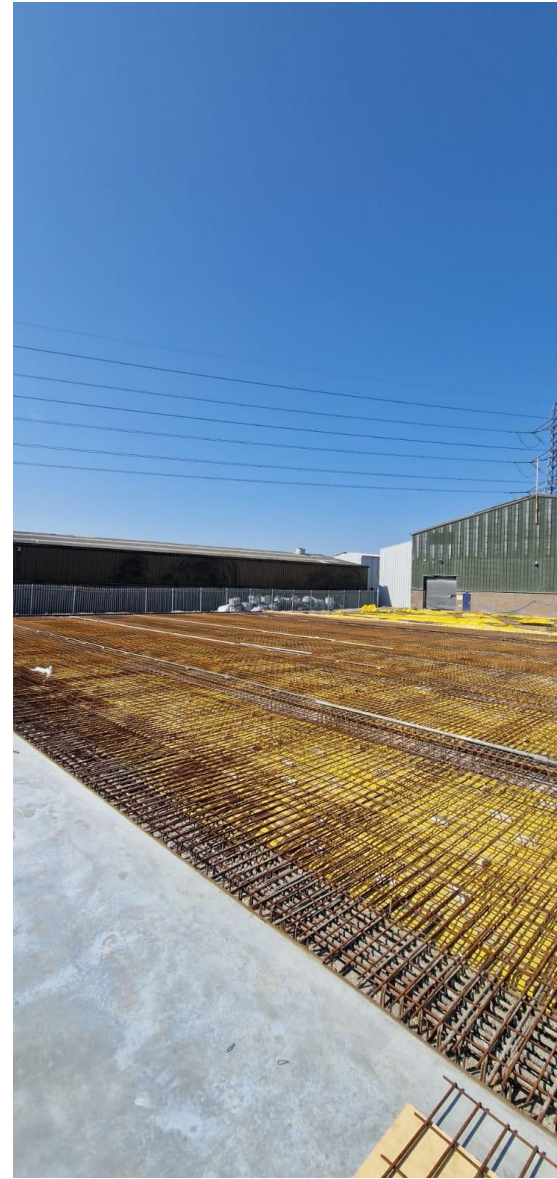
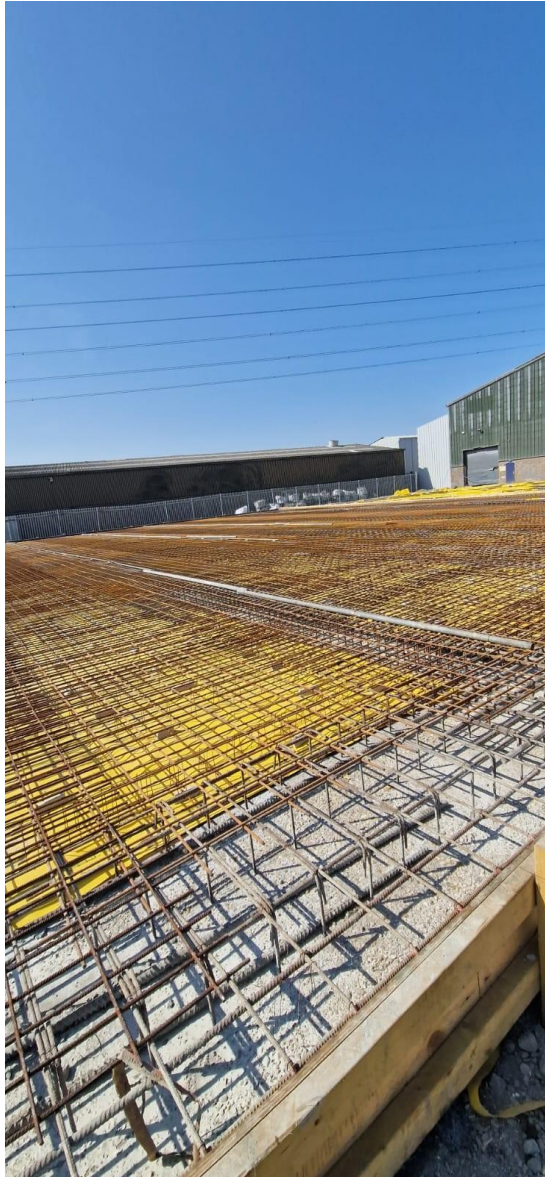
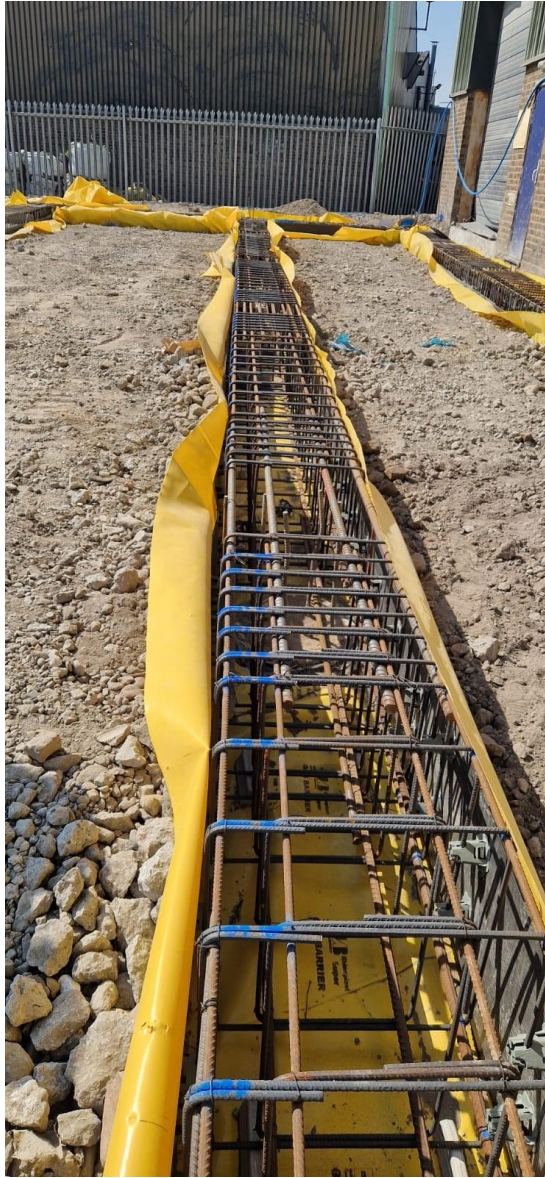
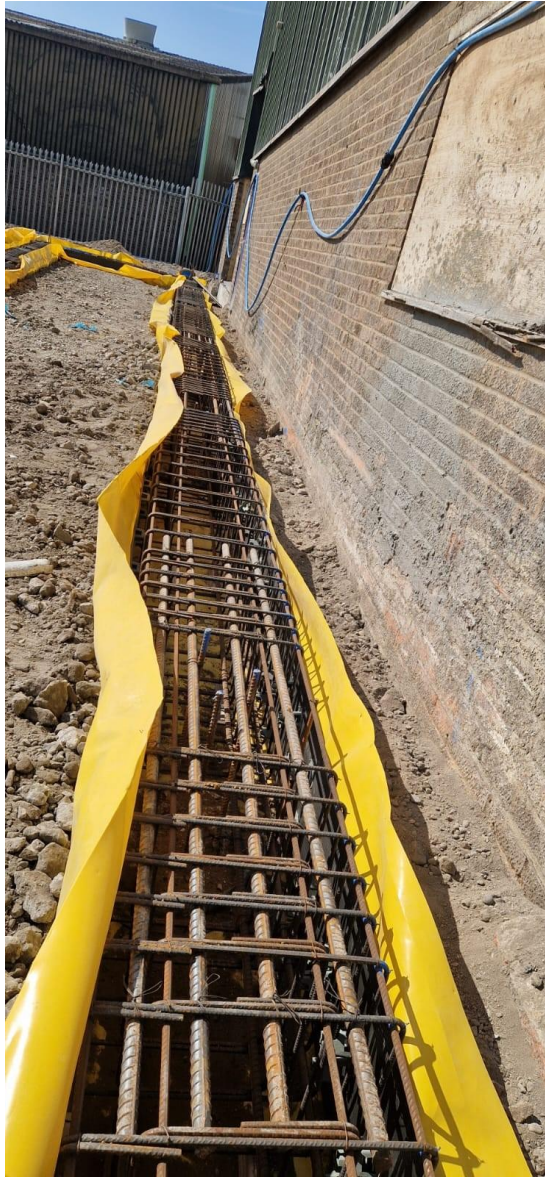
**Appendix D** – Photographs of Gas Membrane and Concrete Slab

Correspondence received from the client confirms that the installation of the gas proof membrane was in accordance with the manufacturer's guidance. Photographic evidence of the installation of the gas proof membrane and the structural slab construction is presented in Appendix D.
