PROPOSED REMOVAL OF EXISTING SOIL AND SUBSEQUENT REPAIR AND REPLACEMENT OF THE STUCCO RENDER TO THE EXPOSED WALL.

AT: 4 CONSTITUTION CRESCENT,  
GRAVESEND, KENT. DA12, 1JS.

DRG No: 2021-05-01

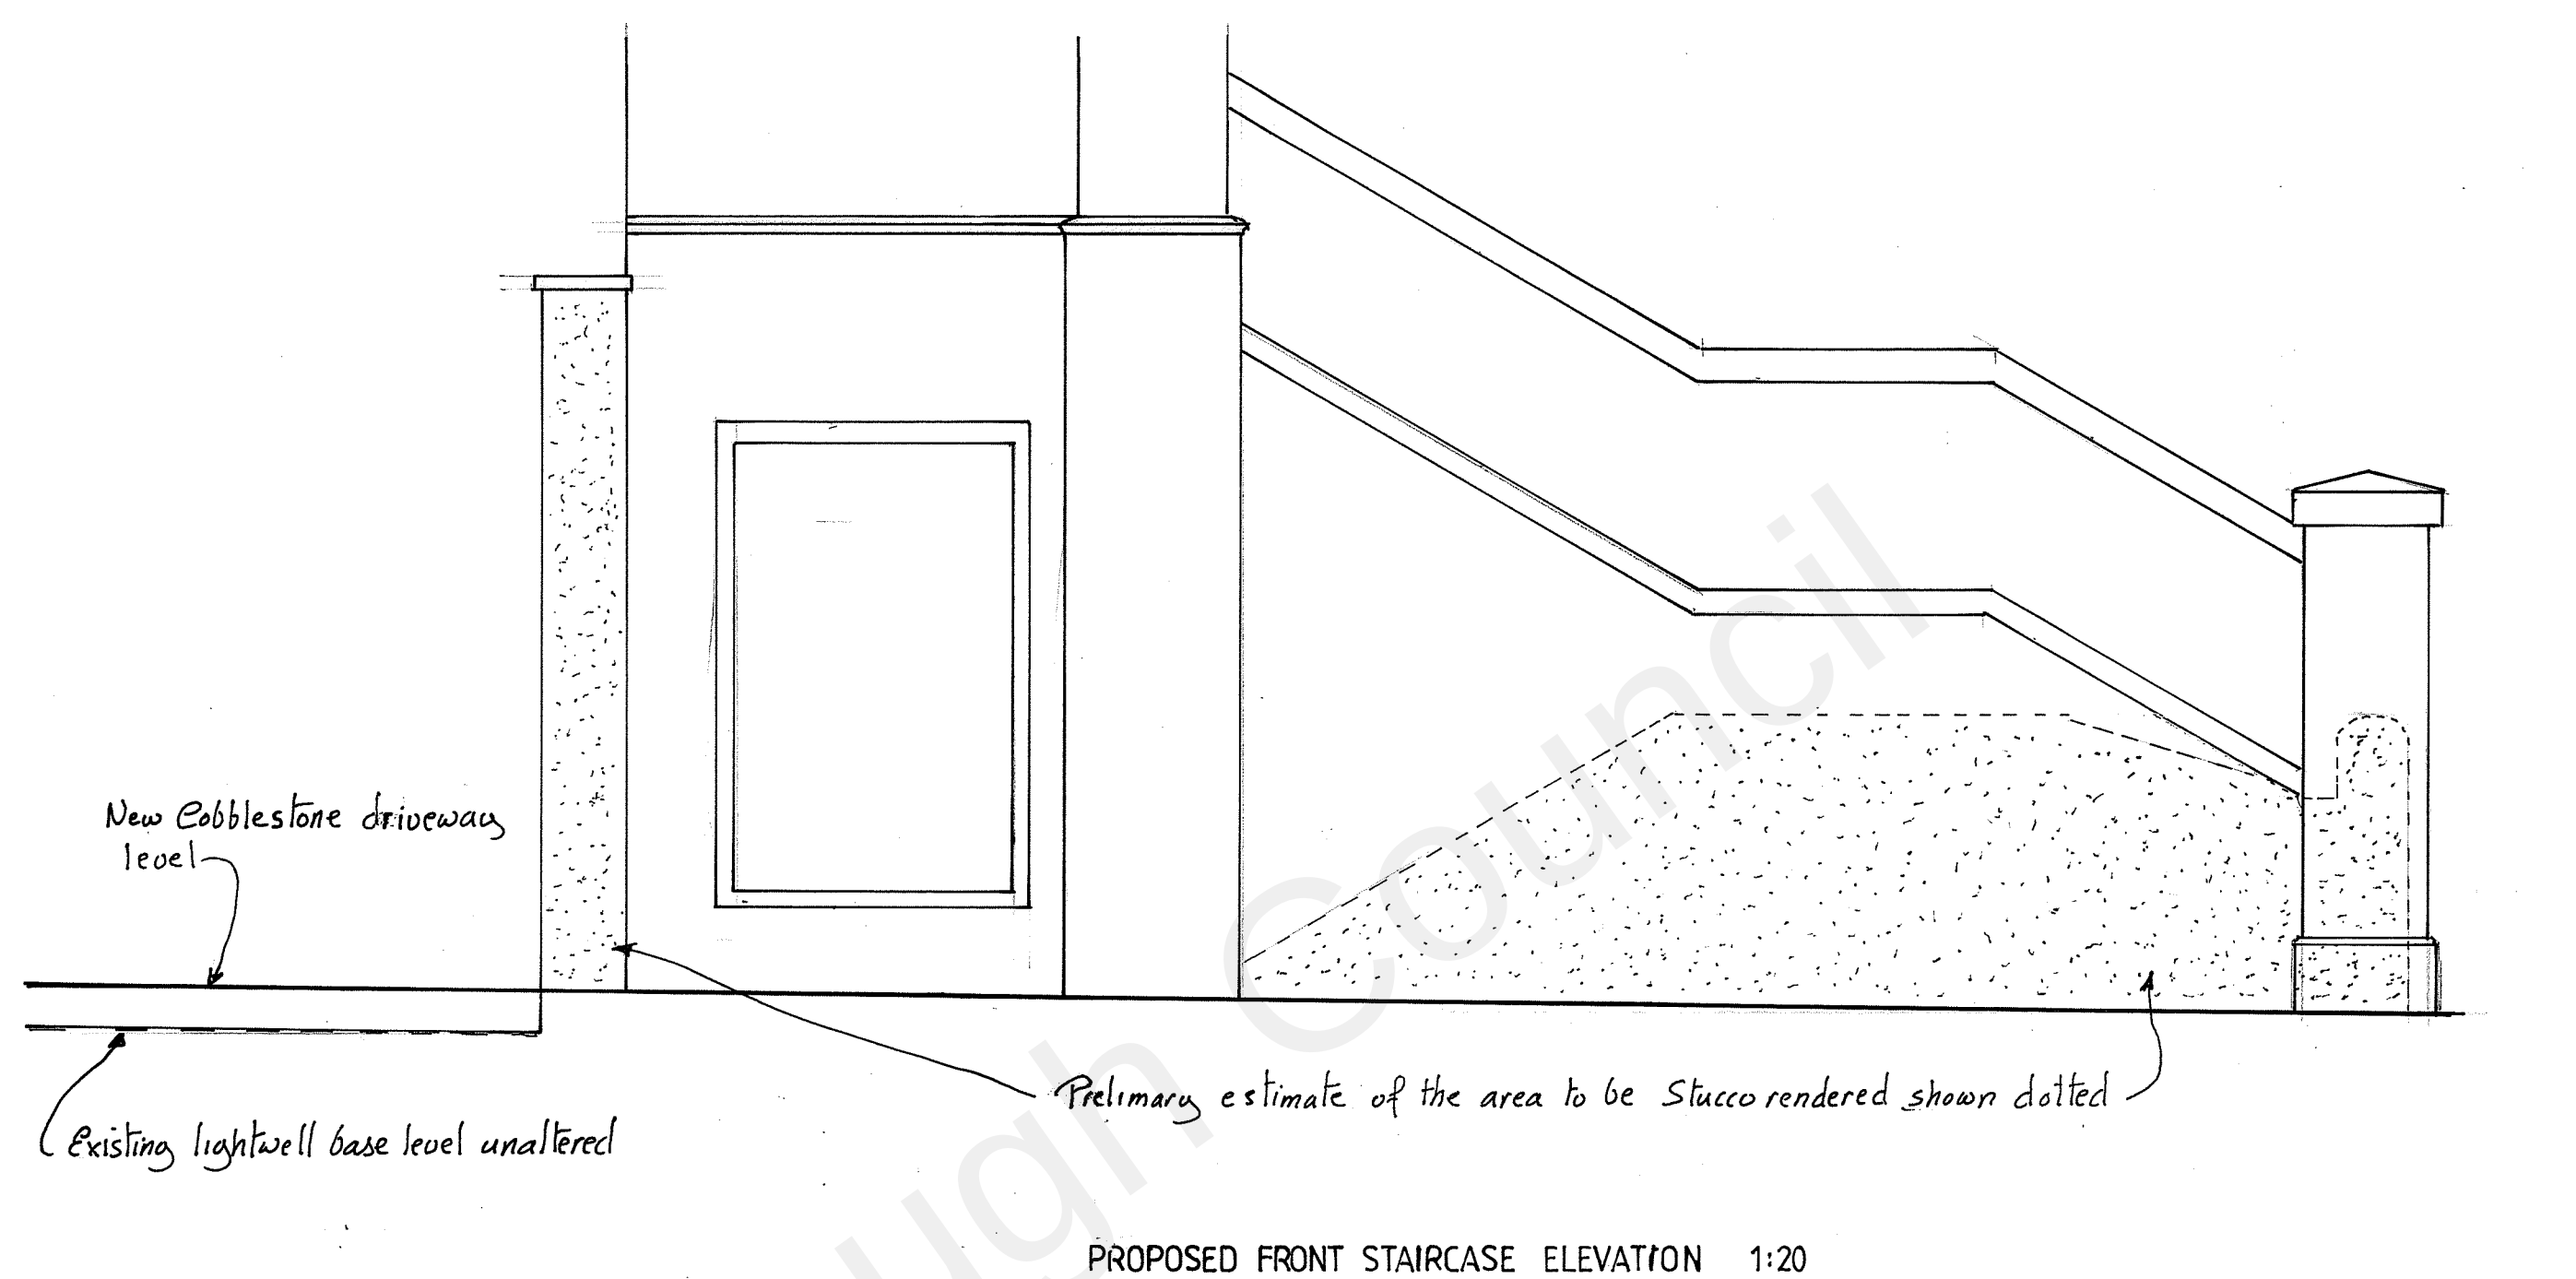
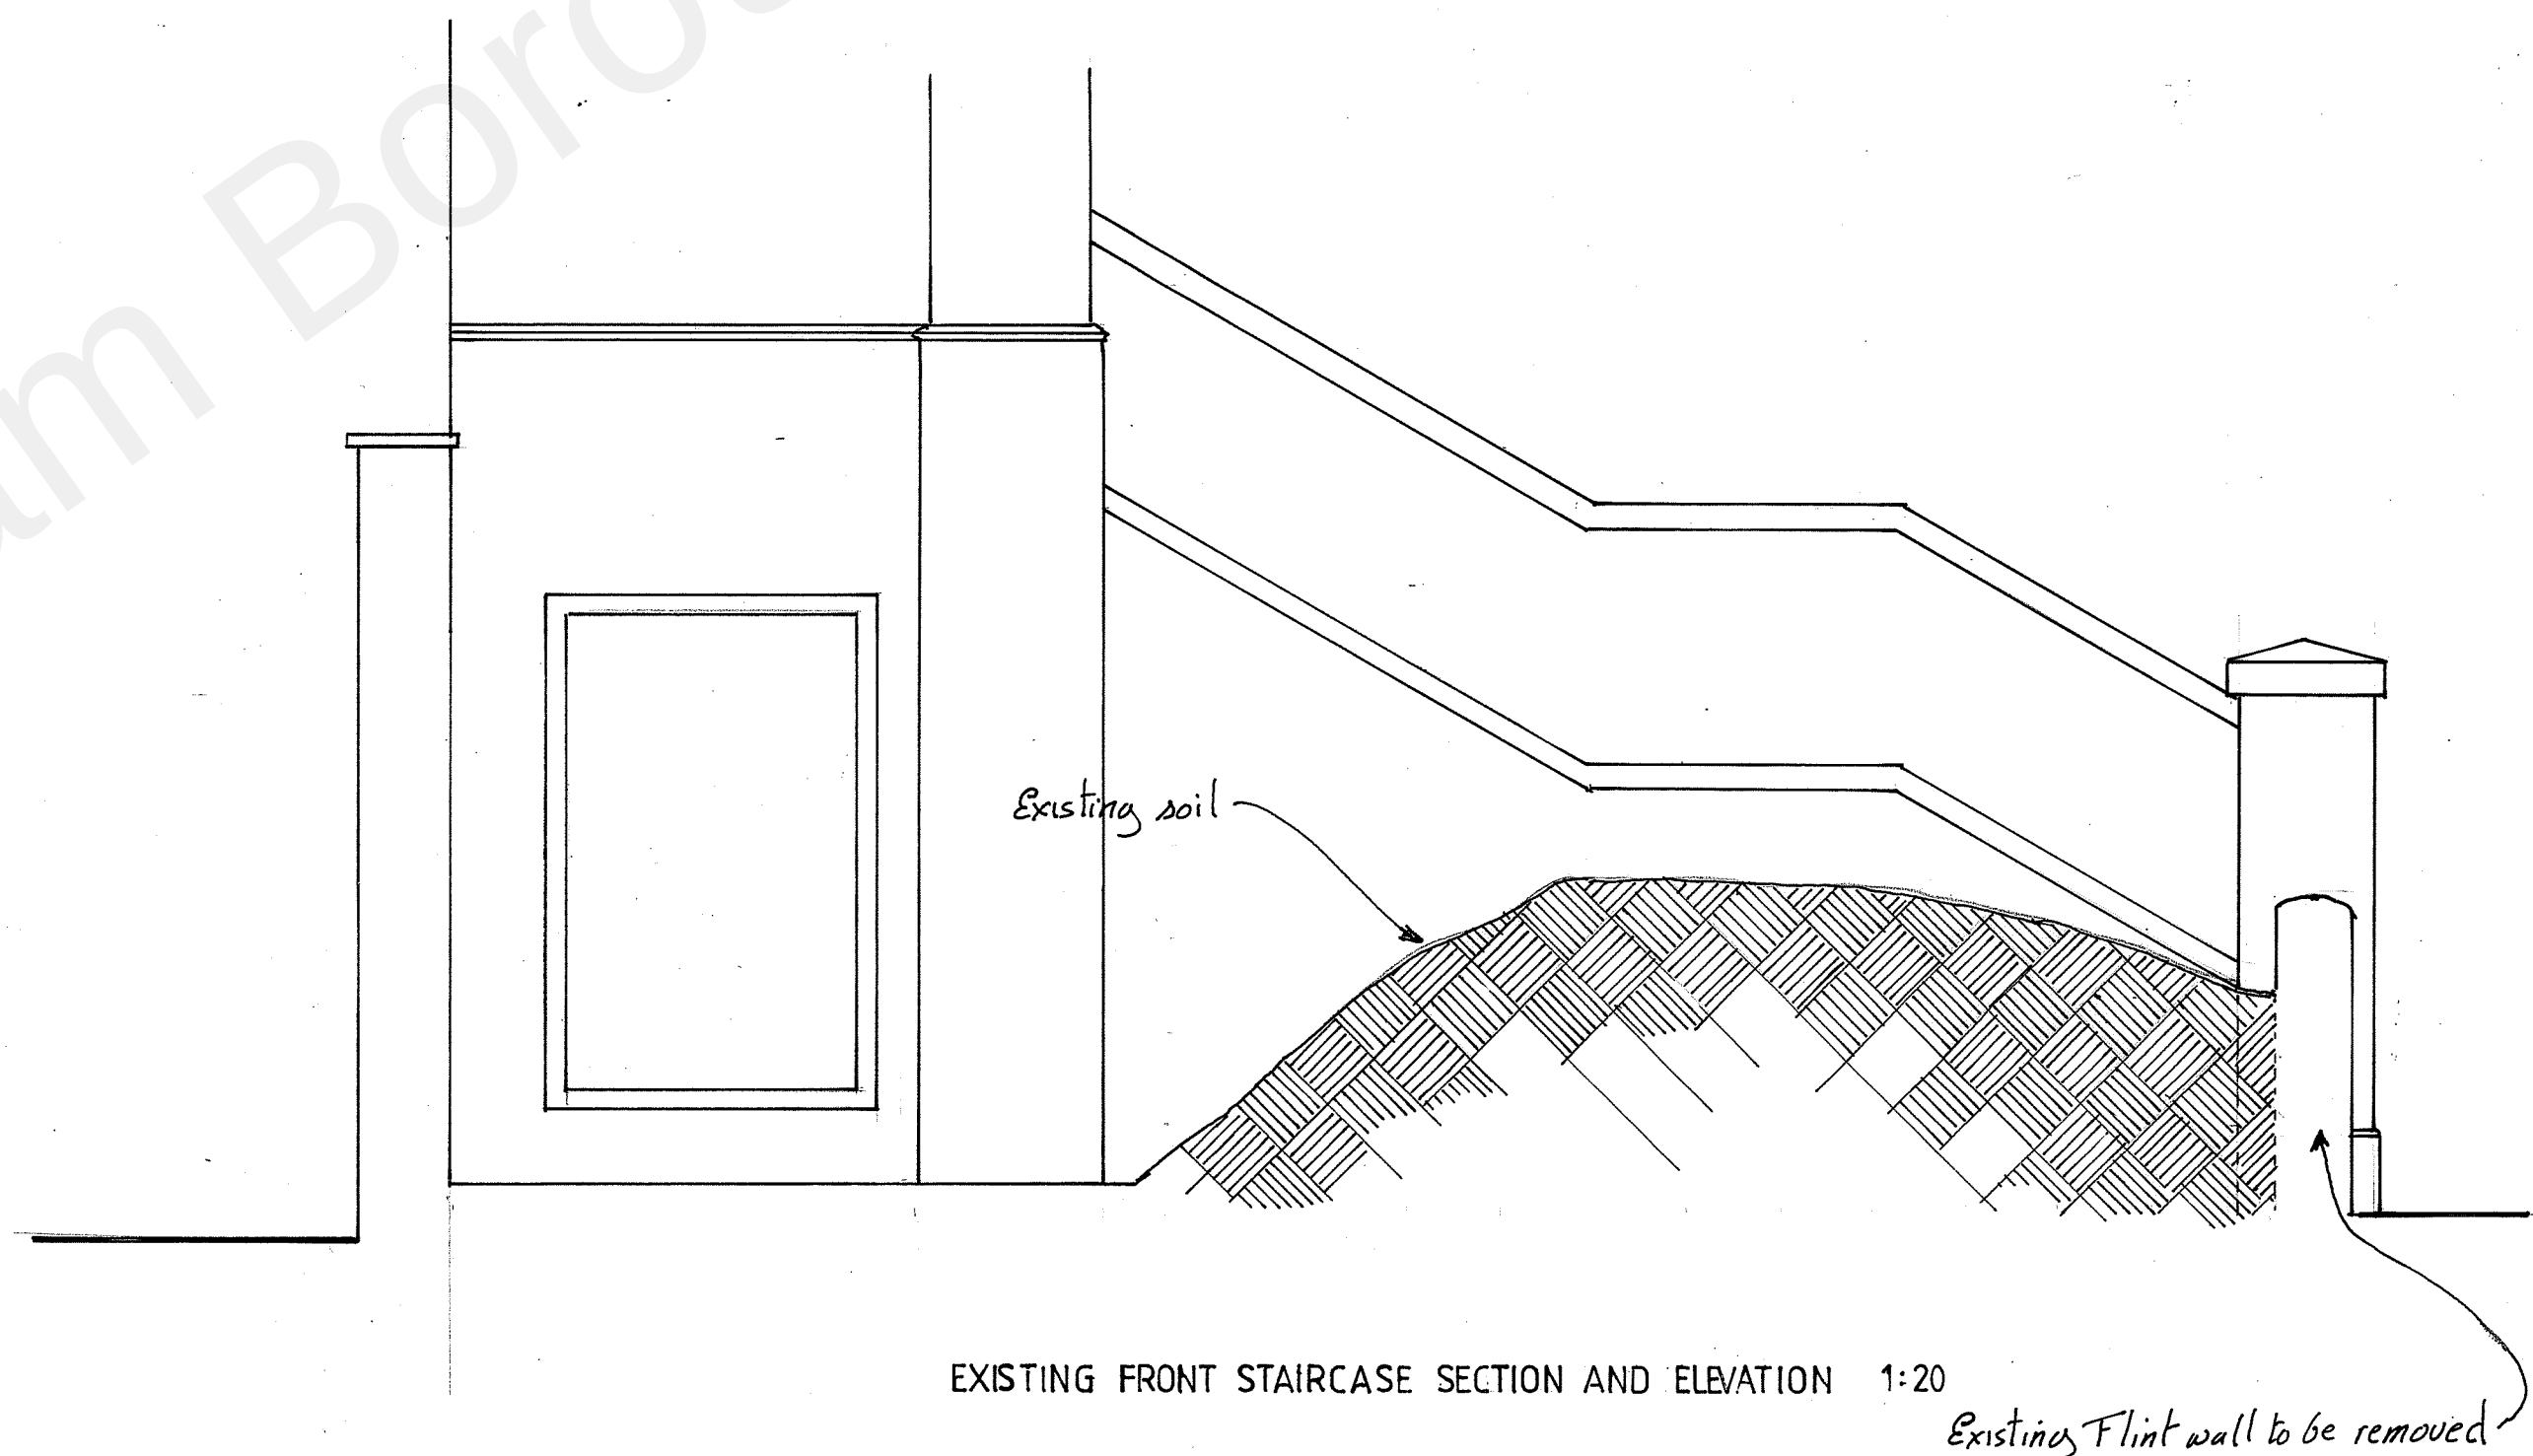
1. Dismantle the original flint and overburnt brick garden wall and set aside flints for re-use.
2. Carefully excavate the soil adjacent to the staircase wall and expose the original Stucco render.

3. Examine the condition of the original Stucco render and keep a photographic record of your findings.
4. Remove any loose cracked or debonded stucco back to the original substrate.

5. Brush away dust and loose debris then hose down to further remove any remaining dust.
6. Whilst wall is still damp apply a coat of Render (Cal RB) Lime render 10-20mm max thickness. In normal conditions the render should take about 4 days to calcify. In hot conditions do not let it dry too quickly or cracking will occur. Cover with damp hessian and protect from direct sunlight. In cold conditions protect from frost.

7. When base layer is set dampen down and apply a 2mm coat of Finish (Cal AC) followed by a second coat 2mm thick when the first coat has firmed up, normally on the same day. Protect from elements as in stage 6 until surface has fully set.
