# Phase I Desk Study & Site Reconnaissance Report

at: Land north of Camer  
Road, Hook Green,  
Meopham

for: Icení Projects Ltd

Report Reference: 3741353 R00(01)

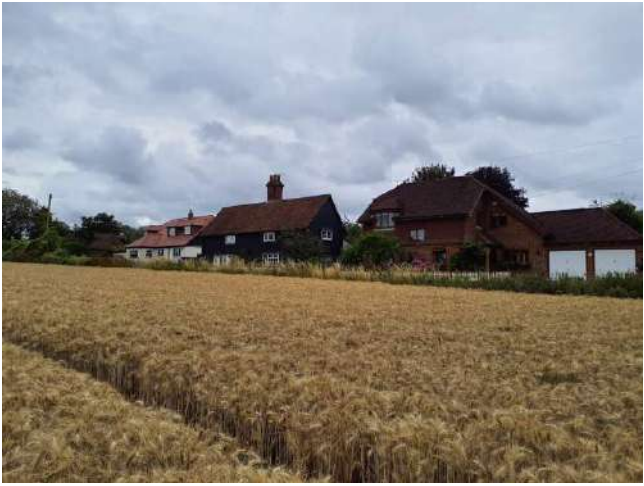
| 8 | 1d. Site boundaries. | Overhead cables in the south offside. The southern boundary is bound by a small hedgeline and residential houses beyond. | S | |

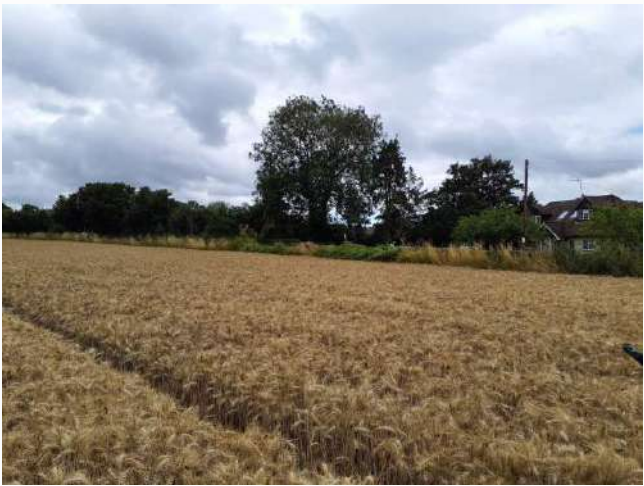
| 9 | 1d. Site boundaries. | Southern boundary bounded by vegetation (grasses and bushes) and a road beyond. | S | |

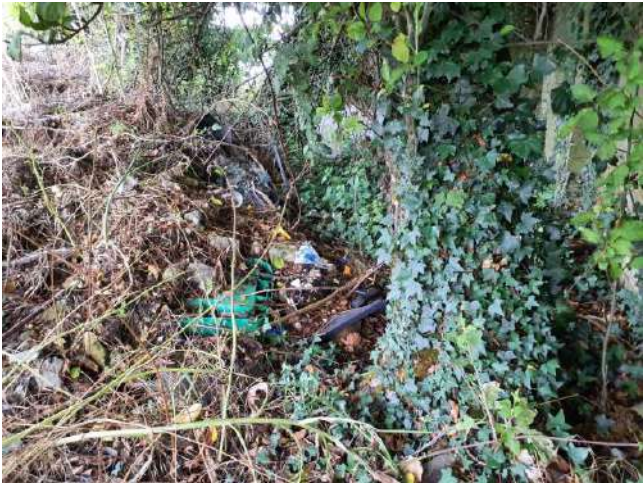
| 20 | 6b. Remains of building structures on site or close to site boundary | Litter on Northern side of brick structure | SE | |

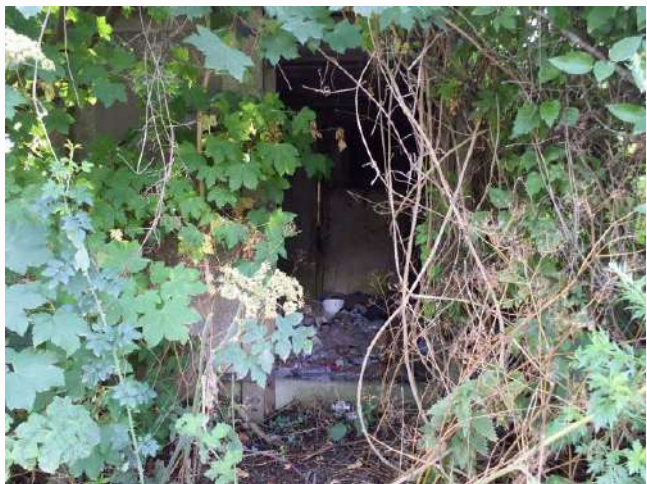
| 35 | 1c. Adjacent land use (s) | Derelict concrete and wood structure with felt roof beyond northern boundary. Overgrown with vegetation. | N | |

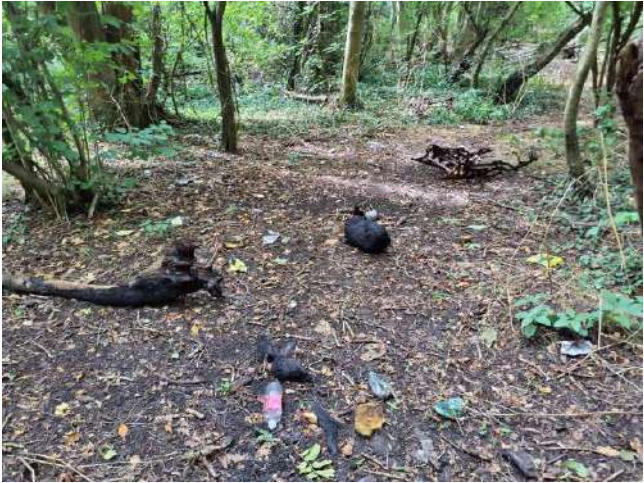
| 49 | 7f. Evidence of possible land contamination on-site | Burnt wood and bonfire area inside Blundells Shaw. Littering of food packaging, glass, metal, plastic, | N | |

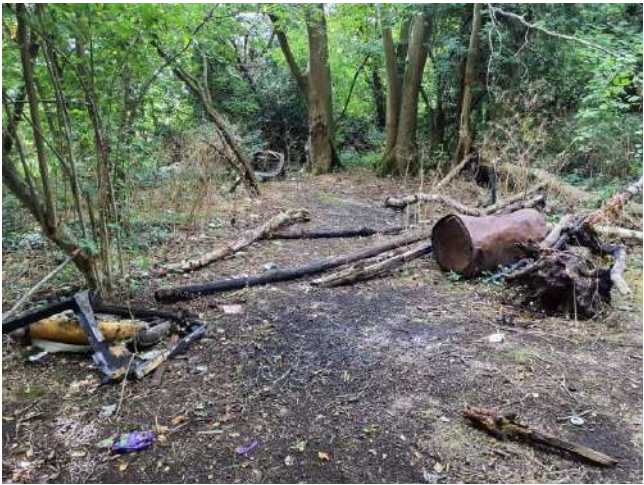
| 50 | 7f. Evidence of possible land contamination on-site | Second bonfire area inside Blundells Shaw woodland including a burnt sofa, wood, metal and drum. | N | |

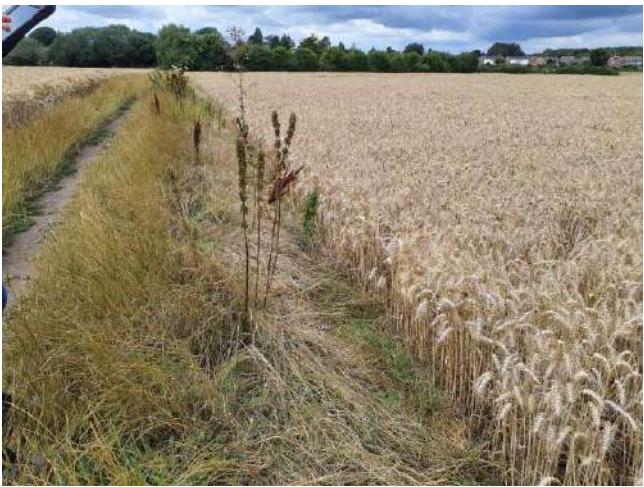
| 54 | 3a. Site Topography | 0.5m drop in elevation from public footpath to agricultural land. | W | |

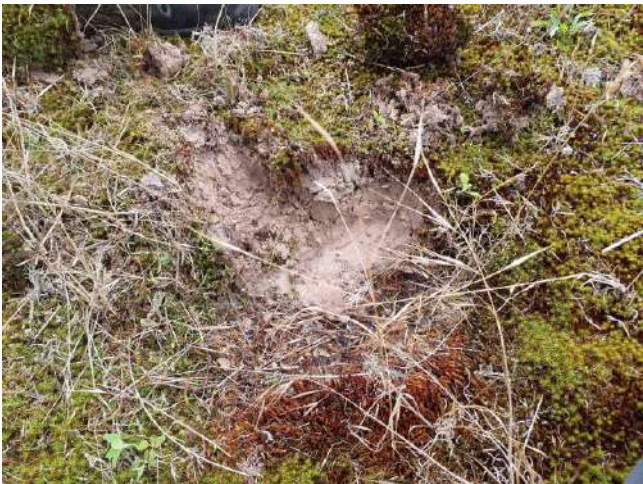
| 61 | 1b. Current site activities. | Disturbed land. Sandy | W | |

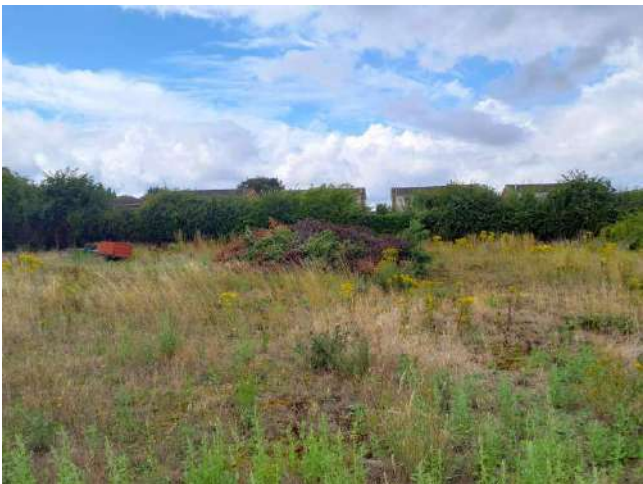
| 62 | 1a. Main land use(s) | Pile of vegetation bonfire area?<br>Landowner confirmed horse manure 25 years ago. | W | |

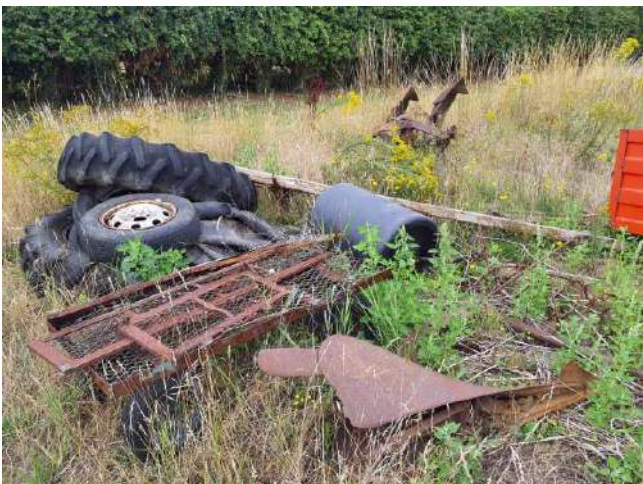
| 63 | 1a. Main land use(s) | Storage of farm equipment. Rusty trolley, ploughs and tires. In the west on disturbed land | W | |
