**REMEDiation VERIFICATION  
REPORT  
FOR  
FORMER BATTLE OF BRITAIN  
SITE, COLDHARBOUR ROAD,  
NORTHFLEET**

| <b>Report Title:</b> | Remediation Verification Report for Former Battle of Britain Site, Coldharbour Road, Northfleet |
| <b>Report Number:</b> | AG3571A-25-AU84 |
| <b>Date:</b> | February 2026 |

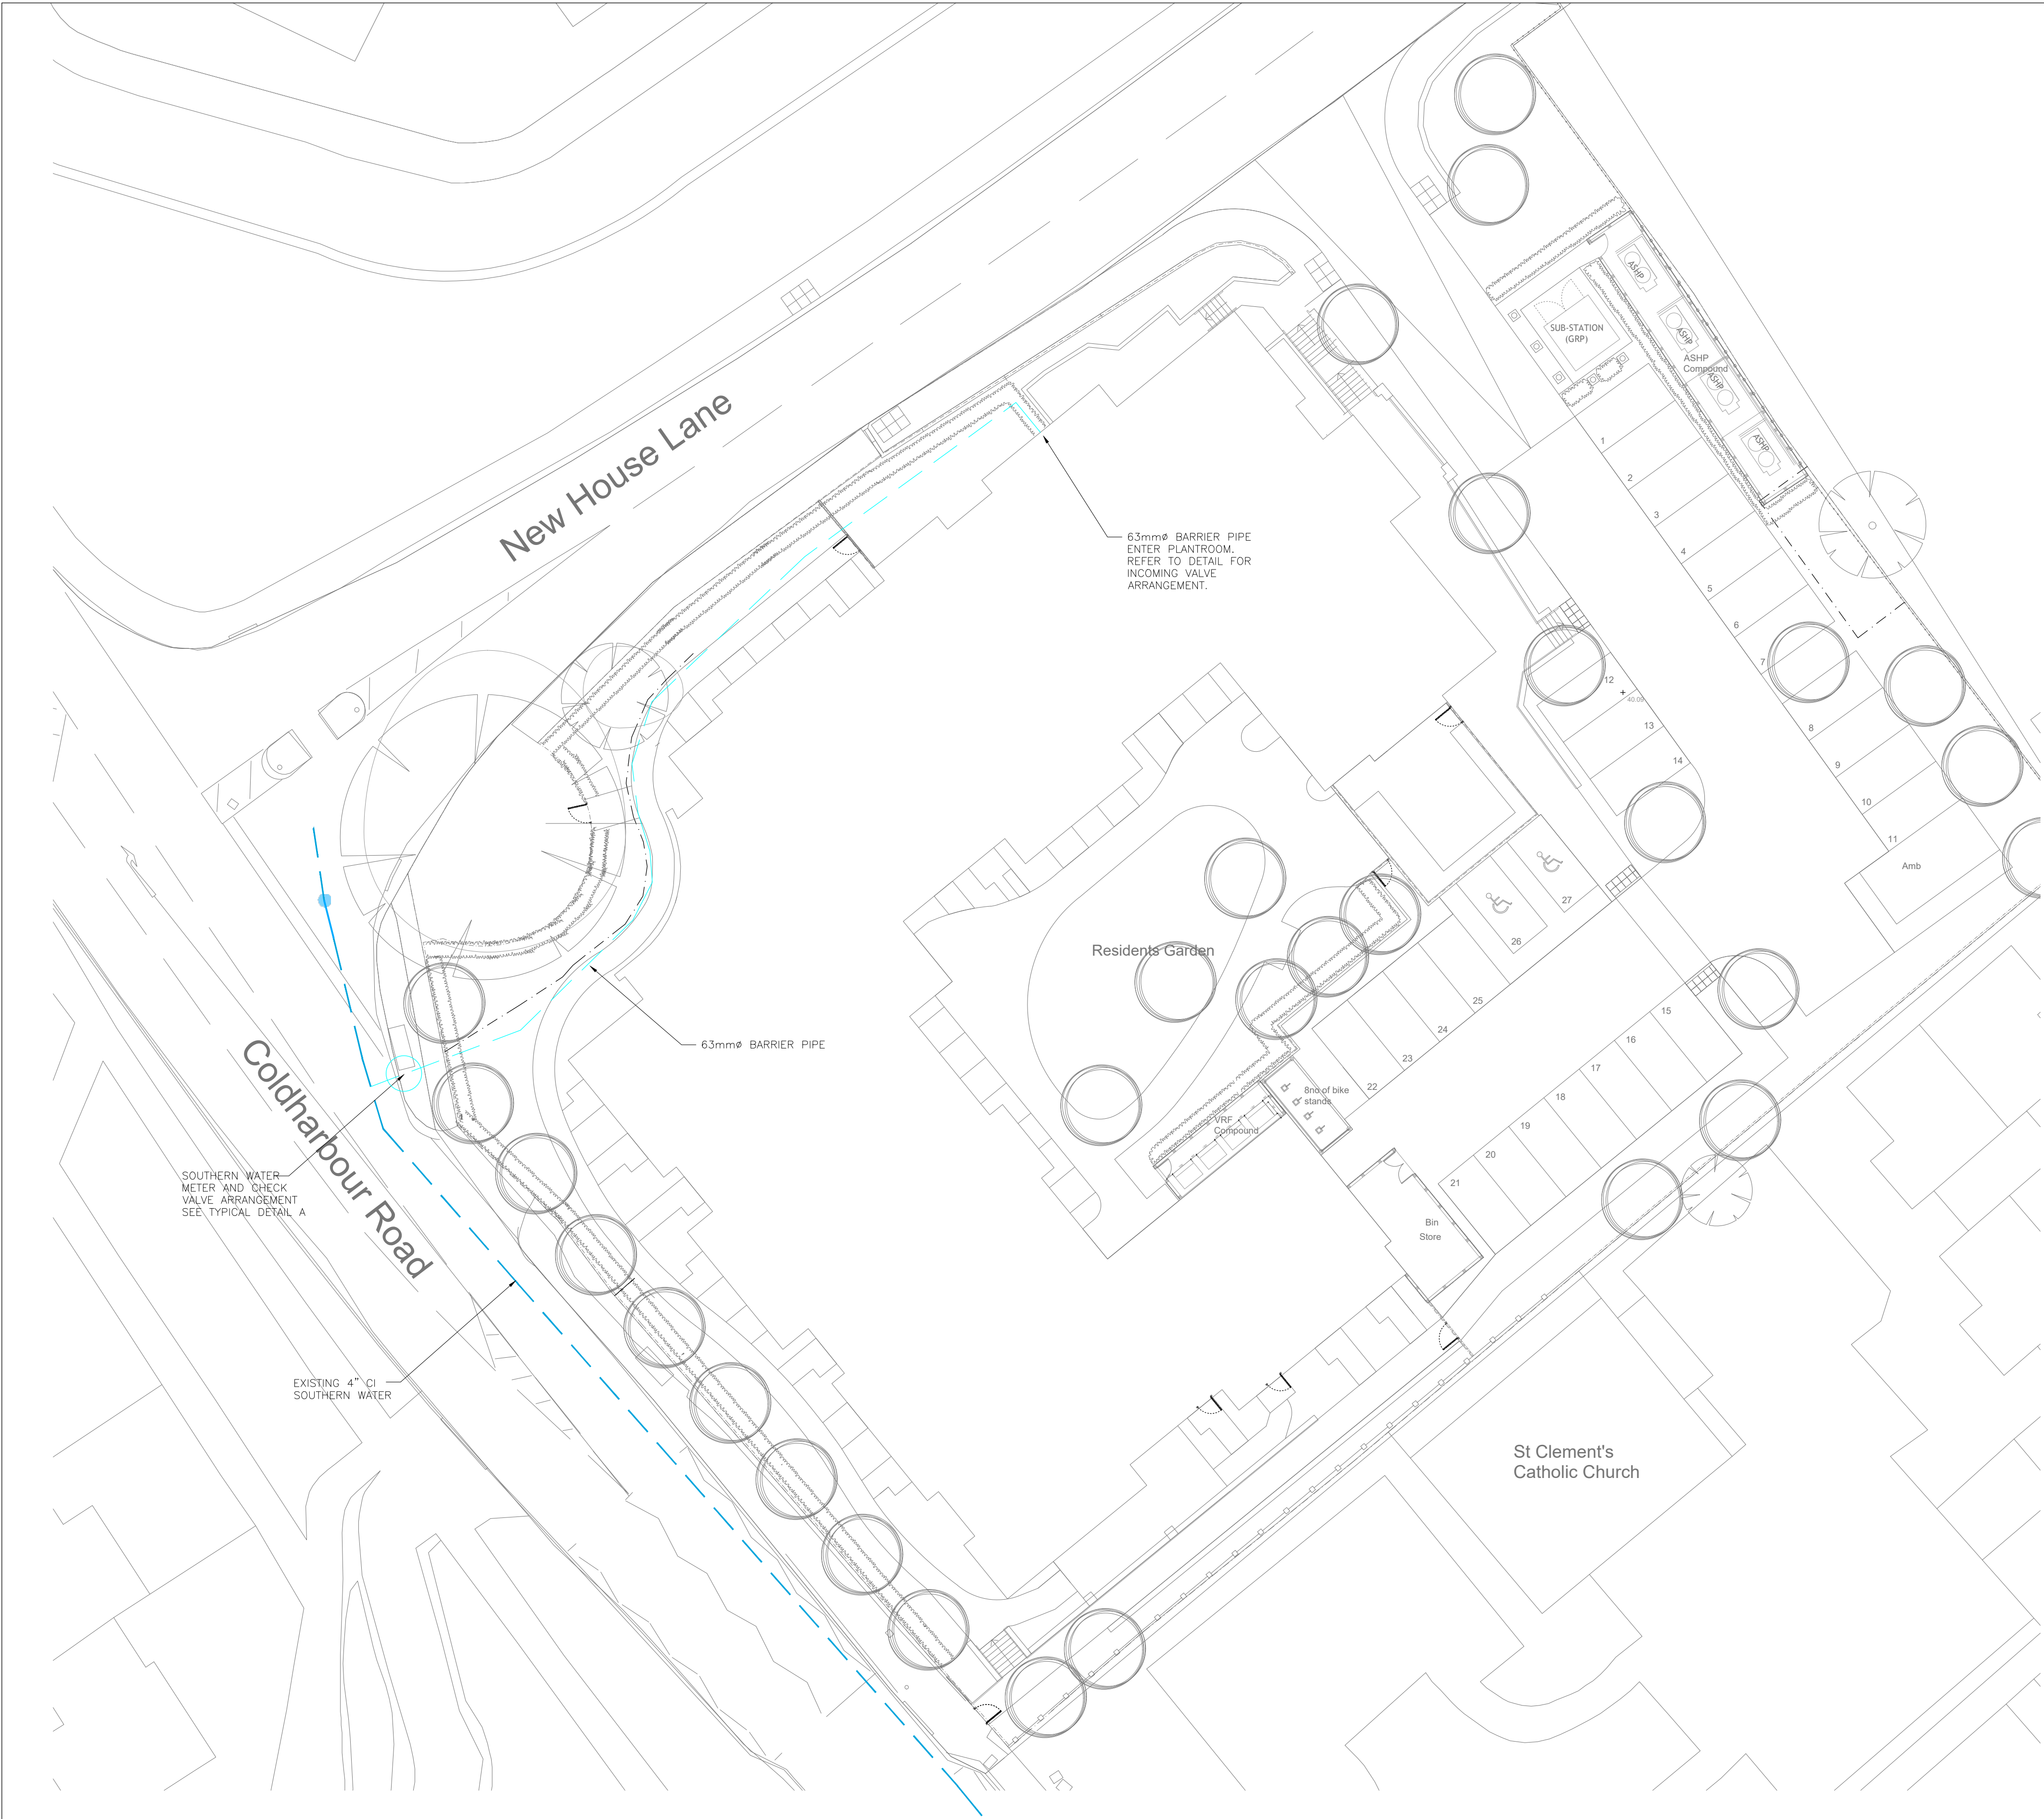
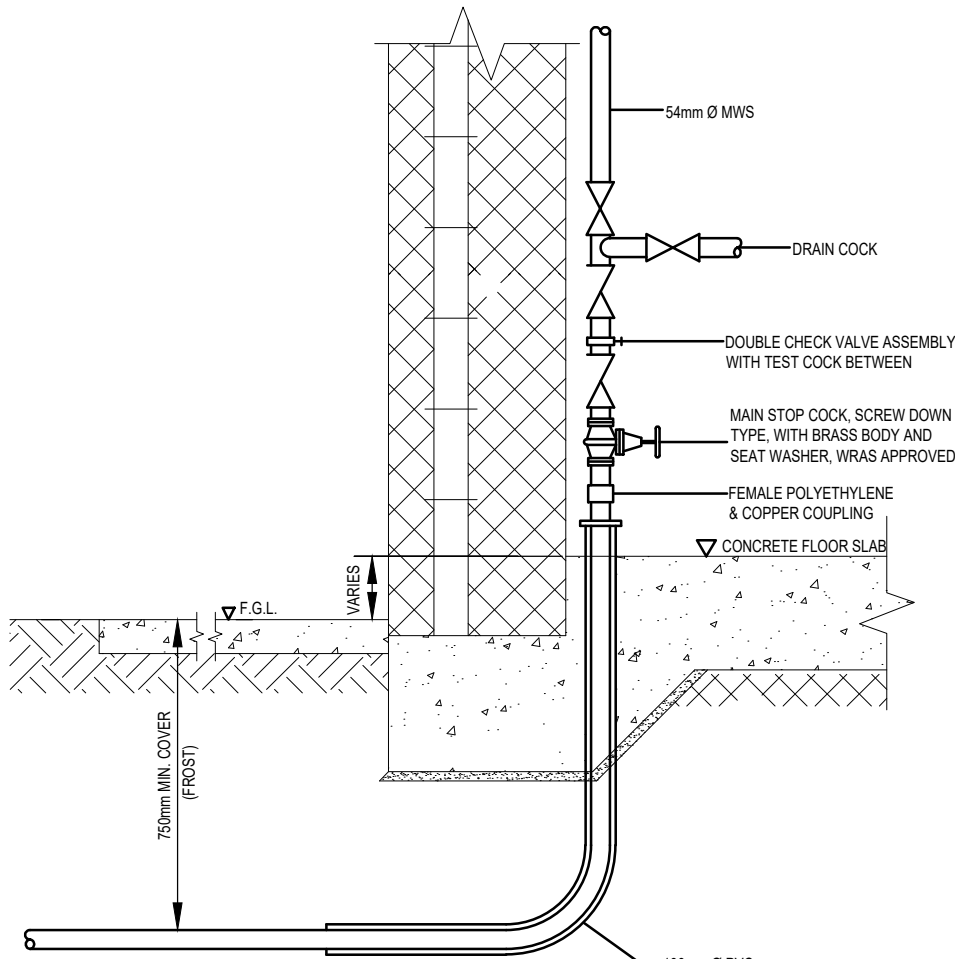
DETAIL A - INCOMING MAINS COLD WATER SERVICE DETAIL (N.T.S.)

- CONTRACTOR DESIGNED THRUST BLOCKS TO BE PROVIDED AT EACH CHANGE OF DIRECTION AND AT EVERY JUNCTION.
- MARKER TAPE TO BE INSTALLED AS PER THE TYPICAL DETAIL, ALONG ROUTE OF ALL NEW PIPEWORK.
- THE NEW SECTION OF PIPEWORK IS TO BE FLUSHED & DISINFECTED IN ACCORDANCE WITH SEVERN TRENT WATER REQUIREMENTS.
- ALL NEW WATER PIPEWORK, FITTINGS & FIXINGS TO BE INSTALLED IN ACCORDANCE WITH THE WATER REGULATIONS AND BYLAWS.
- PIPEWORK MATERIAL TO BE BARRIER (PE/AL/PE)
- FOR DETAILS OF MAJOR LEAK DETECTION SYSTEM REFER TO DRAWING [M-00-S\(53\)011](#)

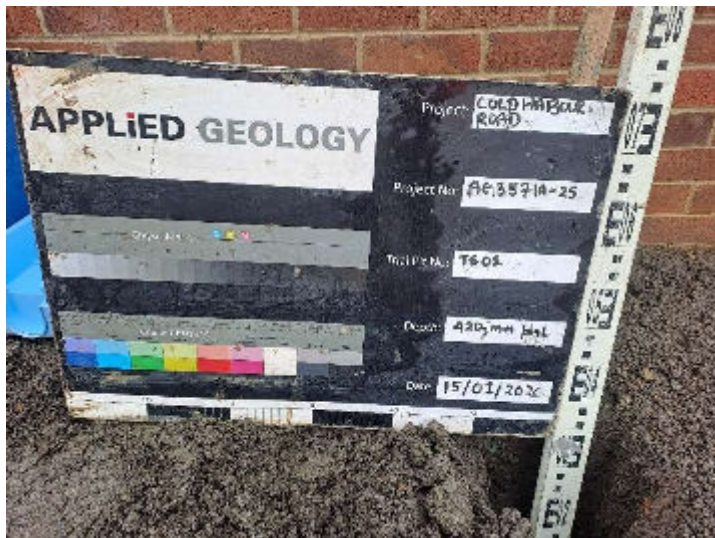
| TS01 | | Depth to Base (m bgl) | Soil Description | 0.42 | Dark grey slightly clayey slightly gravelly fine to coarse SAND with frequent rootlets. Gravel is subangular to subrounded fine to medium sandstone. (TOPSOIL). | Sample taken from TS01 at 0.10m bgl | |
| TS01 | | | | | | | | | | |
| Depth to Base (m bgl) | Soil Description | | | | | | | | | |
| 0.42 | Dark grey slightly clayey slightly gravelly fine to coarse SAND with frequent rootlets. Gravel is subangular to subrounded fine to medium sandstone. (TOPSOIL). | | | | | | | | | |

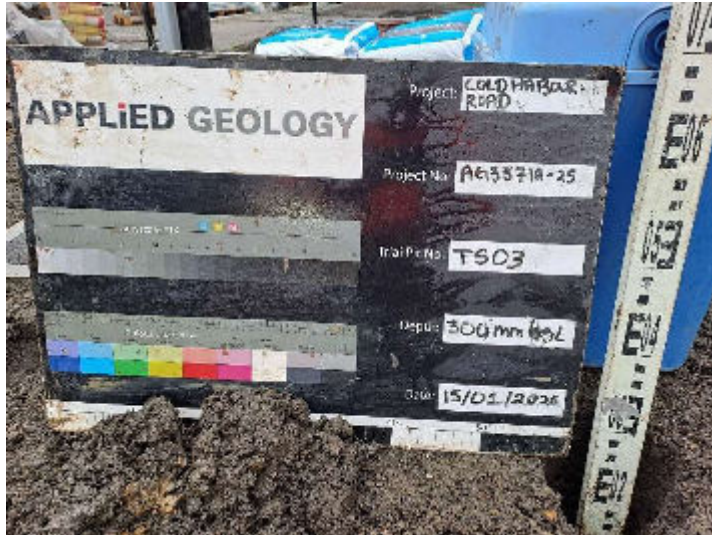
| TS03 | | Depth to Base (m bgl) | Soil Description | 0.30 | Dark grey slightly clayey slightly gravelly fine to coarse SAND with frequent rootlets. Gravel is subangular to subrounded fine to medium sandstone. (TOPSOIL). | N/A | |
| TS03 | | | | | | | | | | |
| Depth to Base (m bgl) | Soil Description | | | | | | | | | |
| 0.30 | Dark grey slightly clayey slightly gravelly fine to coarse SAND with frequent rootlets. Gravel is subangular to subrounded fine to medium sandstone. (TOPSOIL). | | | | | | | | | |
|

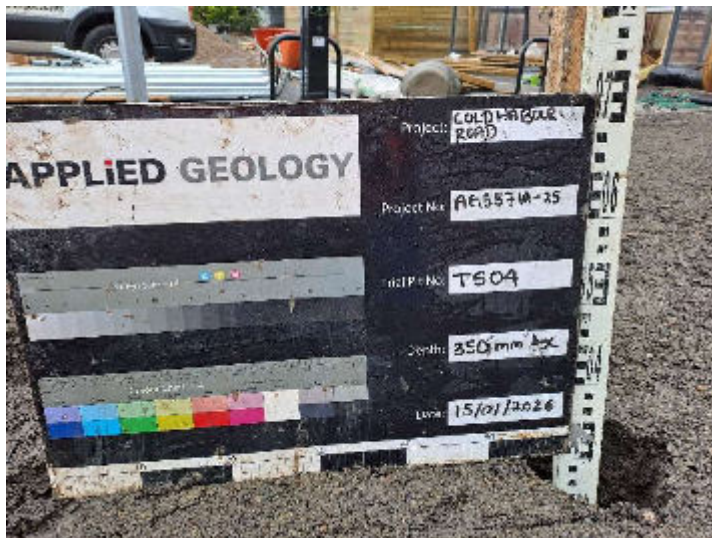
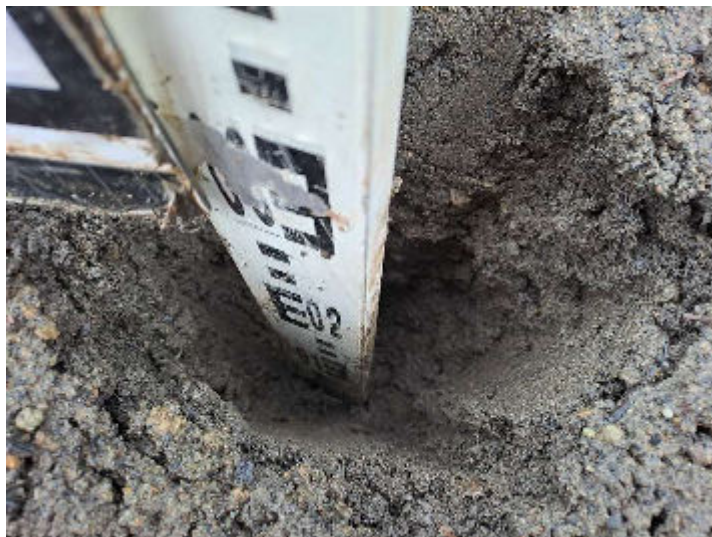
| | | <div>TS04</div> <table><tr><th>Depth to Base (m bgl)</th><th>Soil Description</th></tr><tr><td>0.35</td><td>Dark grey slightly clayey slightly gravelly fine to coarse SAND with frequent rootlets. Gravel is subangular to subrounded fine to medium sandstone. (TOPSOIL).</td></tr></table> | Depth to Base (m bgl) | Soil Description | 0.35 | Dark grey slightly clayey slightly gravelly fine to coarse SAND with frequent rootlets. Gravel is subangular to subrounded fine to medium sandstone. (TOPSOIL). | Sampe,<br>taken at<br>TS04 0.2m<br>bgl | |
|---|---|---|---|---|---|---|---|--|
| Depth to Base (m bgl) | Soil Description | | | | | | | |
| 0.35 | Dark grey slightly clayey slightly gravelly fine to coarse SAND with frequent rootlets. Gravel is subangular to subrounded fine to medium sandstone. (TOPSOIL). | | | | | | | |
| | |

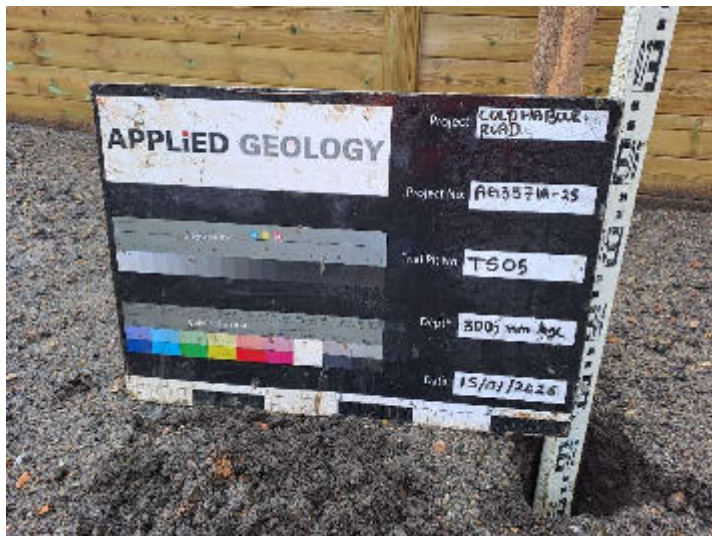
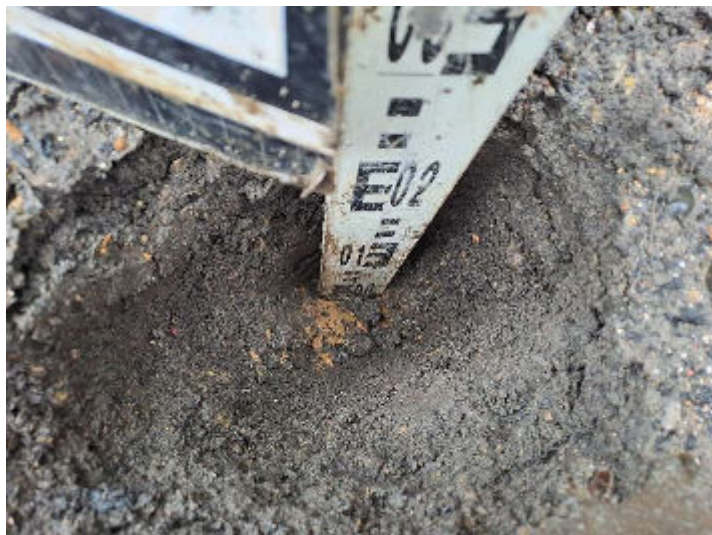
| | | <div>TS05</div> <table><tr><th>Depth to Base (m bgl)</th><th>Soil Description</th></tr><tr><td>0.30</td><td>Dark grey slightly clayey slightly gravelly fine to coarse SAND with frequent rootlets. Gravel is subangular to subrounded fine to medium sandstone. (TOPSOIL).</td></tr></table> | Depth to Base (m bgl) | Soil Description | 0.30 | Dark grey slightly clayey slightly gravelly fine to coarse SAND with frequent rootlets. Gravel is subangular to subrounded fine to medium sandstone. (TOPSOIL). | N/A | |
|---|---|---|---|---|---|---|---|--|
| Depth to Base (m bgl) | Soil Description | | | | | | | |
| 0.30 | Dark grey slightly clayey slightly gravelly fine to coarse SAND with frequent rootlets. Gravel is subangular to subrounded fine to medium sandstone. (TOPSOIL). | | | | | | | |
| | | <div>

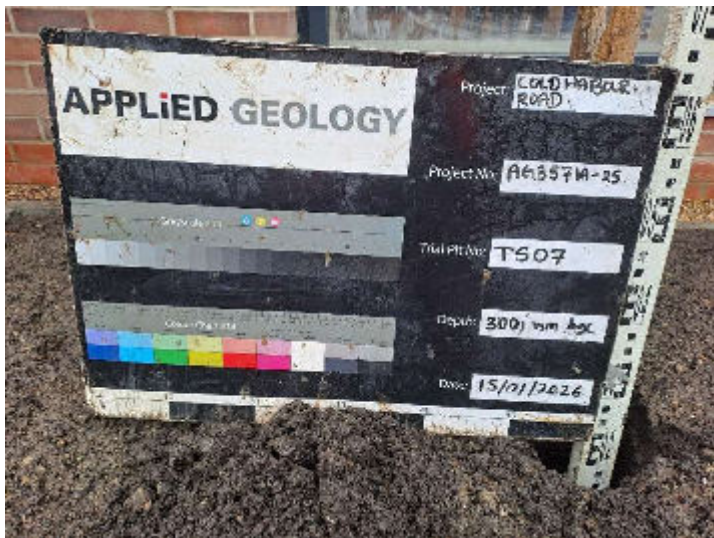
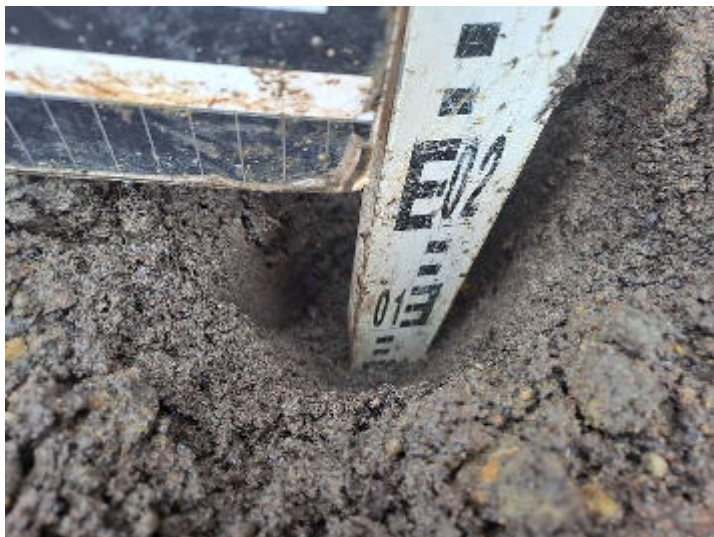
| TS07 | | Depth to Base (m bgl) | Soil Description | 0.30 | Dark grey slightly clayey slightly gravelly fine to coarse SAND with frequent rootlets. Gravel is subangular to subrounded fine to medium sandstone. (TOPSOIL). | N/A | |
| TS07 | | | | | | | | | | |
| Depth to Base (m bgl) | Soil Description | | | | | | | | | |
| 0.30 | Dark grey slightly clayey slightly gravelly fine to coarse SAND with frequent rootlets. Gravel is subangular to subrounded fine to medium sandstone. (TOPSOIL). | | | | | | | | | |
| <div>

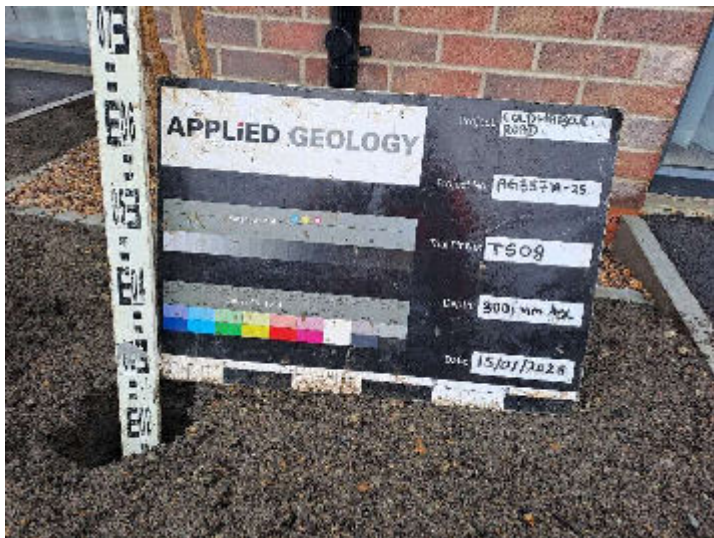
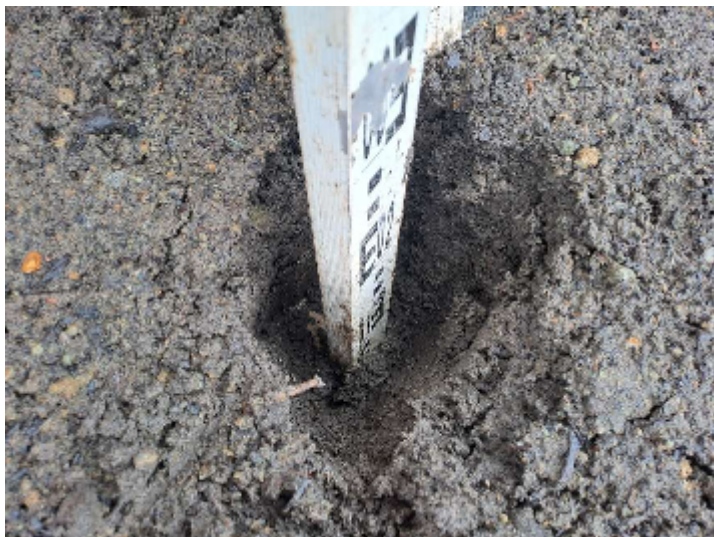
| TS08 | | Depth to Base (m bgl) | Soil Description | 0.30 | Dark grey slightly clayey slightly gravelly fine to coarse SAND with frequent rootlets. Gravel is subangular to subrounded fine to medium sandstone. (TOPSOIL). | N/A | |
| TS08 | | | | | | | | | | |
| Depth to Base (m bgl) | Soil Description | | | | | | | | | |
| 0.30 | Dark grey slightly clayey slightly gravelly fine to coarse SAND with frequent rootlets. Gravel is subangular to subrounded fine to medium sandstone. (TOPSOIL). | | | | | | | | | |
| <div>

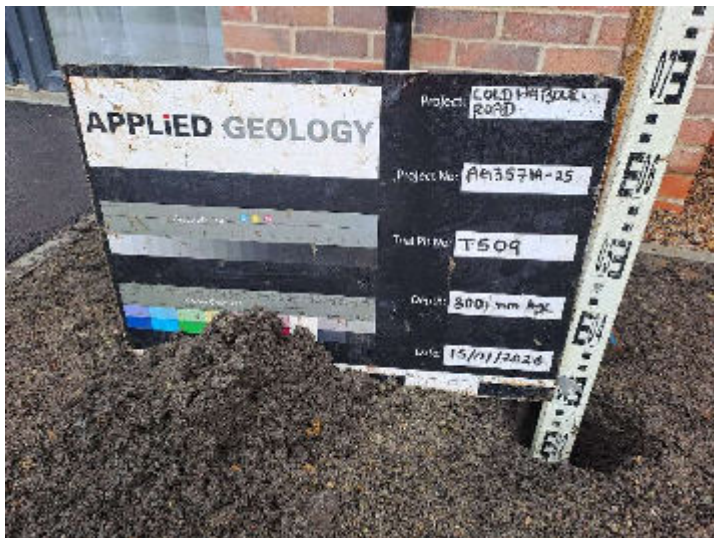
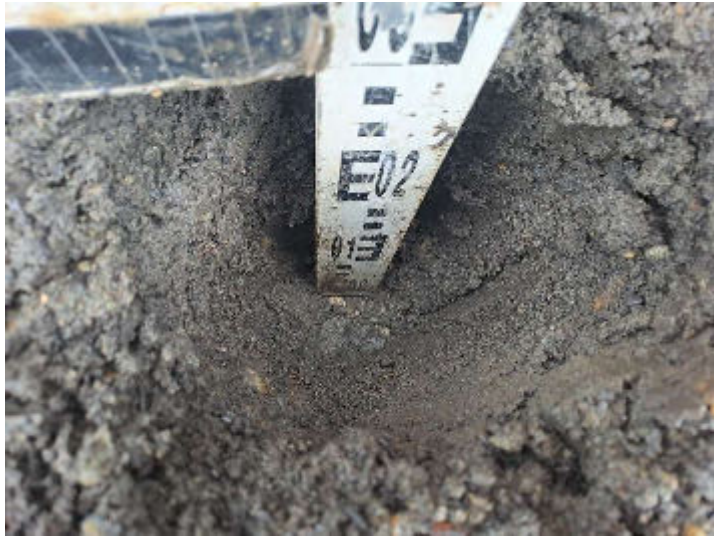
| | | <div>TS09</div> <table><tr><th>Depth to Base (m bgl)</th><th>Soil Description</th></tr><tr><td>0.30</td><td>Dark grey slightly clayey slightly gravelly fine to coarse SAND with frequent rootlets. Gravel is subangular to subrounded fine to medium sandstone. (TOPSOIL).</td></tr></table> | Depth to Base (m bgl) | Soil Description | 0.30 | Dark grey slightly clayey slightly gravelly fine to coarse SAND with frequent rootlets. Gravel is subangular to subrounded fine to medium sandstone. (TOPSOIL). | N/A | |
|---|---|---|---|---|---|---|---|--|
| Depth to Base (m bgl) | Soil Description | | | | | | | |
| 0.30 | Dark grey slightly clayey slightly gravelly fine to coarse SAND with frequent rootlets. Gravel is subangular to subrounded fine to medium sandstone. (TOPSOIL). | | | | | | | |
| | | <div>

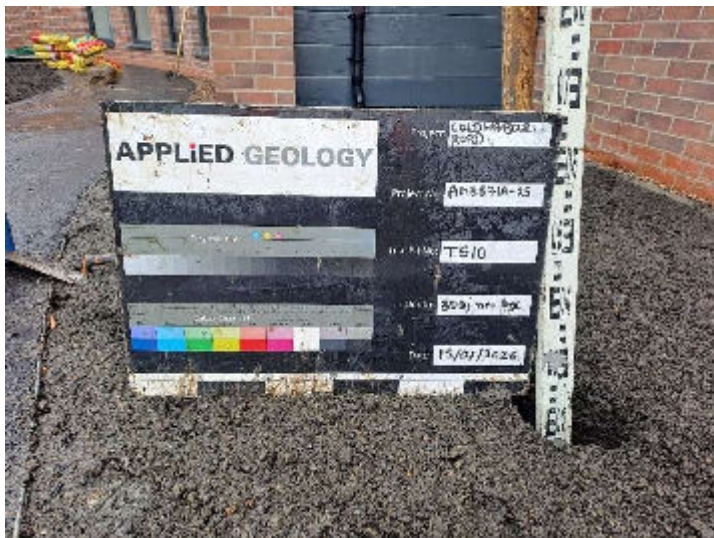
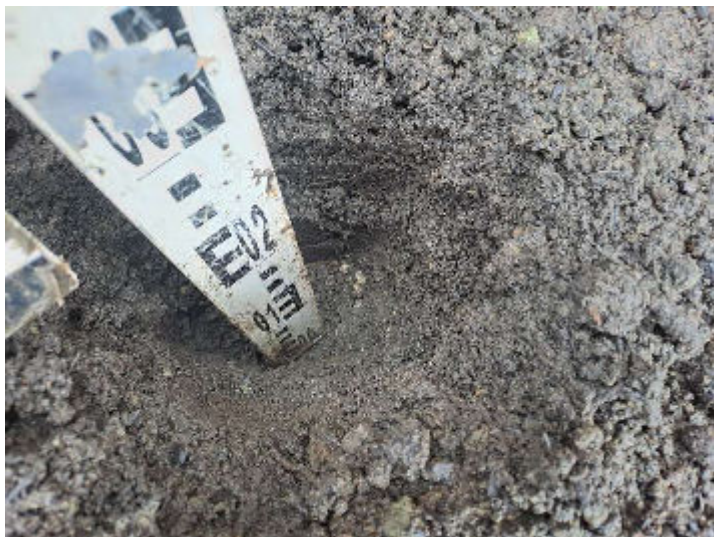
| TS10 | | Depth to Base (m bgl) | Soil Description | 0.30 | Dark grey slightly clayey slightly gravelly fine to coarse SAND with frequent rootlets. Gravel is subangular to subrounded fine to medium sandstone. (TOPSOIL). | N/A | |
| TS10 | | | | | | | | | | |
| Depth to Base (m bgl) | Soil Description | | | | | | | | | |
| 0.30 | Dark grey slightly clayey slightly gravelly fine to coarse SAND with frequent rootlets. Gravel is subangular to subrounded fine to medium sandstone. (TOPSOIL). | | | | | | | | | |
| <div>

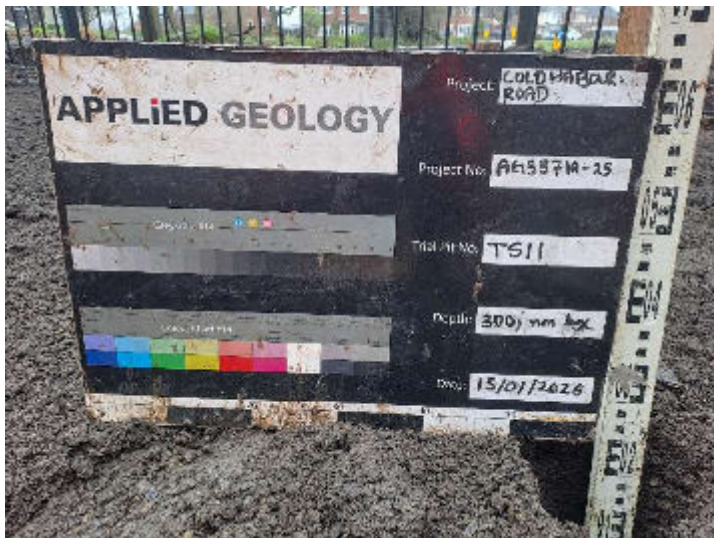
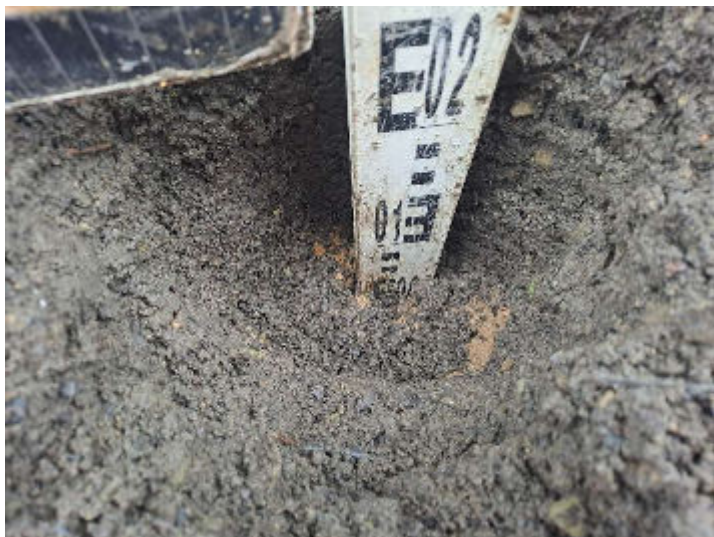
| TS11 | | Depth to Base (m bgl) | Soil Description | 0.30 | Dark grey slightly clayey slightly gravelly fine to coarse SAND with frequent rootlets. Gravel is subangular to subrounded fine to medium sandstone. (TOPSOIL). | Sample taken at TS11 0.25m bgl | |
| TS11 | | | | | | | | | | |
| Depth to Base (m bgl) | Soil Description | | | | | | | | | |
| 0.30 | Dark grey slightly clayey slightly gravelly fine to coarse SAND with frequent rootlets. Gravel is subangular to subrounded fine to medium sandstone. (TOPSOIL). | | | | | | | | | |
|

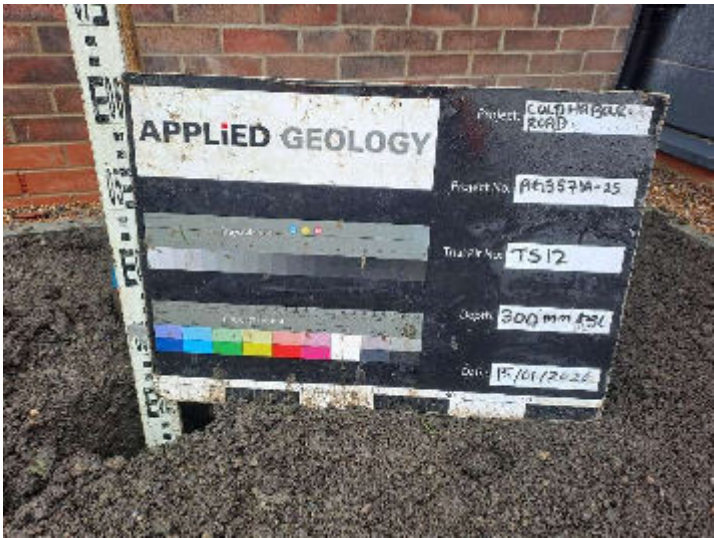
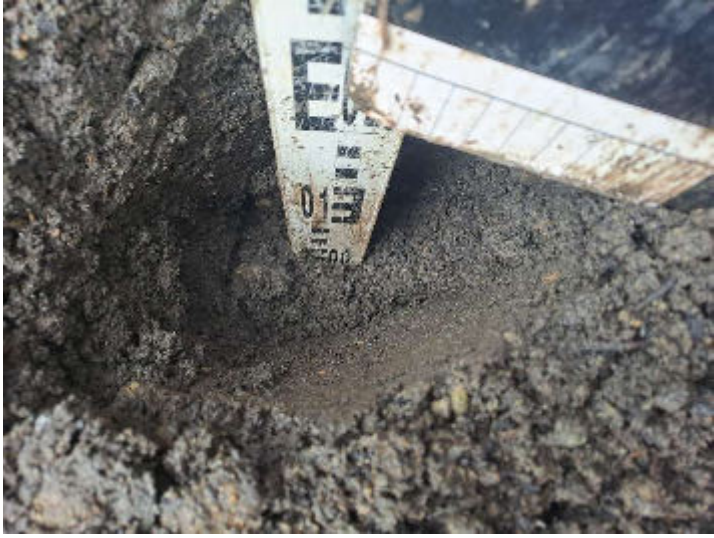
| | | 0.30 | Dark grey slightly clayey slightly gravelly fine to coarse SAND with frequent rootlets. Gravel is subangular to subrounded fine to medium sandstone. (TOPSOIL). | Sample taken at TS12 0.15m bgl |

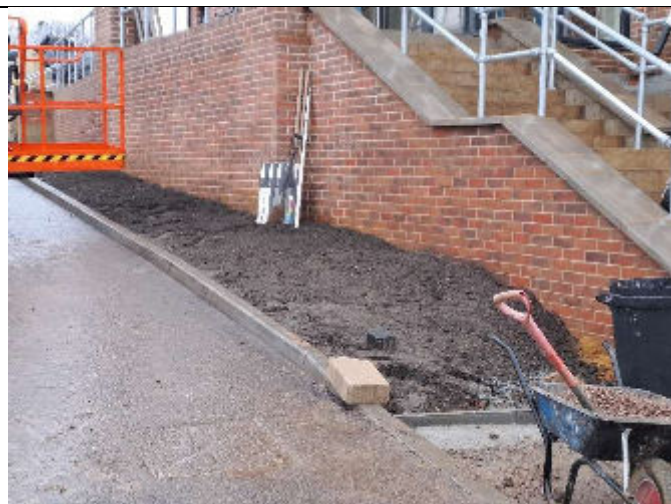
1. Looking southeast at the long strip of soft landscaping at the front of the building.

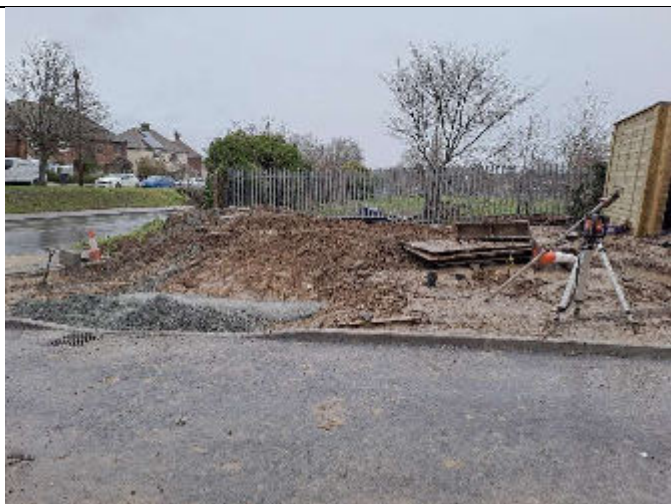
2. Looking northeast, outstanding landscaping work remains at the site entrance.

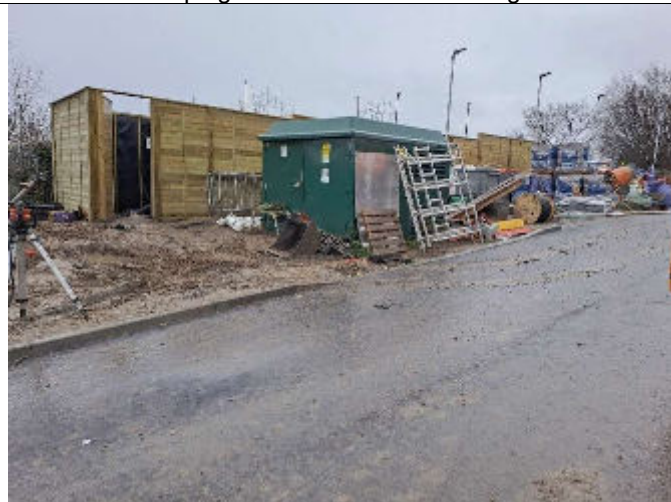
3. Looking northeast, incomplete topsoil placement near the site entrance.

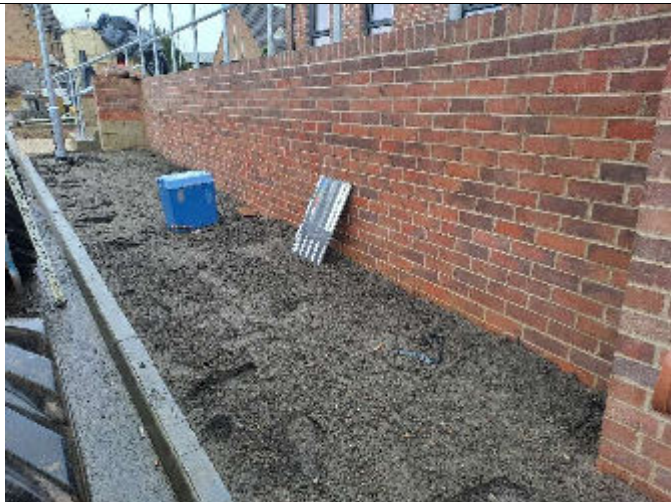
4. Looking southeast, topsoil placement at the front of building.

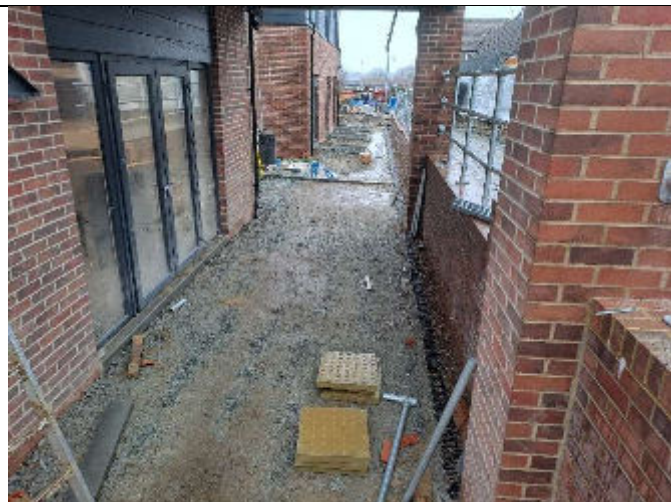
5. Looking northeast, ongoing topsoil placement along the side of the building.

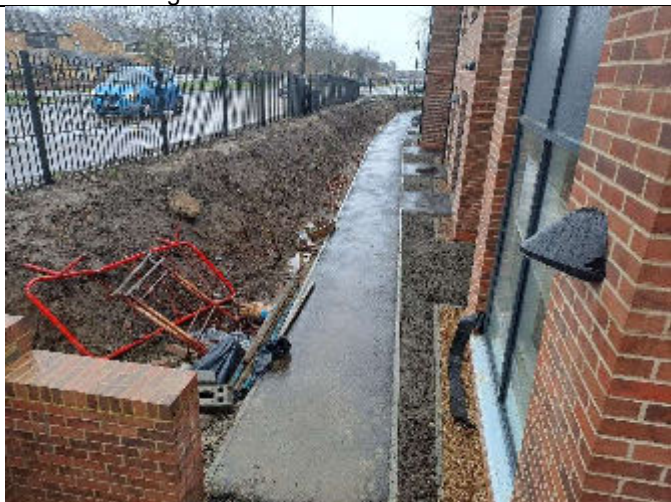
6. Looking northeast, ongoing topsoil placement along the side of the building and the perimeter fence.

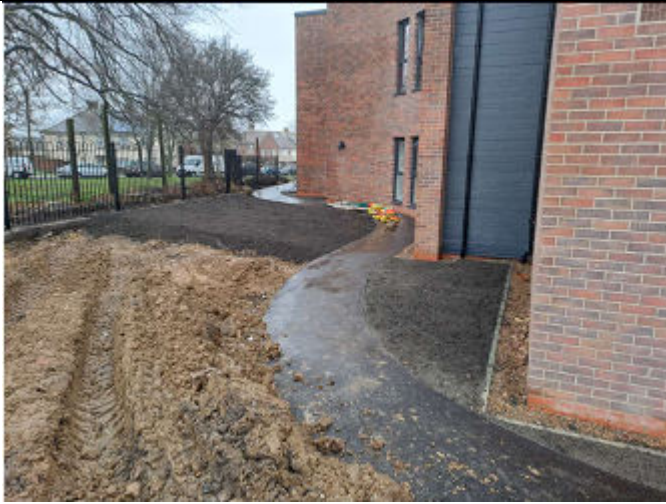
7. Looking northeast, ongoing topsoil placement along the northern perimeter fence

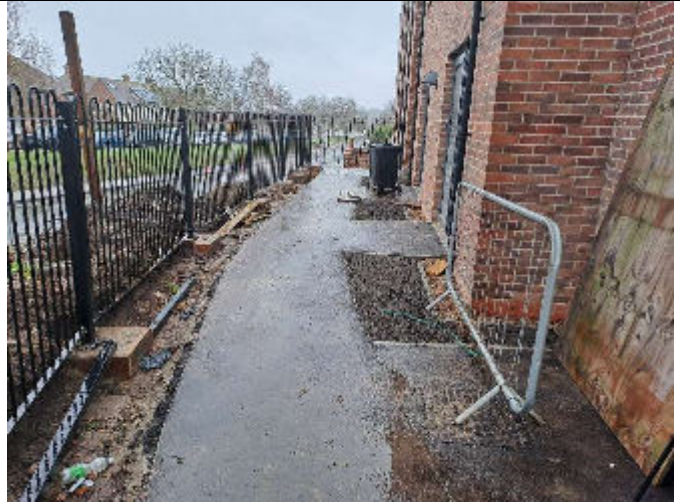
8. Looking northeast, topsoil placement next to the building and the perimeter fence.

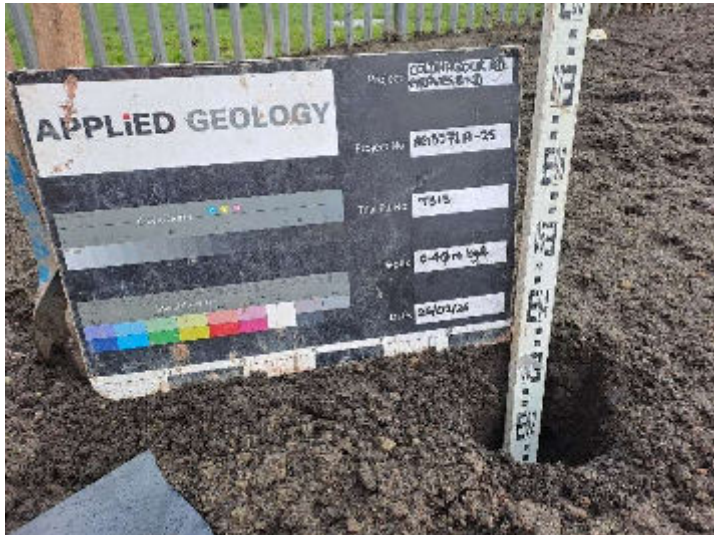
| TS13 (numbering continued from previous visit) | | Depth to Base (m bgl) | Soil Description | 0.40 | Dark grey slightly clayey slightly gravelly fine to coarse SAND with frequent rootlets. Gravel is subangular to subrounded fine to medium sandstone. (TOPSOIL). | Sample taken at TS13<br>0.10m bgl | |
| TS13 (numbering continued from previous visit) | | | | | | | | | | |
| Depth to Base (m bgl) | Soil Description | | | | | | | | | |
| 0.40 | Dark grey slightly clayey slightly gravelly fine to coarse SAND with frequent rootlets. Gravel is subangular to subrounded fine to medium sandstone. (TOPSOIL). | | | | | | | | | |

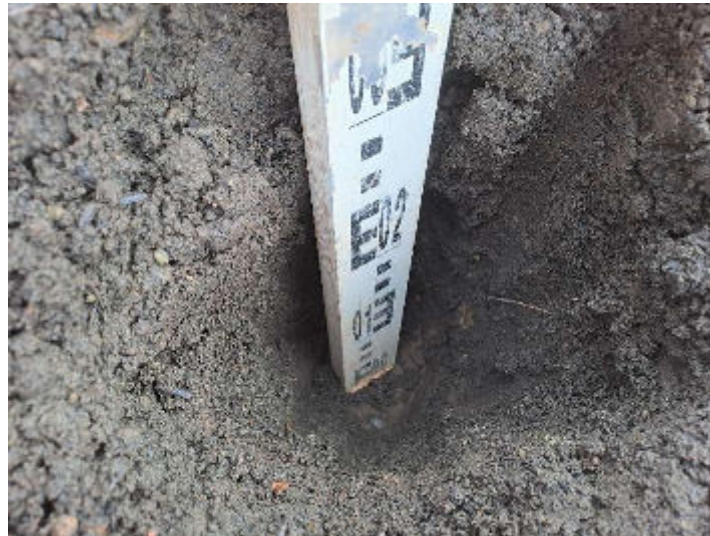
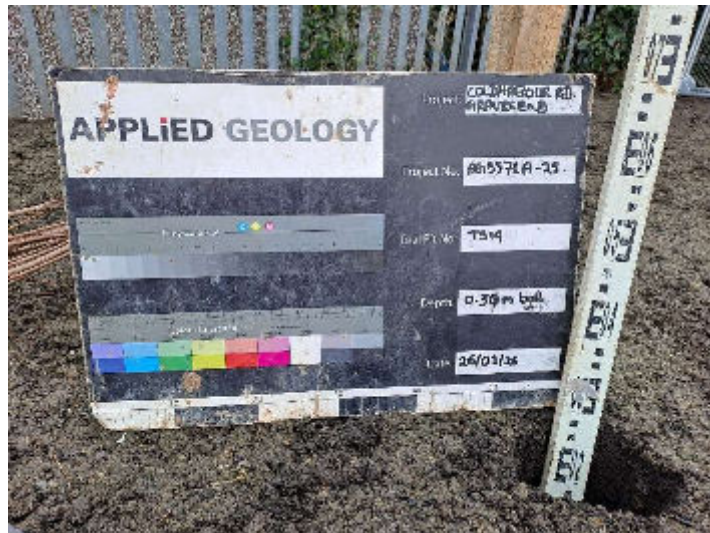
Dark grey slightly clayey slightly gravelly fine to coarse SAND with frequent rootlets. Gravel is subangular to subrounded fine to medium sandstone. (TOPSOIL).

Sample taken  
at TS14  
0.20m bgl

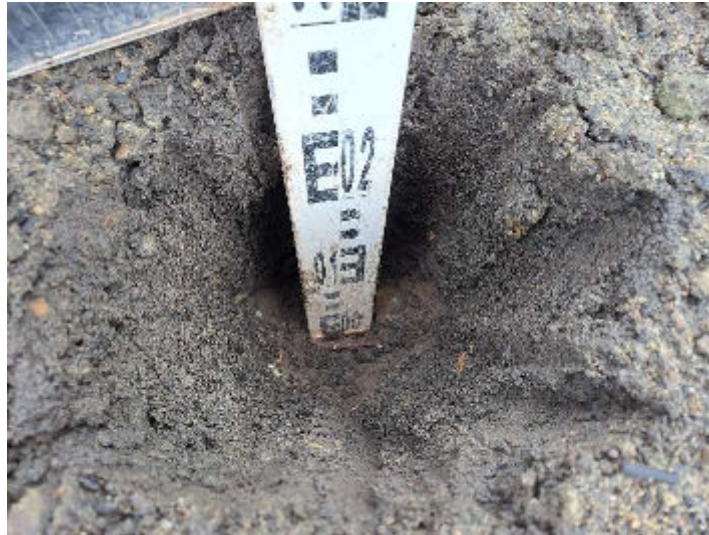
TS15

Dark grey slightly clayey slightly gravelly fine to coarse SAND with frequent rootlets. Gravel is subangular to subrounded fine to medium sandstone. (TOPSOIL).

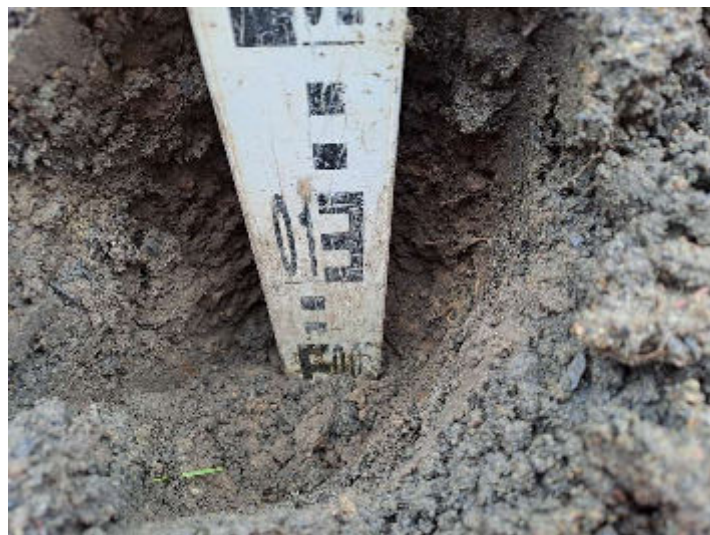
TS23 0.30m  
bgl

Dark grey slightly clayey slightly gravelly fine to coarse SAND with frequent rootlets. Gravel is subangular to subrounded fine to medium sandstone. (TOPSOIL).

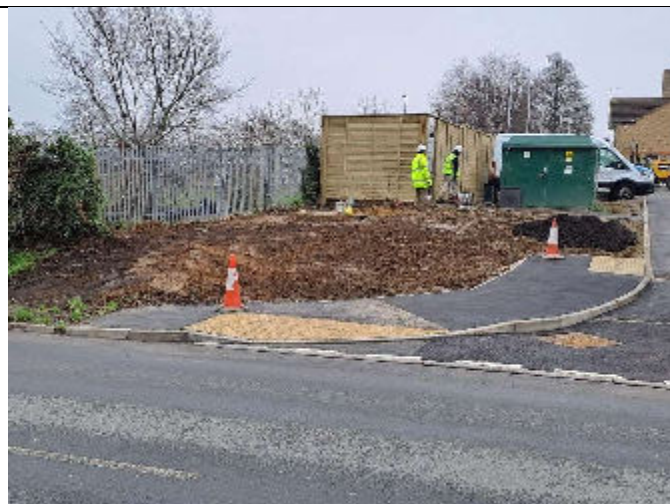
1. Looking northeast, the area next to site entrance where topsoil was not yet placed.

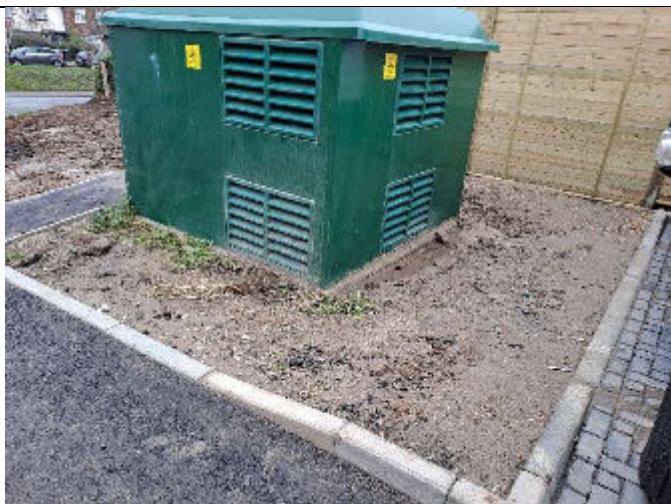
2. Looking northwest, the area surrounding electrical transformer where topsoil was not yet placed.

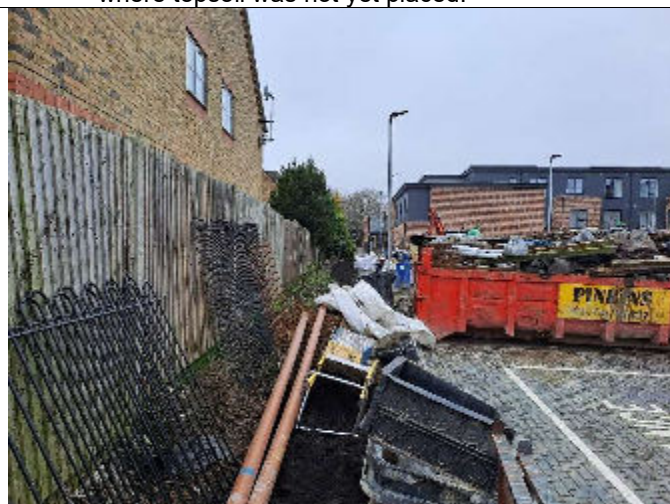
3. Looking southwest, the area next to car park where topsoil was not yet placed.

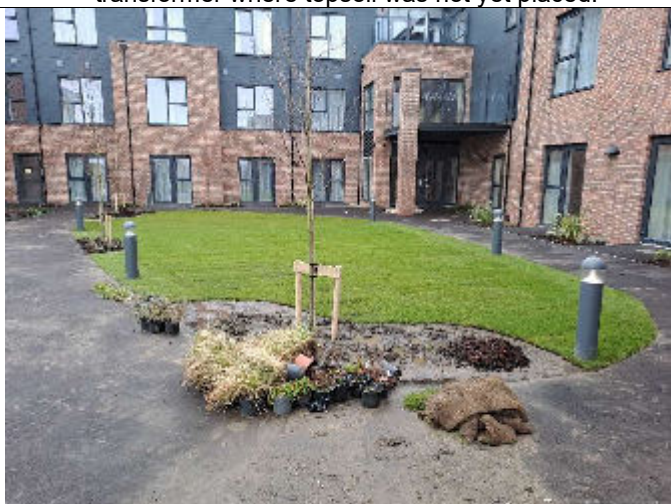
4. Looking west, the grass turfed roll being placed in the area behind the building.
