RE: 22a High Street  
Gravesend  
DA11 0BA  
2 No. Box Frames & Sashes

RE: 22a High Street  
Gravesend  
DA11 0BA  
Cross section of proposed  
Sash window replacements

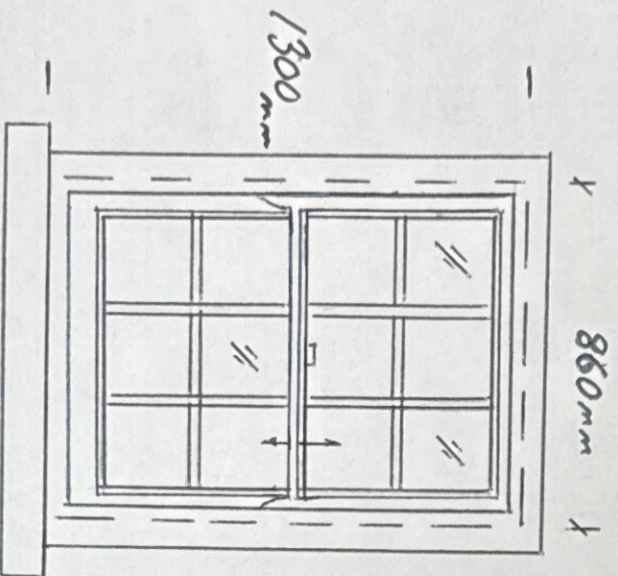
1 No. First Floor Front  
&  
1 No. Ground Floor Front

Broken markings depict  
outside brickwork line

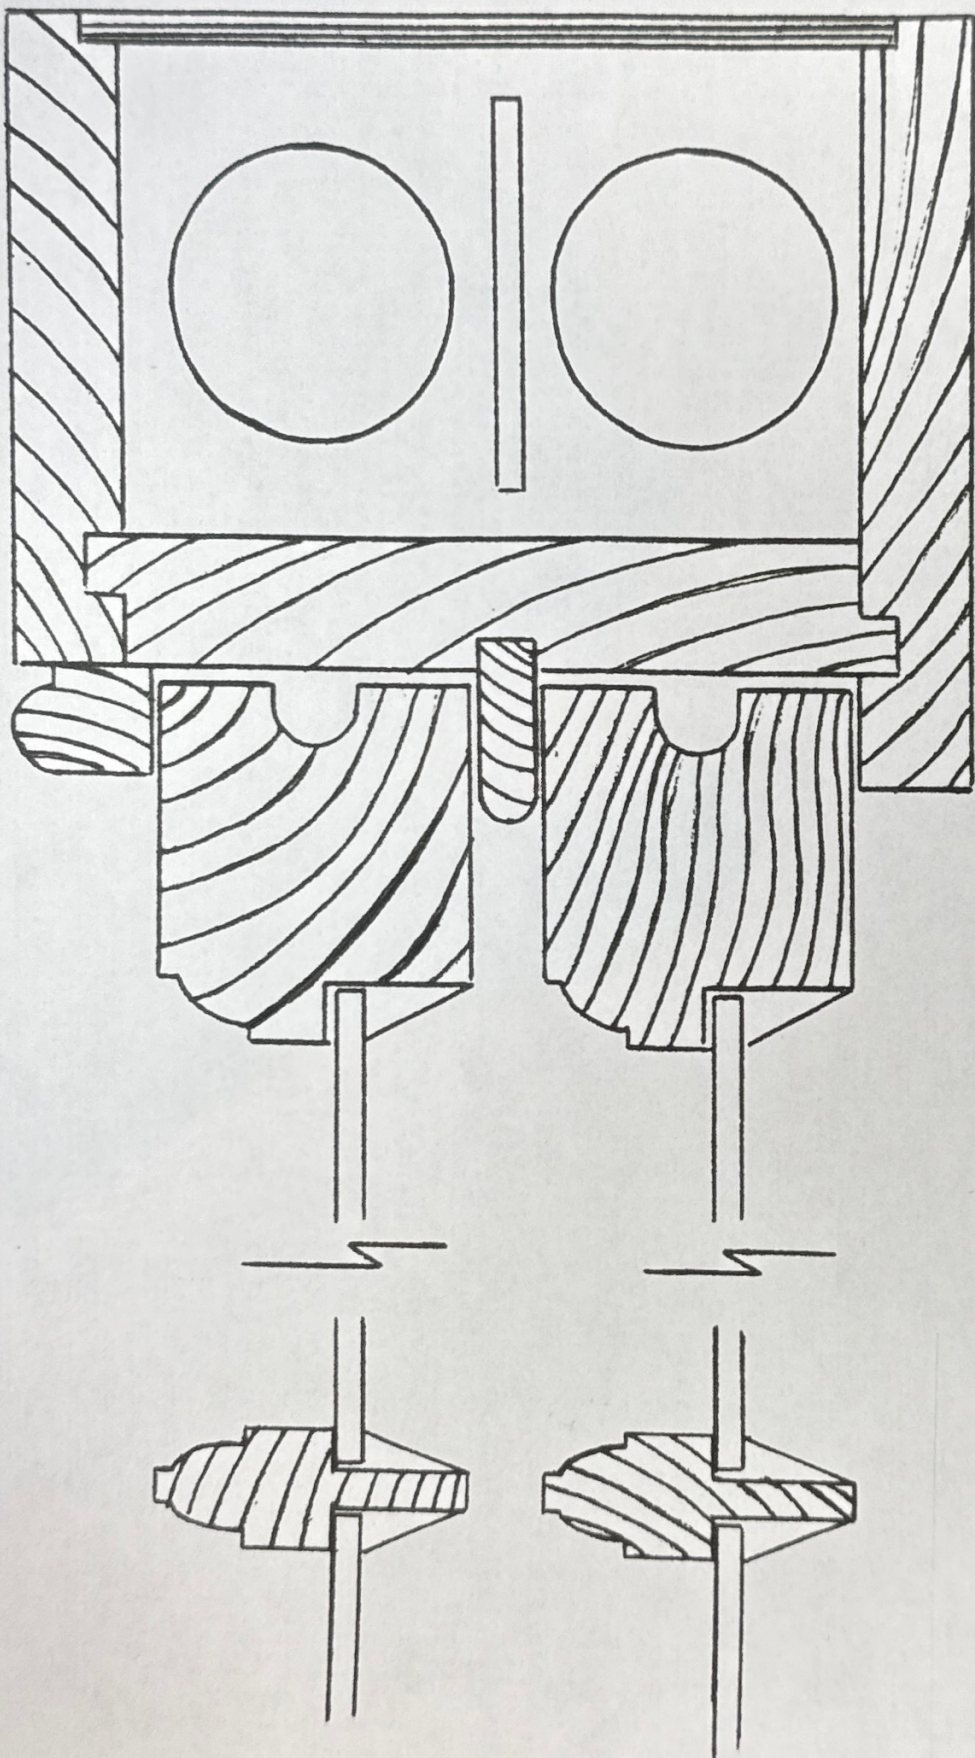
Cross section of Box Frame  
Upright, Sash Stiles and  
Glazing Bars

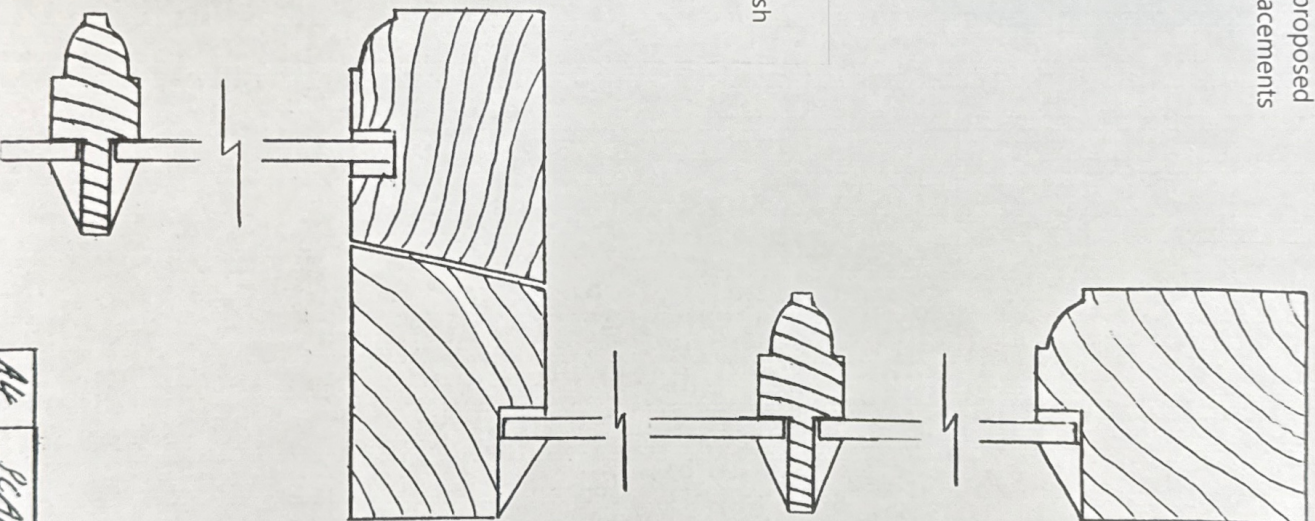
Cross section of Top Sash  
and Lower Sash  
Meeting Rail and  
Glazing Bar

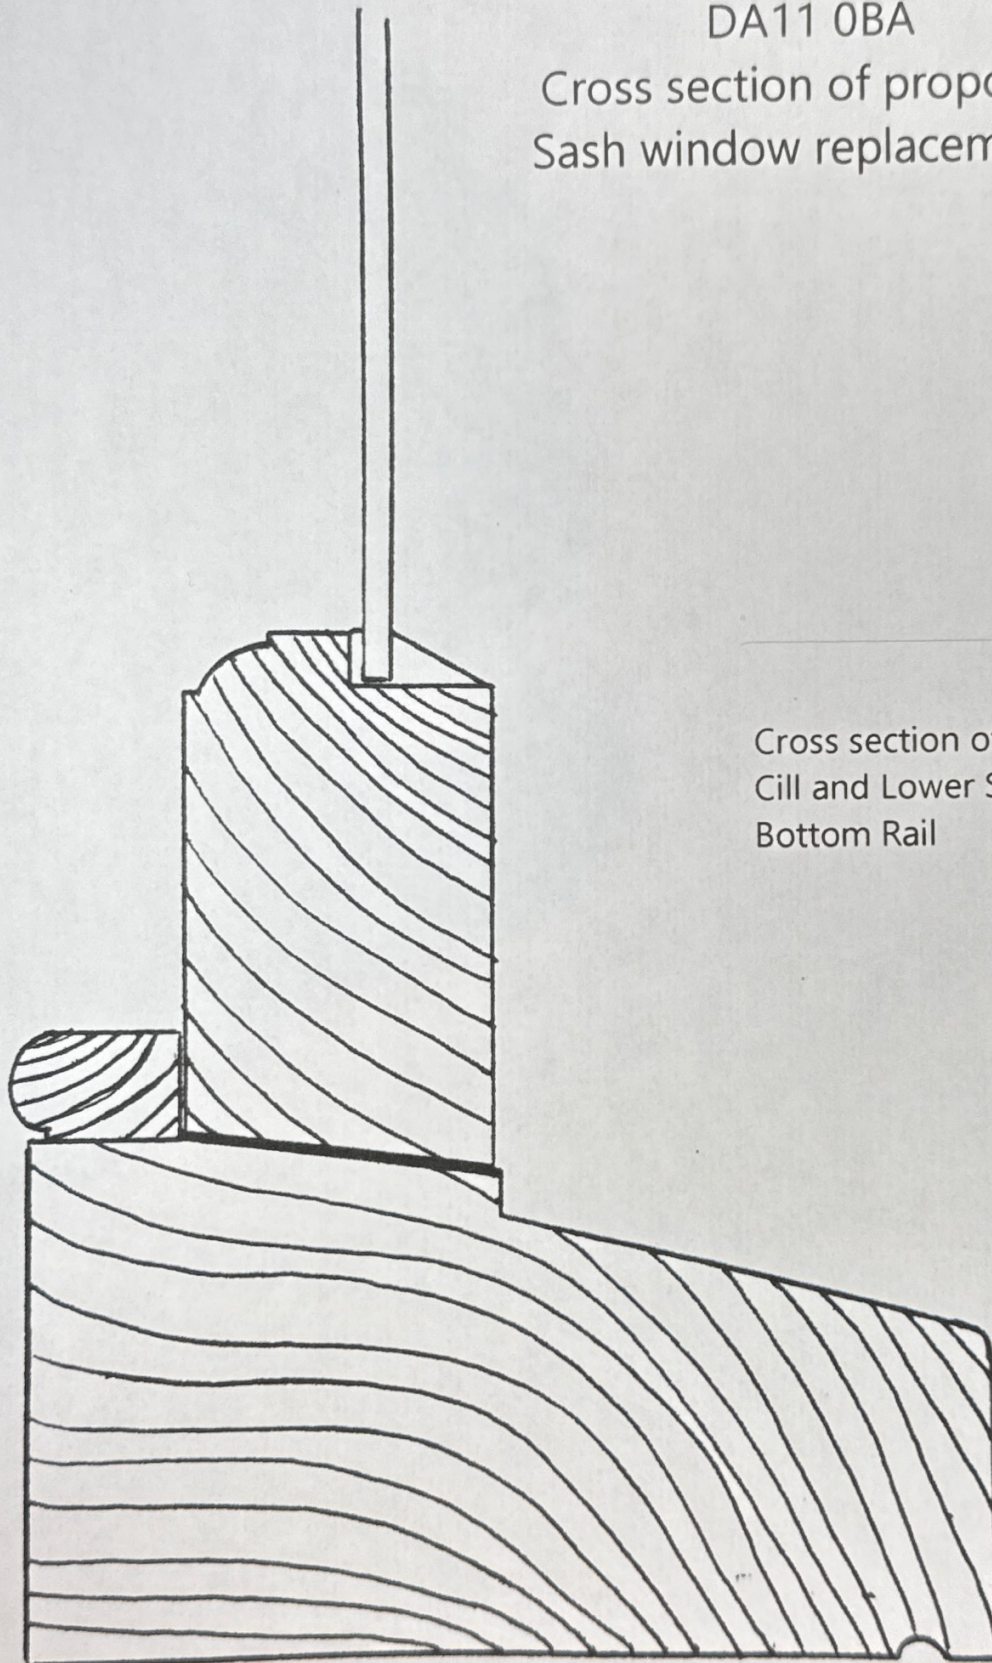
Cross section of Box Frame  
Cill and Lower Sash  
Bottom Rail

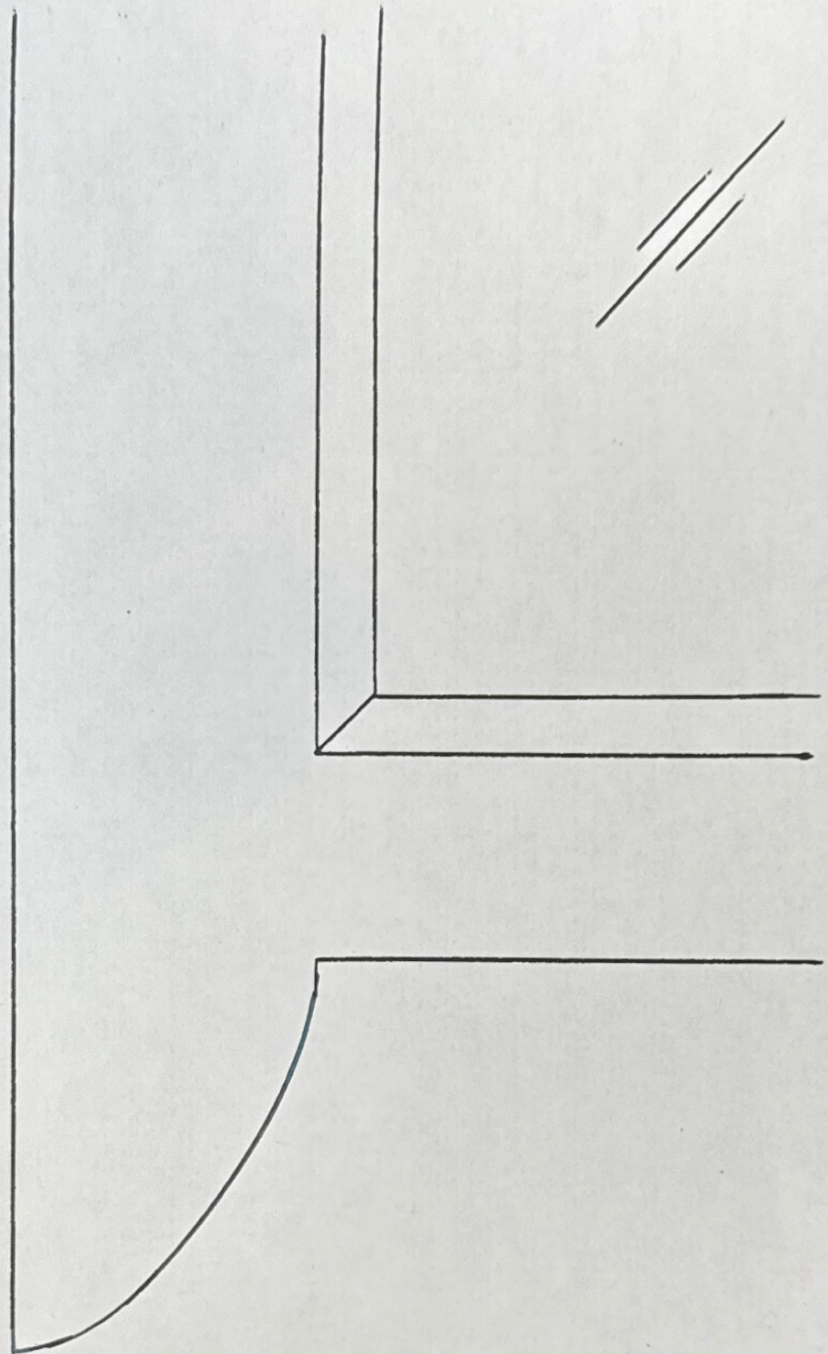
Sash Horn detail of proposed  
Sash window replacements
