# DESKTOP STUDY REPORT

| Site Address: | Brimsole Barn, Brimstone Hill, Meopham, Gravesend, Kent DA13 0BN |
| Project No.: | 19458 |

## PRELIMINARY RISK ASSESSMENT – DESKTOP STUDY - PHASE 1 REPORT

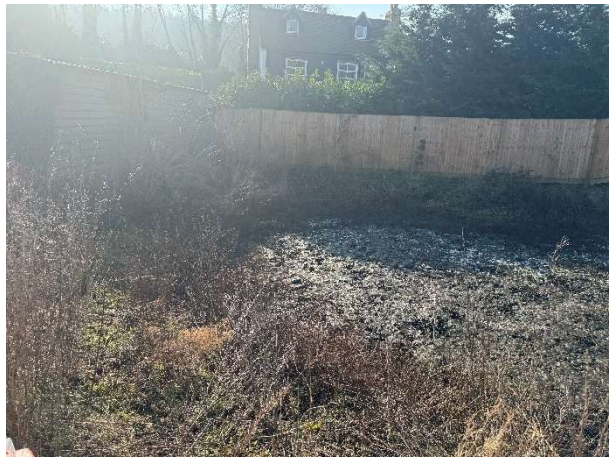
**Print 8** View of historic pond

The pond area was overgrown with weeds and wild grasses with the pond recorded as infilled with a slurry infill, (likely muds and organic material).

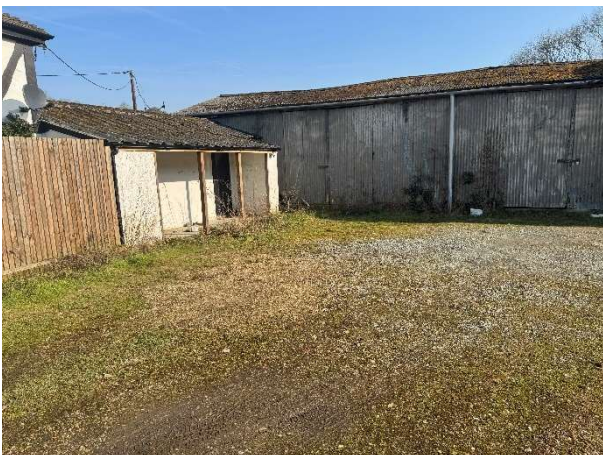
**Print 11** View of rear barns

Possible Asbestos containing materials were reviewed on the roof and clad walls of the building towards the rear of the site area, the sheeting looked to be intact and in a good state of repair, suggesting that there is limited risk of this forming a risk of fragment being in place within the soils. From the walk over no obvious fragments were seen in place. We recommend that an asbestos survey of the building be carried out, if not done so already, prior to any further demolition or works on site. A full assessment for asbestos within the fill in site will be required to fully consider risk from Asbestos.
