**REMEDiation STRATEGY  
FOR  
FORMER BATTLE OF BRITAIN  
SITE, COLDHARBOUR ROAD,  
NORTHFLEET**

| <b>Report Title:</b> | Remediation Strategy for Former Battle of Britain Site, Coldharbour Road, Northfleet |
| <b>Report Number:</b> | AG3571A-25-AU83 |

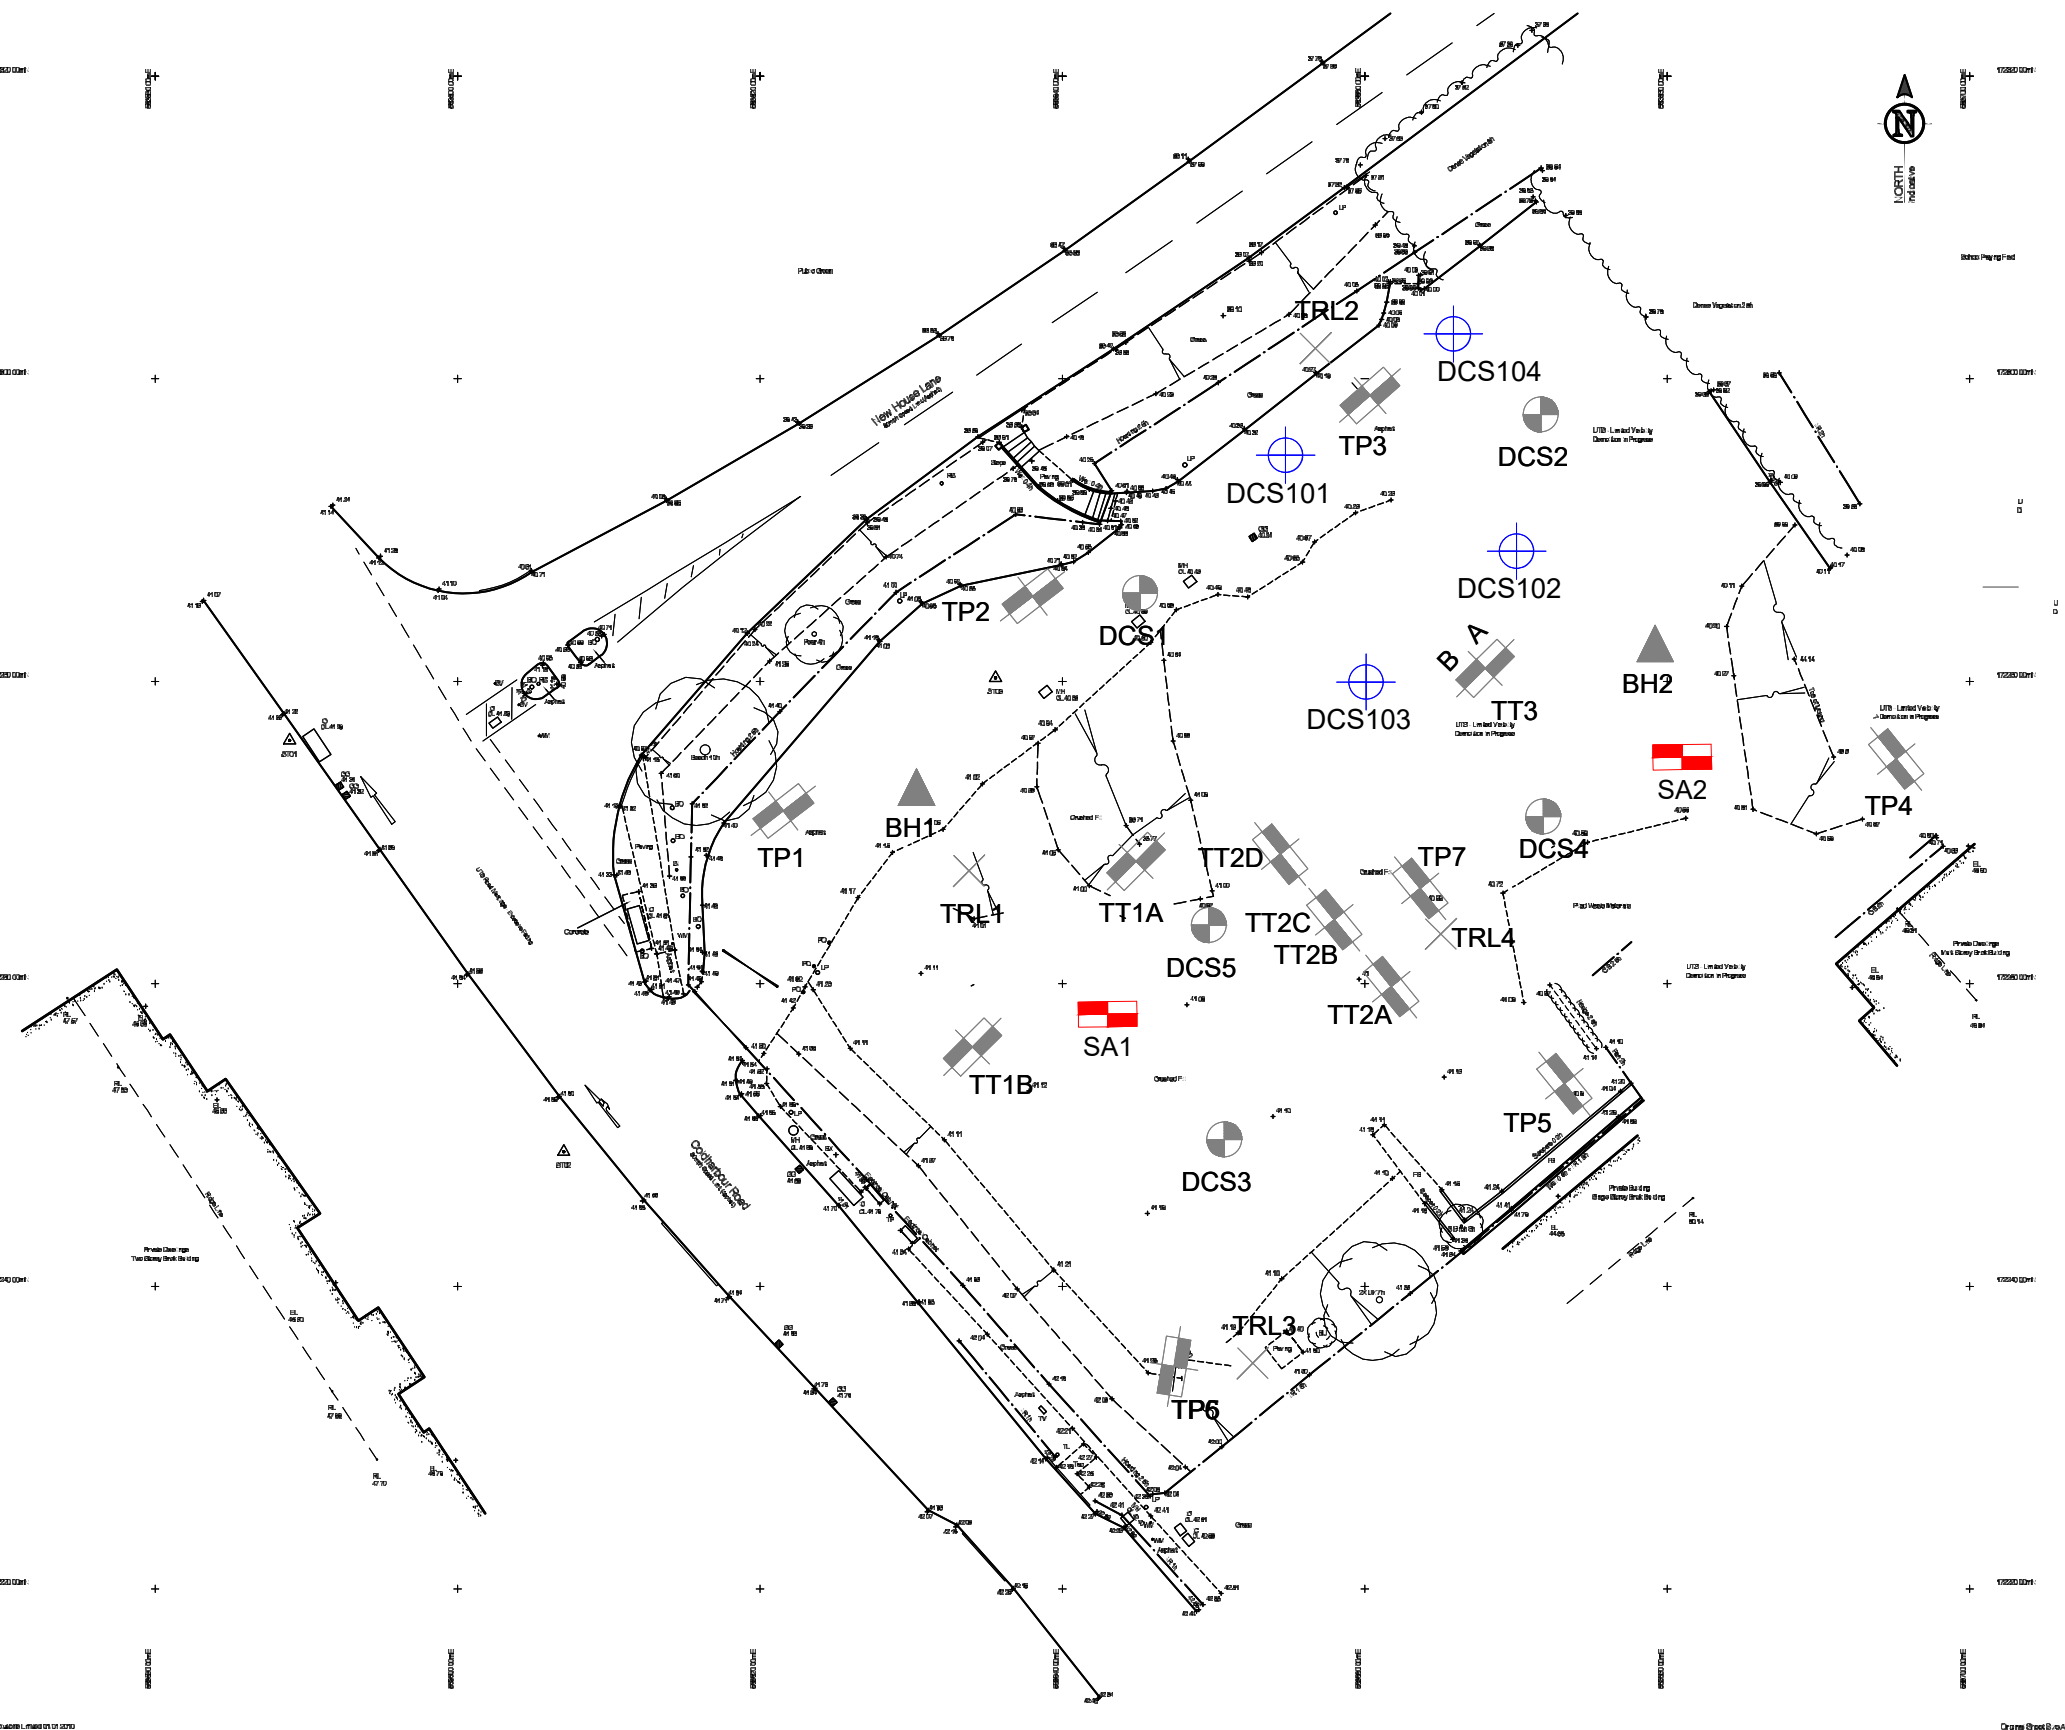
| AG3571-23-02 | | 0 |

Key:

Investigation by Applied Geology 2024:

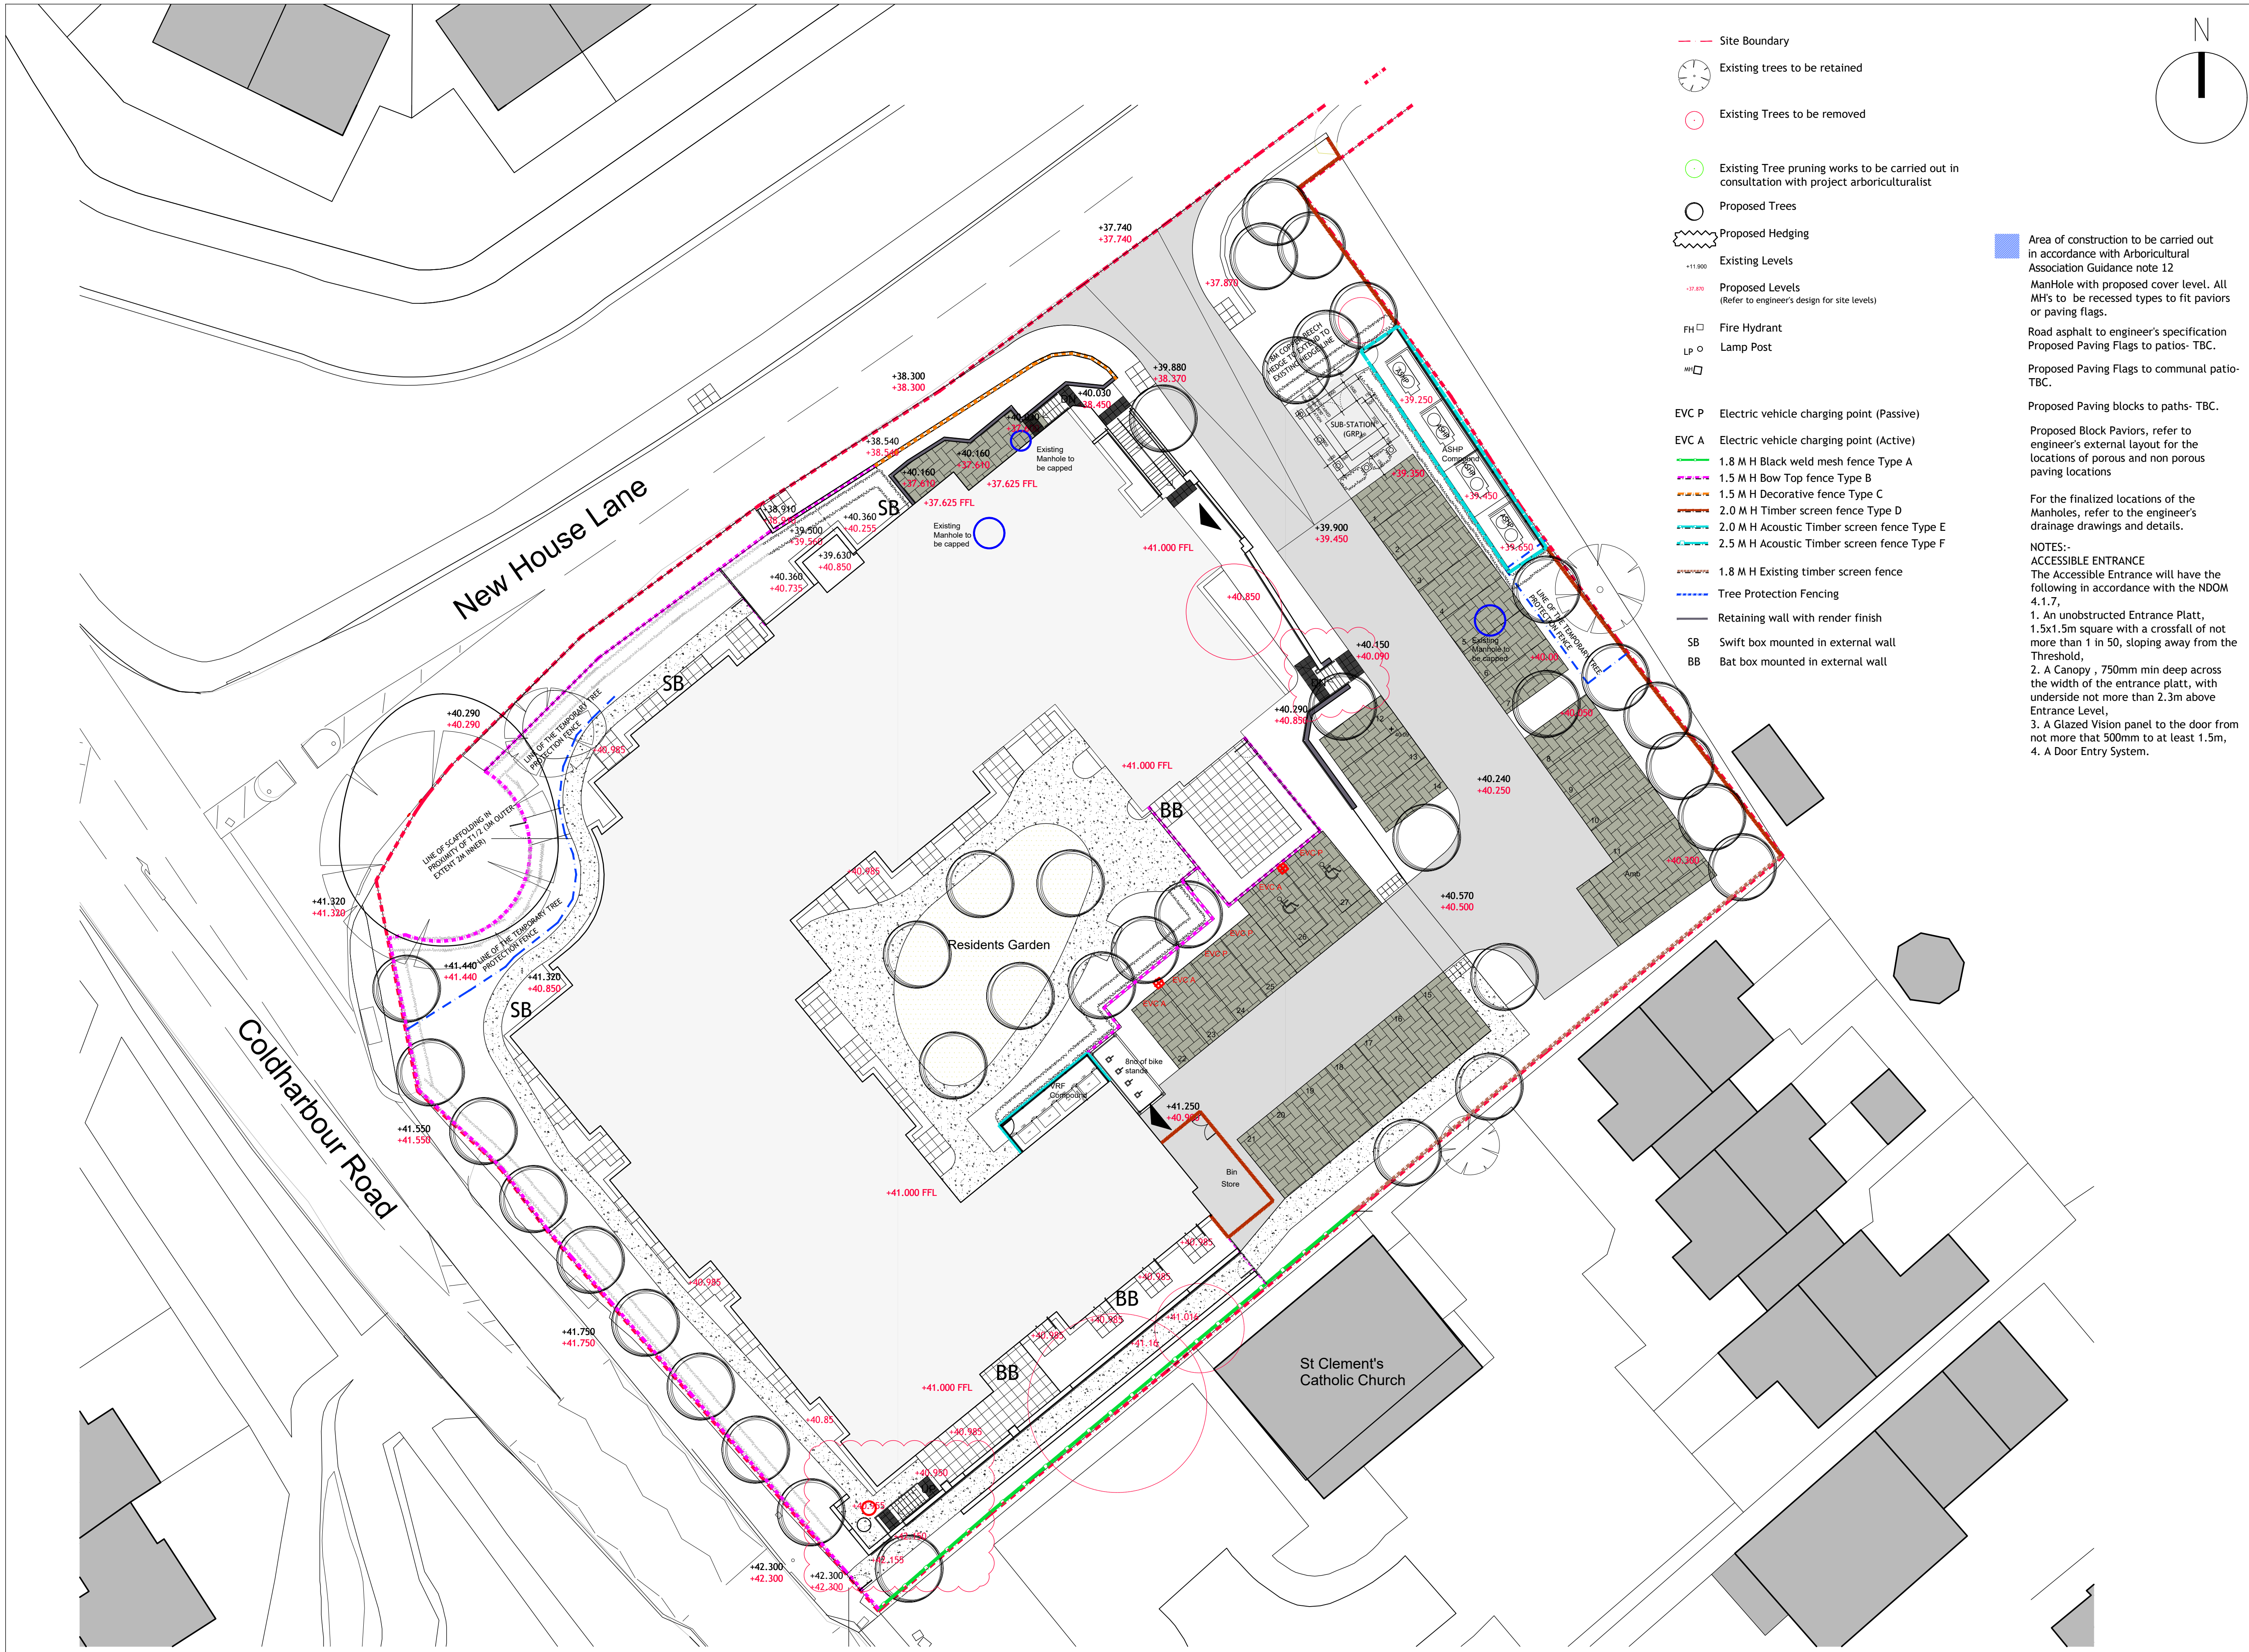
- Site Boundary
- Existing trees to be retained
- Existing Trees to be removed
- Existing Tree pruning works to be carried out in consultation with project arboriculturalist
- Proposed Trees
- Proposed Hedging
- Existing Levels
- Proposed Levels (Refer to engineer's design for site levels)
- Fire Hydrant
- Lamp Post
- EVC P Electric vehicle charging point (Passive)
- EVC A Electric vehicle charging point (Active)
  - 1.8 M H Black weld mesh fence Type A
  - 1.5 M H Bow Top fence Type B
  - 1.5 M H Decorative fence Type C
  - 2.0 M H Timber screen fence Type D
  - 2.0 M H Acoustic Timber screen fence Type E
  - 2.5 M H Acoustic Timber screen fence Type F
- 1.8 M H Existing timber screen fence
- Tree Protection Fencing
- Retaining wall with render finish
- SB Swift box mounted in external wall
- BB Bat box mounted in external wall

The Accessible Entrance will have the following in accordance with the NDM 4.1.7,

1. An unobstructed Entrance Platt, 1.5x1.5m square with a crossfall of not more than 1 in 50, sloping away from the Threshold,
2. A Canopy , 750mm min deep across the width of the entrance platt, with underside not more than 2.3m above Entrance Level,
3. A Glazed Vision panel to the door from not more that 500mm to at least 1.5m,
4. A Door Entry System.
