**McCARTHY & STONE RETIREMENT LIFESTYLES LIMITED**

**GRFC BOWLS CLUB, CHURCH WALK, GRAVESEND, KENT, DA12 2TU**

**DESK STUDY APPRAISAL**

February 2022  
Report No. CCL03525.CP31

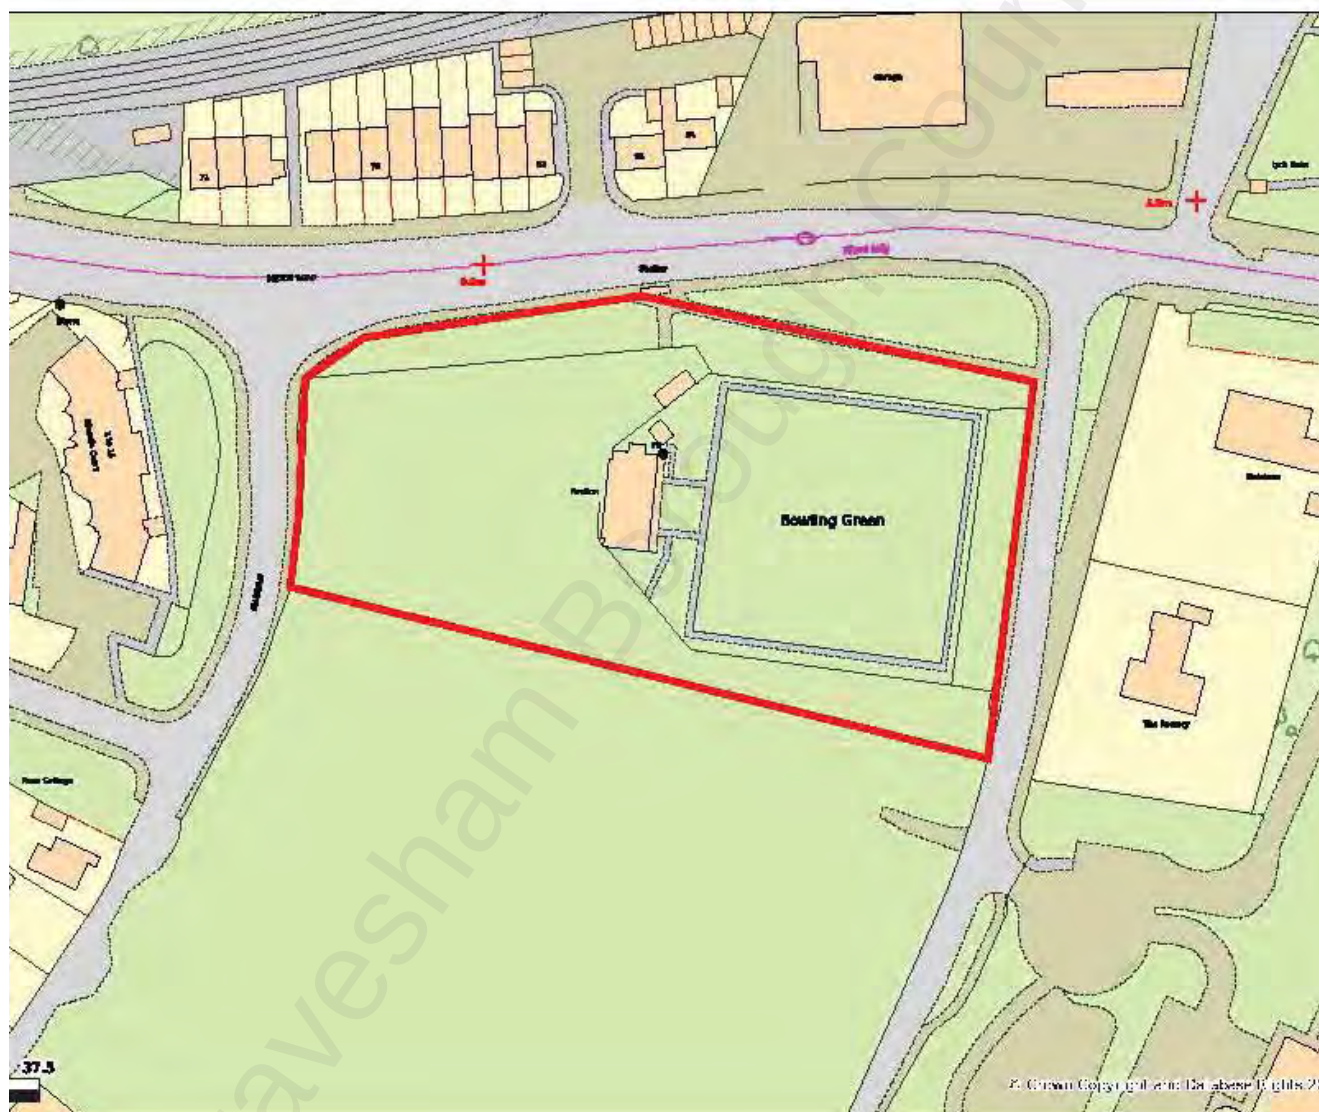
FIGURE 2

**SITE PLAN**

The site is located adjacent to Church Walk, approximately 0.9 km to southeast of Gravesend town centre, as shown on Figure 1. The National Grid Reference for the site is TQ 6572 7378. The site is bounded by Milton Road to the north, Church Walk to the east, a road identified as Ellerslie on the western boundary and sports ground playing fields on the southern boundary, as shown on Figure 2.

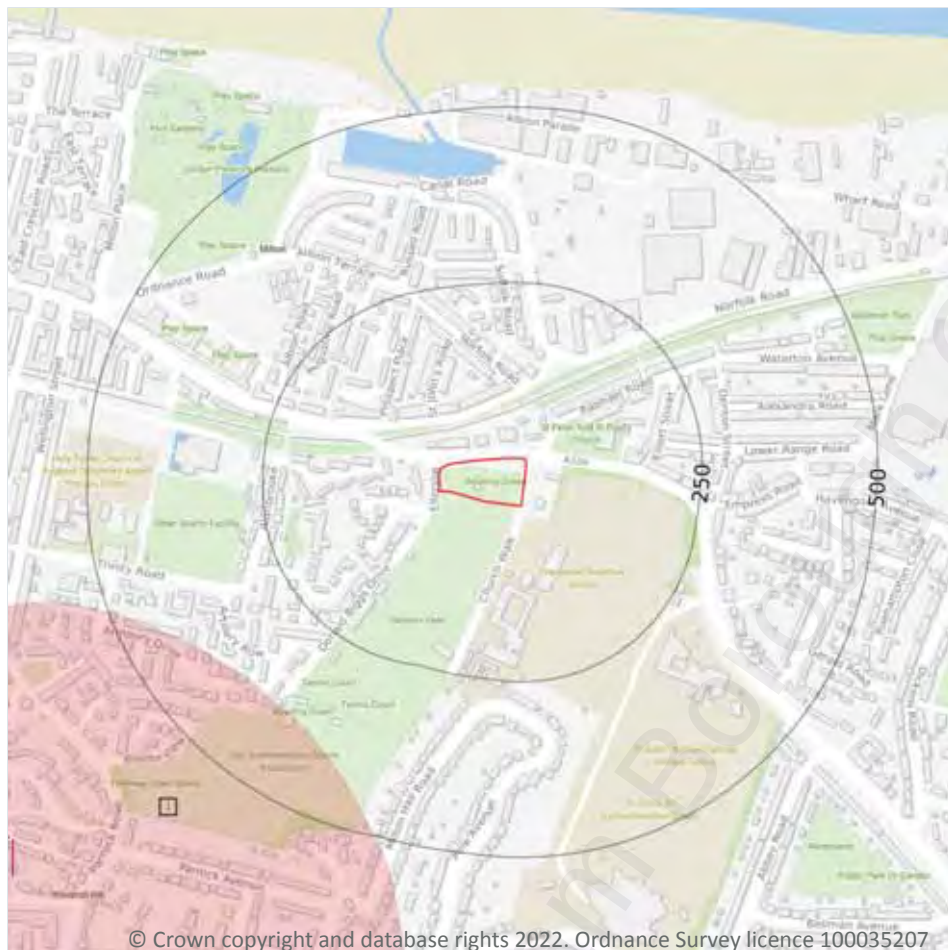
## Abstractions and Source Protection Zones

- Site Outline
- Search buffers in metres (m)
- Source Protection Zone 1  
Inner catchment
- Source Protection Zone 2  
Outer catchment
- Source Protection Zone 3  
Total catchment
- Source Protection Zone 4  
Zone of Special Interest
- Source Protection Zone 1c  
Inner catchment - confined aquifer
- Source Protection Zone 2c  
Outer catchment - confined aquifer
- Source Protection Zone 3c  
Total catchment - confined aquifer
- Drinking water abstraction licences  
Polygon features
- Drinking water abstraction licences  
Linear features
- Groundwater abstraction licence (point)
- Groundwater abstraction licence (area)
- Groundwater abstraction licence (linear)
- Surface Water Abstractions (point)
- Surface Water Abstractions (area)
- Surface Water Abstractions (linear)

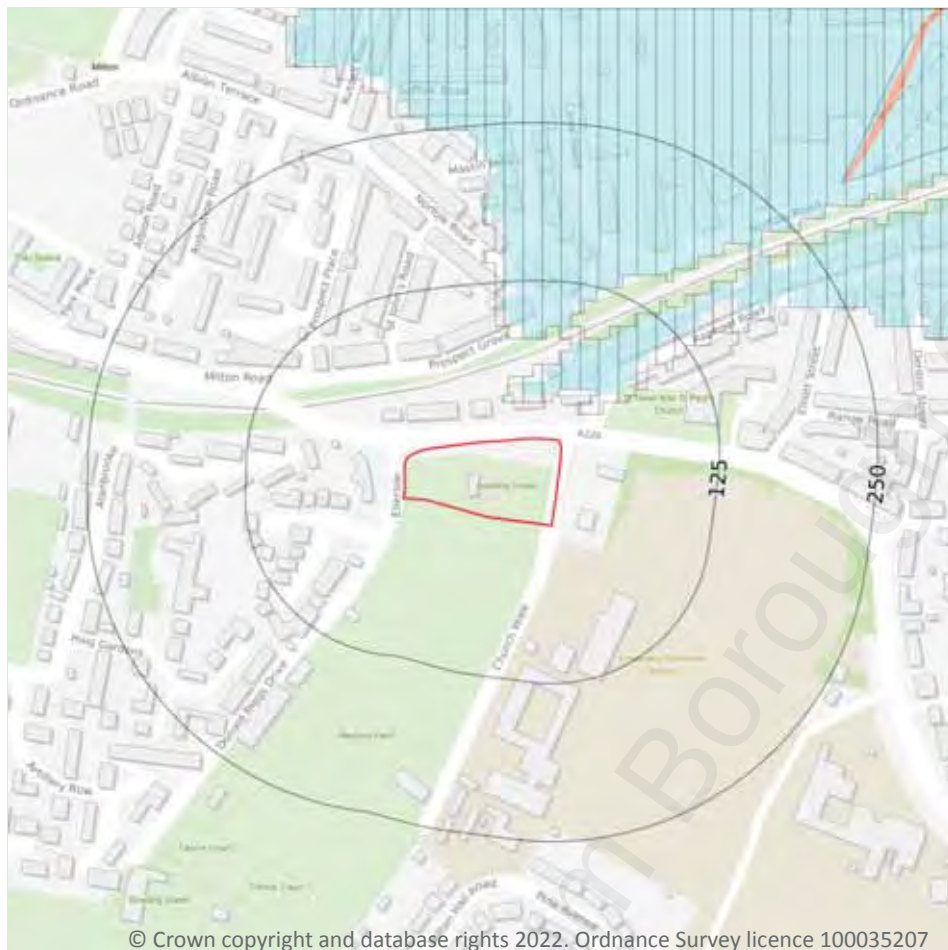
## 7 River and coastal flooding

- Site Outline
- Search buffers in metres (m)
- River and coastal flooding:
- High
- Medium
- Low
- Very Low
- Historical Flood Events
- Areas Used for Flood Storage
- Areas Benefiting from Flood Defences
- Flood Defences

Features are displayed on the River and coastal flooding map on **page 75**

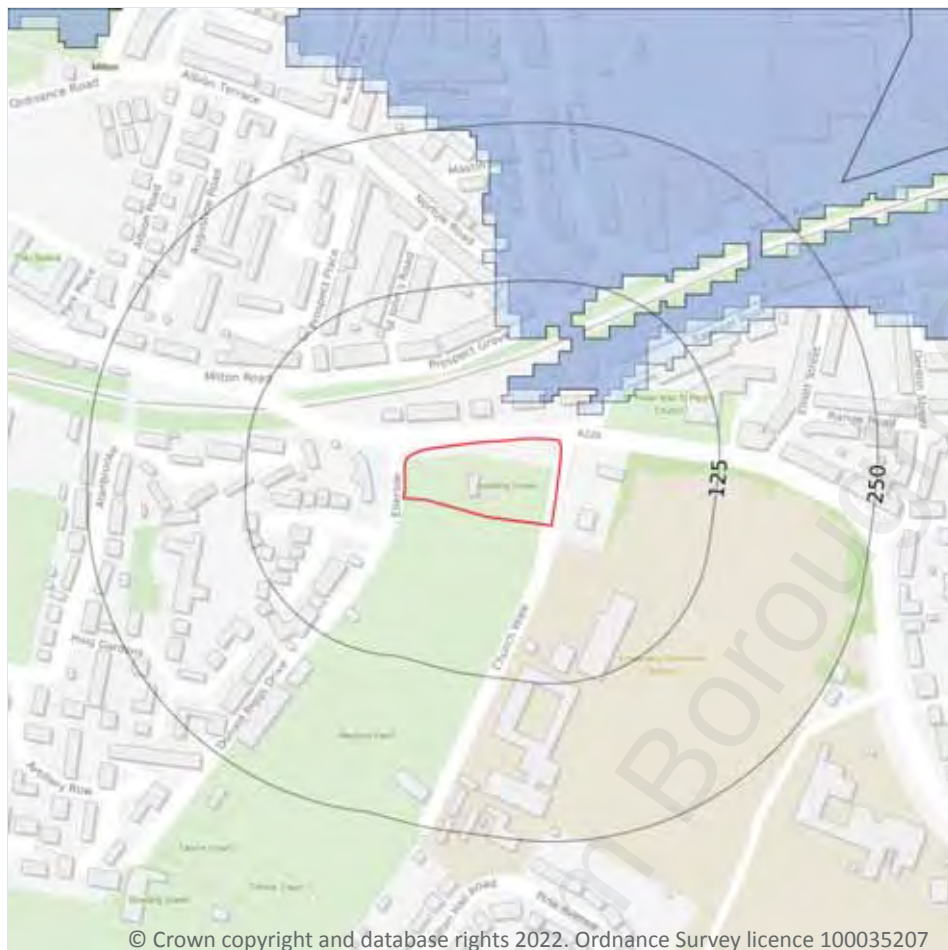
## River and coastal flooding - Flood Zones

- Site Outline
- Search buffers in metres (m)
- Flood zone 2
- Flood zone 3

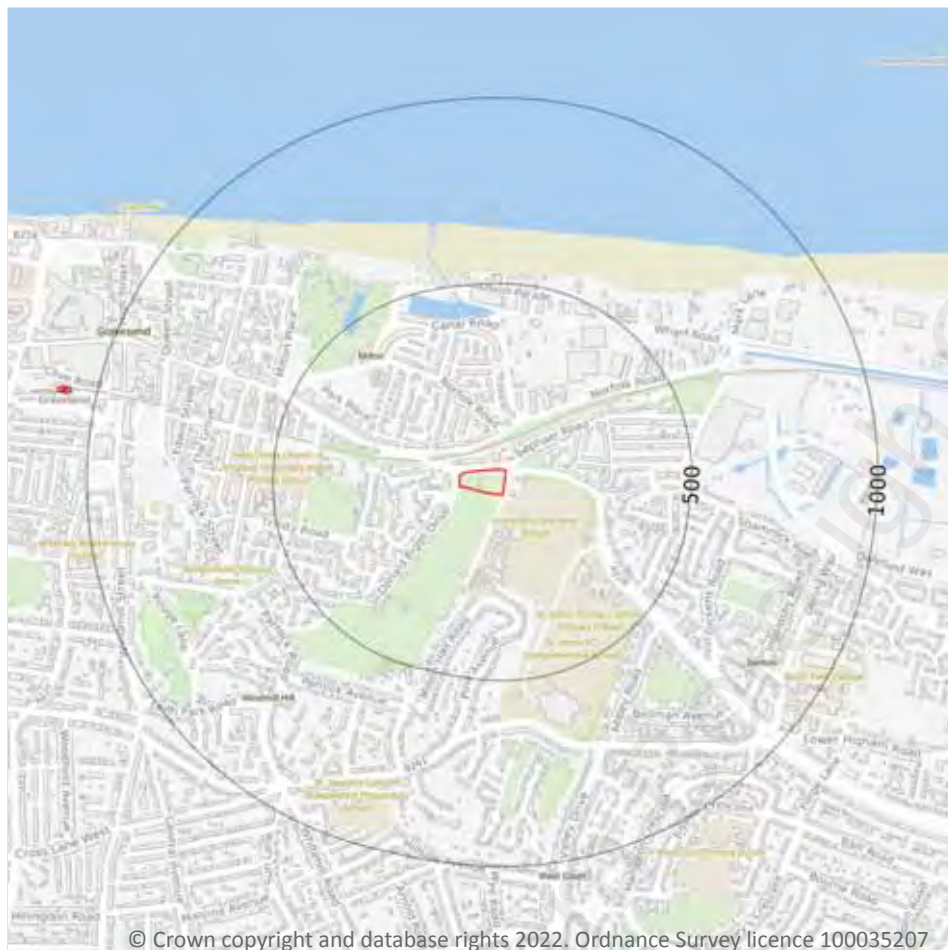
## 10 Environmental designations

- Site Outline
- Search buffers in metres (m)
- Sites of Special Scientific Interest (SSSI)
- X Conserved wetland sites (Ramsar sites)
- Green Belt

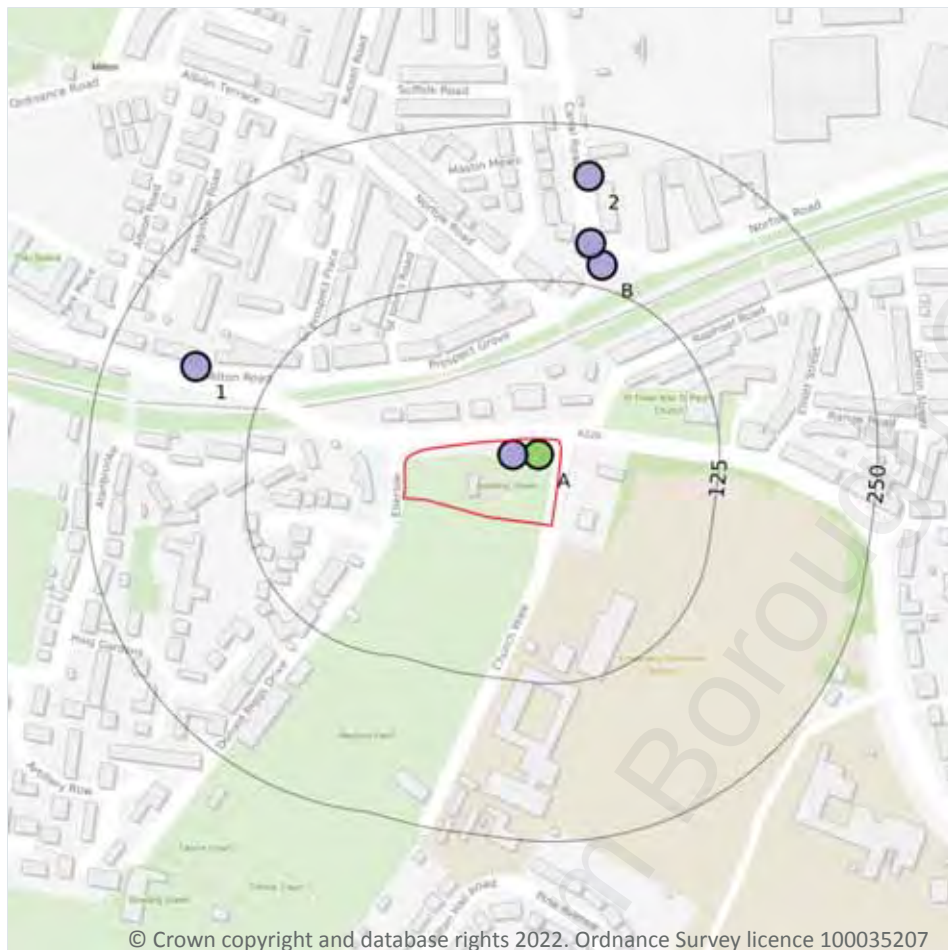
## 16 Boreholes

— Site Outline  
Search buffers in metres (m)

- Confidential
- 0 - 10m
- 10 - 30m
- 30m+
- Unknown

Borehole records from the BGS show that two boreholes were sunk immediately north of the site. The records indicate that ground conditions comprise approximately 2.0 m to 3.5 m of superficial Head Deposits, consisting of silty clay/clayey silt/silty sand overlying chalk. Groundwater was present at 4.8 m depth.
