195 Parrock Street

Gravesend,  
Kent  
DA12 1ER

DESIGN & ACCESS  
AND  
HERITAGE STATEMENT  
Dec 2025

*‘Interior works to form 4 self contained flats over 5 floors, including replacing front and rear windows with gates to form an internal through passage; minor adjustments to internal arrangements; associated services; new doors and windows; rear light well expansion; works to flat roof including new AOV smoke vent; new boundary, light well and Juliet balcony railings; new cycle store and refuse siting location and associated landscaping’*

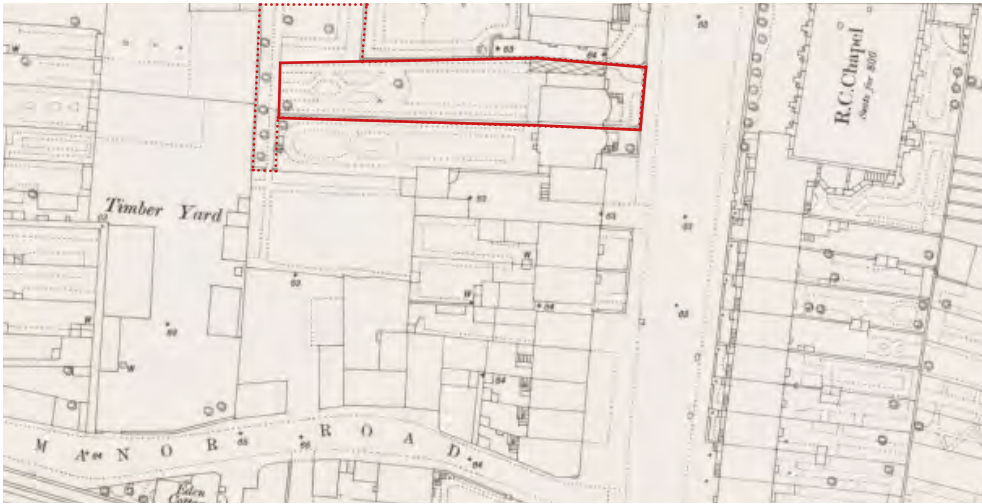
OS Map dated 1866

- Mirroring side wing to no. 196 assumed under pitched slate roof
- North wing extension apparent, elongated to west - hatch denotes under glass roof, hence assumed single storey.

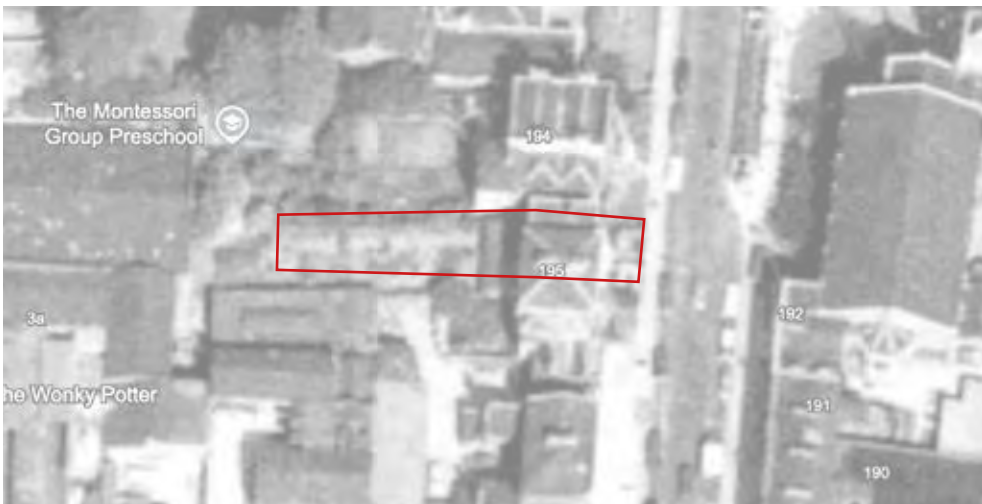
1907

- Additional single storey flat roof extension to the rear
- Part glass roof replaced with flat roof denoting the glass roof of the late 19th century removed and the 3 storey north wing 3 flat roof extension evident
- Chimney within flat roof

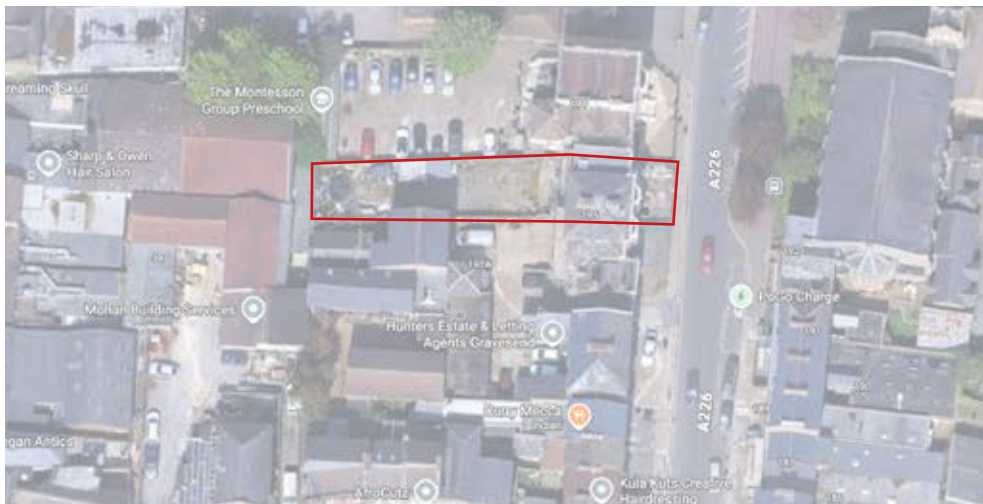
Map dated 2025

- Redundant use - no cars in yard
- Roof light over flat roof relocated
- Chimney to flat roof removed

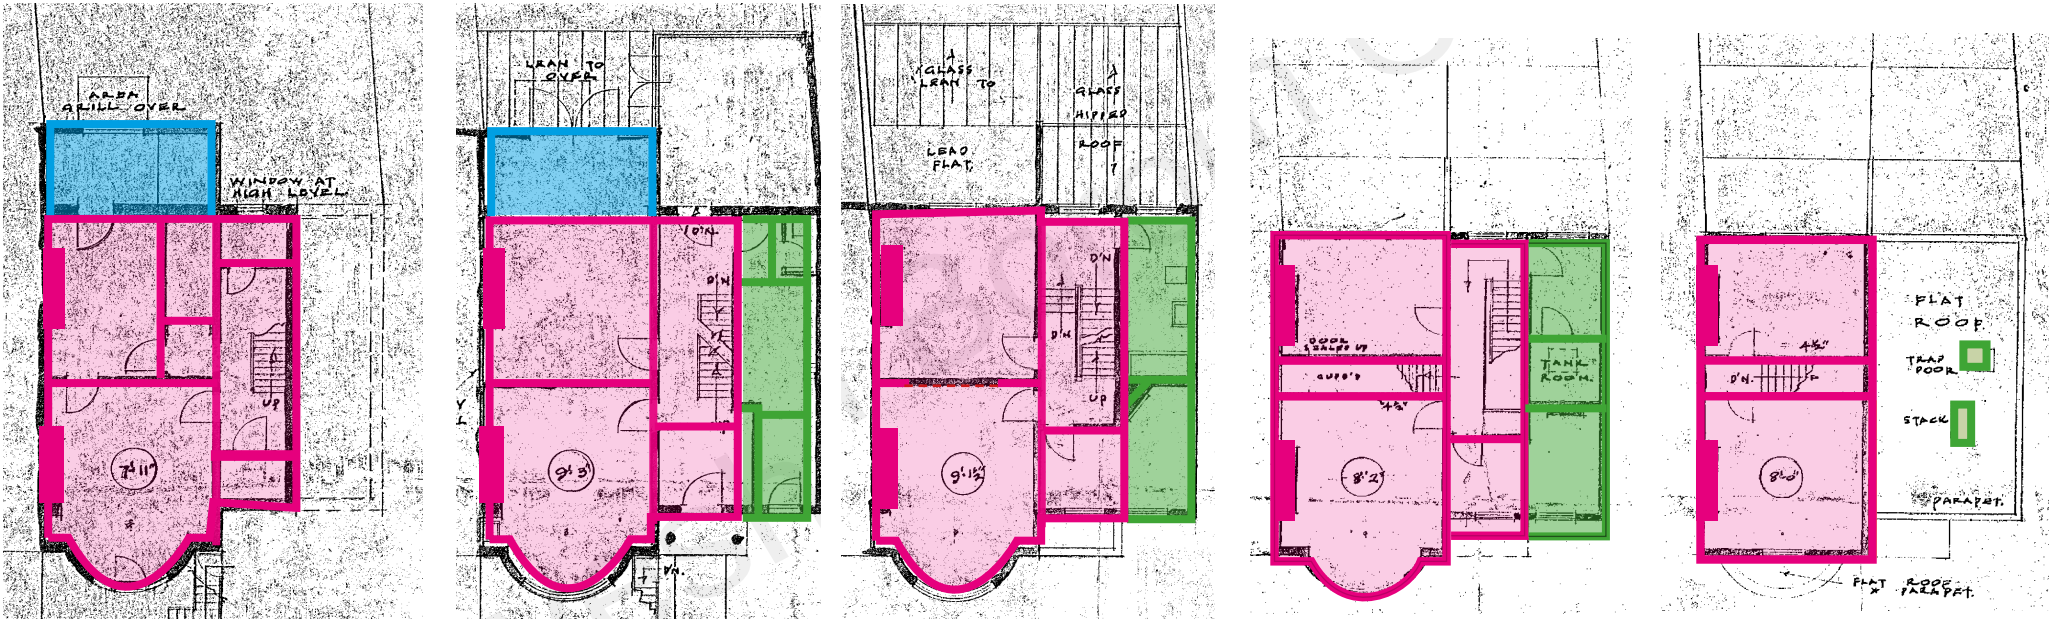
1966 Pre dental use

- Evidence of
- Original 5 storey plan form evident to all floors:
    - front and rear reception rooms to all floors, fireplaces within each
    - front bay to basement, ground, first and second floors

- centrally located stairwell from basement to second floor under lower slate pitched wing (evidenced later from drone footage) and associated circulation

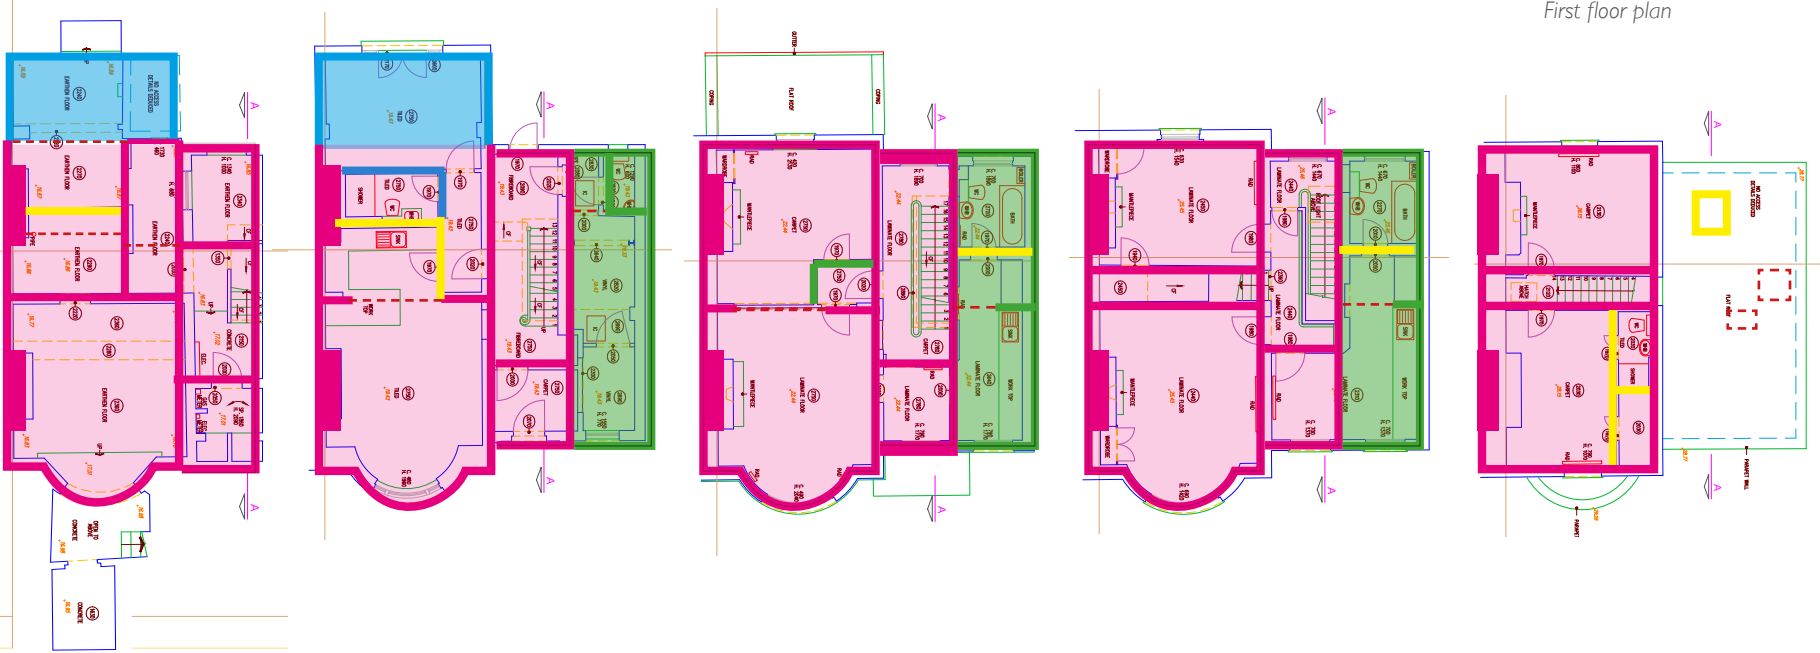
2025 As Existing Survey

- Evidence of
- Original front and rear reception room plan form to all floors
  - Removal of dividing wall to ground and first floors, to form arch
  - Door infill's
  - Fitted cupboards retained
  - Plasterboard application throughout basement, severing windows
  - Meter cupboard in basement corridor
  - Hoist (lift) between basement and ground floors
  - New partition divisions
  - Angular chimney in later north wing
  - Wc divisions to first and second floors in later north wing
  - Trap door in later north wing flat roof

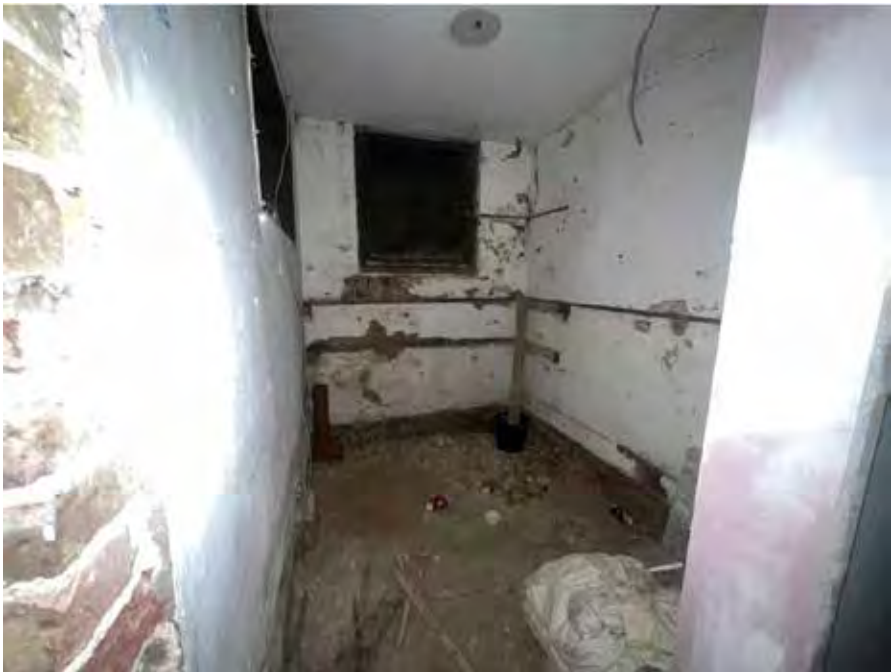
View A - No. 195 existing basement smaller light well window and interior side wall window- evidence of aborted works

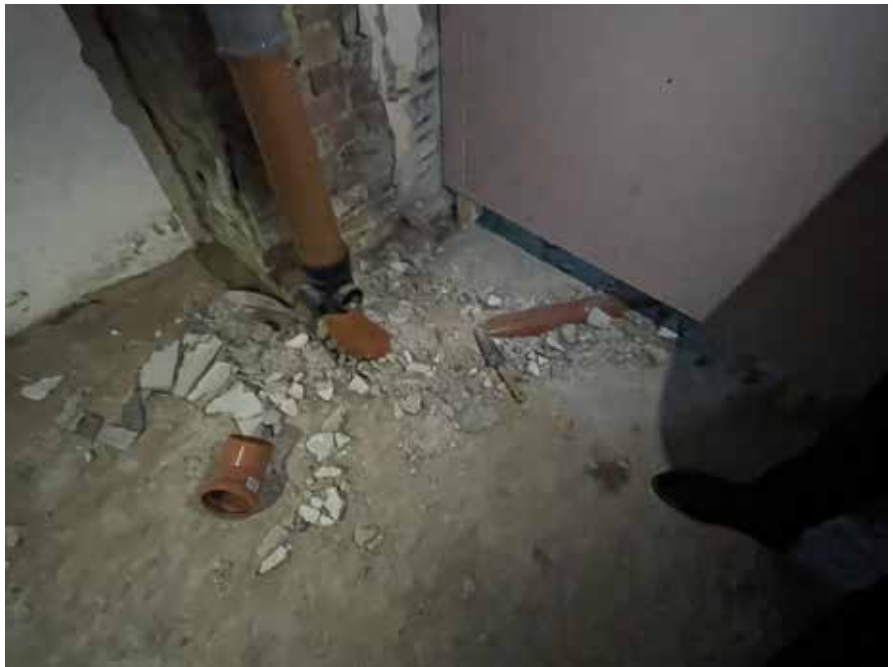
View C - Basement finished floor depicting new waste run and SVP

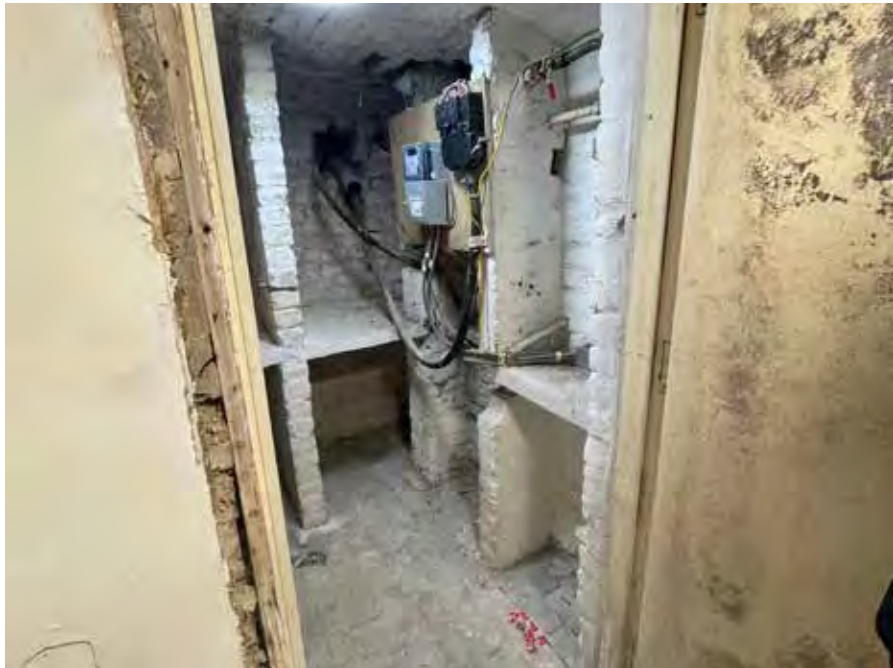
View B - No. 195 existing basement services cup. Noteworthy brick barrel ceiling, brick floor and divisions intact

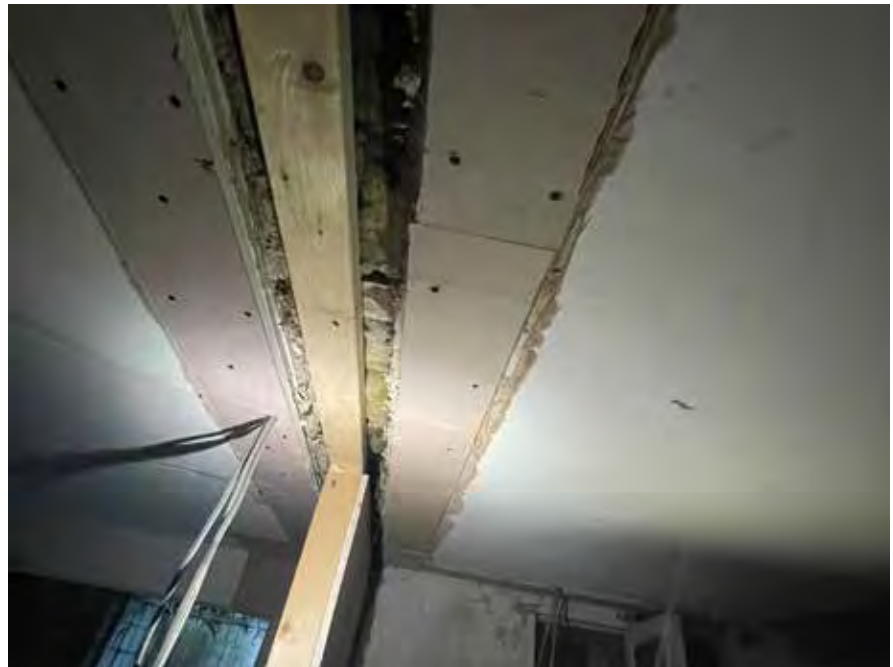
View D - No. 195 Basement partitions being installed prior to aborted work. Evidence of construction methods, timber stud, fire rated gypsum plasterboard,

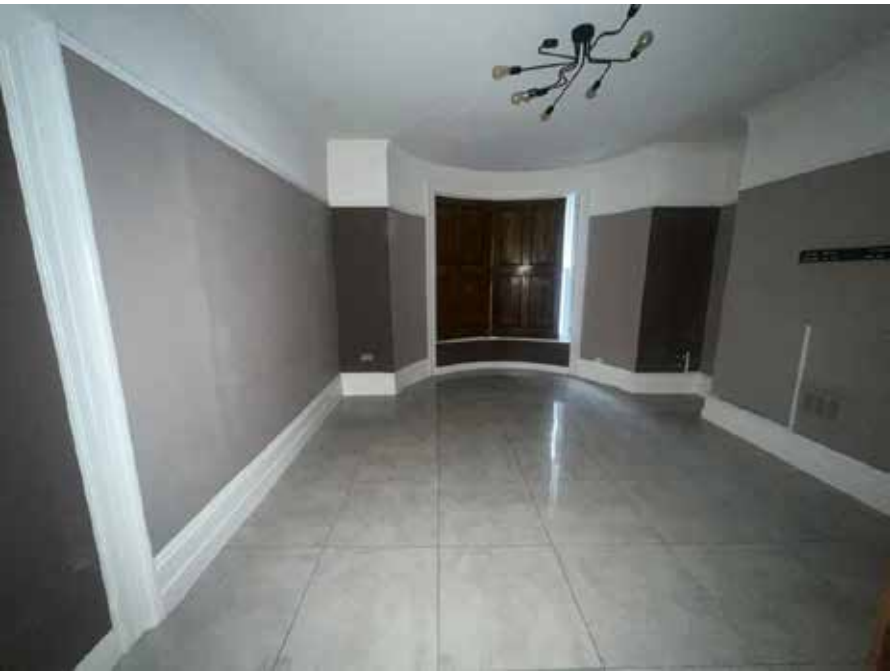
View A - No. 195 ground floor interior front living room looking east toward front bow window.. Note ceramic tiled floor. Evidence of architrave, skirting, cornice and dado intact.

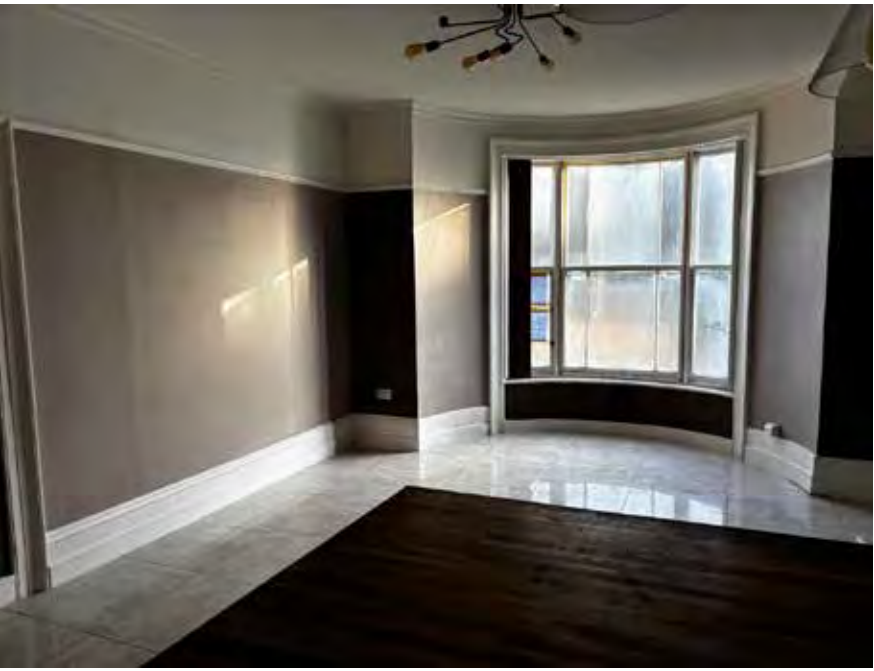
View B - ground floor interior front living room looking north toward front bow window.. Noteworthy - shutters recess sliders working

Historic skirting, architraves, fireplaces, dado rails, windows, shutters and doors all appear in tact. Shadow gaps have been formed where new partitions formed.

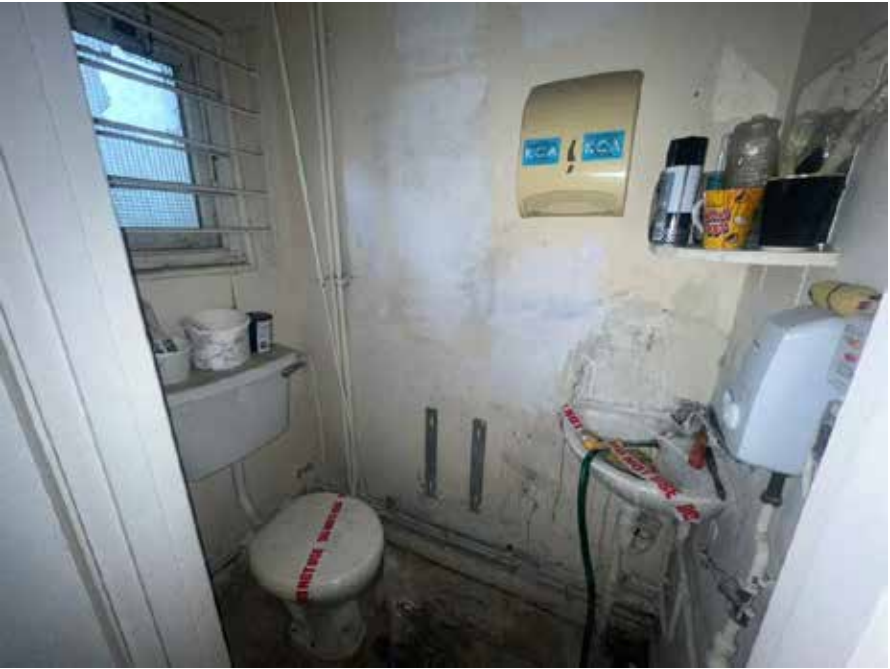
View E - existing basement WC - works appear not to have commenced  
Drawing not to scale - for publication purposes only

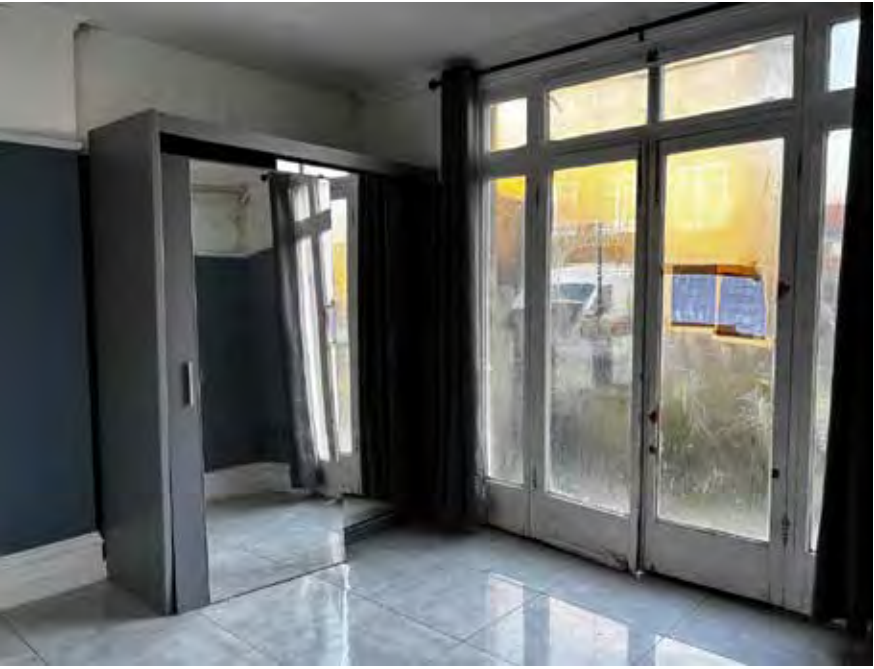
View D - No. 195 ground floor interior - rear bedroom looking west toward French doors  
French doors and side and top lights appear as existing not replaced

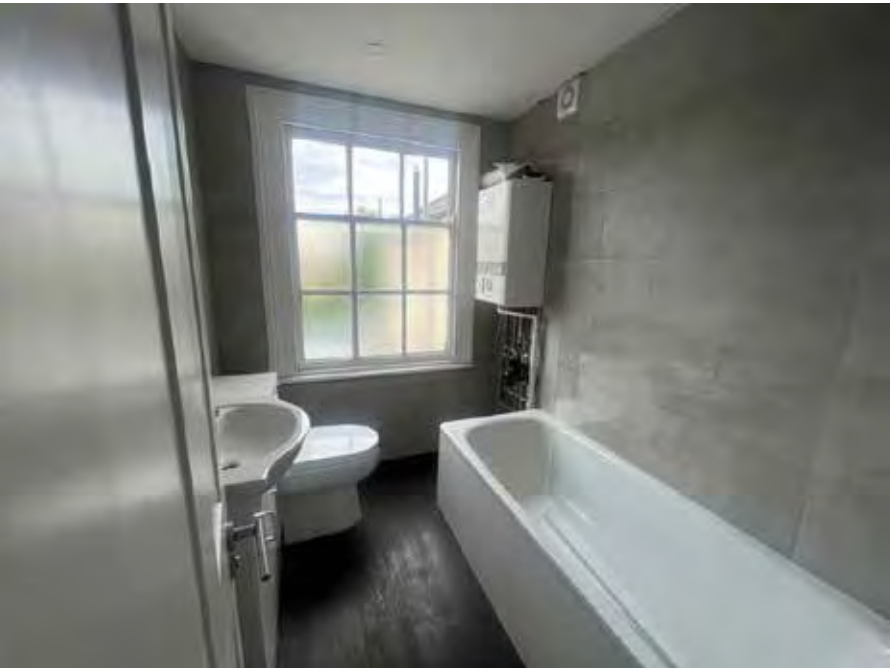
View A - bathroom interior rear looking west toward rear sash opaque glass window.  
Noteworthy - window and frame in tack.

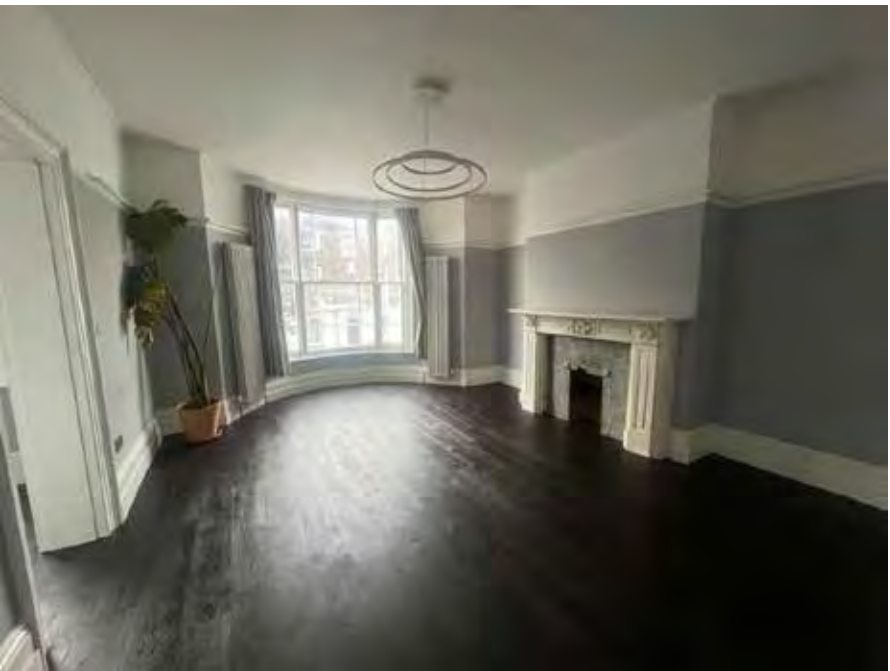
View D - Front living room looking east toward bow window  
Noteworthy - window, architrave, picture rail and skirting in tack.  
Drawing not to scale - for publication purposes only

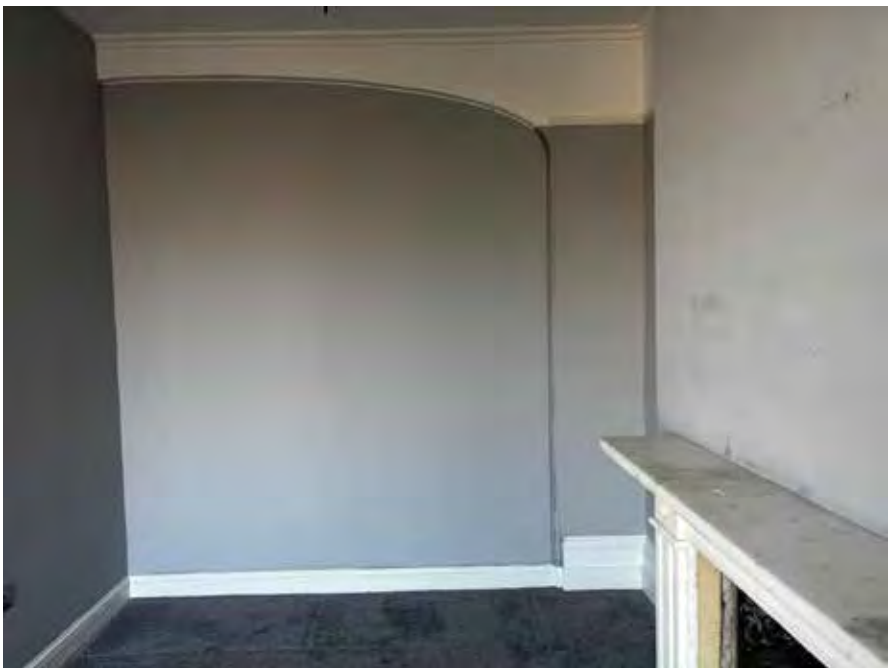
View B - Front living room interior looking west toward arch  
Noteworthy - arch in tack. Panel infill provides shadow gap

The central wall dividing the front and rear reception rooms was opened up when used as a bank, an arch formed over. In conjunction with Section 73 approvals, the arch has been in filled. Historic skirting, architraves, fireplaces, dado rails and doors appear in tact. Shadow gaps have been formed at new partitions. Cornices remain around the perimeter of a new ceiling application.

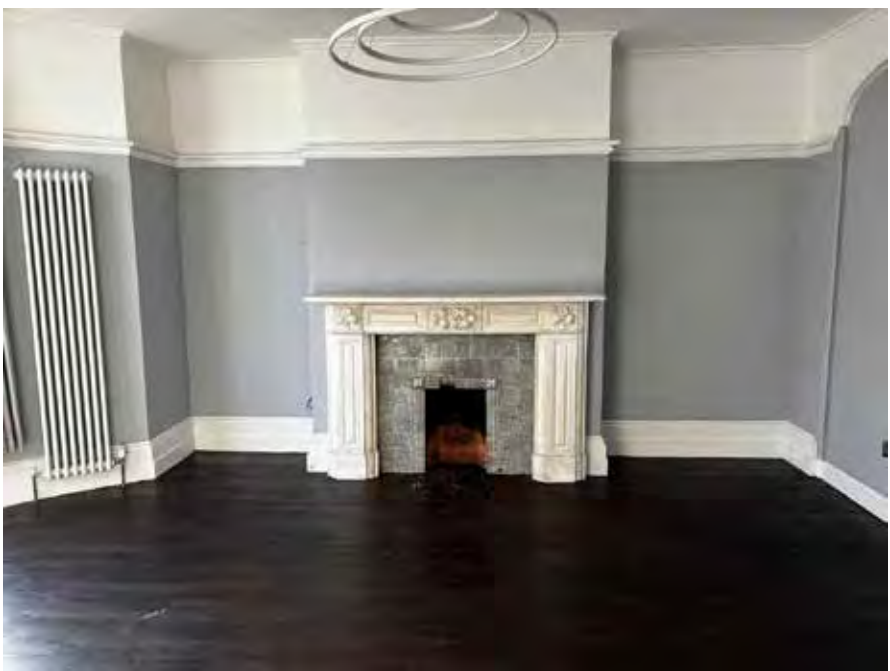
View E - Front living room looking south toward fireplace  
Noteworthy - fireplace, mantel, and tiles in tack.

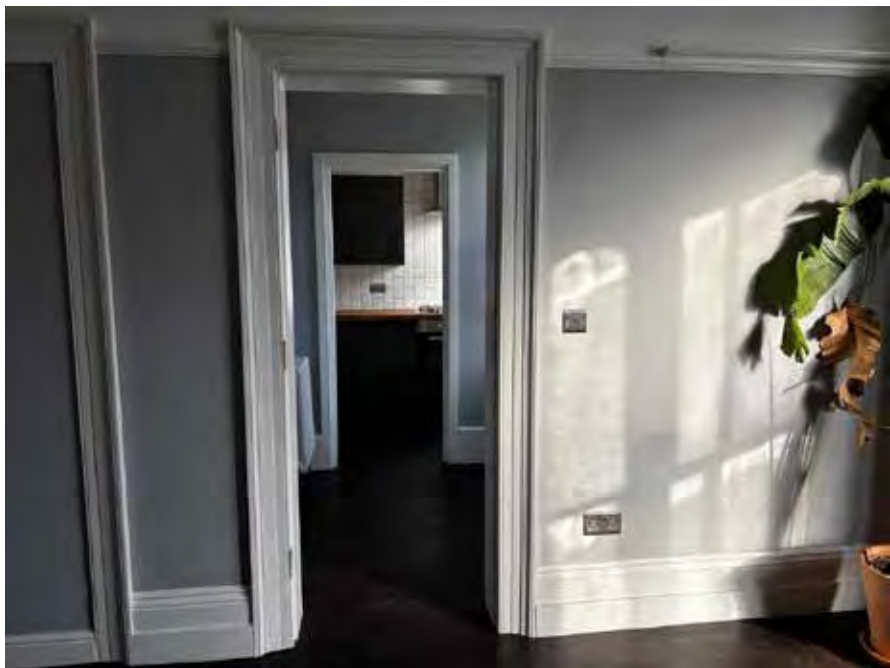
No. 195 second floor interior lobby - mid unit looking east.  
Noteworthy: architrave and skirting intact

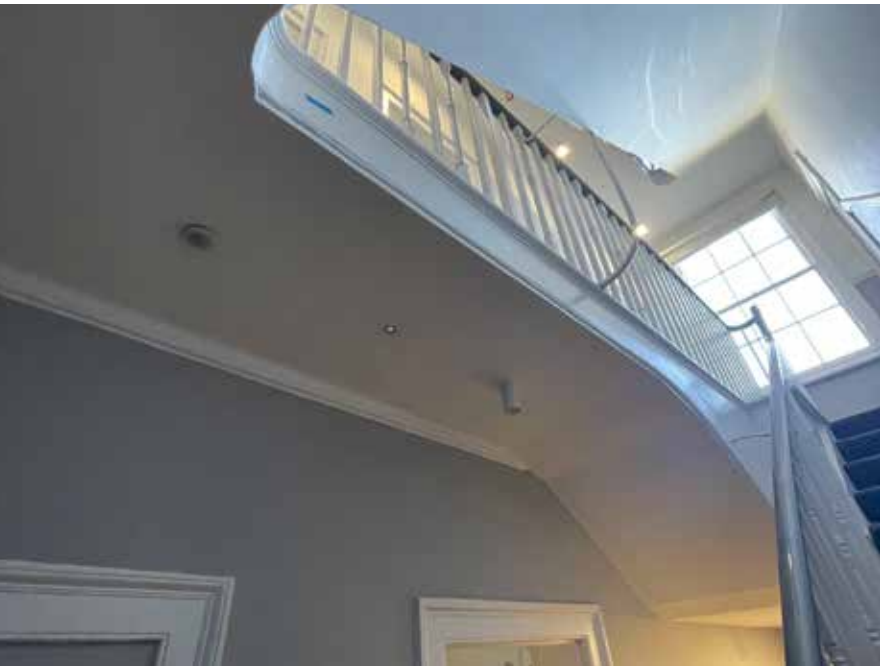
No. 195 GF to 1F  
Noteworthy: spindles, timber stringer and banister in tact. Historic architraves and coving in tact. Evidence of smoke alarms and lighting installed.

Smoke alarms and spot lights are apparent, in accordance with NICEIC confident installer certification as logged with STG local authority building control.

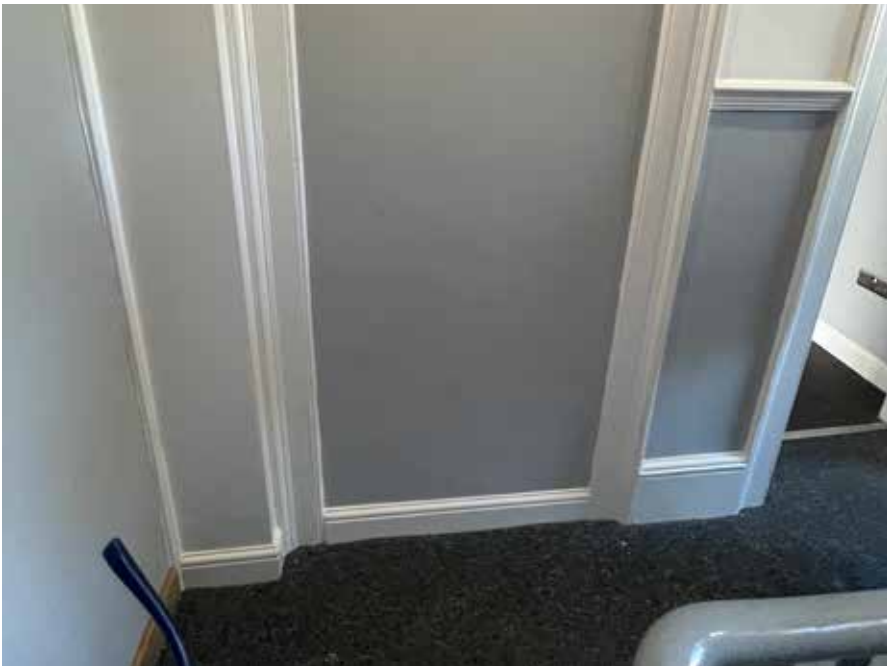
No. 195 Previous staff WC access door infill  
Noteworthy: all architrave appears intact. New skirting depicted to match existing.

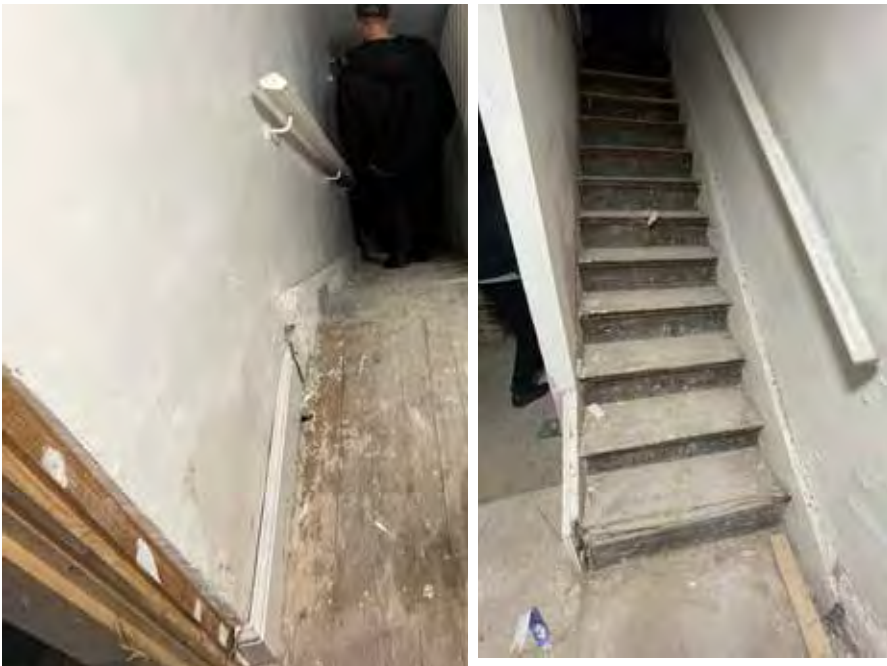
No. 195 GF to LGF  
Noteworthy: floorboards in tack. Evidence of new skirting and architrave being formed to previously utilised GF WC (proposed to provide inner access to passageway in JCA scheme)

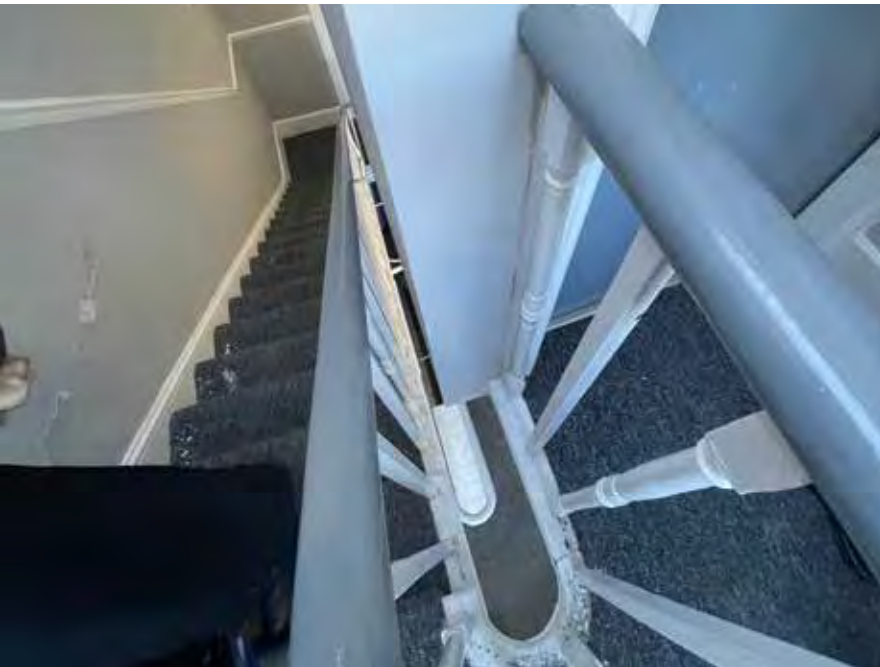
No. 195 1f to 2f stairwell  
Noteworthy: solid partition infill (noted as glazed in Section 73 drawings)  
Drawing not to scale - for publication purposes only

The 2nd floor partition has been formed as a fire rated solid partition, contrary to Heritage direction to locate a glazed partition in order to not sever the stairwell. However, the balustrade and spindles remain intact.

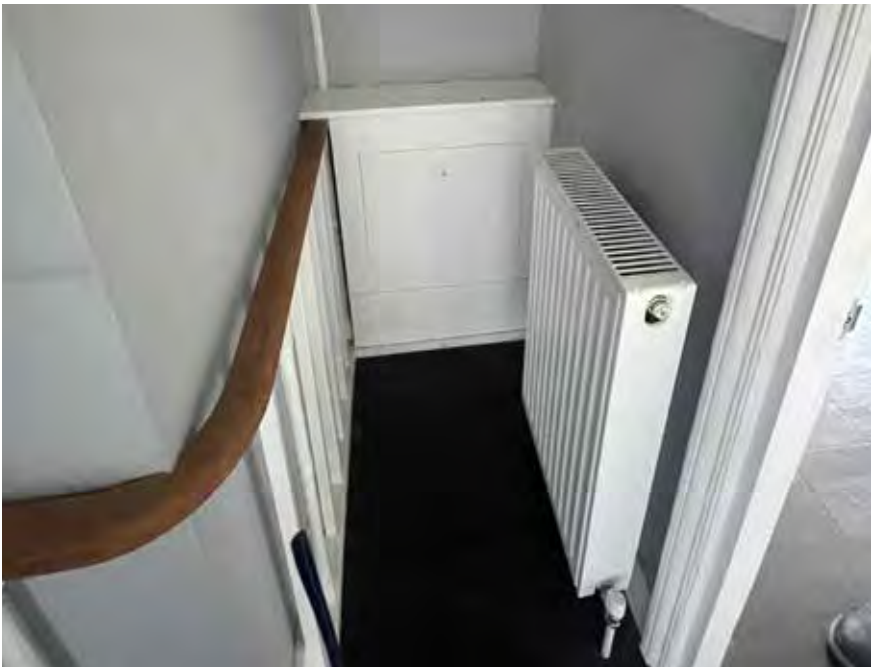
No. 195 2f landing - note balustrade and spindles remain in situ behind partition  
Noteworthy: solid partition infill (noted as glazed in Section 73 drawings)

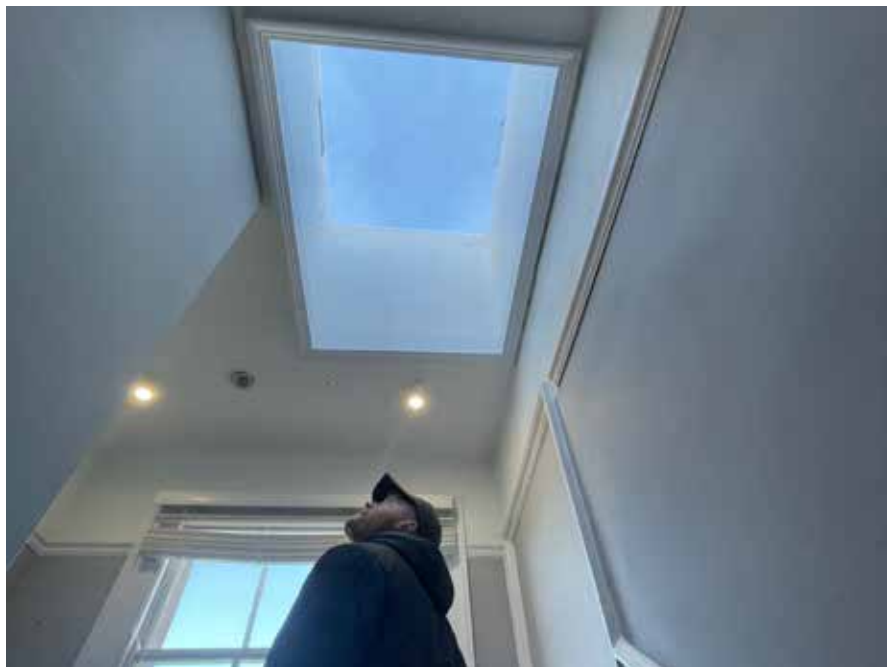
No. 195 2F light well to form AOV in JCA scheme

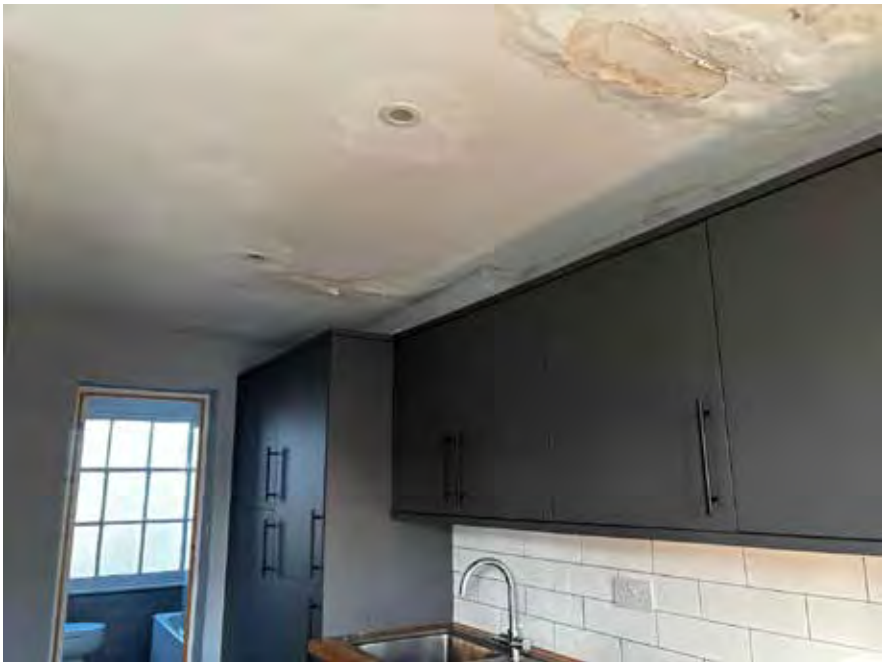
View A - No. 195 third floor kitchen to bathroom

There is water ingress through the flat roof to the north wing extension, evident in the kitchen ceiling. This is in the location of the previously evident chimney (since removed) however drone footage depicts remedial works required to the roof which may be further causing water ingress.

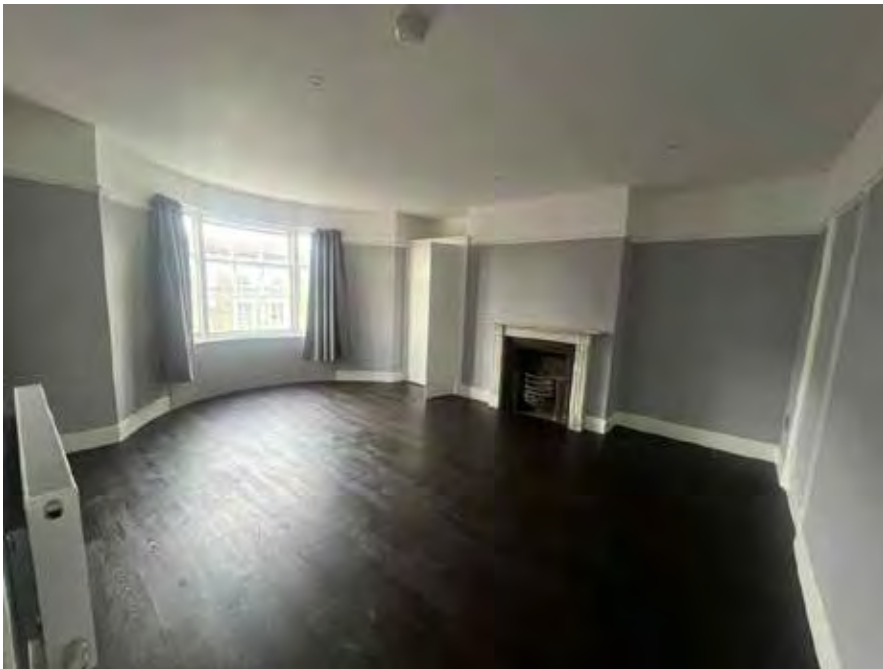
View D - No. 195 third floor interior - front living room looking south  
Noteworthy fireplace, mantel, window, sill, skirting and architrave intact  
Drawing not to scale - for publication purposes only

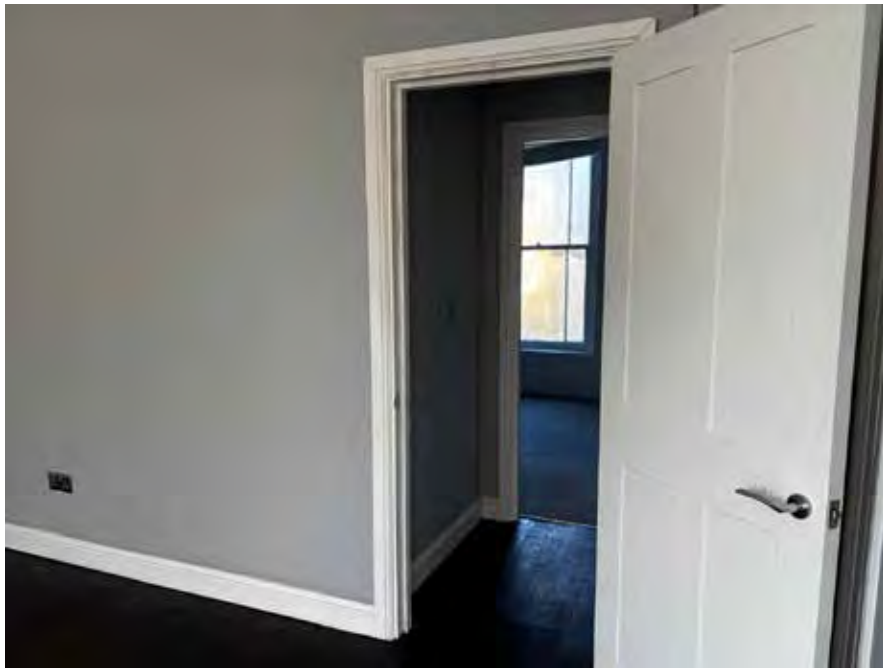
Door and architrave assumed replaced like for like

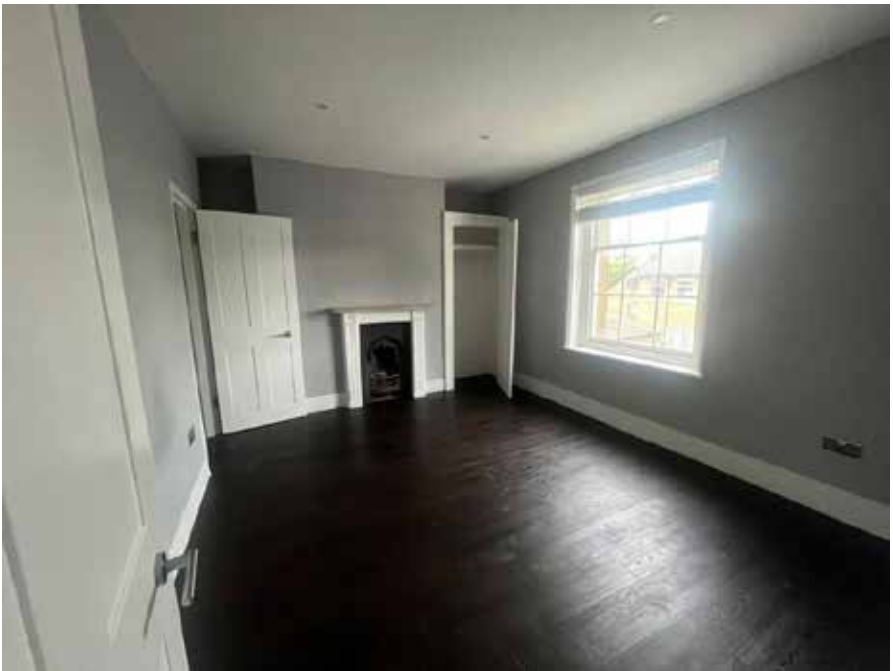
View C - No. 195 second floor rear bedroom looking south toward fireplace  
Noteworthy - fireplace, mantel, grate, window, sill, cupboard still in tack  
Evidence of replacement door and modern electrical fittings

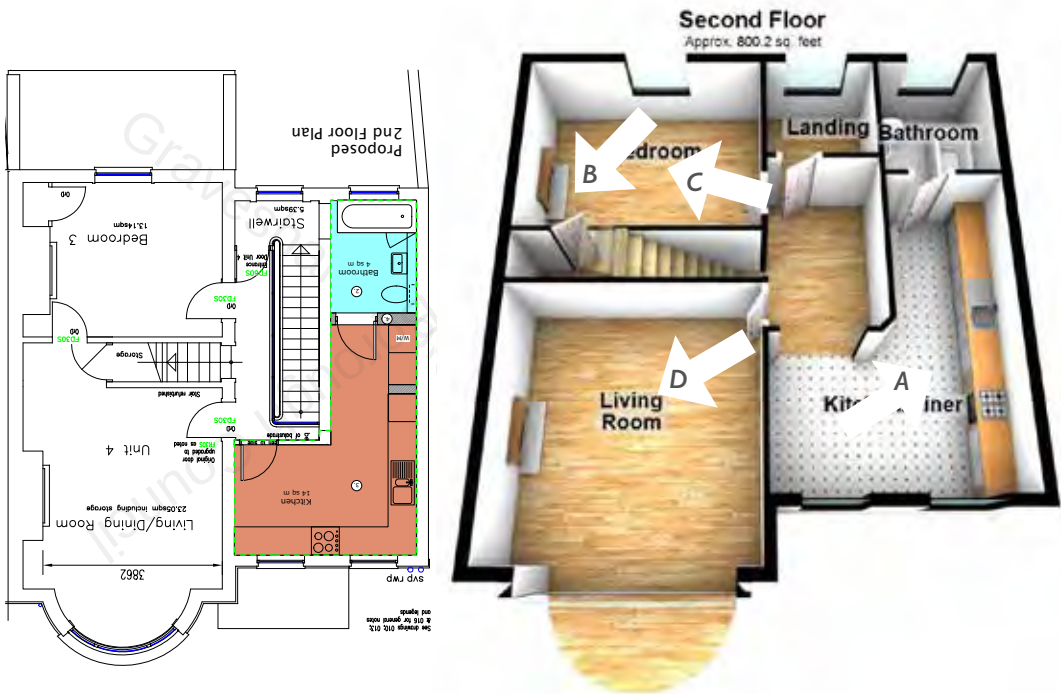
Section 73 approved 2nd floor arrangement  
Depicting glazed screen to stairwell  
2029-NMA-00-01-DR-A-00100 Rev. P5

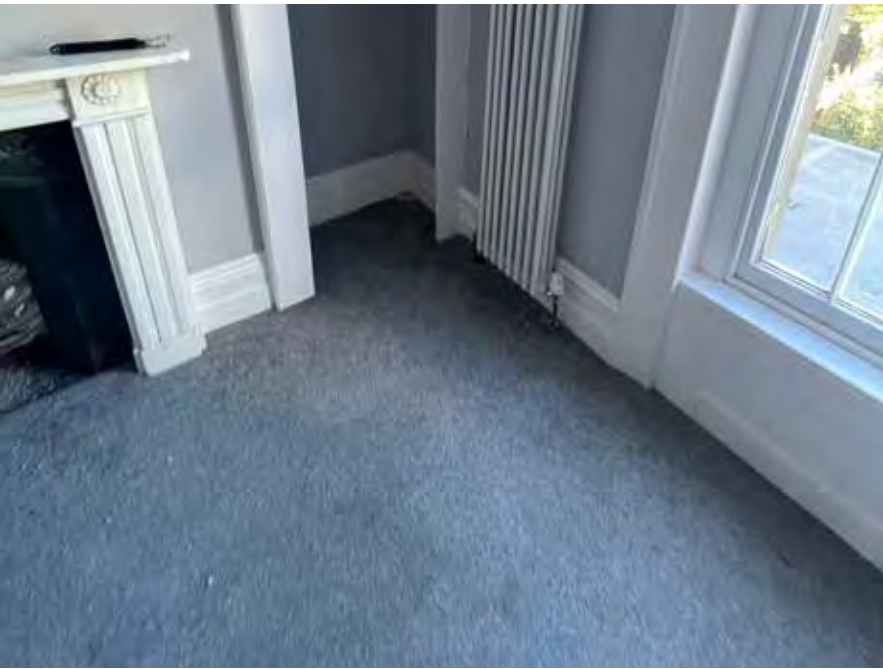
A. No. 195 third floor rear bedroom  
Noteworthy cupboard, fireplace, mantel, window, sill, skirting and architrave intact

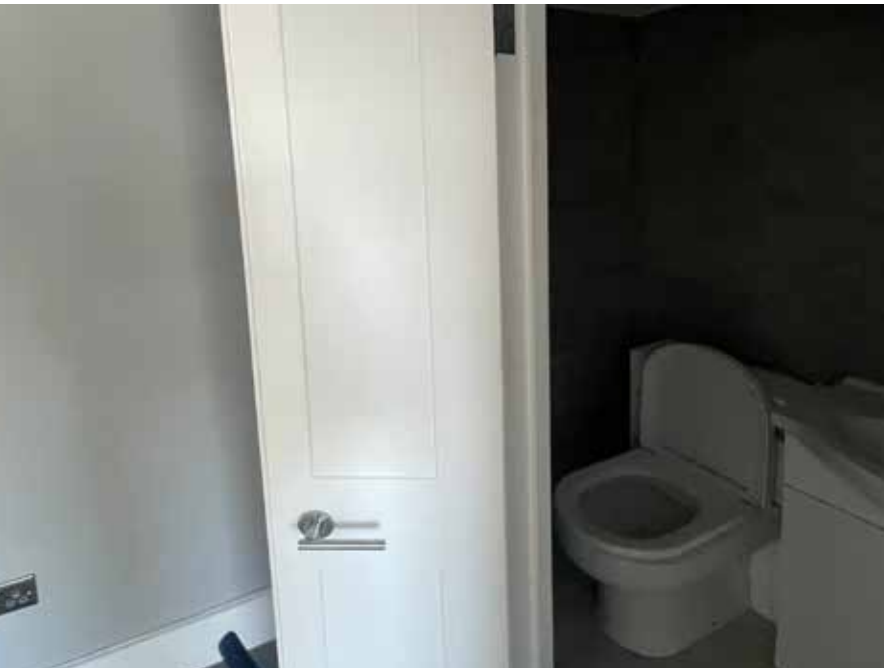
B. No. 195 en-suite with tiled floor and a transition strip located between carpeted bedroom and wet area.

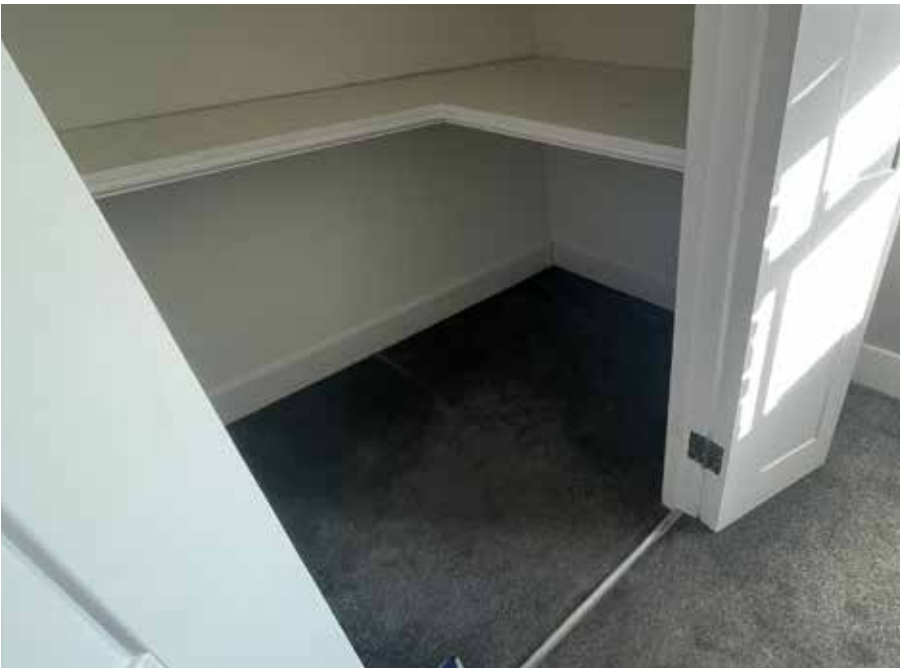
C. No. 195 storage cupboard with carpeted floor located to corner of bedroom.

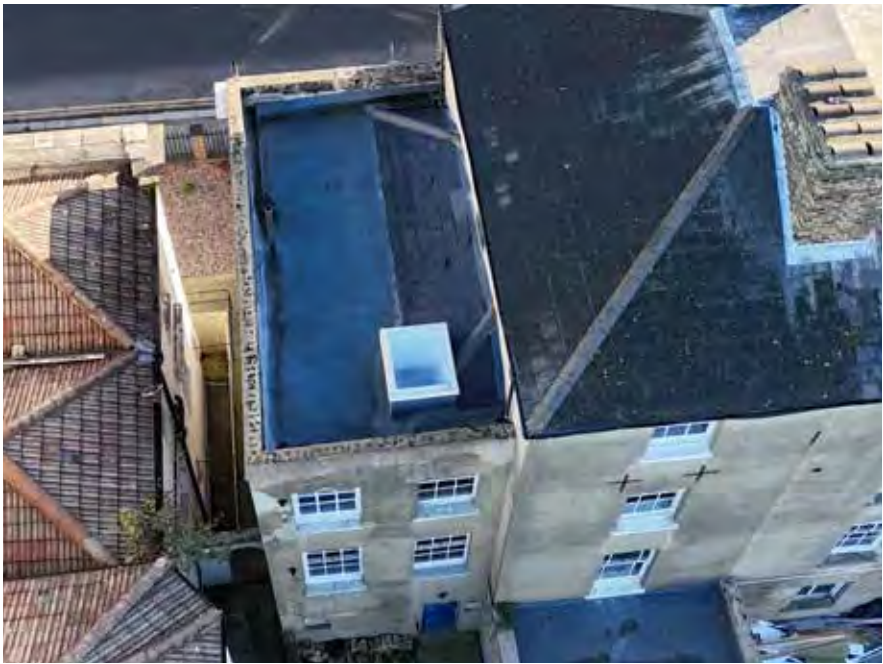
Looking east - No. 195 flat roof depicting roof light through historic pitched hipped slate roof, EPDM (or similar) surface treatment.

The roof light depicted on the approved scheme drawings by JNW appears to be in its historic location. There are no apparent Section 73 amendments to this arrangement, despite a newly located rooflight apparent over the stairs within the north wing. Furthermore, no planning drawings depict the pitched slate roof which remains in situ.
