195 Parrock Street

Gravesend,  
Kent  
DA12 1ER

DESIGN & ACCESS  
AND  
HERITAGE STATEMENT  
Dec 2025

*‘Interior works to form 4 self contained flats over 5 floors, including replacing front and rear windows with gates to form an internal through passage; minor adjustments to internal arrangements; associated services; new doors and windows; rear light well expansion; works to flat roof including new AOV smoke vent; new boundary, light well and Juliet balcony railings; new cycle store and refuse siting location and associated landscaping’*

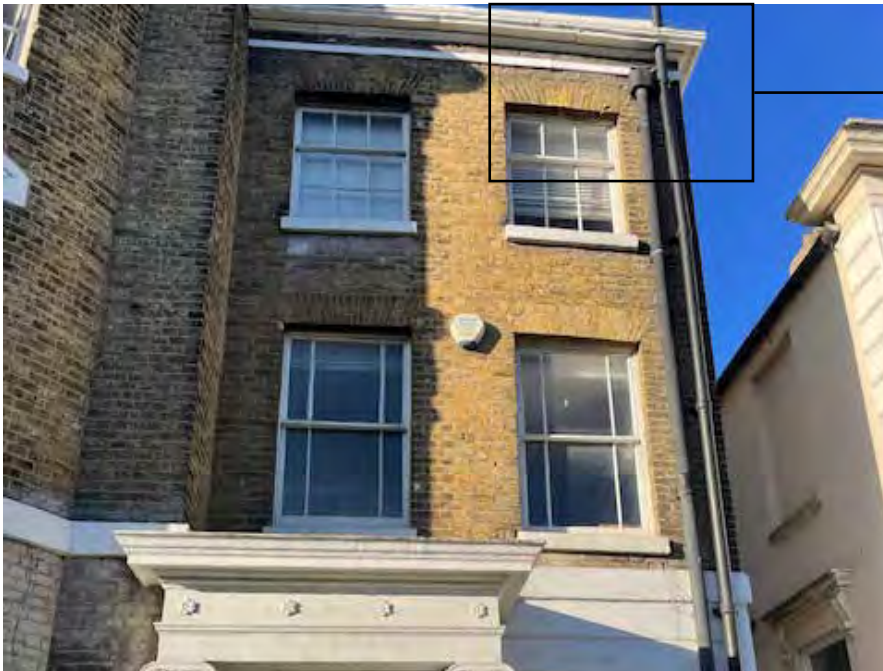
Front elevation - there is evidence of the later north wing side extension with a slight brick colour variation  
Drawing not to scale - for publication purposes only

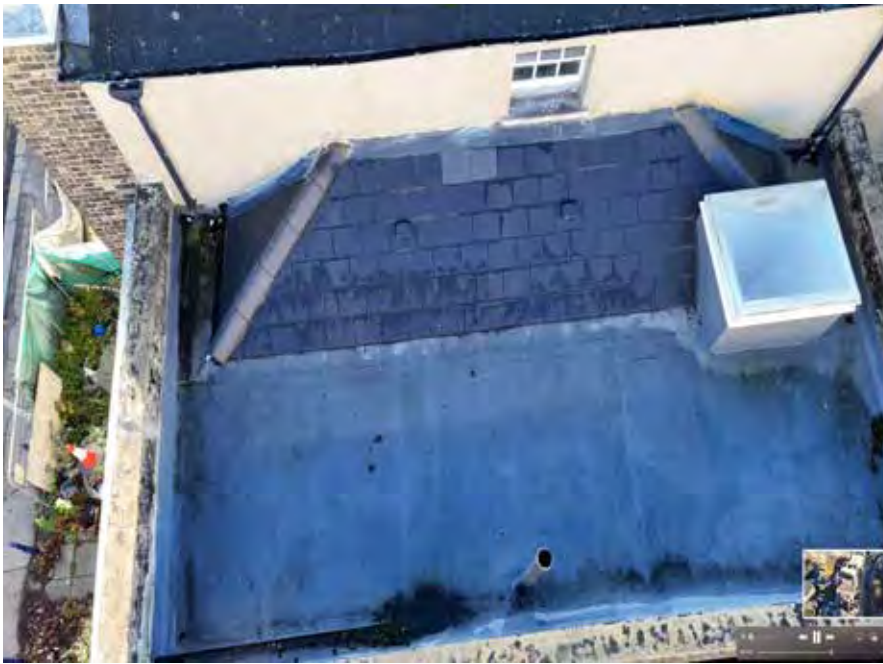
Looking south - No. 195 flat roof depicting SVP (assumed in same location since 1970's office wc's to second floor) Chimney removed. Roof vents assumed to be servicing

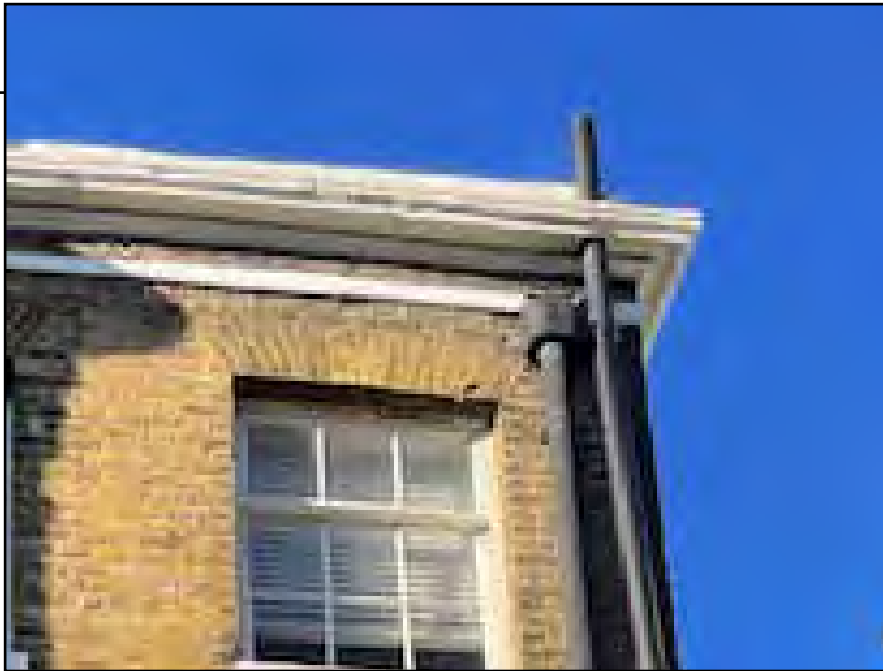
Front elevation - there is evidence of suspected rainwater goods debris blockages  
Resulting in brickwork failure with water ingress into the brick mortar

There appears inadequate lead abutment cloaking and standing water below the downpipe from the main roof, as well as railed render to the parapet.  
Please refer Section 7.7 for further drone images and waterproofing works.

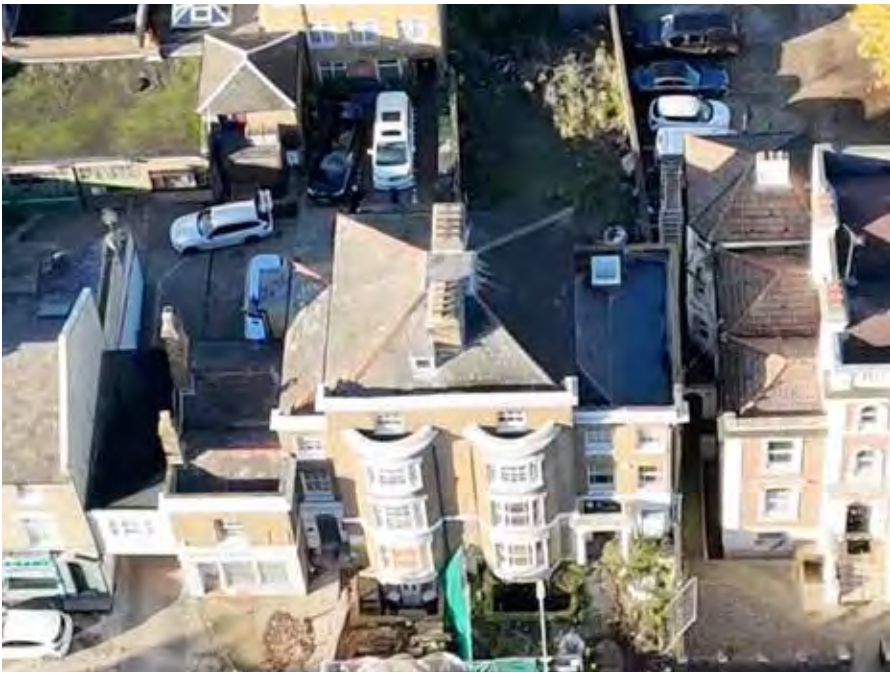
Looking west - No. 195 & 6 forming a pair with matching hipped slate roofs over wings, evidence of No. 195 later flat roof extension to the north

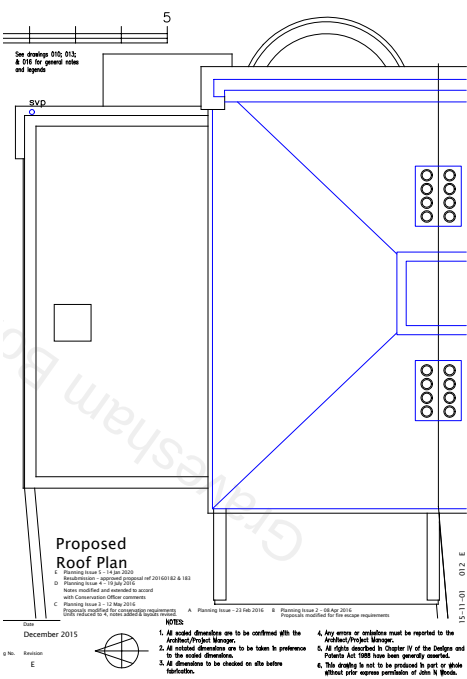
Approved JNW roof plan arrangement  
No evidence of Section 73 amendment online

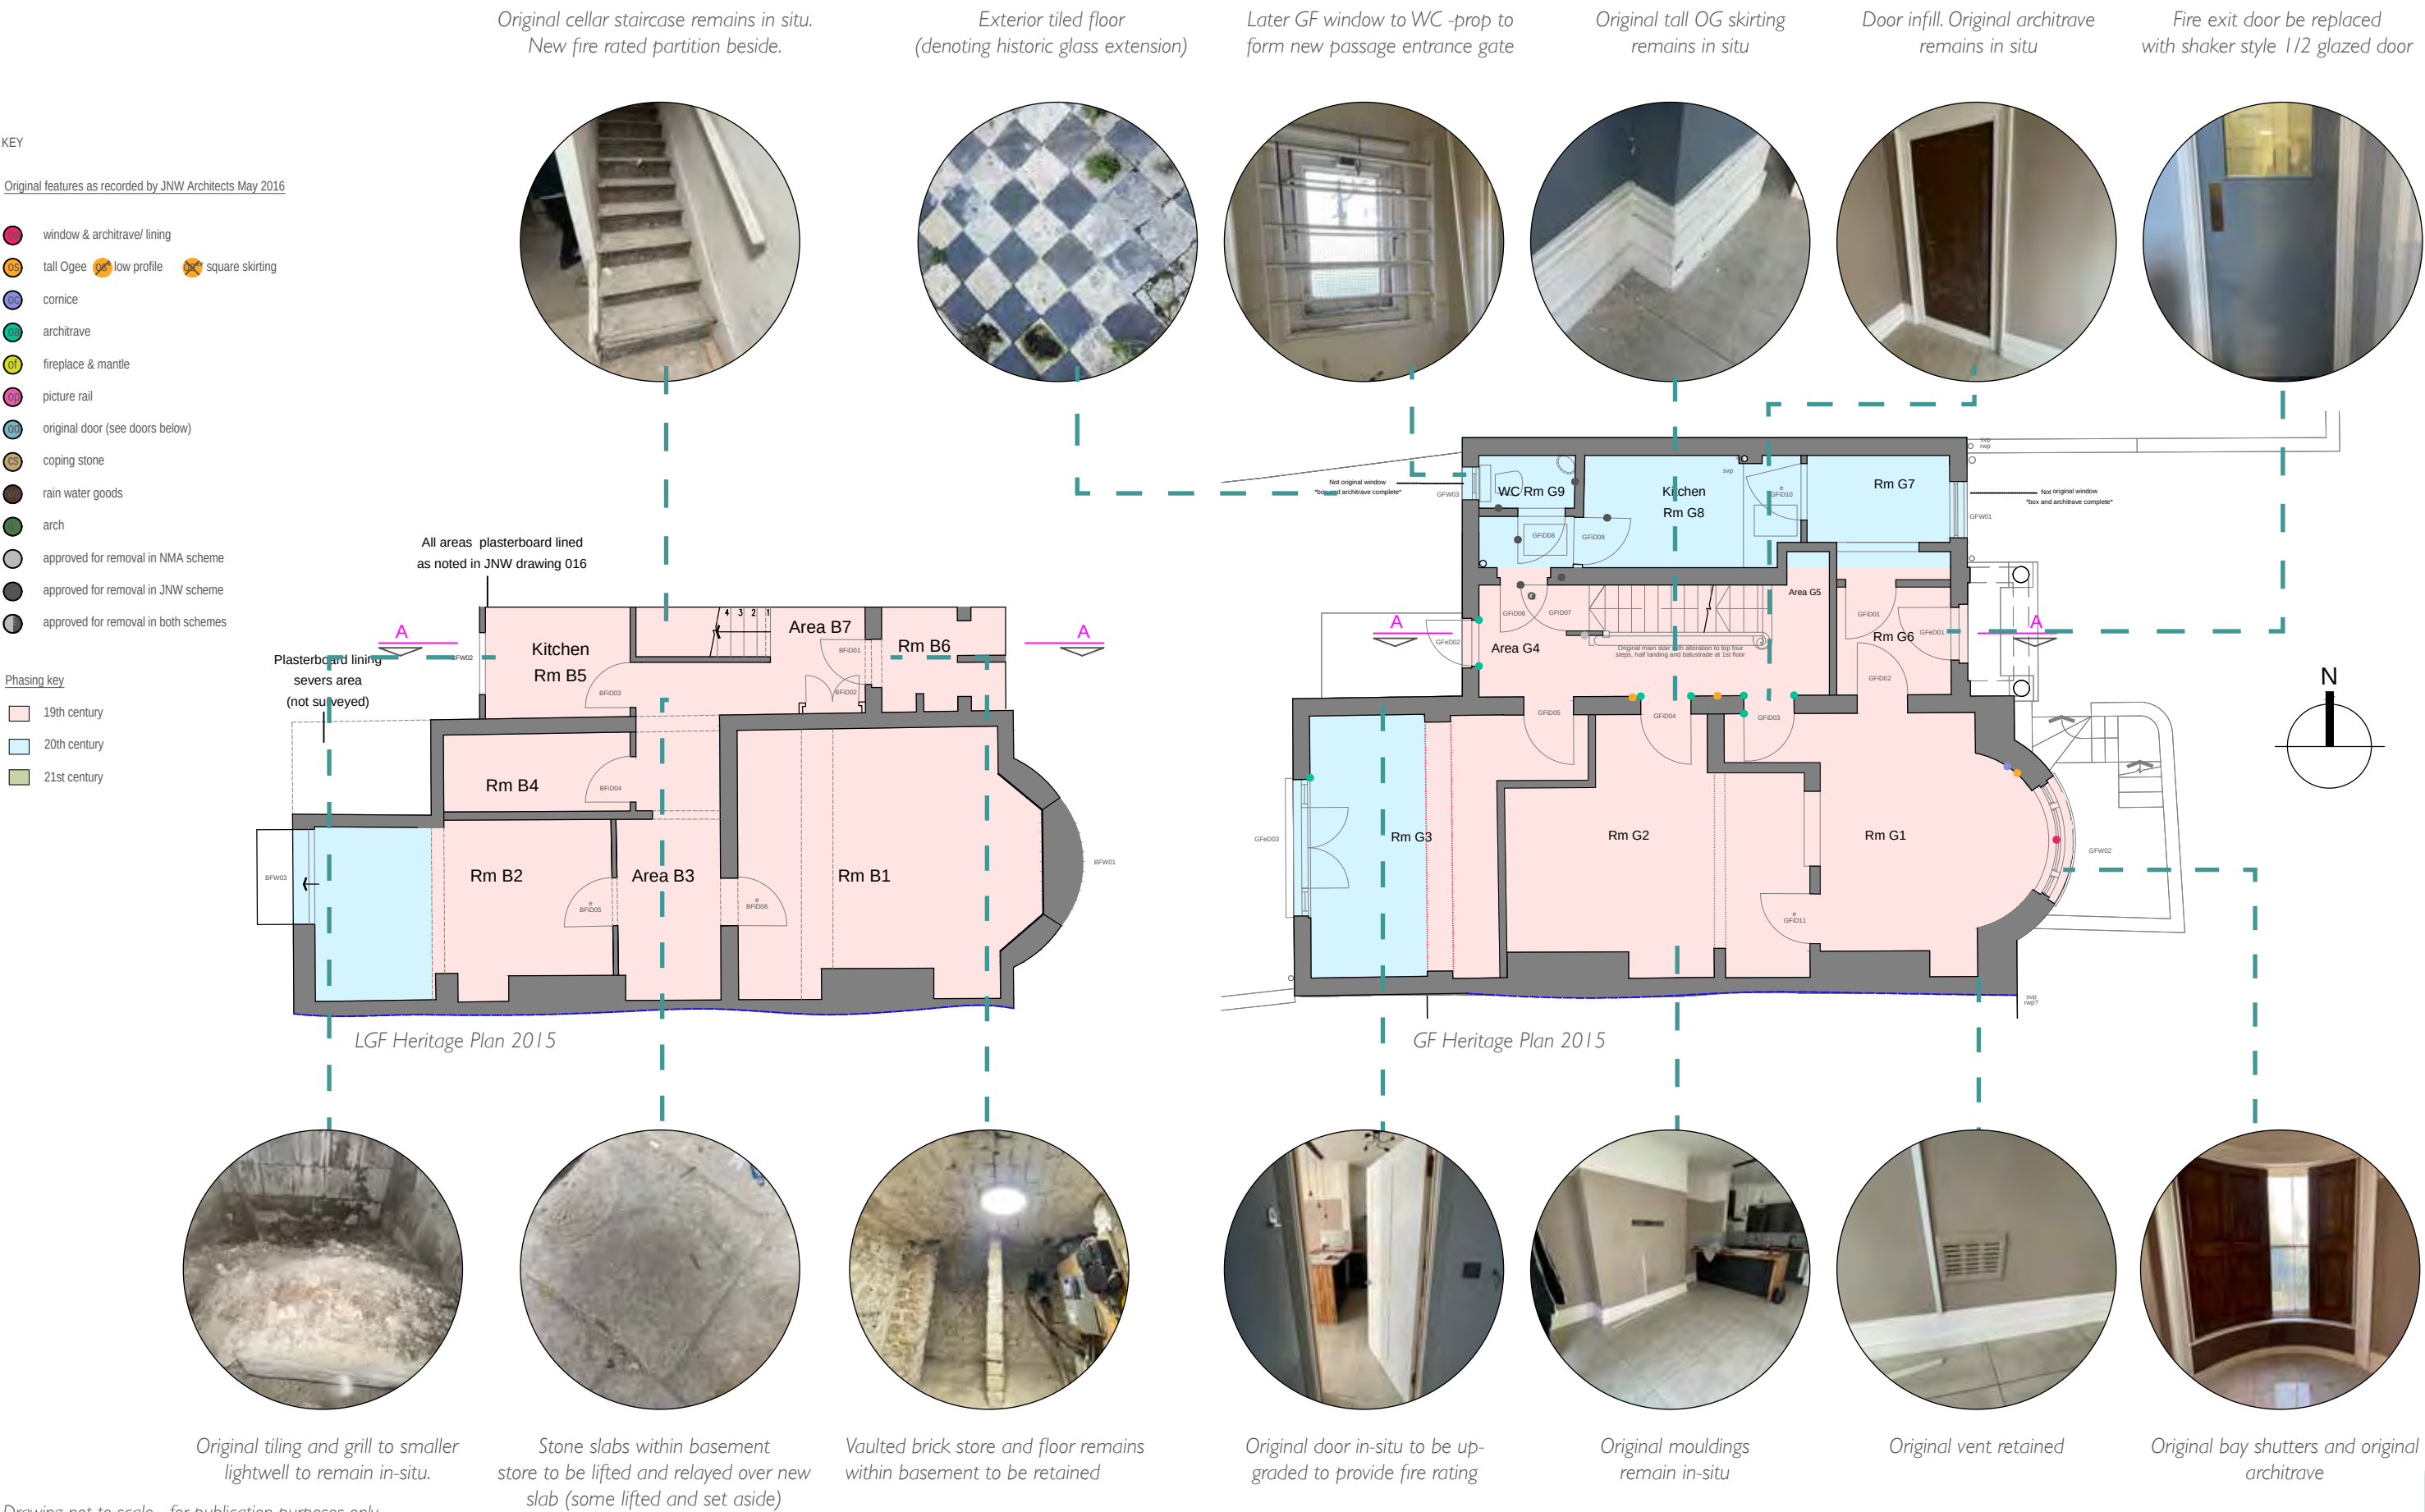
5.1.1 LGF & GF Heritage Plans as at 2015

The following plans depict evidence of original joinery remaining in locations as recorded in 2015 Heritage and existing site evidence (during JCA site visits May and Oct 2025)

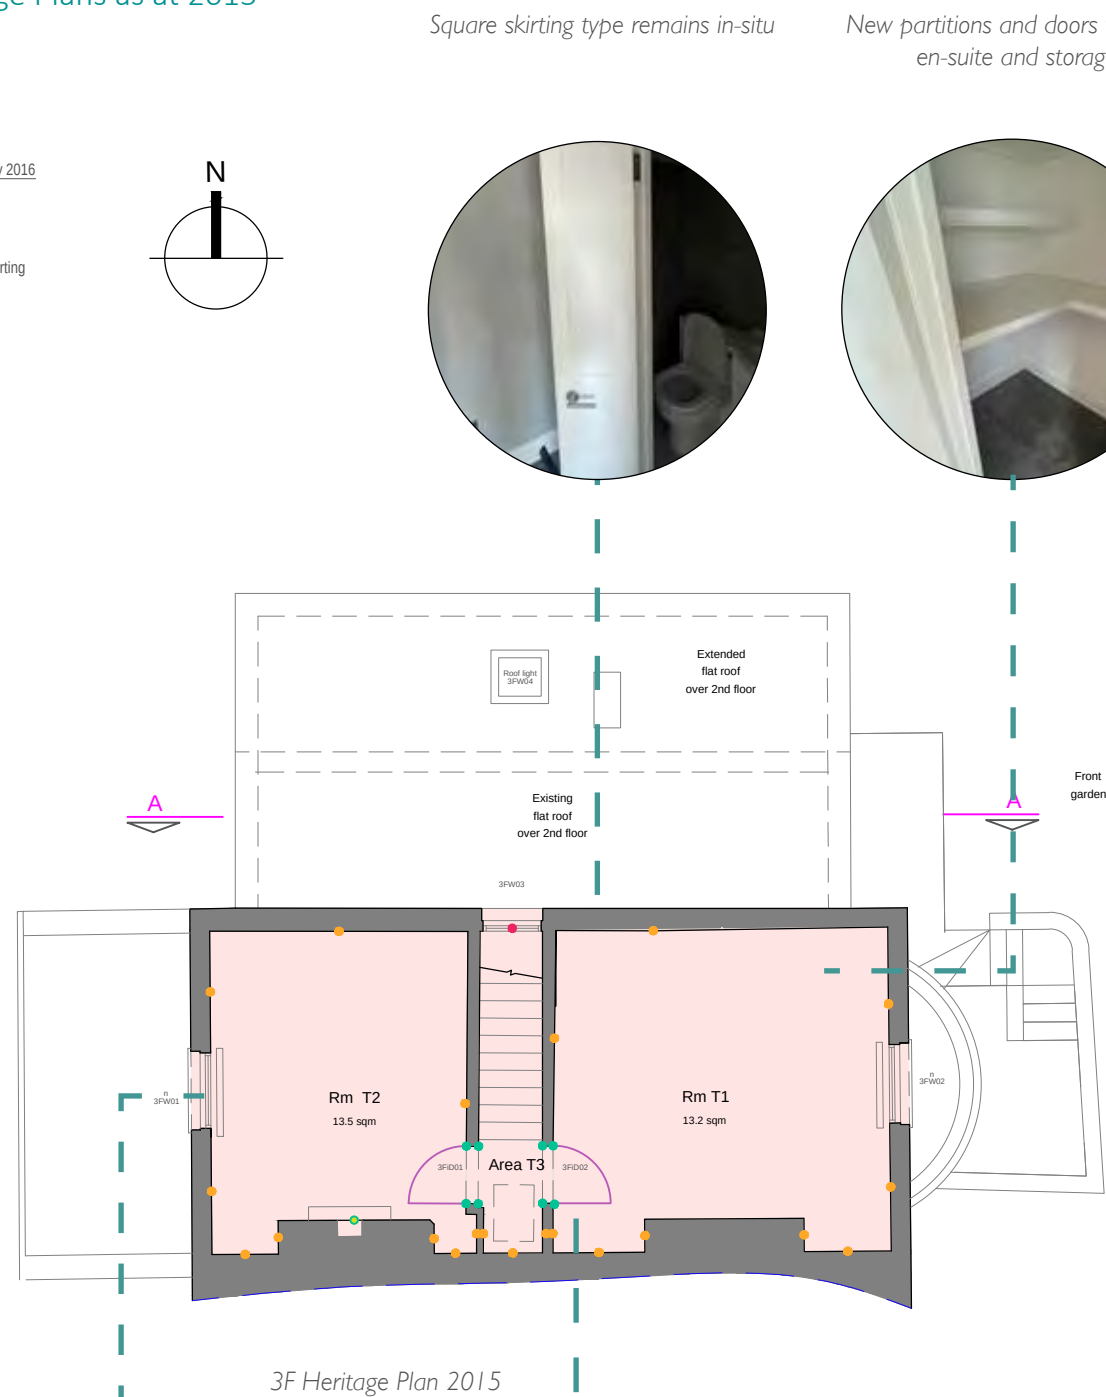
Square skirting type remains in-situ

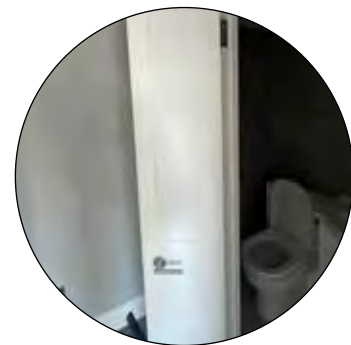
New partitions and doors to frame en-suite and storage.

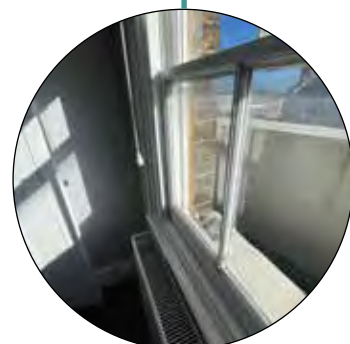
Sash window in keeping with original

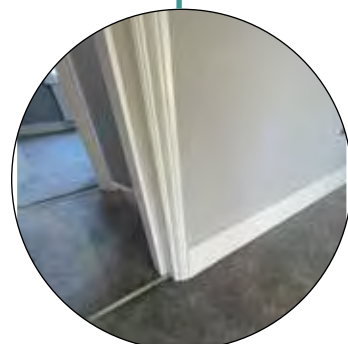
Original architrave and skirting remains in-situ.

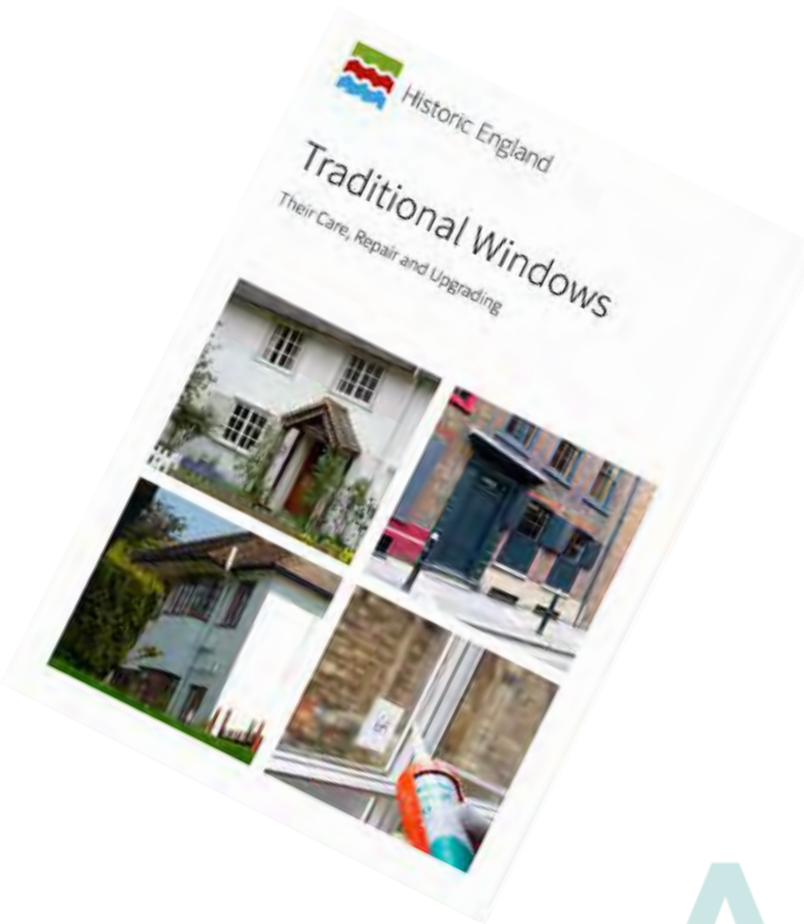
## 6.2.9 AOV roof light

1:10 scale plans and elevations are included in this submission, illustrating details of a replacement smoke vent at the top of the stairwell, utilising a void already formed to locate a roof light.

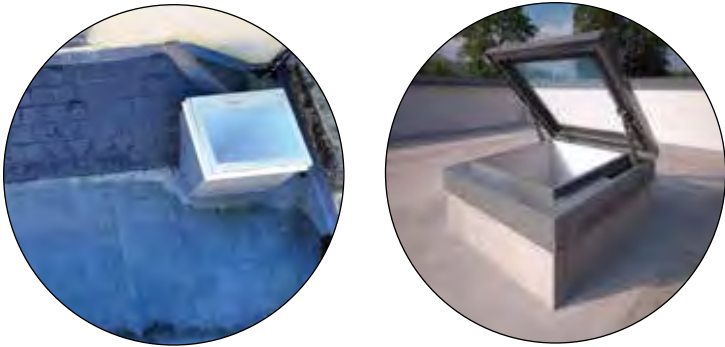
Rooflight to be removed and replaced with AOV

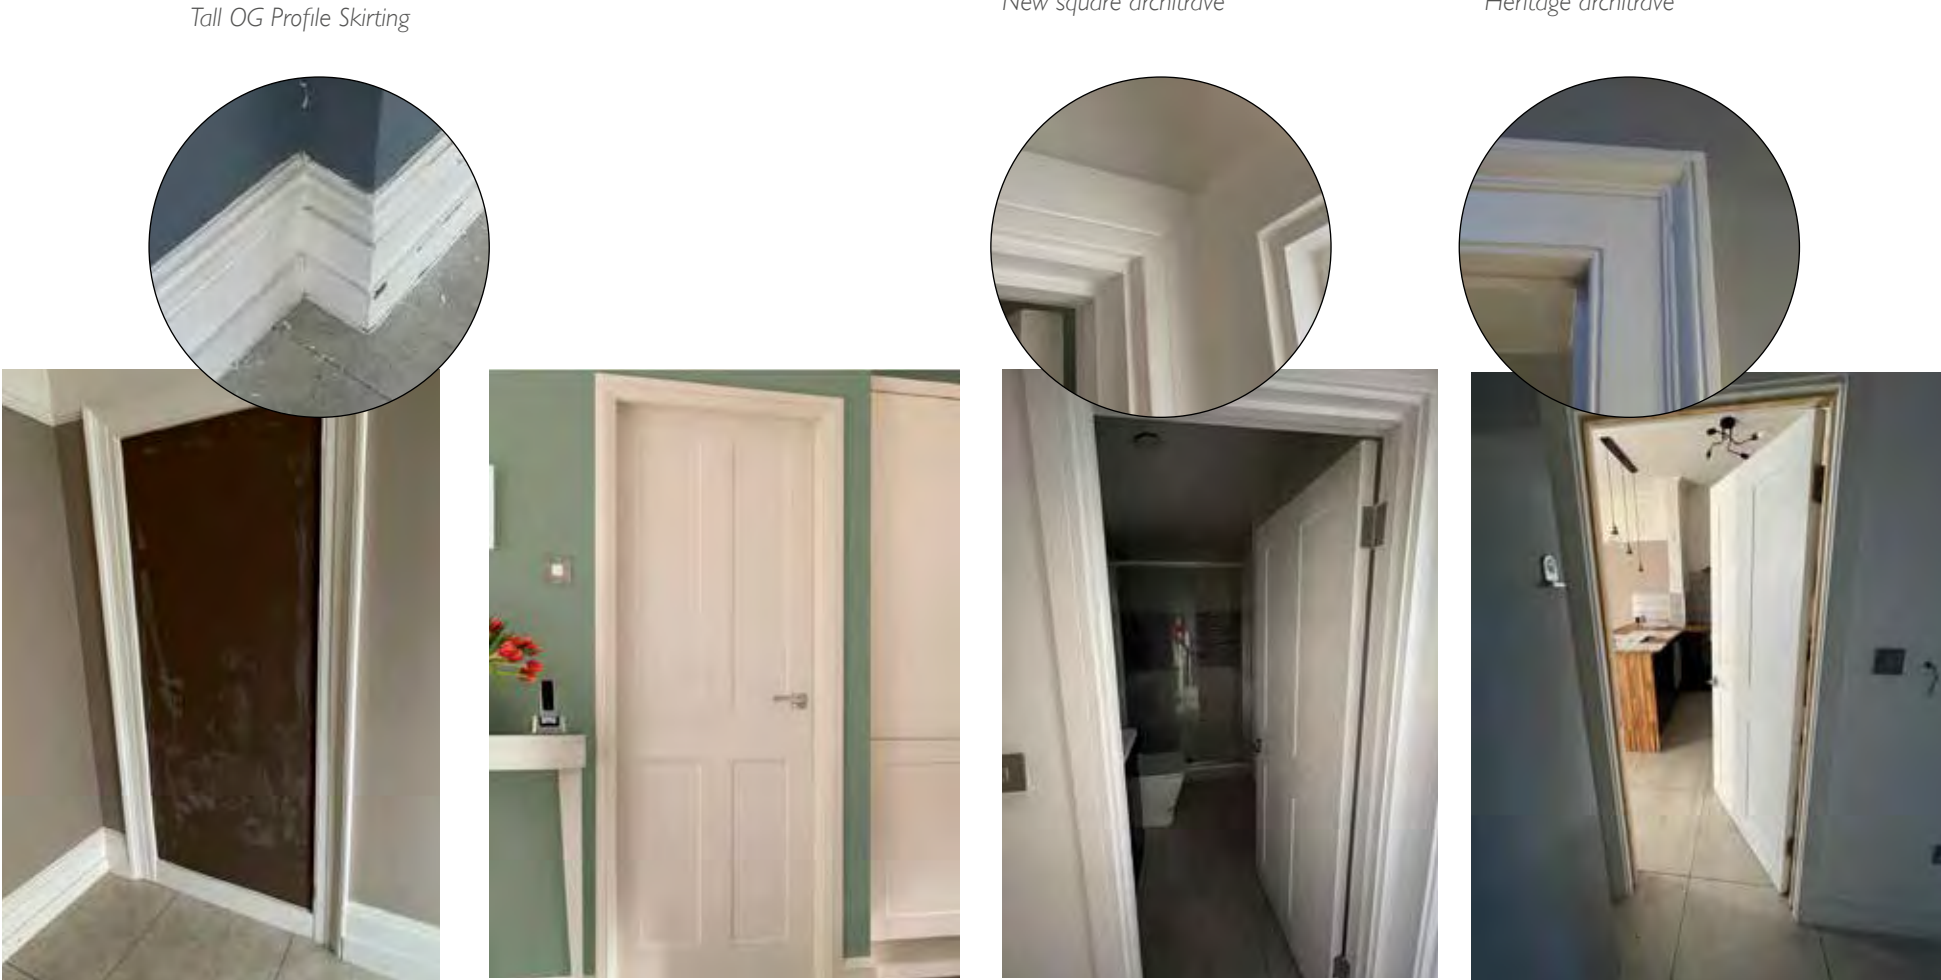
Evidence of sympathetically installed partition infill. Heritage architrave and heritage skirtings in situ

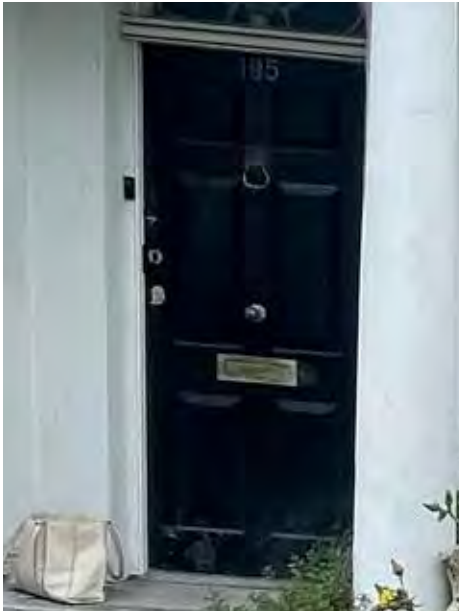
Existing main external entrance door to remain in situ

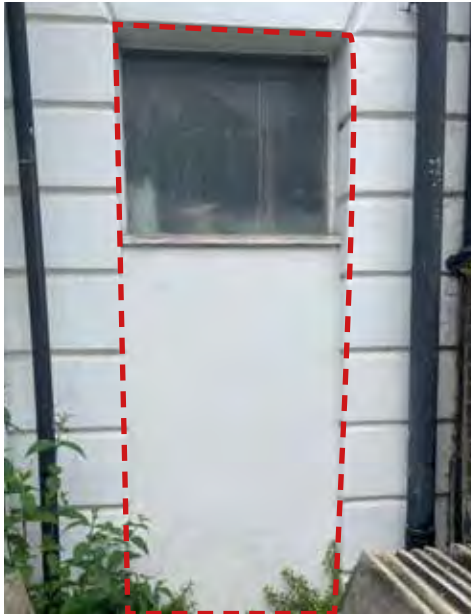
North wing extension later window (previous bank night deposit box aperture) To be replaced with side passage door

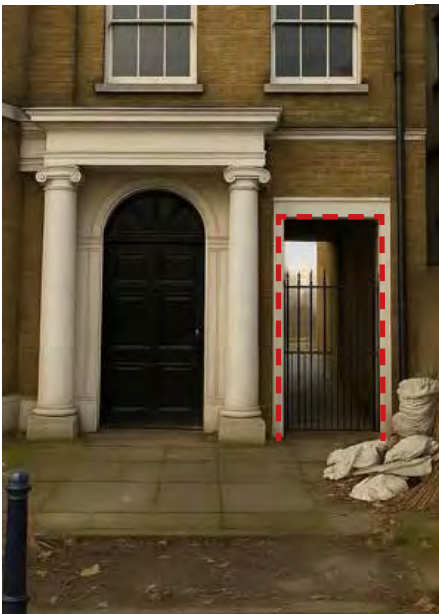
AI example image by others. Proposed secure gated entrance front and rear of passageway

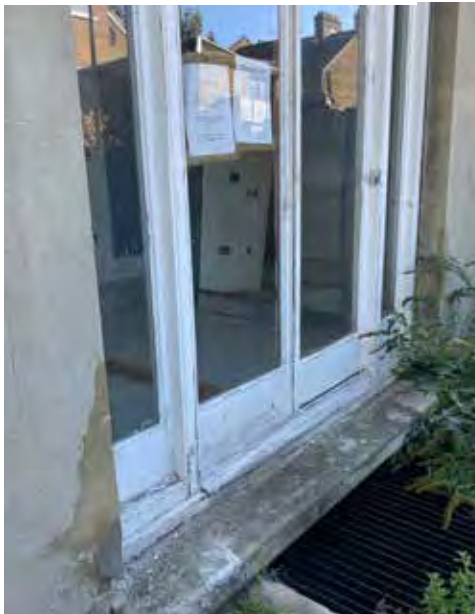
Existing ele 04 rear ground floor French doors GFed03 GF U2 and side lights (exterior) to have Juliet balcony to outside

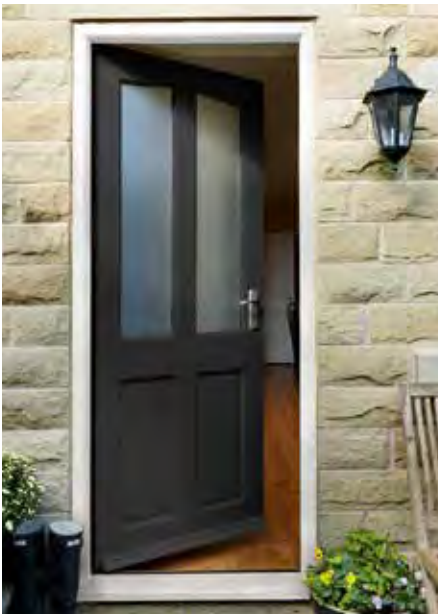
Proposed Howdens Richmond FD60 fire door to foyer entrance

Where original doors to be upgraded, it was recommend Envirograf product 42 range of paints, clear or coloured, applied to manufacturer's instructions, in conjunction with Envirograf surface mount; FD60s fire rated doors required to all entry doors from stairwell and all associated openings to be closed off in accordance with fire rated stud partitions.

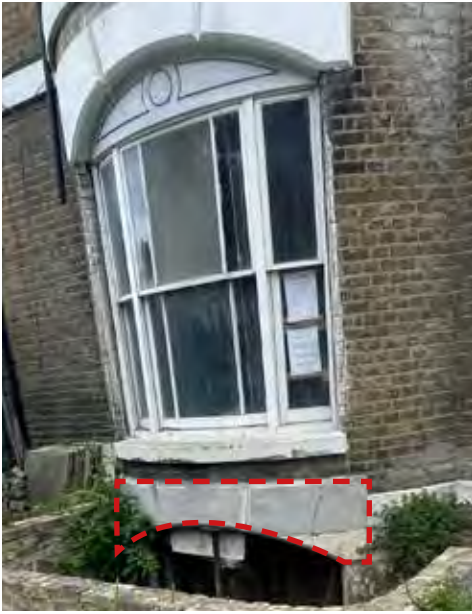
Front ground floor bay and window with stone lintel to basement lightwell aperture below
