**FINCHES, RHODODENDRON AVENUE, CULVERSTONE,  
MEOPHAM, KENT, DA13 0TU**

**PRELIMINARY ROOST ASSESSMENT and  
BAT ACTIVITY SURVEYS**

**Report: BWE\_Combined\_FINCHESDA13 (Final)**

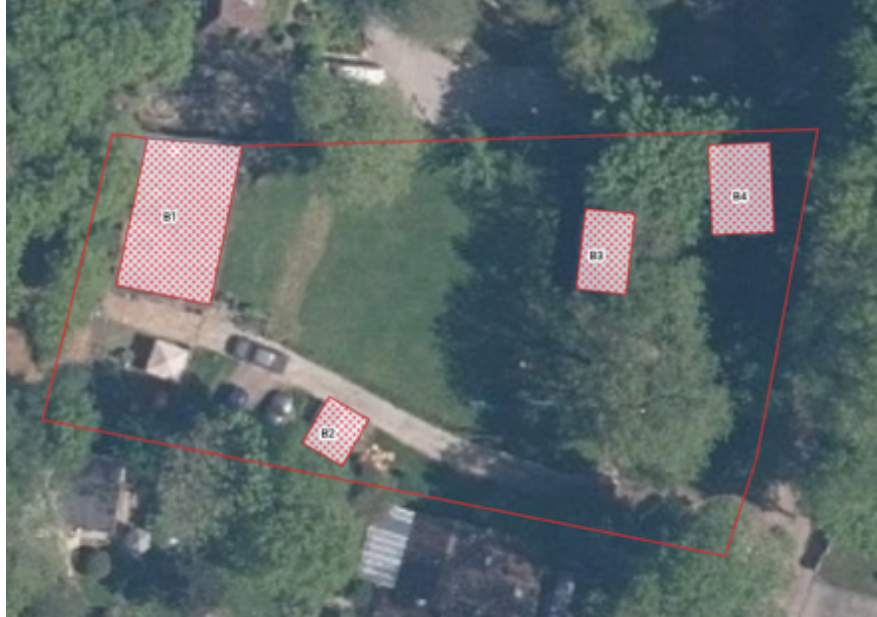
Figure 1. Buildings within the site boundary (Source: The LandApp, 2025)

A total of four buildings were present within the site boundary at *Finches*, as identified during the Preliminary Roost Assessment. These structures are labelled on the accompanying site plan (Figure 1) and described as follows:

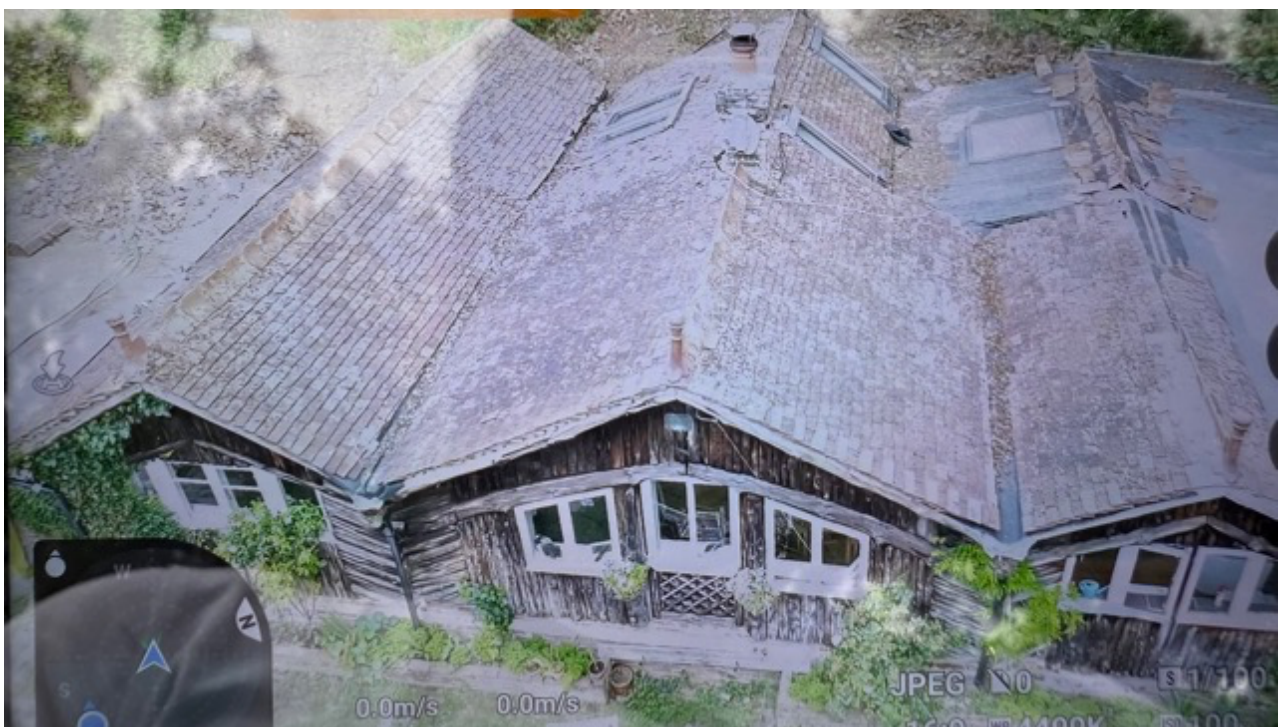
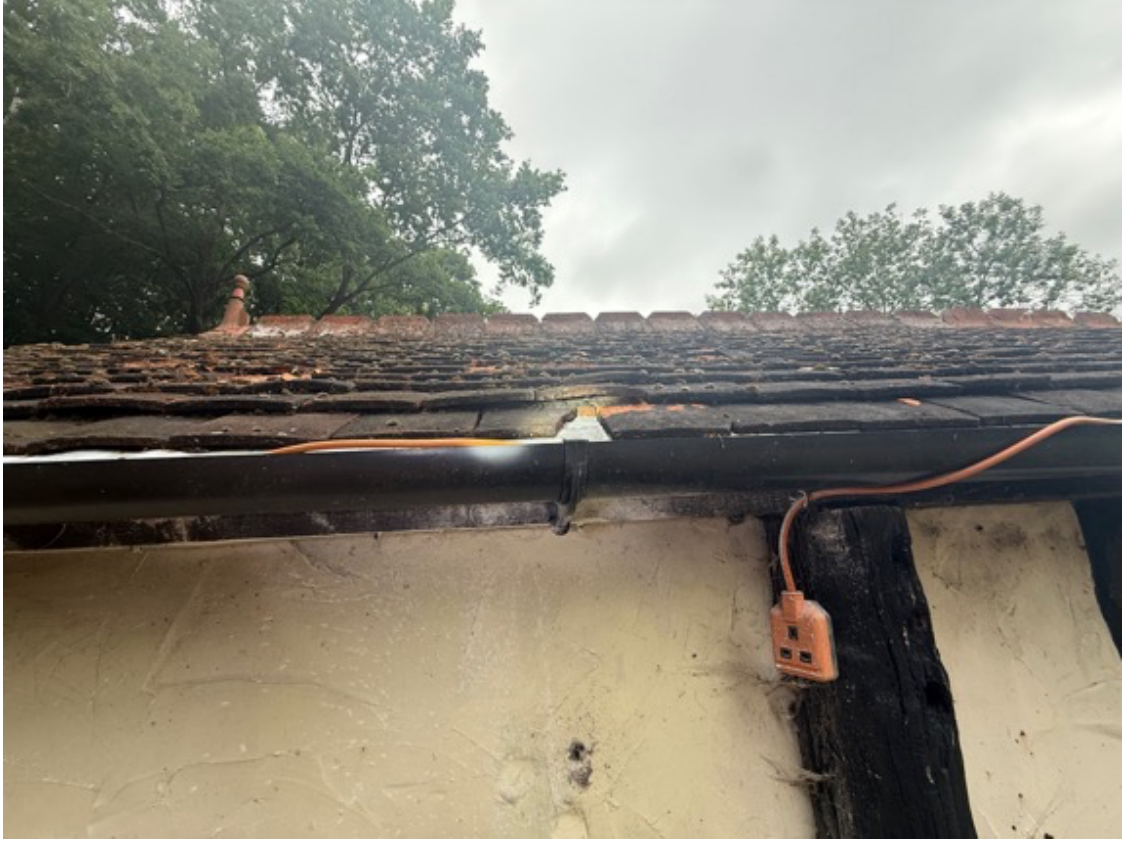
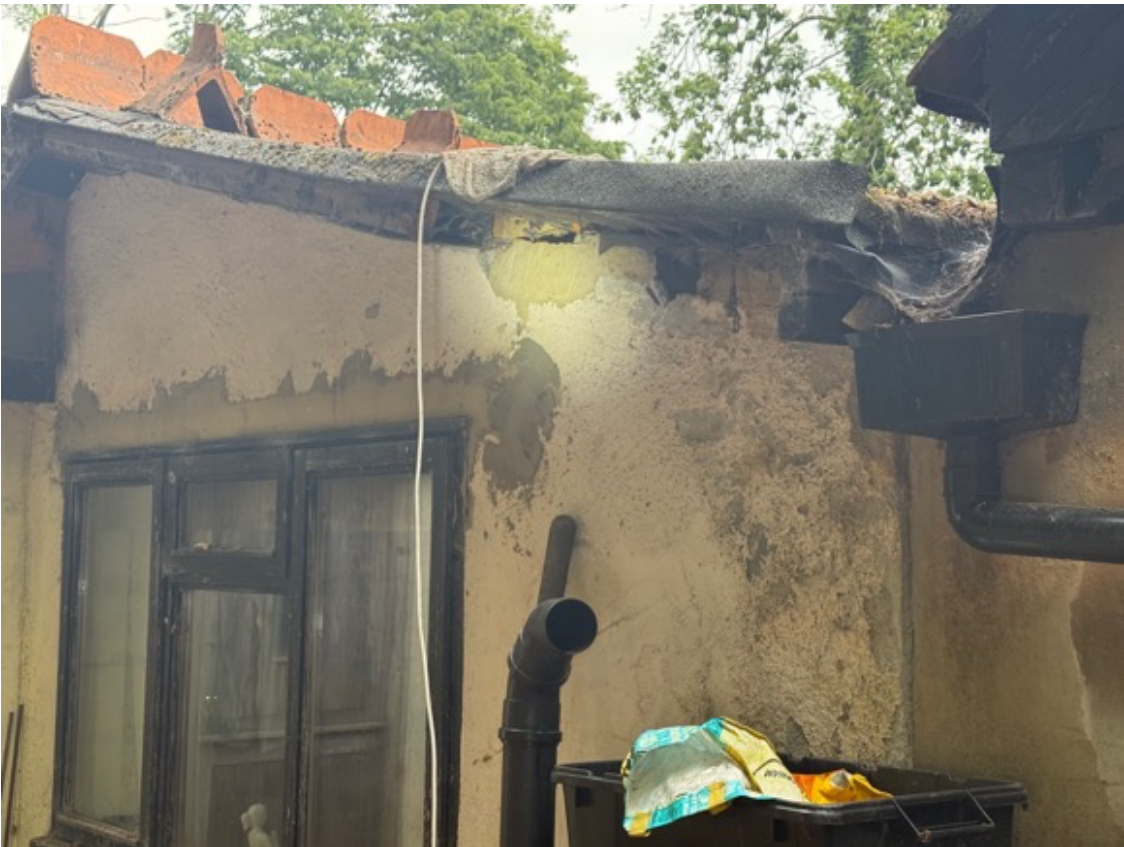
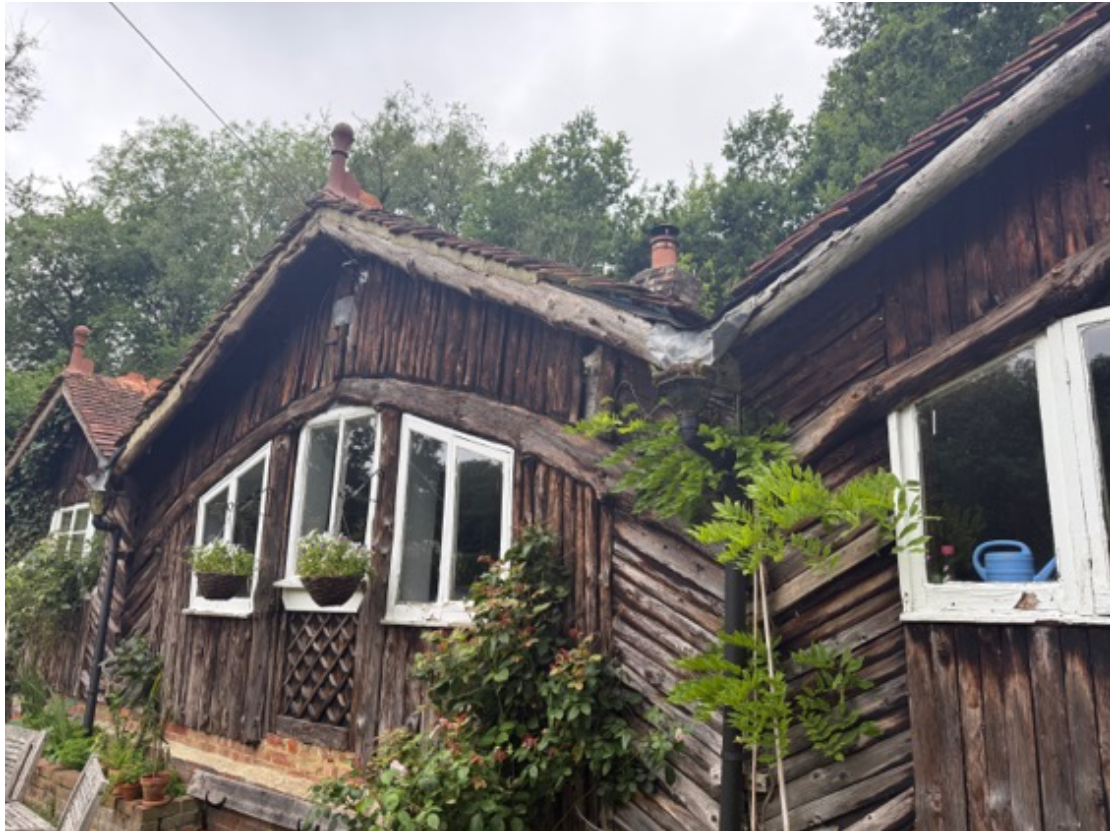
**B1 – Main Residential Dwelling:** The main building was one storey building with multi-hipped clay tiled roof. No loft void was present within the building.

Externally, several potential bat roosting features (PRFs) were noted, including:

- Gaps beneath lifted or displaced ridge and verge tiles;
- Crevices between soffits and external wall junctions;
- A small number of lifted tiles near the eaves;
- Timber cladding and boxed dormers which may include lifted edges or weathered joints.

No obvious signs of bat activity (e.g. droppings, staining, or feeding remains) were recorded at the time of the inspection. However, due to the structure, age, and location of the building, as well as the number of potential access points, B1 is assessed as having low potential to support roosting bats.

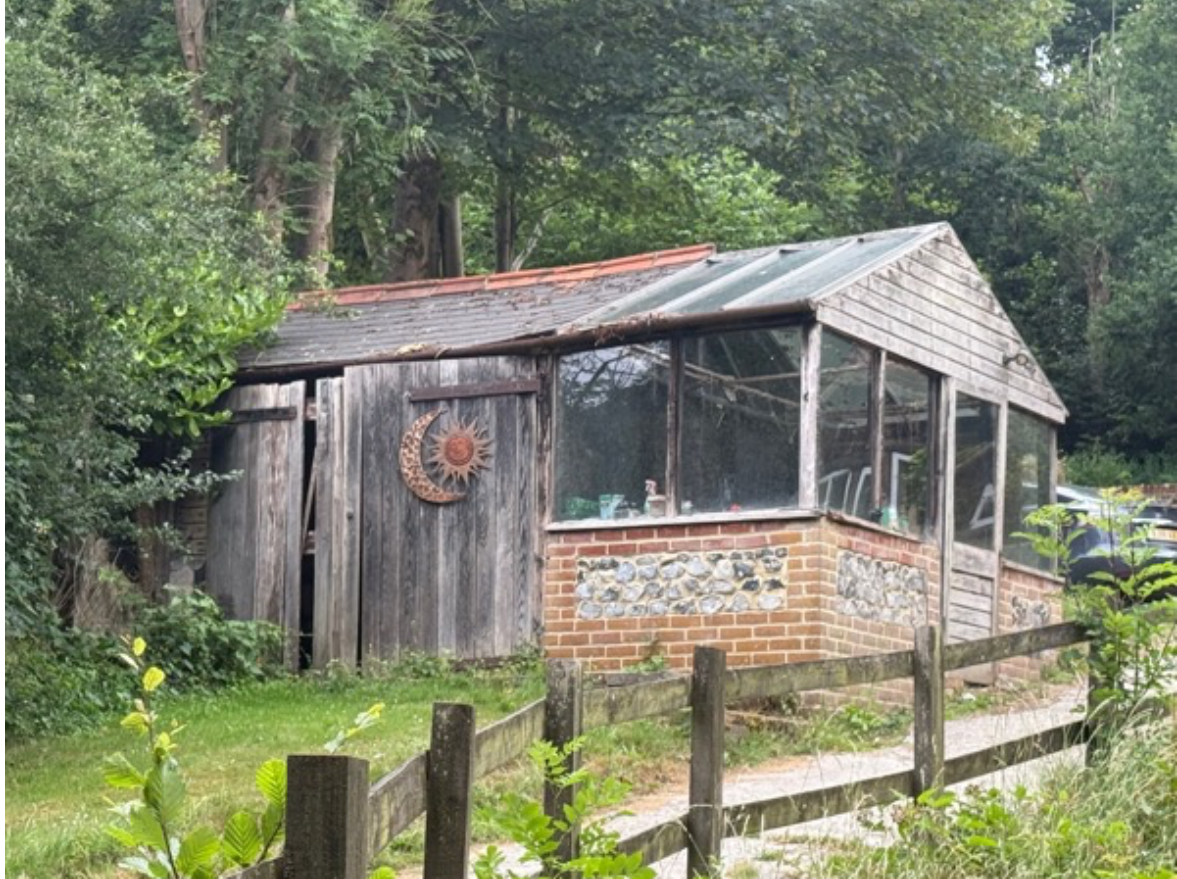
B2 is a small, single-storey greenhouse structure located adjacent to the main driveway within the front garden of the property. The structure comprises a lightweight metal or timber frame supporting transparent glazed panels, including a sloped roof. The building is free-standing and situated in an open, well-lit part of the garden, away from dense vegetation.

- The greenhouse is of typical modular design with no enclosed roof void or insulation.
- All glazed panels appear intact and well-sealed, with no significant cracks or gaps that would provide access for roosting bats.
- The structure is unheated and unoccupied, with minimal shelter or cover that could provide thermal stability or roosting potential.

Due to its open design, lack of enclosed spaces, and the absence of features suitable for bat access or shelter, B2 is assessed as having negligible potential to support roosting bats. No further survey or mitigation is considered necessary in relation to this structure.

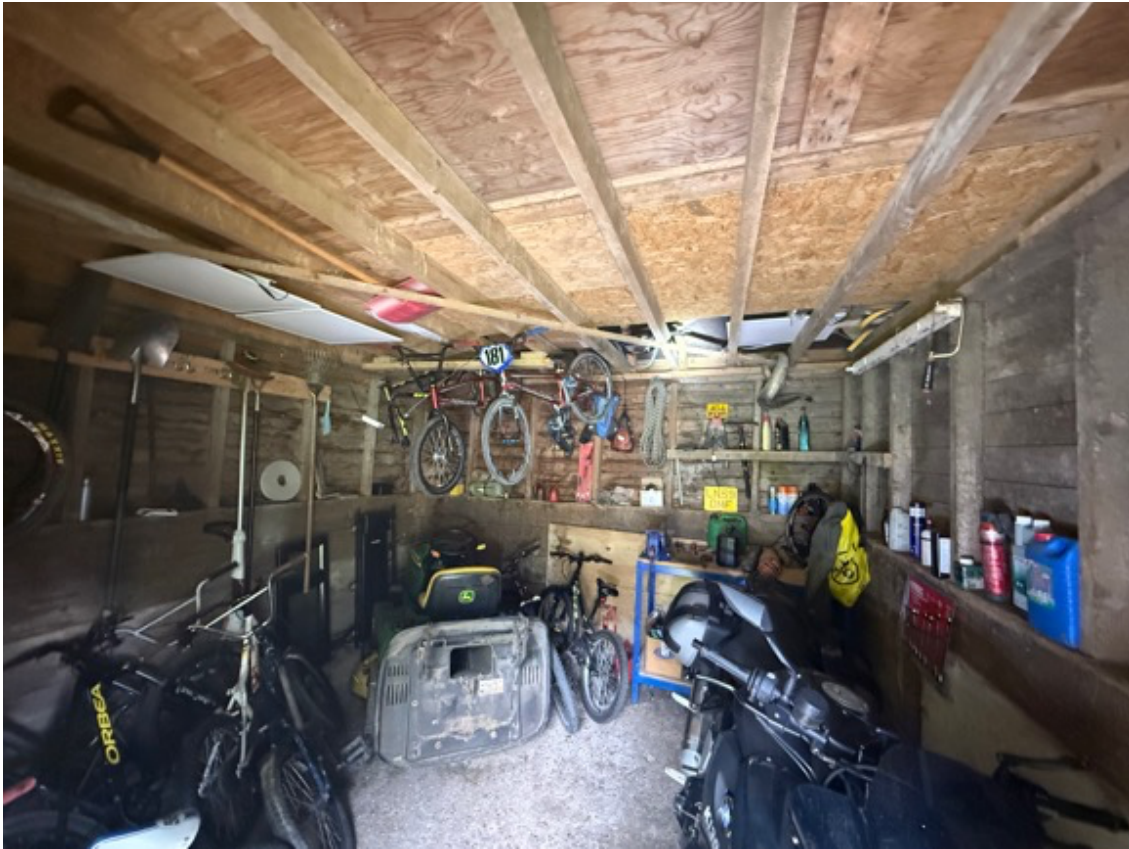
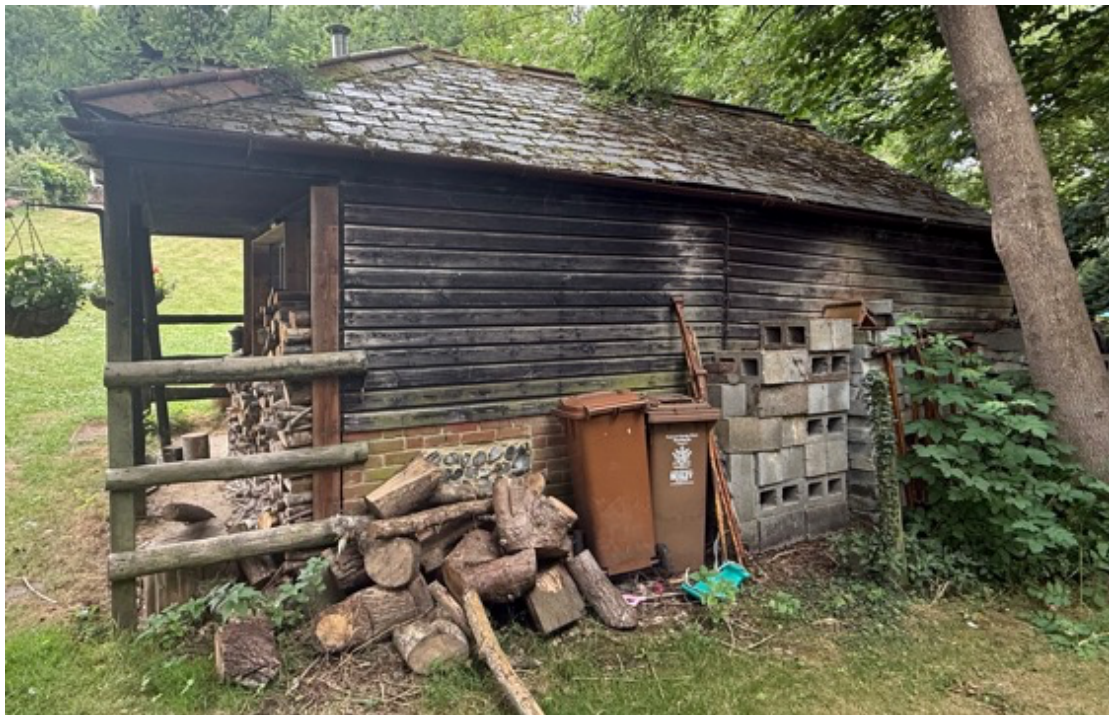
B3 is a small, detached single-storey timber outbuilding located within the rear garden of the property. The structure appears to be used as a garden study or hobby room and is positioned beneath partial tree cover, adjacent to ornamental planting and informal lawn.

- No visible access to an internal roof void is present, and the internal structure is limited to a single open room with a finished ceiling.

While the structure is modest in size, no potential roosting features (PRFs) were identified during the survey; therefore, B3 is assessed as having negligible bat roosting potential.

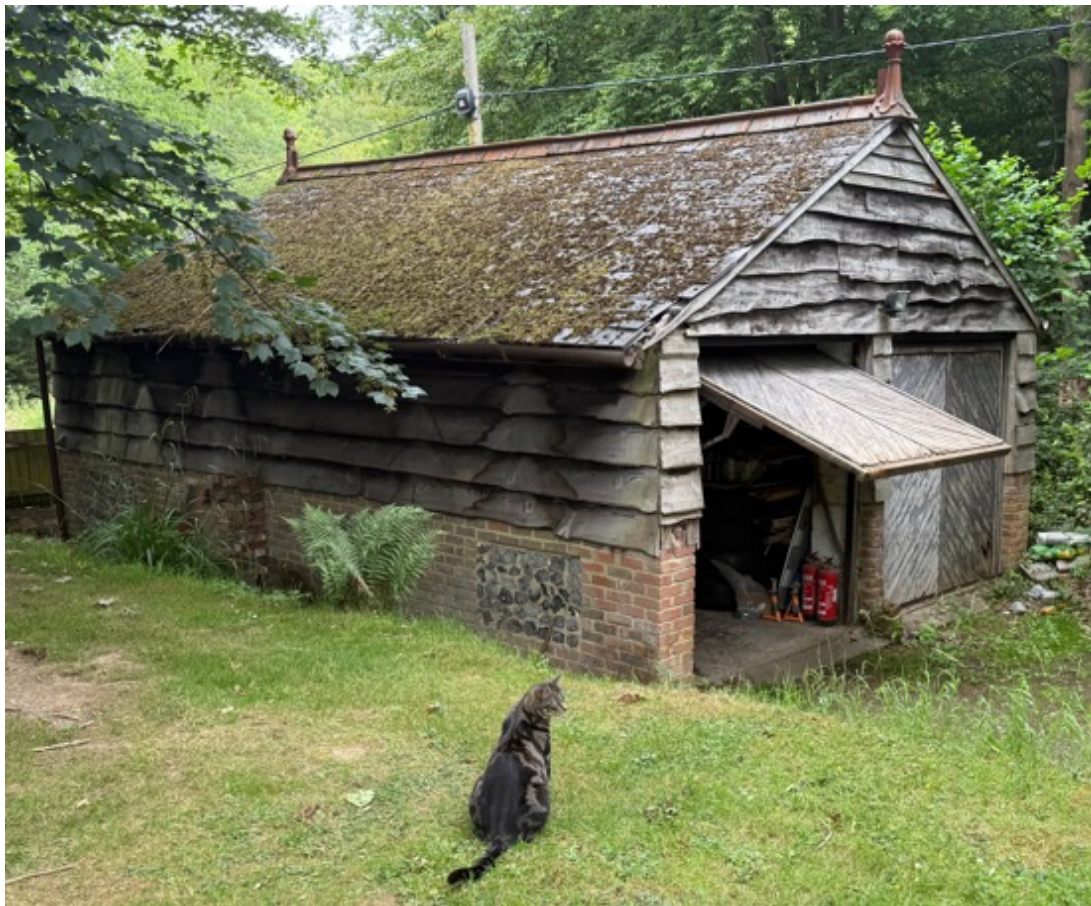
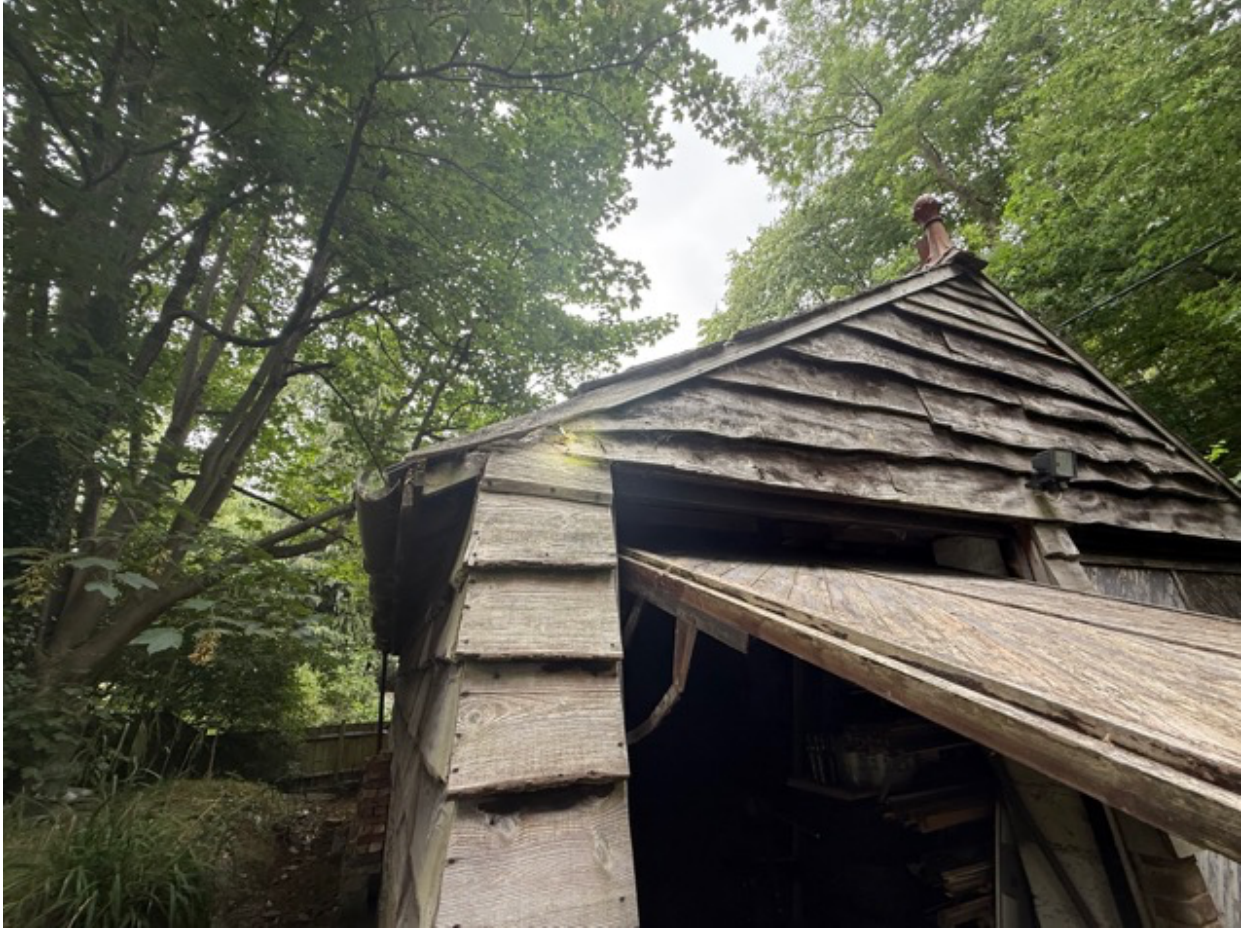
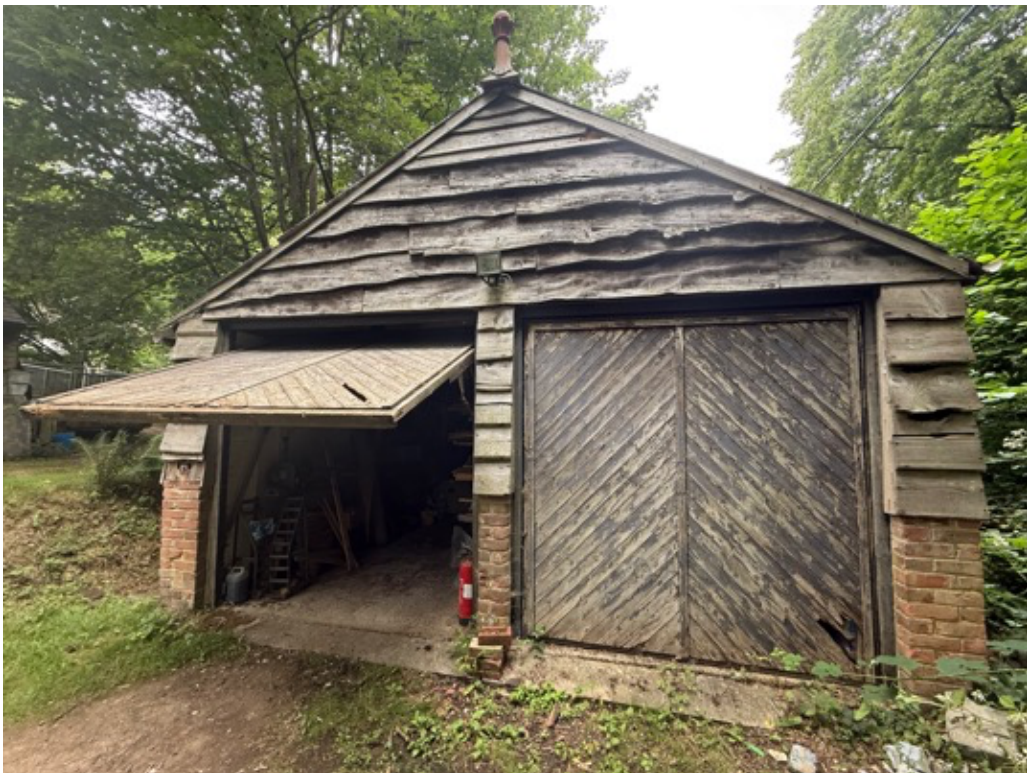
B4 is a detached single-storey structure located toward the rear of the site, positioned near the rear garden boundary. It is of timber construction with a shallow pitched corrugated roof and timber cladding. The building appears to be used as a storage area and workshop.

- The external walls are clad with overlapping horizontal timber panels, some of which appear weathered and slightly warped, creating potential crevices.

The building exhibits features that could support crevice-dwelling bats, including lifted timber cladding and gaps under roof sheeting. The presence of nearby vegetation and the semi-natural rear garden setting adds to its ecological value. B4 is assessed as having low bat roosting potential.
