## Preliminary Roost Assessment

Boughurst Farm, Leywood Road, Meopham, Gravesend, Kent DA13 0UD

This report is prepared to inform a planning application with the Gravesham Borough Council. The proposal is described as: A two-story rear extension providing a new kitchen area and bedroom above.

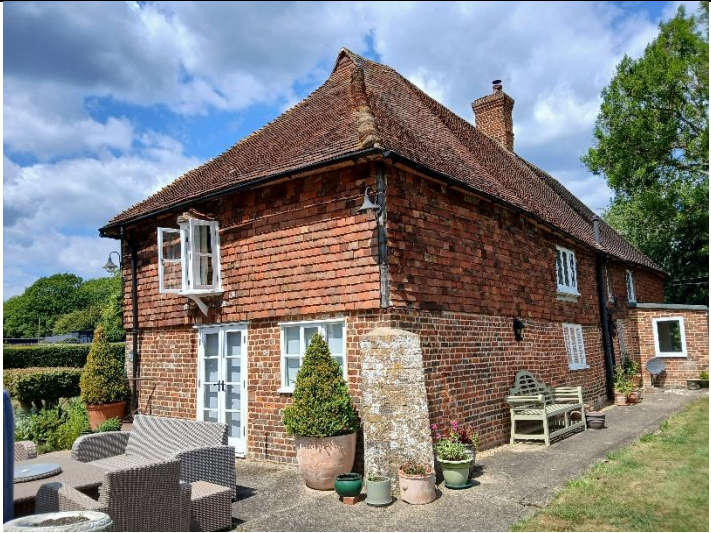
| | | Buildings and trees to be impacted by the proposed development are assessed for their suitability to support roosting bats below. There is a total of 1 building on site; the main dwelling (B1). Evidence of roosting bats was identified within B1, see below. |
|---|---|---|
| <p><i>Summary</i></p> <p>B1 is a double storey brick built residential dwelling. The walls are lined with clay hanging tiles on the second storey, along all elevations. The windows and doors are timber framed. There are timber soffits along all elevations. The roof is hipped with clay tiles. There is one chimney present. There is one internal void within B1 (see below). &gt;1000 Brown long eared bat droppings were identified within the loft void of B1.</p> <p>The building has <b>high habitat value</b>.</p> | | |

| <i>Recommendations</i> | <p><b><u>Roosting Habitat [Buildings]</u></b></p> <p>Three bat emergence/re-entry surveys are required on B1 during the active bat season (May – September) to confirm presence/likely-absence of bats roosting in or on the building. These survey visits should be completed during the optimal survey period mid-May to August inclusive. The survey visits should be at least three weeks apart.</p> <p>Two surveyors are required to provide full coverage of the building's elevations to look for emerging/re-entering bats. Surveyors will be equipped with infrared cameras to see where any specific roost locations are located.</p> <p>If any bat roosts are confirmed from this survey schedule, a bat license would be required to demolish the buildings as it would involve the destruction of roosts. This is applied for with the help of a class 2 licensed bat ecologist after planning permission is granted, but before commencement of works. Lighting mitigation may be required based on the outcome of the night bat survey(s).</p> <p><b><u>Foraging and Commuting Habitat</u></b></p> |

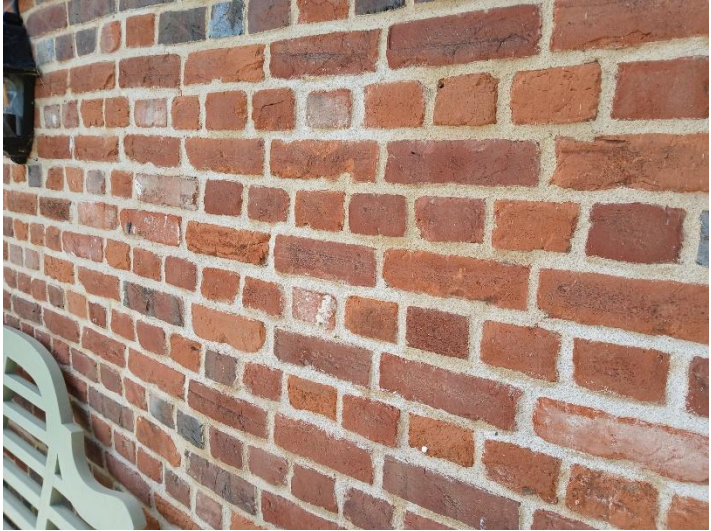
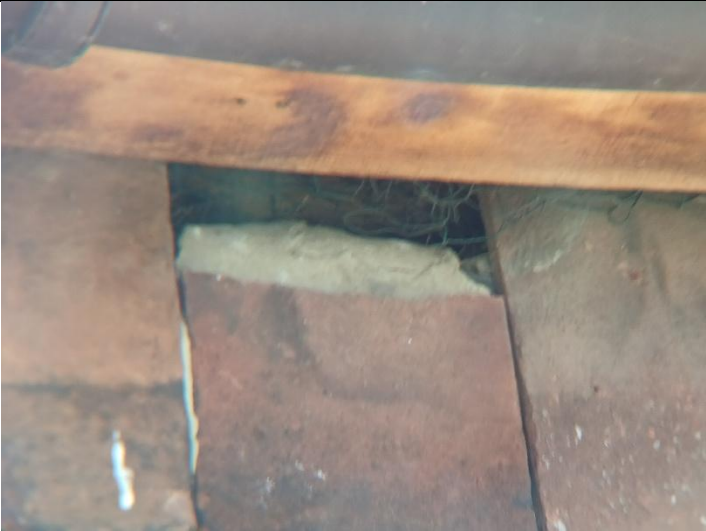
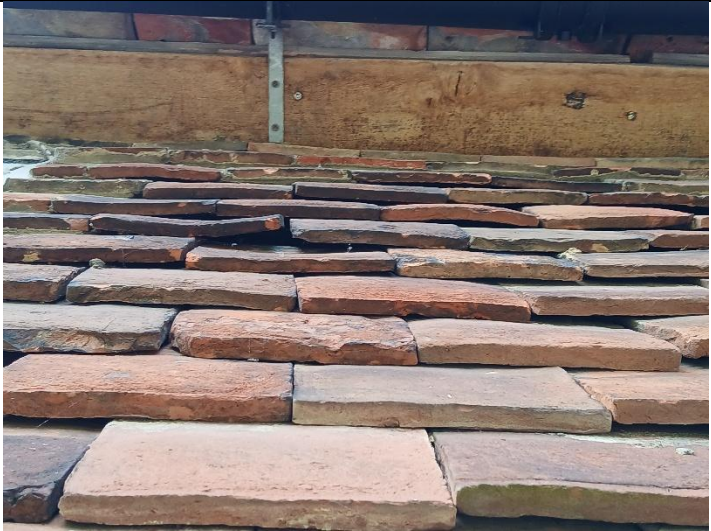
| <p>Brick built walls, with clay hanging tiles along the second storey.</p> | <p><b>Condition/Description</b></p> <p>Brick work is in good condition with no cracks or gaps. Clay hanging tiles are lifted in several places. A hanging tile is slipped creating a large gap under the soffit at the southwestern corner of B1.</p> <p><b>Suitability/Access/Evidence of Bats</b></p> <p>Gaps beneath hanging tiles could provide opportunities for crevice dwelling species. Slipped hanging tiles can provide access into the loft void.</p> | |

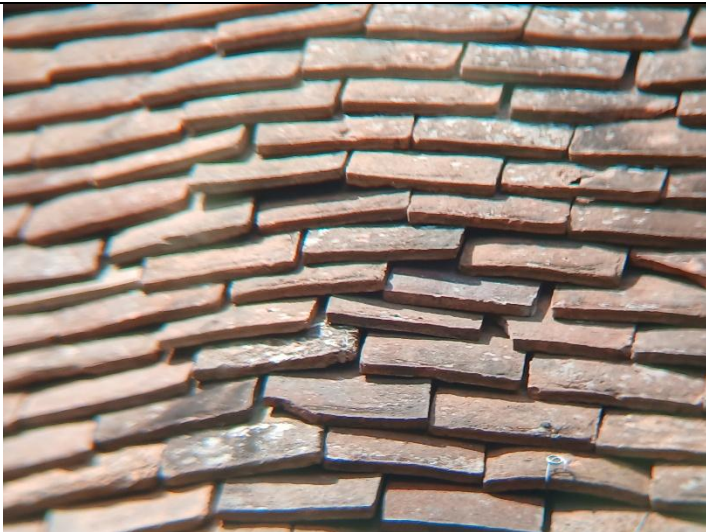
| Clay roof tiles | <p><b>Condition/Description</b></p> <p>Multiple slipped/raised tiles across the roof.</p> <p><b>Suitability/Access/Evidence of Bats</b></p> <p>Slipped/raised tiles may provide access into the loft void as well as provide opportunities for crevice dwelling species.</p> | |

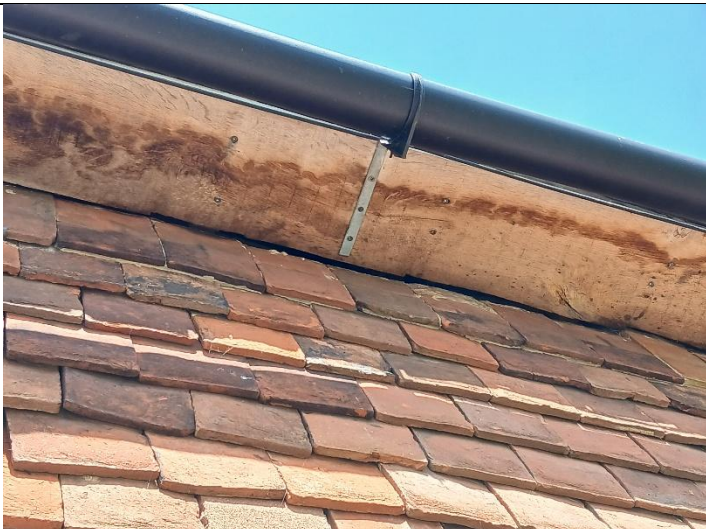
| Timber soffits | <p><b>Condition/Description</b></p> <p>Linear gap between the façade of the building and the soffit along all elevations.</p> <p><b>Suitability/Access/Evidence of Bats</b></p> <p>Provides possible bat access into internal void.</p> | |

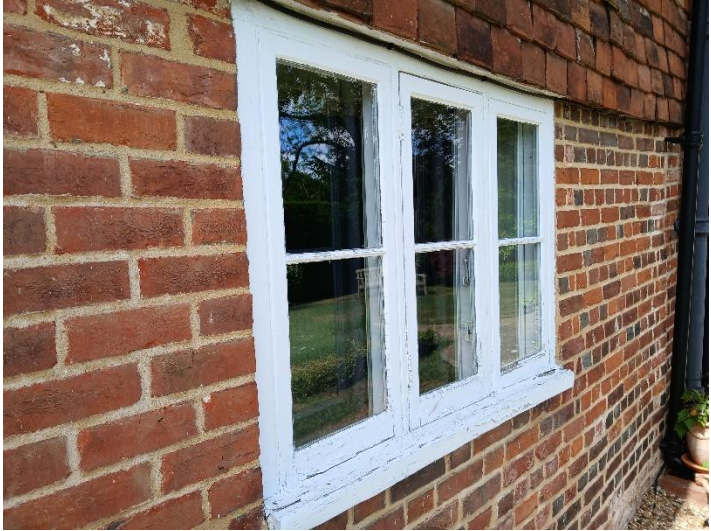
| Timber framed window/doors | <p><b>Condition/Description</b></p> <p>Well-sealed.</p> <p><b>Suitability/Access/Evidence of Bats</b></p> <p>N/A</p> | |

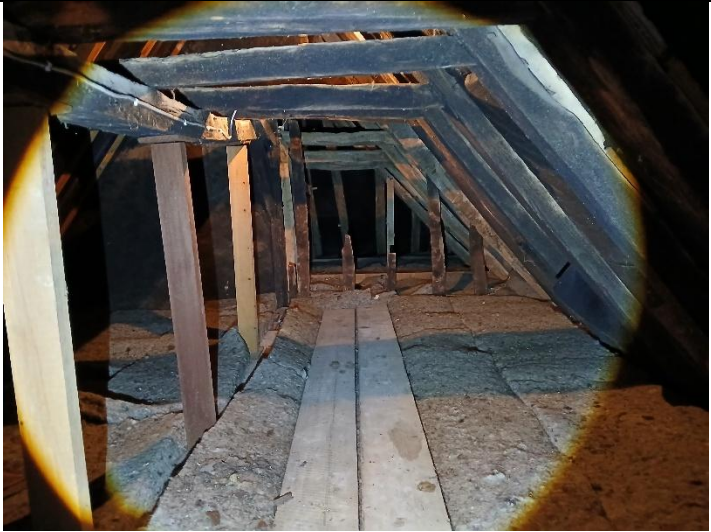
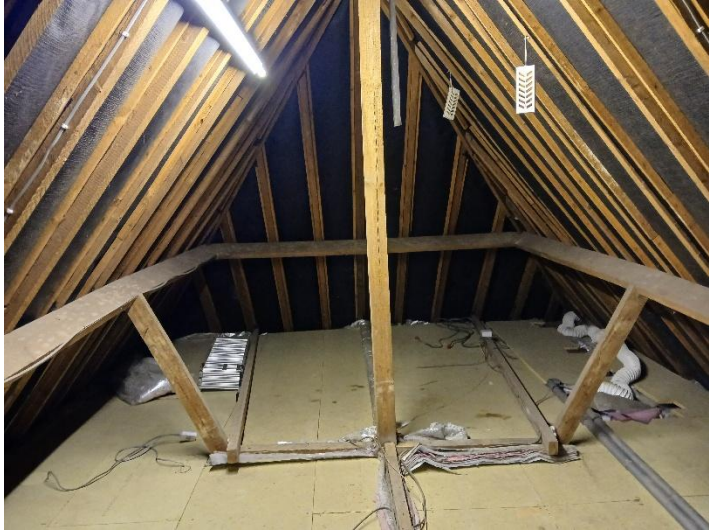
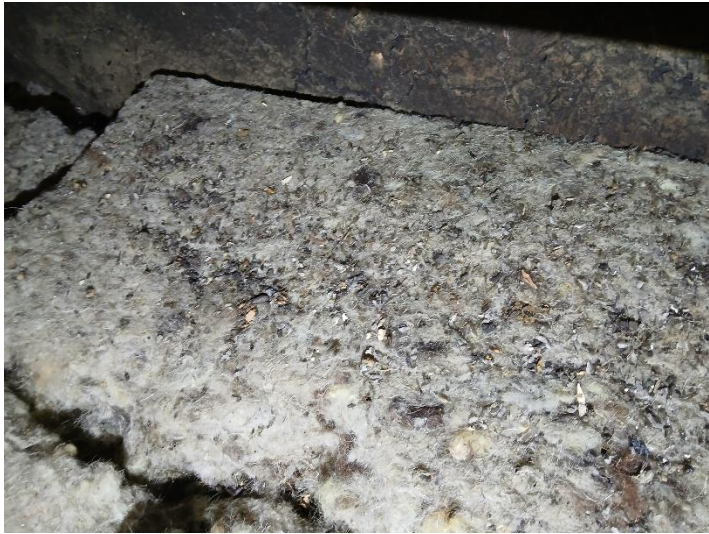
| Internal voids | <p><b>Condition/Description</b></p> <p>L1 is a rectangular loft that measures 14.7m long, 3.2m wide and 2.6m tall from the floor to the ridge.</p> <p>Conditions: 19.1°C, 41.1% RH.</p> <p>The roof is lined with plastic lining along all aspects of the loft. The floors are insulated with mineral wool. The loft is supported by timber beams. The loft is largely empty with only a few stored household items.</p> <p><b>Suitability/Access/Evidence of Bats</b></p> | |

| | <p>High numbers (&gt;1000) bat droppings were found on the floor of the loft. Samples were collected for DNA analysis. The results of the DNA analysis reveal these are brown long eared bat droppings.</p> <p>No estimates can be made of species, roost type at this stage, however the large volume of droppings indicates a possible maternity roost. Furthermore, the droppings were scattered across the entire loft, suggesting this is a long standing roost. Bat dropping locations shown in appendix 1. High numbers of insect remains such as wings were also identified.</p> <p>The loft lining is damaged in multiple places, allowing access into the loft void, via slipped/raised tiles.</p> | |

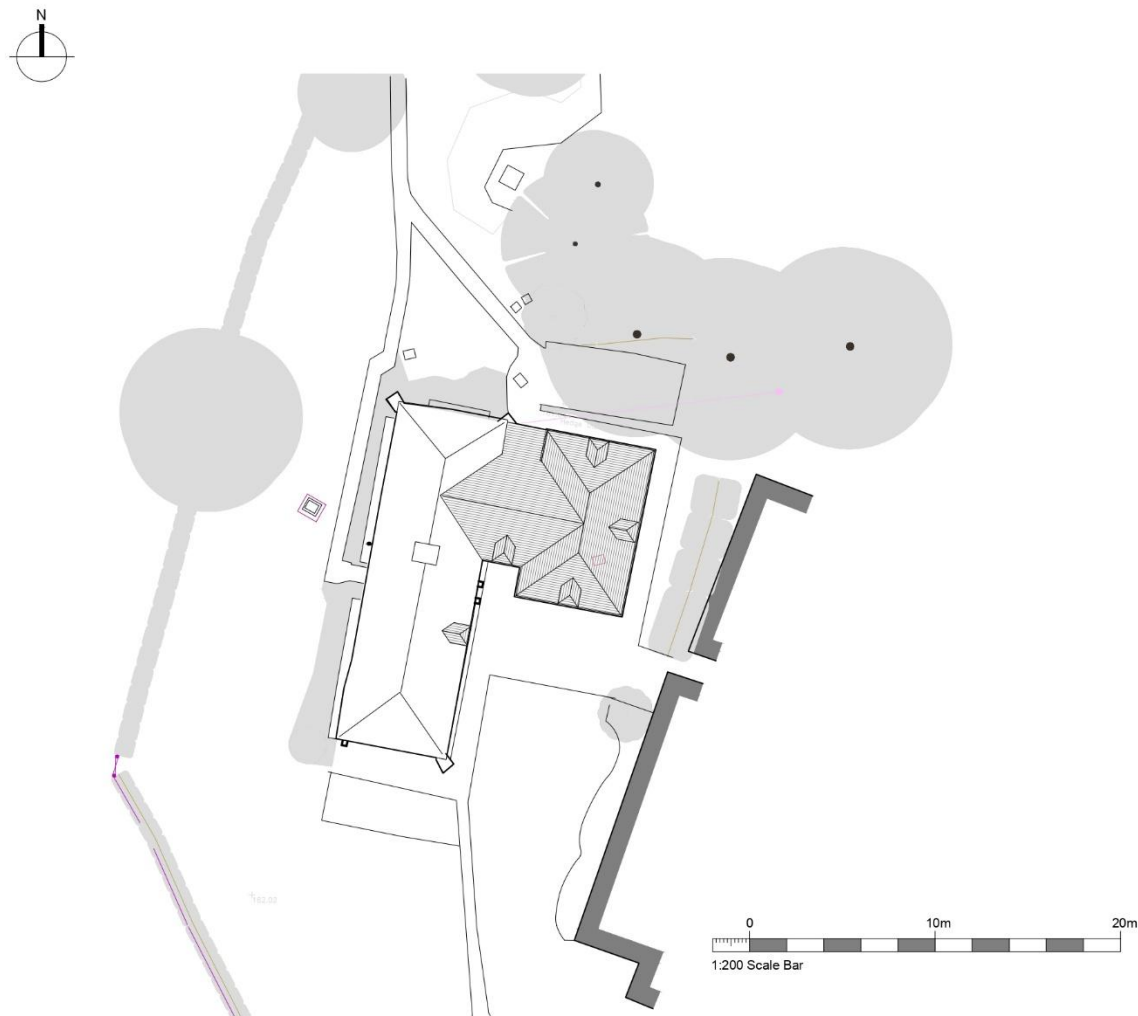
Appendix 3: Proposed plan

| | <p>The proposed development will result in the construction of a double storey extension to the northeast elevation. This will involve a part removal of the existing roof and loft structure. This could result in the destruction of any bat roosts present and could cause disturbance, death or injury to bats.</p> <p><b><u>Foraging and Commuting Habitat</u></b></p> <p>The proposed development will not result in the removal of any habitats which could be used by foraging or commuting bats.</p> <p><b><u>Artificial Lighting</u></b></p> <p>No new lighting will be installed as a result of the proposed development.</p> |

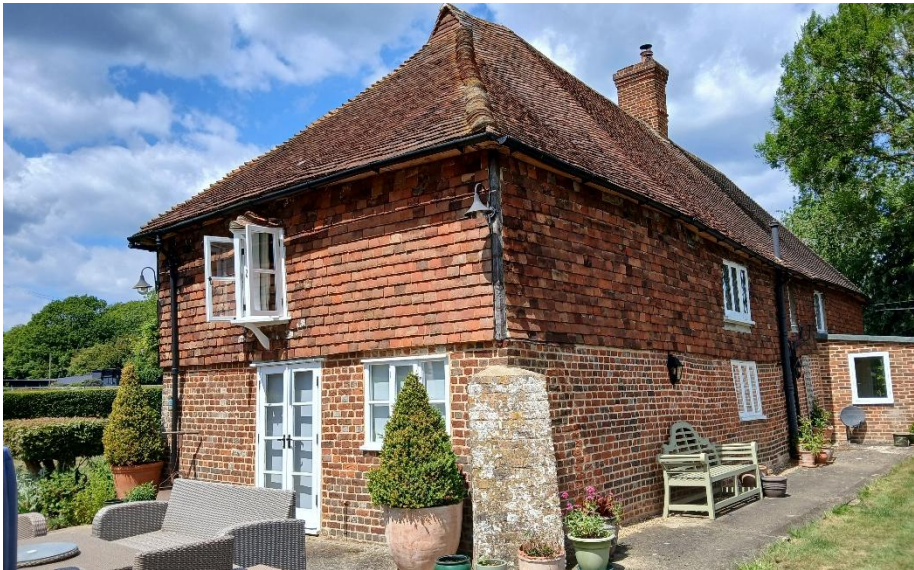
*Figure 1. Southern and eastern elevations of B1.*

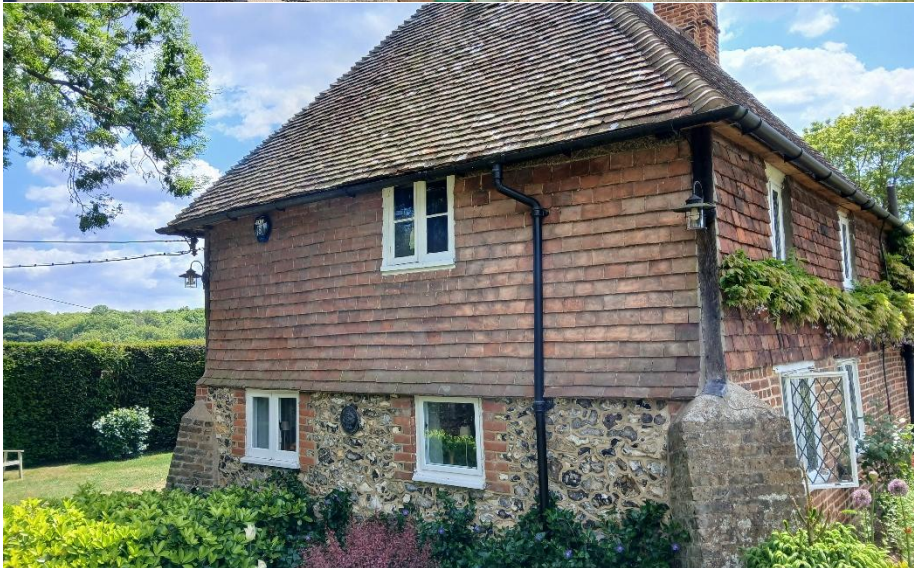
*Figure 2. Northern and western elevations of B1.*
