## **Preliminary Roost Appraisal**

Milton Mount Scout Hut

Clients Name: Wakes Ltd.

Date of Completion: 30/11/21

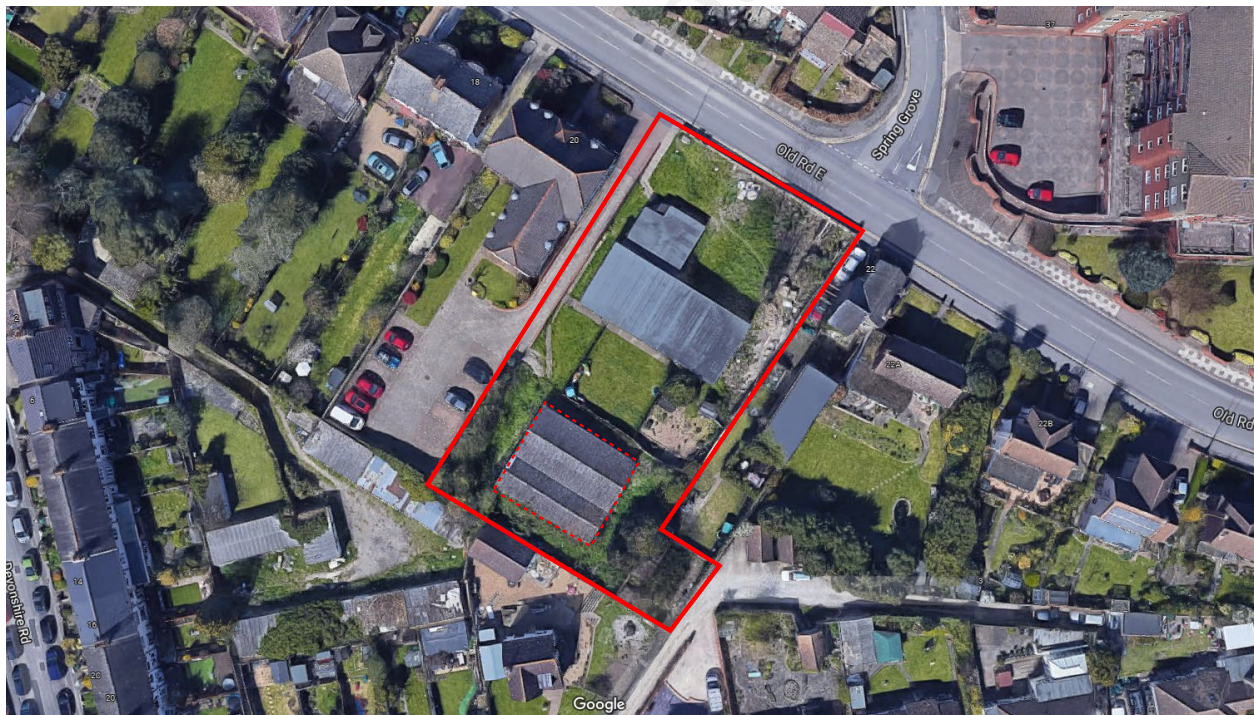
Figure 1 below shows the extent of the site and the immediate surrounding habitat. Figure 2 shows the site situated within the dense urban sprawl that makes up the wider area.

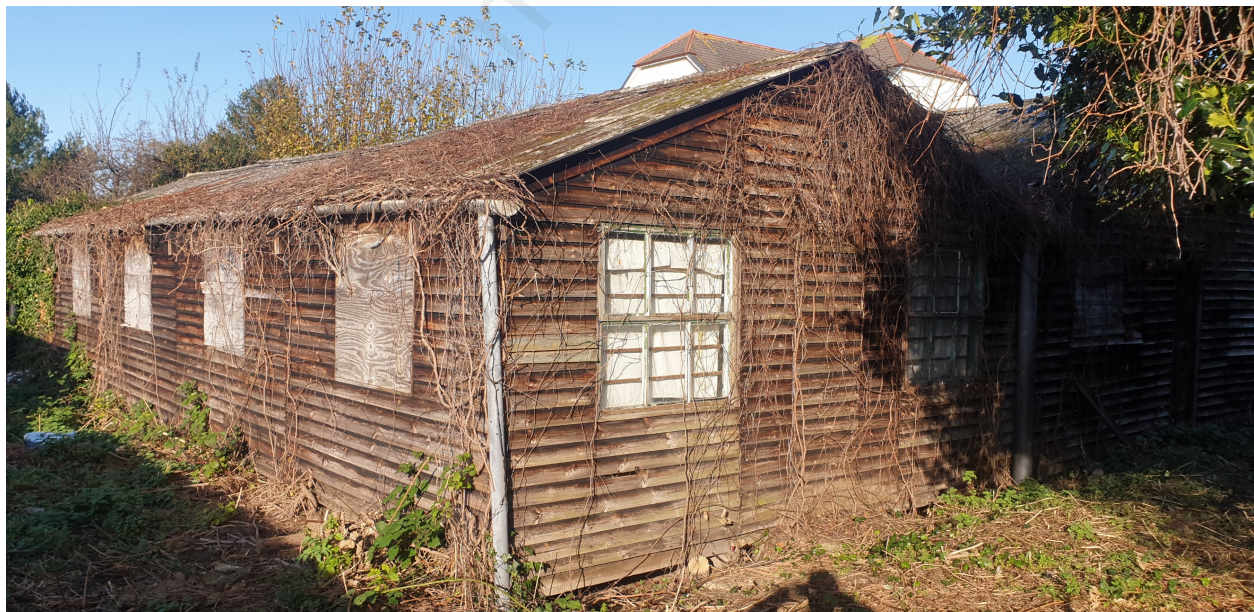
The site comprises the scout hut, which is ostensibly two timber sheds abutted together side by side and some surrounding vegetation. The scout hut is of relatively lightweight construction with external weather cladding, a corrugated asbestos/concrete roof on part metal; part timber frame, with multiple timber-framed windows.

**Figure 3: view of scout hut from the north**

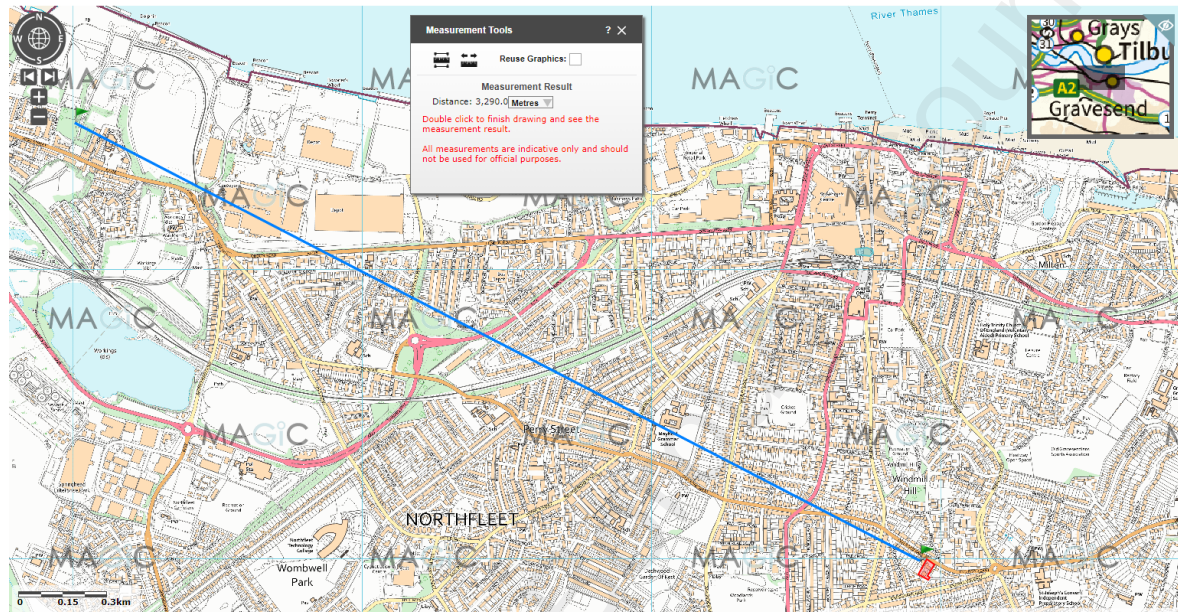
Figure 5: Nearest bat EPSL record

There were no European protected species licence (EPSL) applications for bats within 2km of the site. The nearest was c. 3290m northwest of the site at grid reference: TQ62017449 (2016-21327-EPS-MIT). This was for a common pipistrelle *Pipistrellus pipistrellus* roost. The distance between the site and the nearest recorded EPS return is shown in Figure 5 below.

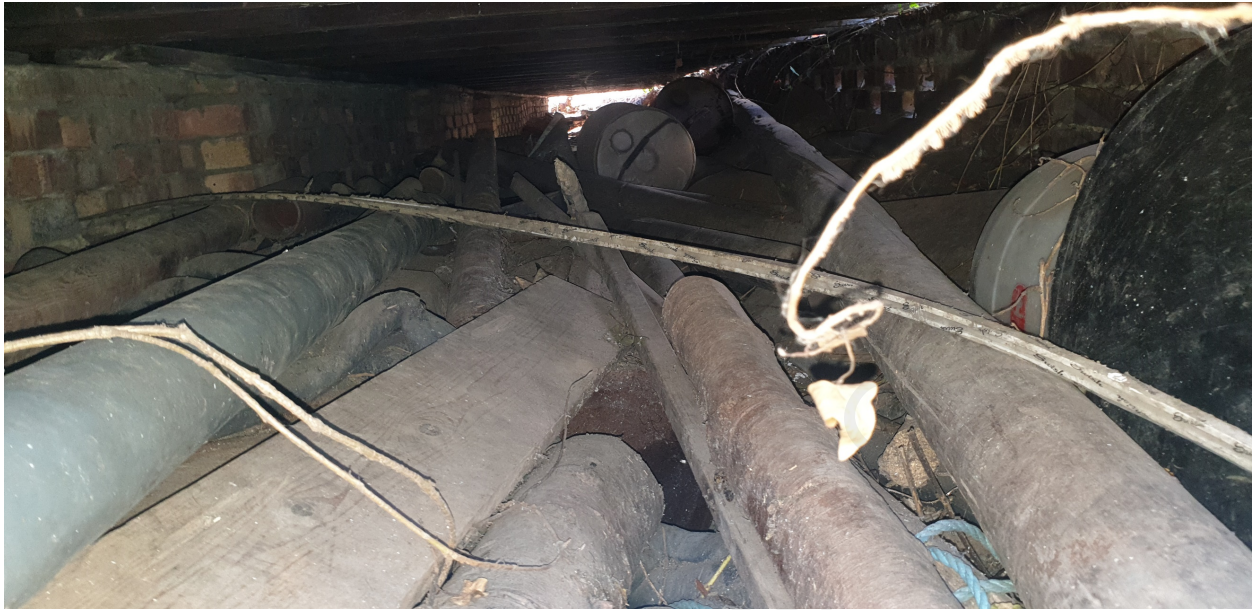
The scout hut sits on top of several linear brick plinths which run parallel to the apexes of the sheds. This has created several partitioned voids beneath the scout hut; presumably to combat rising damp. A photo showing a partition beneath the south westernmost part of the shed is reproduced in Figure 5 below.

**Figure 6: View of part of the partitioned void beneath the shed**

These voids are open at both ends and strong airflow was experienced when looking through them at either end.

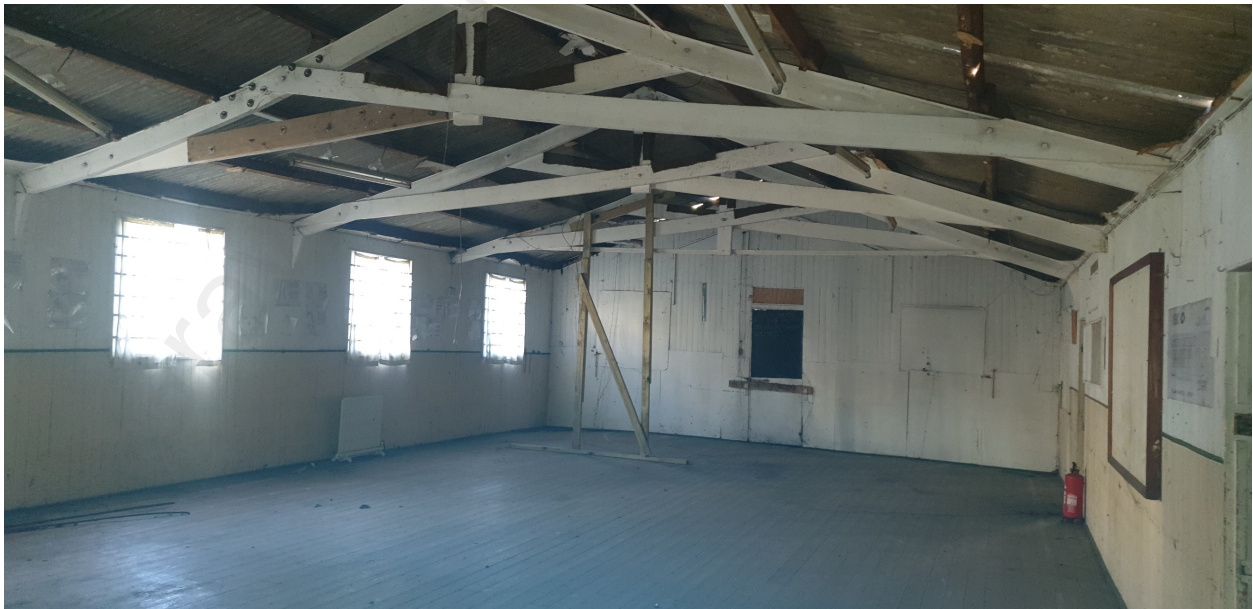
Bat field signs would have been obvious within the 'main hall' which had white painted walls and a fairly clean and painted floorboards as shown in Figure 6 below. With the number of potential openings, any visitation by bats to this area would have been conspicuous to an experienced and competent bat building surveyor but no signs of bat habitation were encountered despite extensive searches..

**Figure 7: view of the main hall**

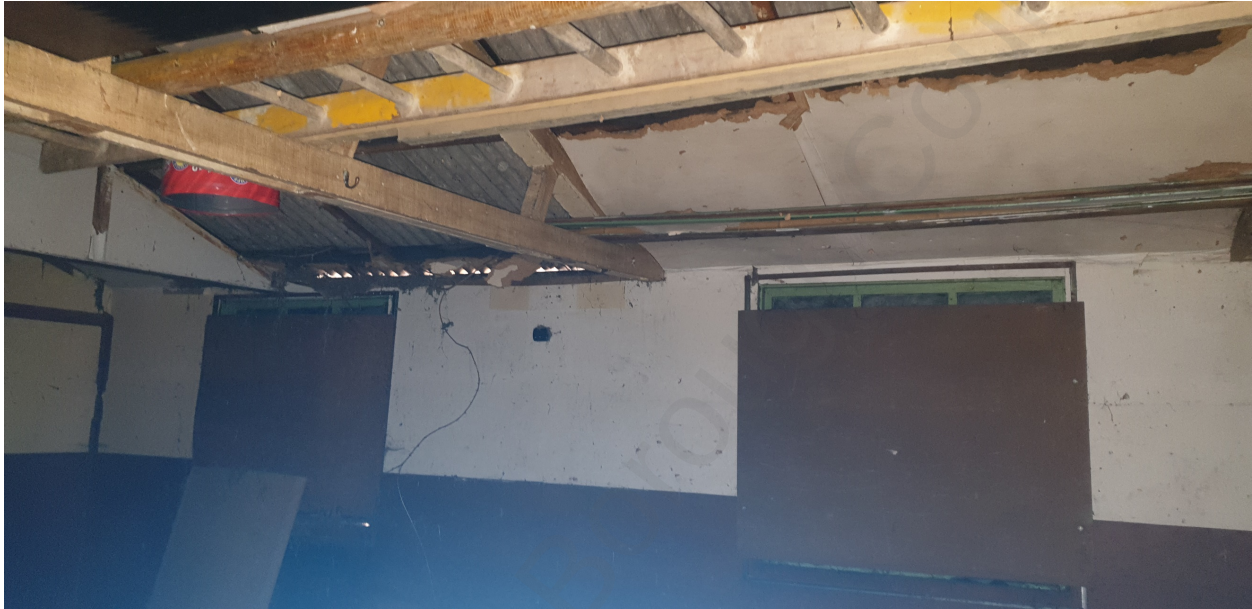
In all rooms much of the internal lining of the corrugated asbestos roof had been removed, reducing potential roosting opportunities for crevice dwelling species. Where the internal boarding remains it appeared to be a type of chipboard or fiber board with no evidence of any infill/insulation.

In the areas where boards and cavities remained, searches with survey mirrors and endoscopes found no signs of bat habitation. It is clear from the lack of any insulating material and structural layout that these voids would have been subject to substantial airflow, rendering it unsuitable for roosting bats. Figures 7 & 8 below show opposite sides of the scout hut (southeast and northwest respectively) all of which are open promoting airflow through the roof cavity and the entire building.

**Figure 8: open eaves on south east side**

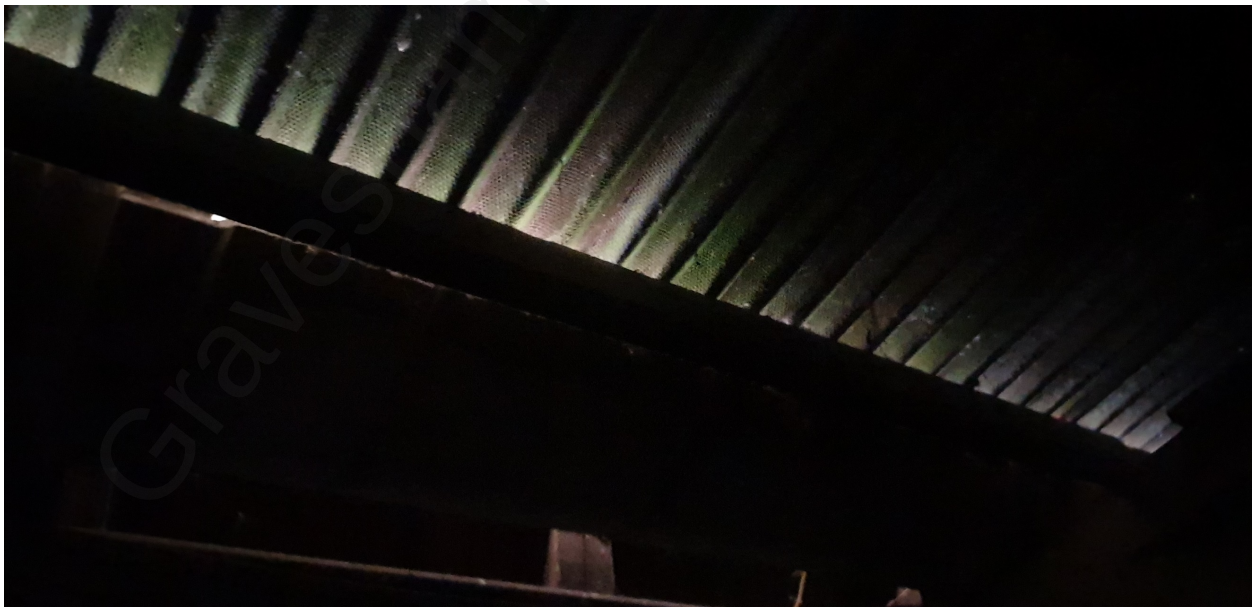
**Figure 9: View of open eaves on northwest of main hall. Photo taken in the dark**

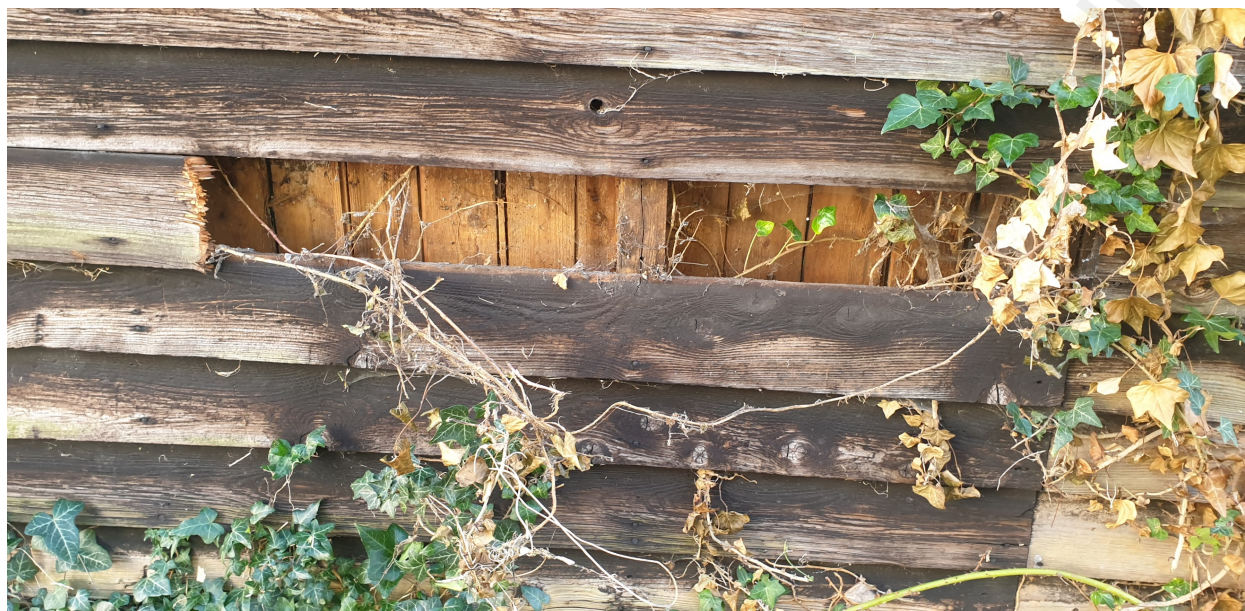
Cavities have been created within the walls with additional timber cladding throughout the internal space. The cavities between the internal and external coverings could not be fully inspected at the time of survey. Where loose boards were encountered these were pulled back or removed to assess the cavity and allow a further search for bat field signs. An area where boards were removed by the surveyor is shown in Figure 9 below.

**Figure 10: loose boards removed for inspection of the cavity between wall coverings**

In the areas inspected no insulating material or signs of bat habitation were found. However, these cavities have some suitability for crevice dwelling species of bat.

- It is recommended that the external boards covering the walls be removed by hand under the supervision of a qualified bat worker outside of the main activity season which is May – September to enable search for bat field signs within the cavities.
- A single board should be removed on each section allowing the bat worker to inspect the cavity before gradually opening it up further.
- Should any bat signs be found, work must stop.
