Boughurst Farm, Leywood Road, Harvel, Kent

## Bat Survey and Mitigation Strategy

5<sup>th</sup> December 2025 / Ref No 2025/06/16

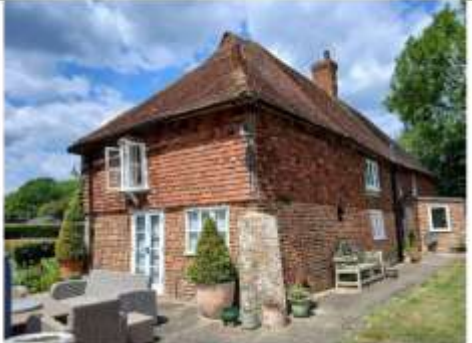
| B1 Building Description | Photographs |
|---|---|
| <p><b>Summary</b></p> <p>B1 is a double storey brick built residential dwelling. The walls are lined with clay hanging tiles on the second storey, along all elevations. The windows and doors are timber framed. There are timber soffits along all elevations. The roof is hipped with clay tiles. There is one chimney present. There is one internal void within B1 (see below). &gt;1000 Brown long eared bat droppings were identified within the loft void of B1.</p> <p>The building has <b>high habitat value</b>.</p> | |

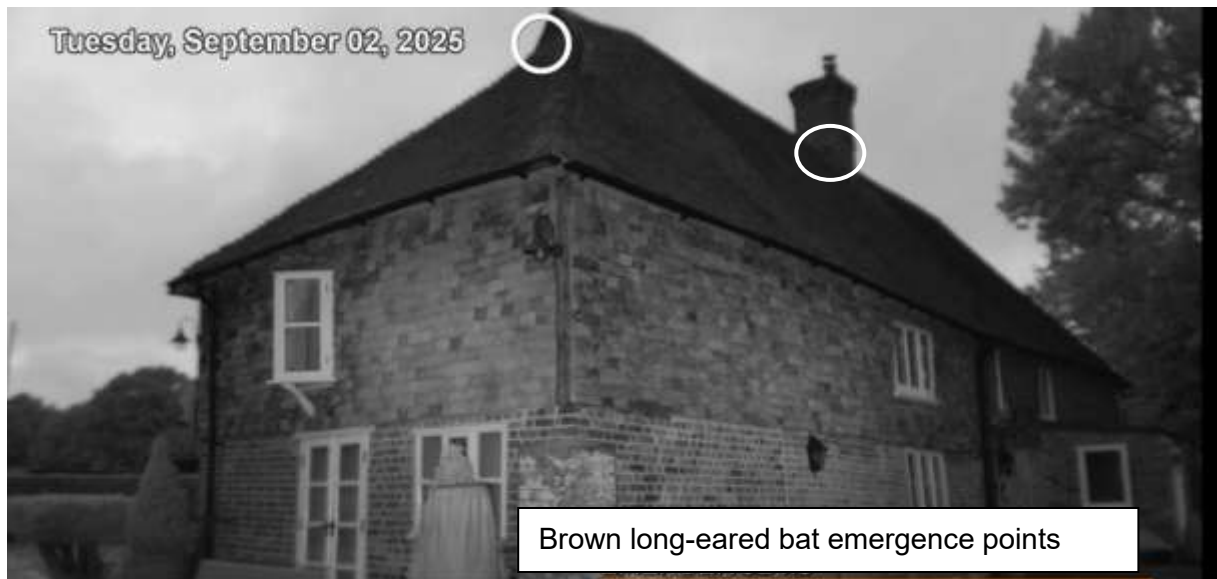
During the third survey (in early September 2025), five common pipistrelle emerged from different hanging tiles (from south and east elevations) and three brown long-eared bats emerged from the roof.

It should be noted that all the hanging and roof tiles offer suitable roosting opportunities and thus could be used by roosting bats.
