**Gads Hill School**  
**Gads Hill Place**  
**Gravesend Road. Higham.**  
**Rochester. ME3 7PA**

**Low Level Retaining Wall**  
**between Mansion and EYFS**  
**Remedial and Repair**  
**Measures**

| Scale | Date | Drawn By |
|---|---|---|
| 5516 | D-05 | |

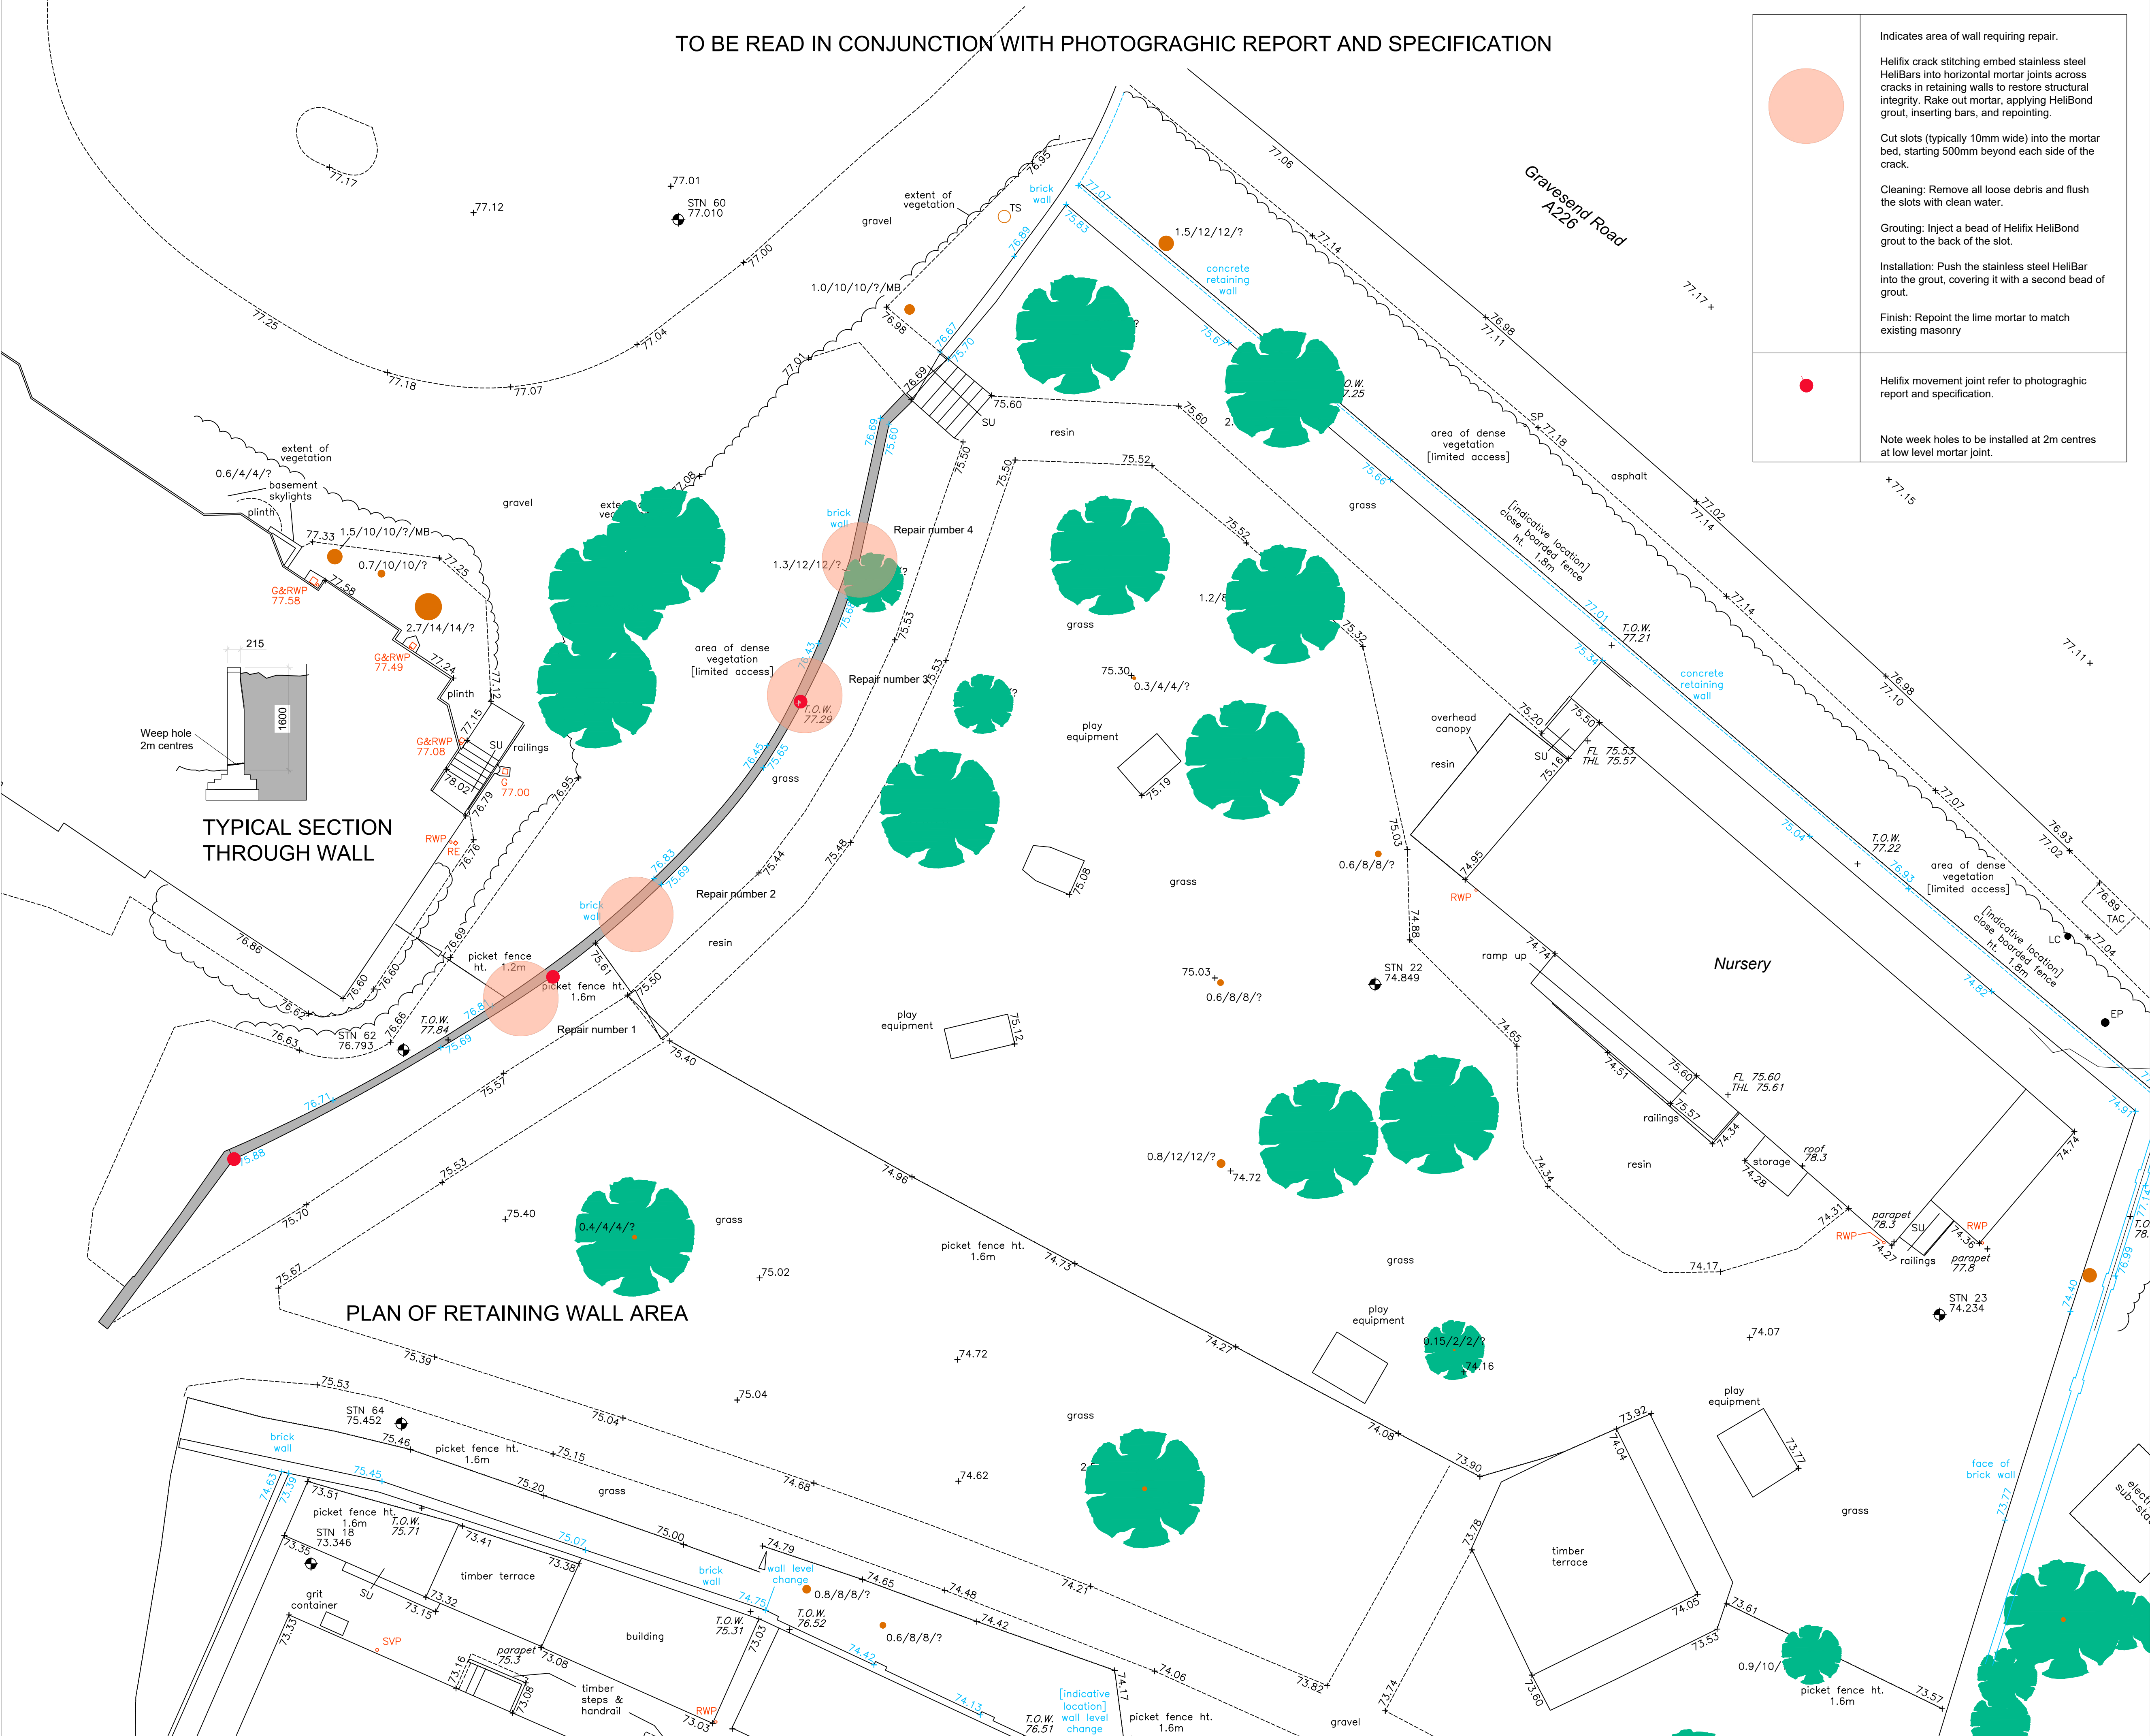
Indicates area of wall requiring repair.

Helifix movement joint refer to photographic report and specification.

Note week holes to be installed at 2m centres at low level mortar joint.

Helifix crack stitching embed stainless steel Helibars into horizontal mortar joints across cracks in retaining walls to restore structural integrity. Rake out mortar, applying HeliBond grout, inserting bars, and repointing.

Cut slots (typically 10mm wide) into the mortar bed, starting 500mm beyond each side of the crack.

Cleaning: Remove all loose debris and flush the slots with clean water.

Grouting: Inject a bead of Helifix HeliBond grout to the back of the slot.

Installation: Push the stainless steel HeliBar into the grout, covering it with a second bead of grout.

Finish: Repoint the lime mortar to match existing masonry
