# Technical Note

## Walking, Cycling and Horse-Riding Assessment and Review (GG 142)

### Former Tollgate Hotel, Gravesend

Project Number: 22052  
Doc Number: WCHAR01  
Prepared for: BP Pulse

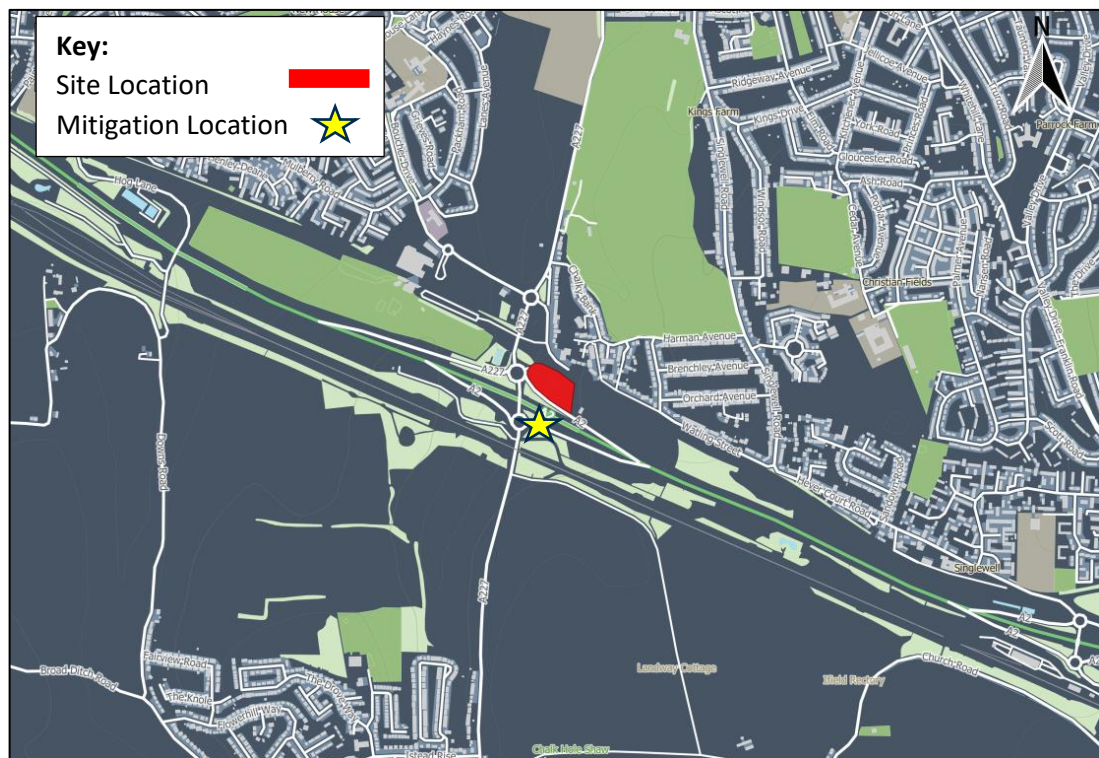
**Figure 2.1** Site Location

- 2.2.1 The proposed development lies to the south of Gravesend in Kent and to the north of the A2 with access derived from a dedicated arm of the A227 Wrotham Road / A2 eastbound slip road roundabout.
- 2.2.2 The site location is indicated in **Figure 2.1** below, with the corresponding location of the proposed capacity improvement scheme also highlighted on the A2 westbound off slip.

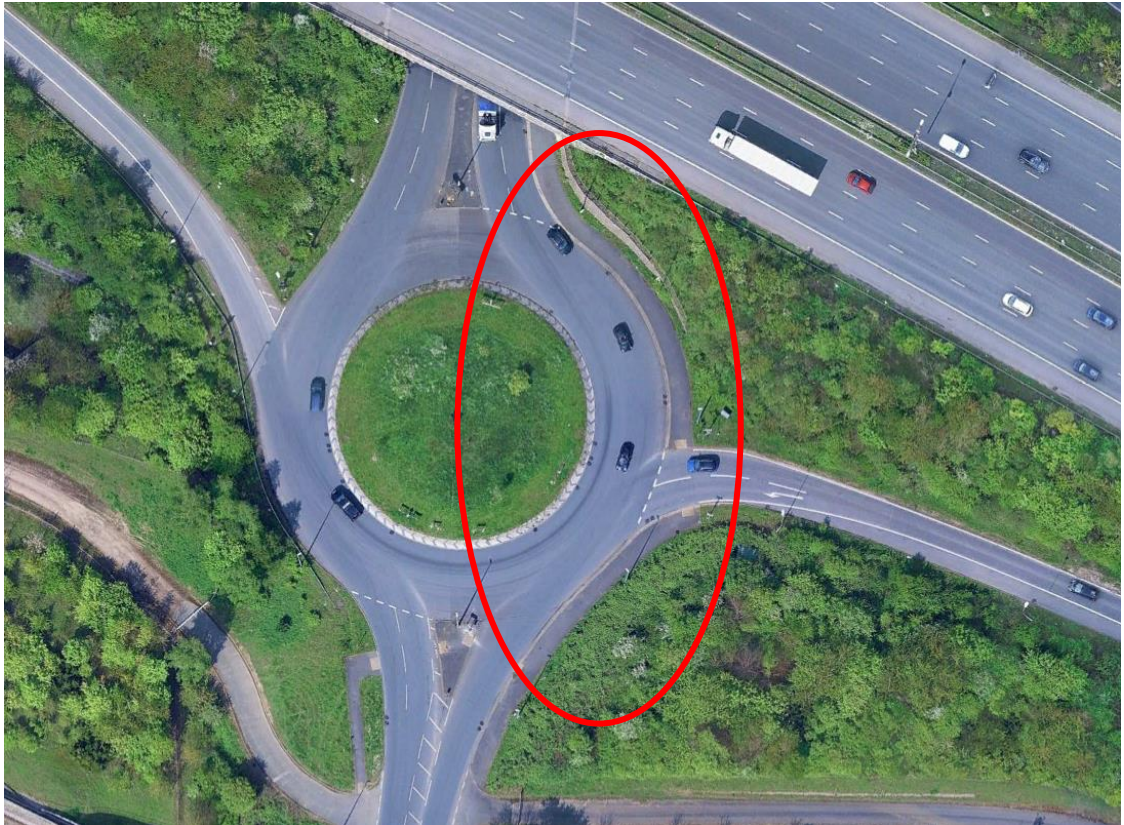
Figure 2.4 WCHAR Study Area

- 2.4.1 The study area for the WCHAR is shown below in **Figure 2.4**. This has been considered suitable by the Lead Assessor, as it is directly related to the proposed capacity improvement scheme. The area encompasses the existing slip road crossing and the shared footway / cycleway adjacent to the crossing.

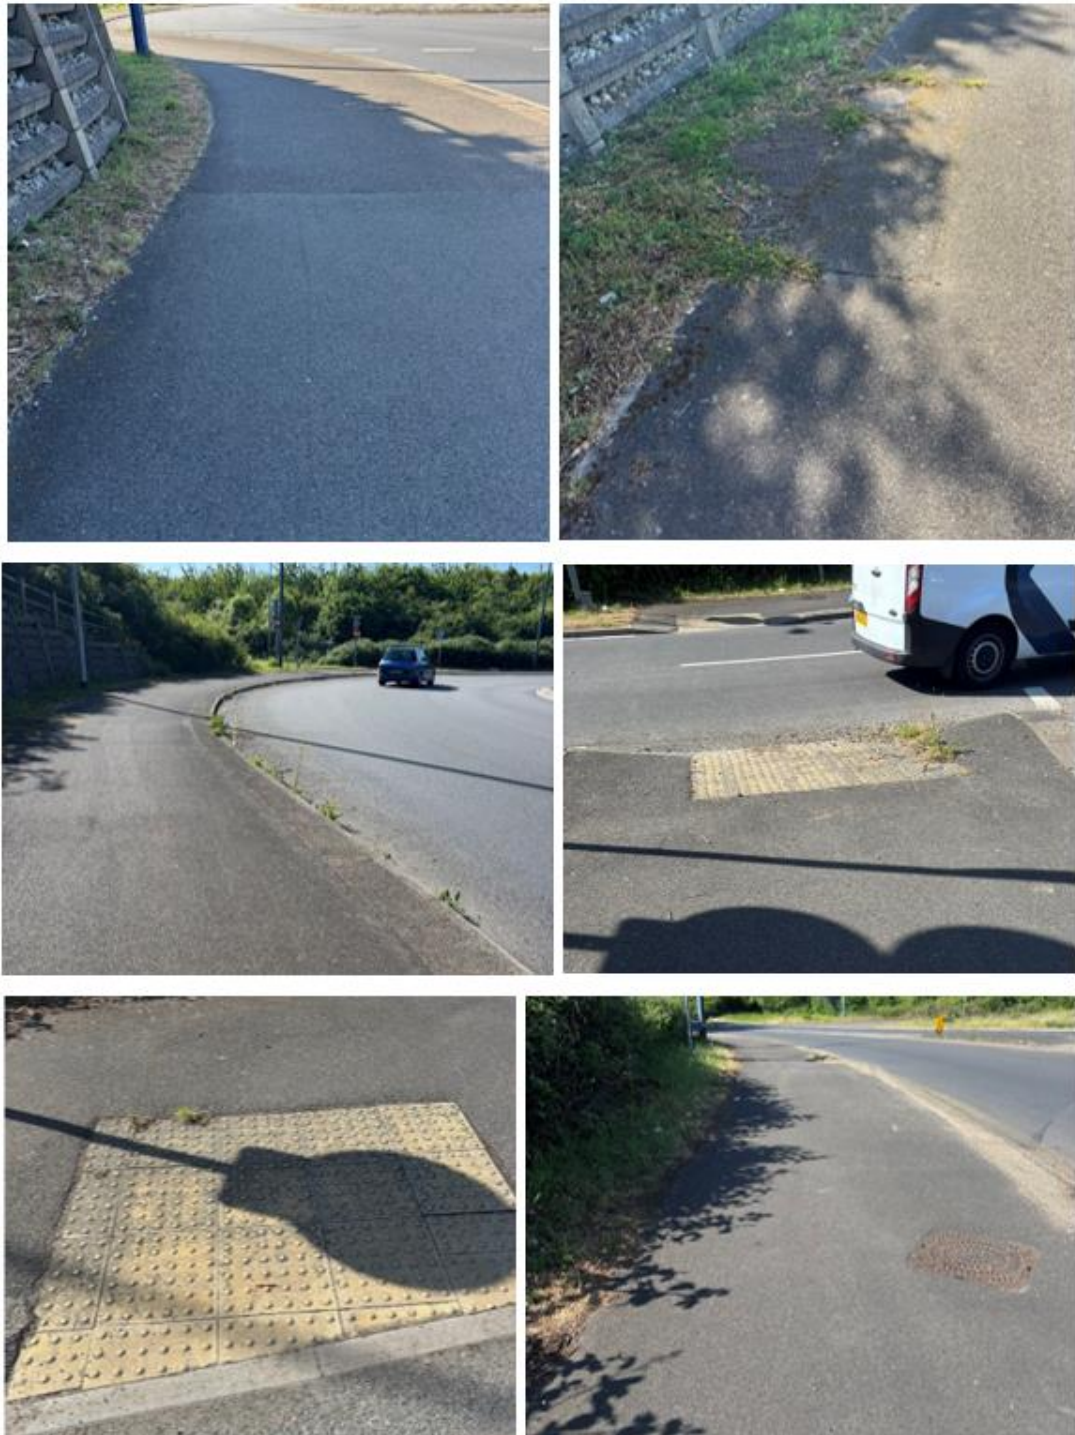
**Figure 3.1 Existing Infrastructure – WCHAR Study Area**

- 3.5.1 To ensure the onsite conditions have been suitably assessed, a site visit was conducted on Friday 23<sup>rd</sup> May 2025, during the morning (08:00-09:00) peak period. The site visit was attended by Emily Gardiner, where the study area was walked and photographed.
- 3.5.2 The weather during the visit was fine and dry. During the visit, no pedestrians or cyclists were observed.
- 3.5.3 The existing shared footway / cycleway facilities within the study were found to be maintained to a good standard, with no signs of damage. The existing dropped kerb, tactile paving crossing on the westbound off slip is in good condition and considered suitable to accommodate the needs of active travel users at this location. The shared footway / cycleway provision has a consistent width of 3.0m within the study area.

- 
- 3.5.4 In places, small elements of vegetation encroachment were observed with vegetation noted within the tactile paving. Vegetation was also observed within the edge of carriageway.
  - 3.5.5 Given the level of usage is likely to be very low as result of the location of the study area, it is considered that this provision is acceptable.
  - 3.5.6 Images confirming the condition of the study area are provided in **Figure 3.1** below.

- 4.3.2 Enhancements to the existing shared use facility through maintenance of existing vegetation to reduce encroachment onto the facility. Vegetation removal from the existing tactile paving to improve its condition.
