# National Grid Cable Tunnel Replacement Project

## Land Contamination Preliminary Risk Assessment Gravesend

December 2023

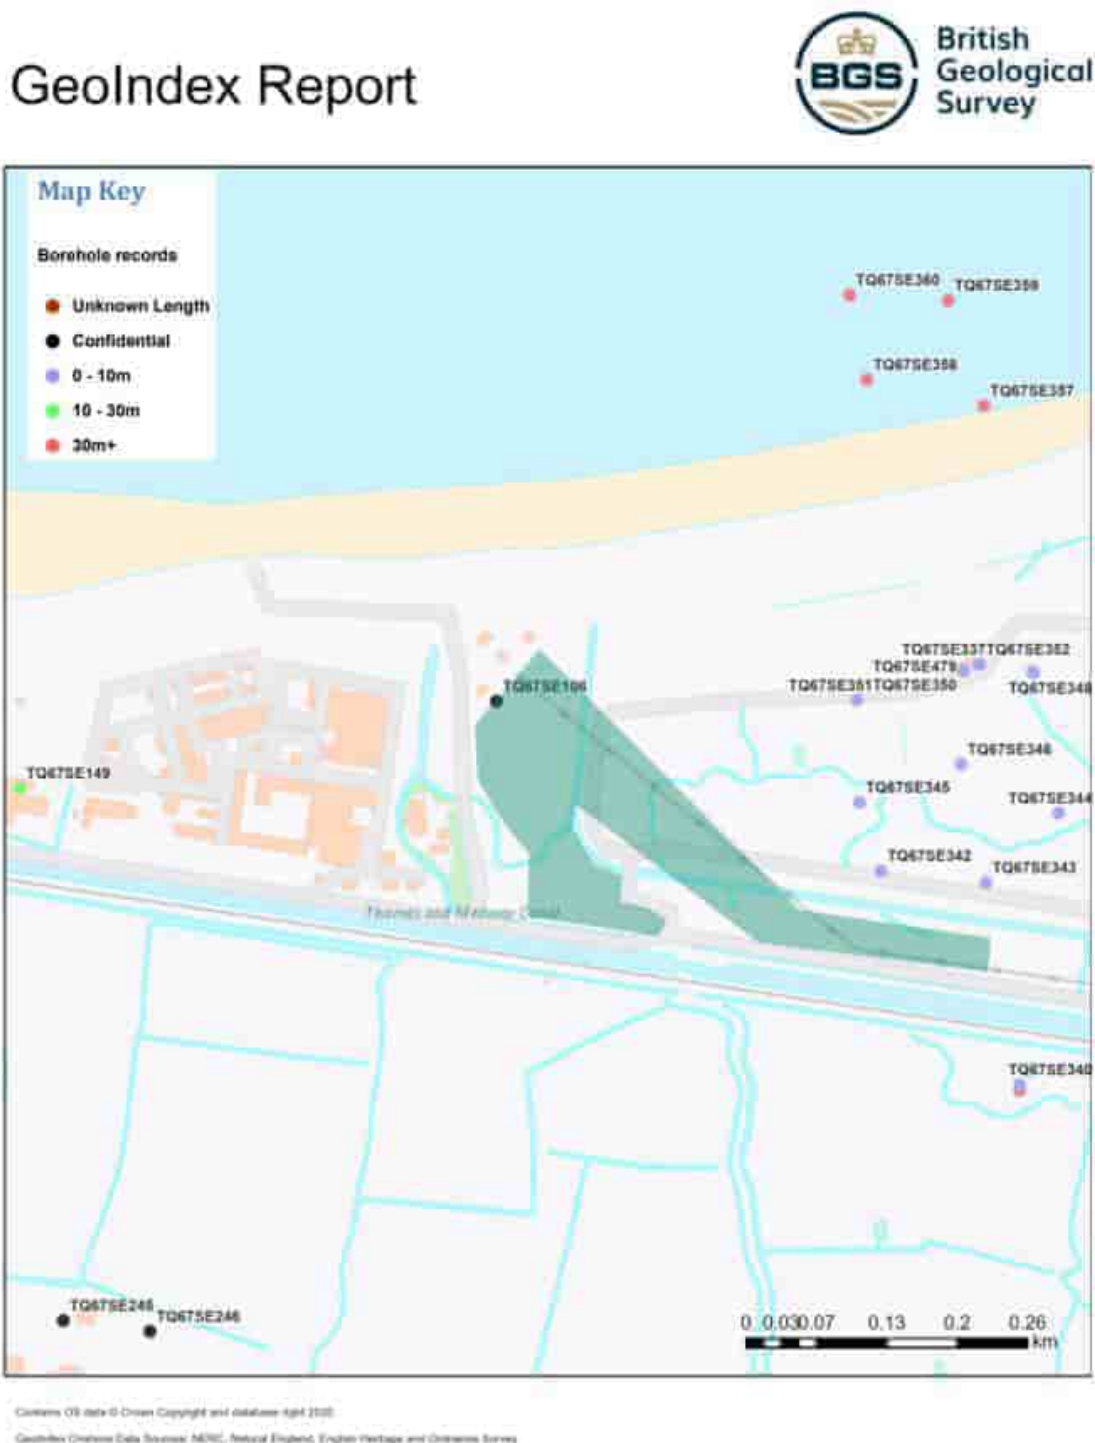
of the Preliminary Ground Model in Section 8. Note that records of some of the boreholes shown in Plate 3-1 were not available.

**Plate 3-1: Extract from BGS GeoIndex Online Viewer showing the relevant historical exploratory boreholes (the Site Boundary shown is approximate)**

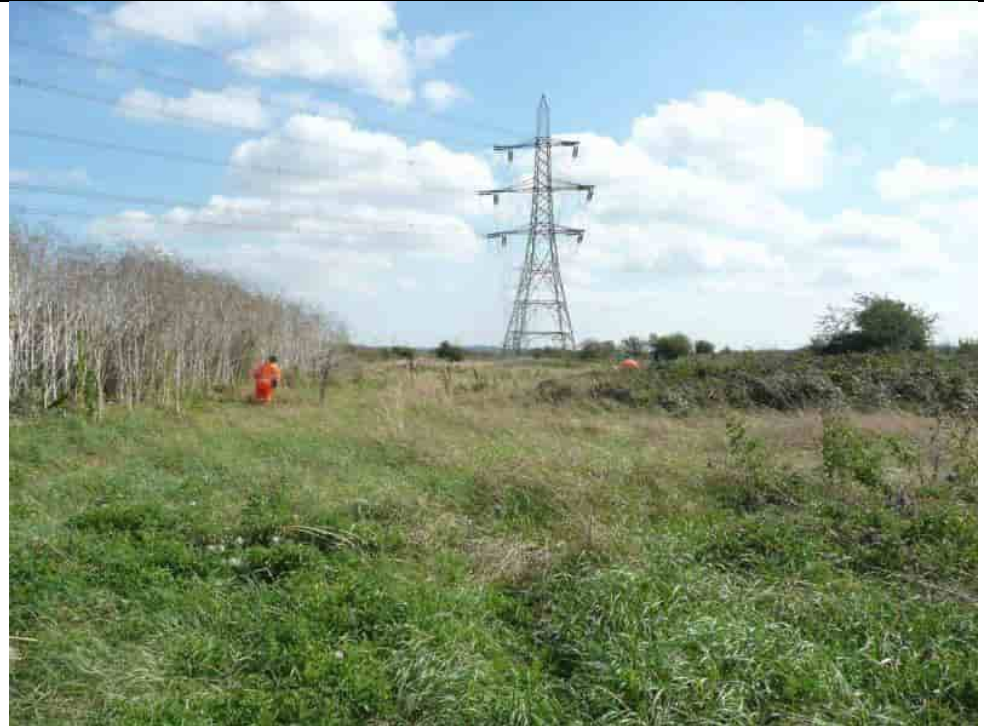
The Site is located within a vegetated area, characterised by rough grassland and bushes.

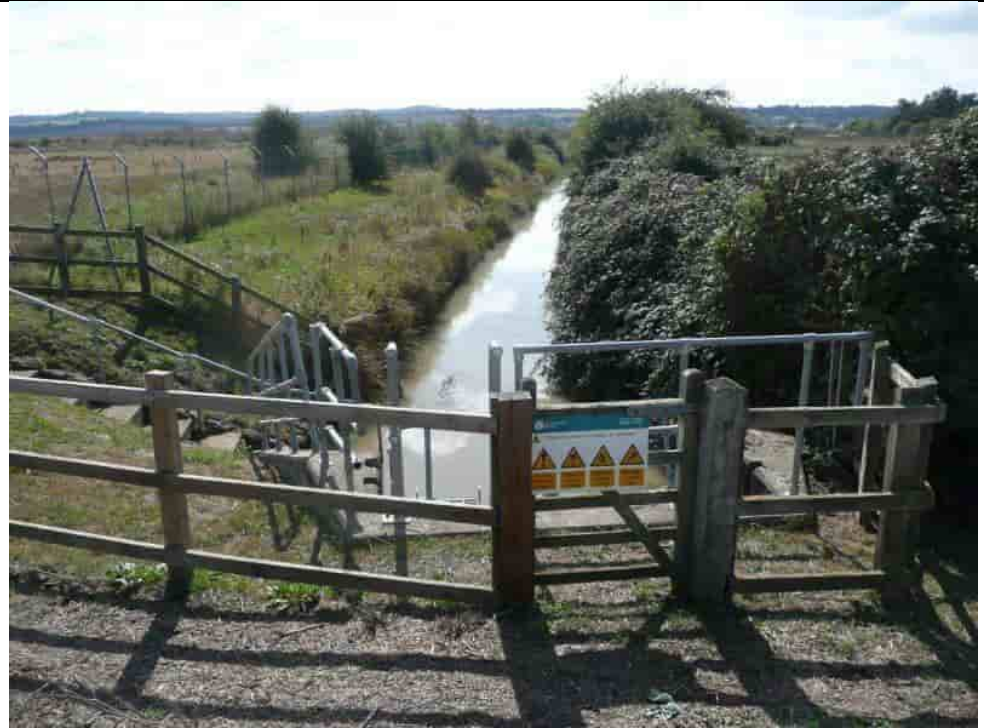
**Description**  
Several surface water drains are located on the Site. Photo shows the sluice gate / outfall which leads to the River Thames.

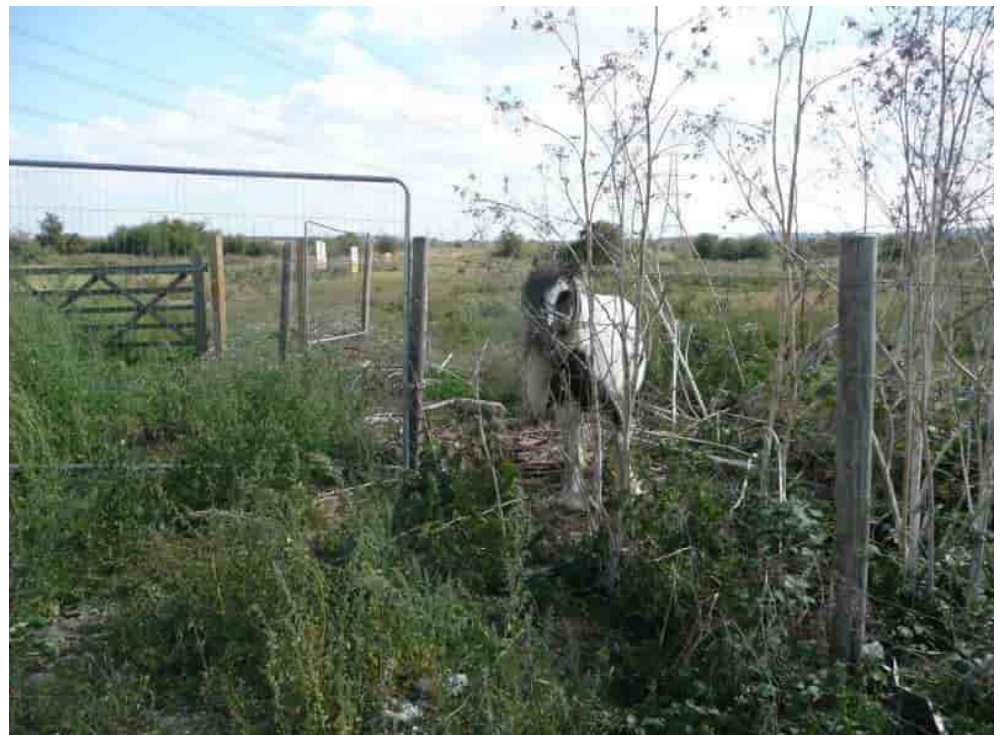
**Description**  
The eastern part of the Site was fenced with horses grazing.
