## **PHASE II GEO-ENVIRONMENTAL ASSESSMENT**

### **GRANGE TRAVEL COACH HIRE, CANAL ROAD, GRAVESEND, KENT, DA12 2RS**

GEO-GTCH-001-24

**Report Date:** 14<sup>th</sup> June 2024

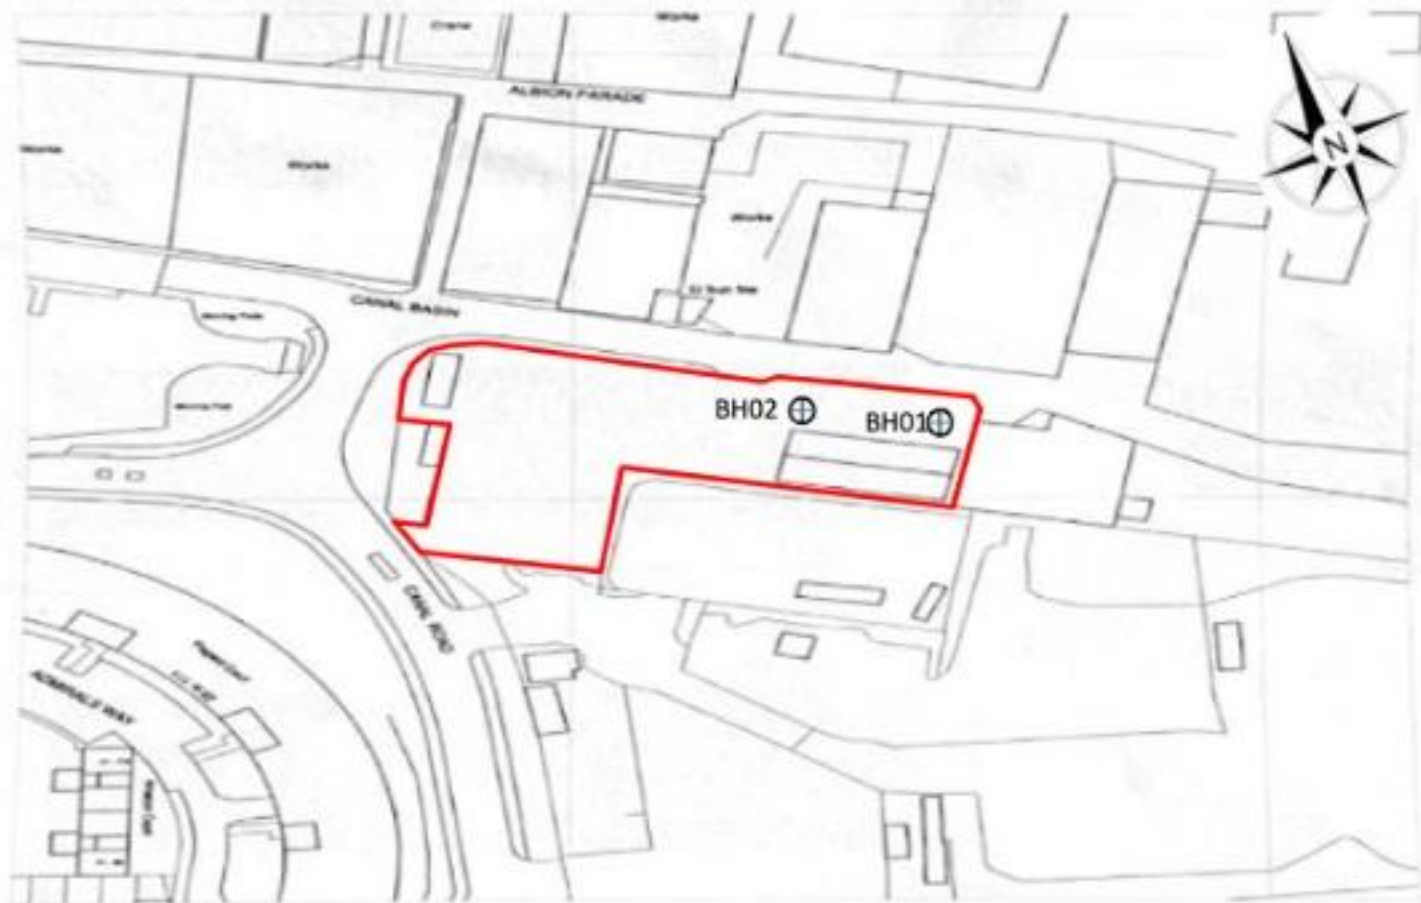
Block Plan

3.2.2 An exploratory hole location plan is provided in Appendix 4. Logging of exploratory holes was undertaken by an Engineer from GDGES. Depths of the exploratory holes, descriptions of strata encountered and comments on the groundwater conditions are presented in the borehole logs presented within Appendix 5.

- Exploratory Hole Location Plan
- Gas/groundwater Monitoring Installation Plan
