Land off Longfield Road, Meopham
Phase I Geo-Environmental Desk Study
September 2025

Report Ref: 29473-GEO-0402

CLIENT: Richborough

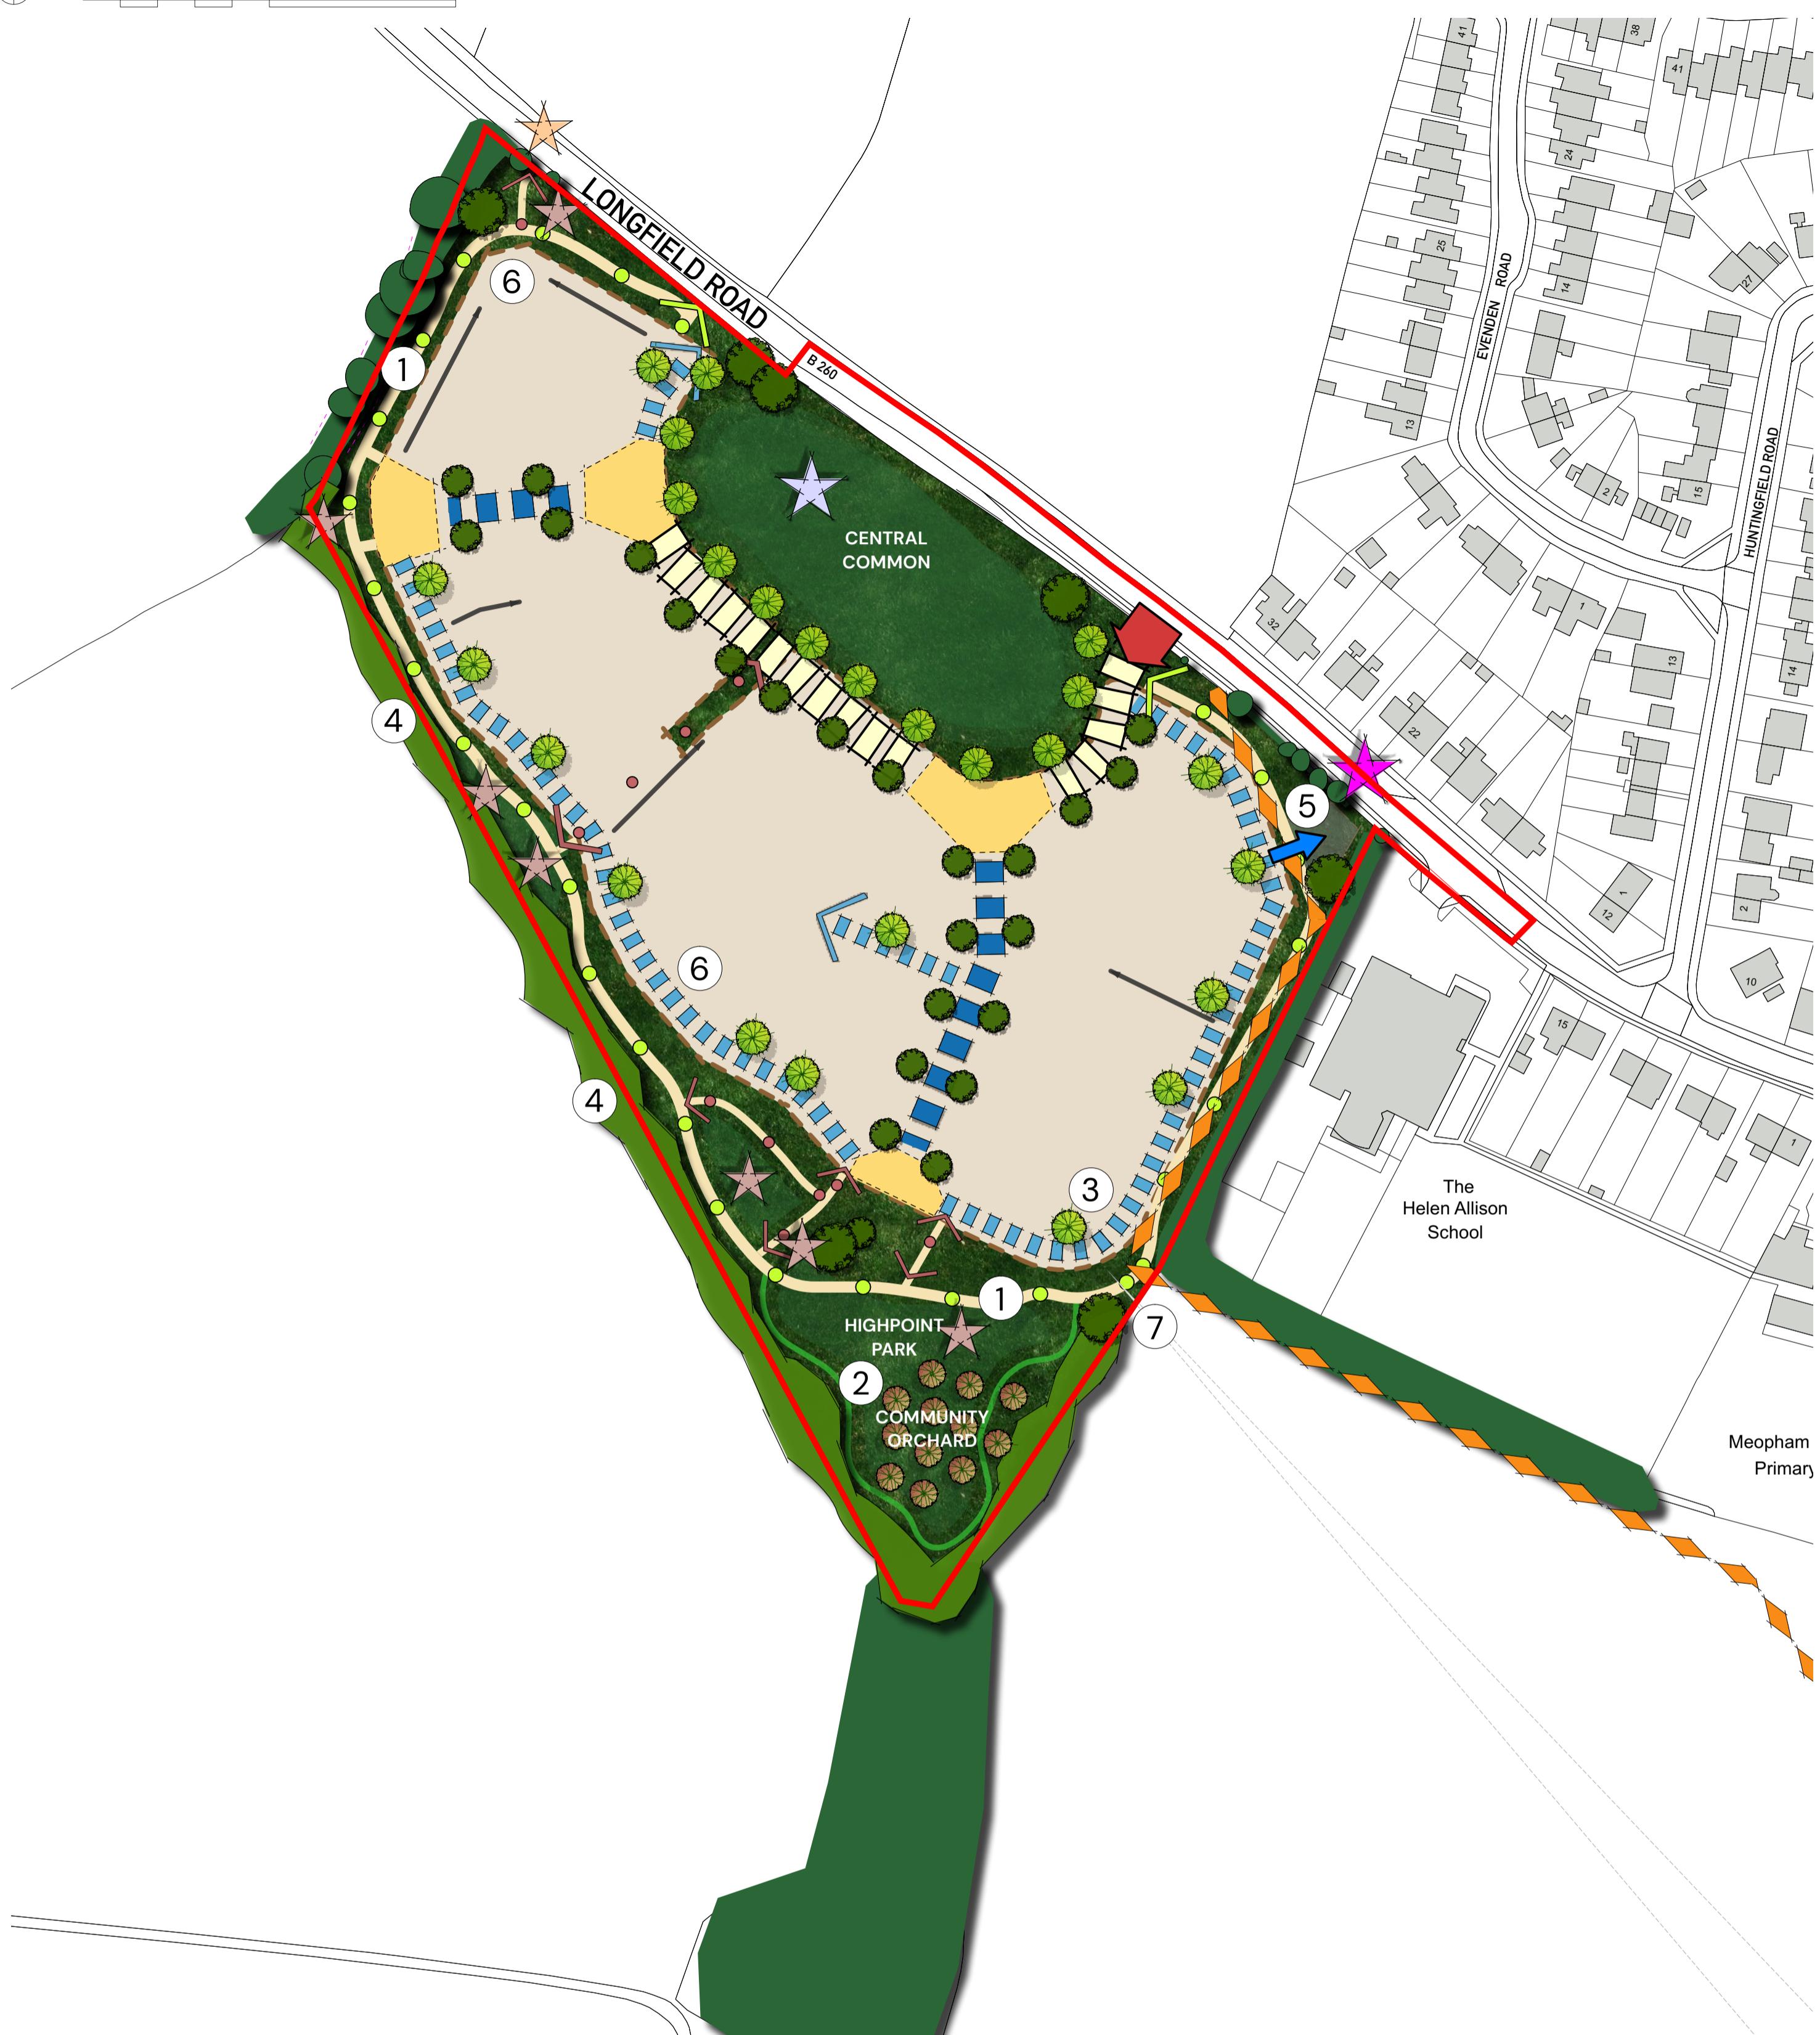
**KEY**

SITE BOUNDARY
	SITE ACCESS VIA LONGFIELD ROAD
	RESIDENTIAL DEVELOPMENT
	PUBLIC OPEN SPACE
	PRIMARY STREET
	SECONDARY STREET
	TERtiARY STREETS
	FOCAL SPACES
	PRIVATE LANES
	EXISTING PUBLIC RIGHTS OF WAY
	ACTIVE TRAVEL / CYCLE ROUTES
	FOOTPATH LINK
	EXISTING TREES
	NEW STRUCTURAL PLANTING
	NEW TREE PLANTING
	PROPOSED PLAY

1.3 A development framework plan is included in **Appendix A**.

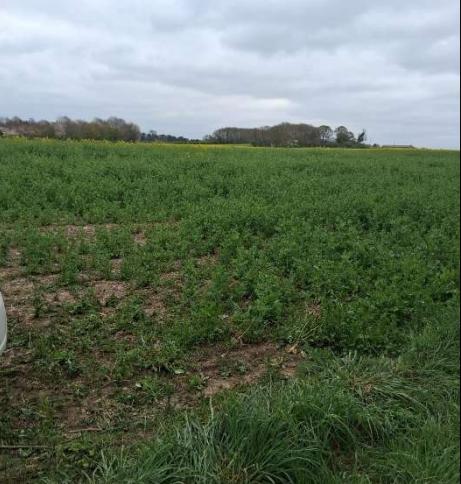
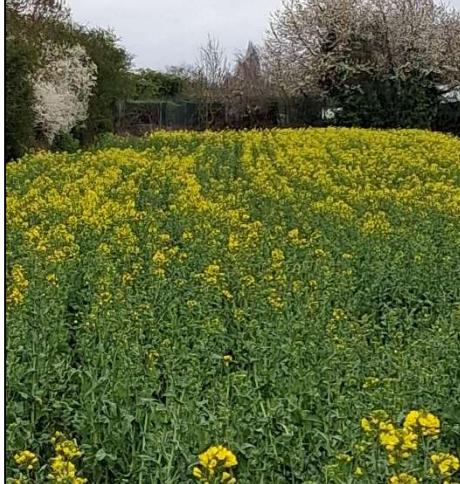
<p>Site Name: Land West of Wrotham Road, Meopham</p> <p>Project No.: 29473</p> <p>Client: Richborough</p> <p>Site Walkover Date: 10th April 2025</p>
<p>Photo 5: View east across the site.</p>		<p>Photo 6: View east at north-eastern boundary.</p>

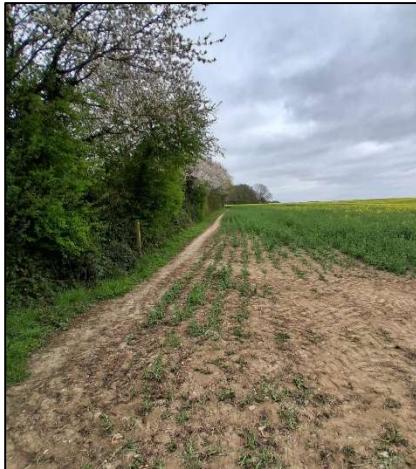
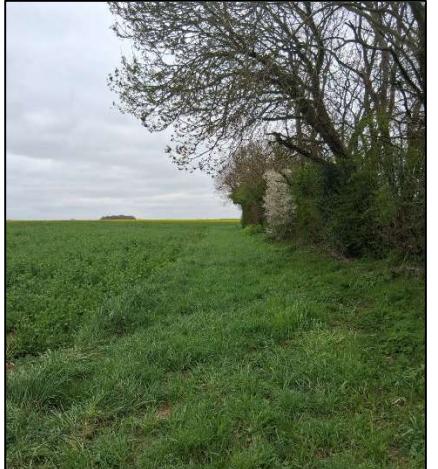
<p>Photo 7: View south along south-eastern boundary.</p>		<p>Photo 8: View south along north-western boundary.</p>

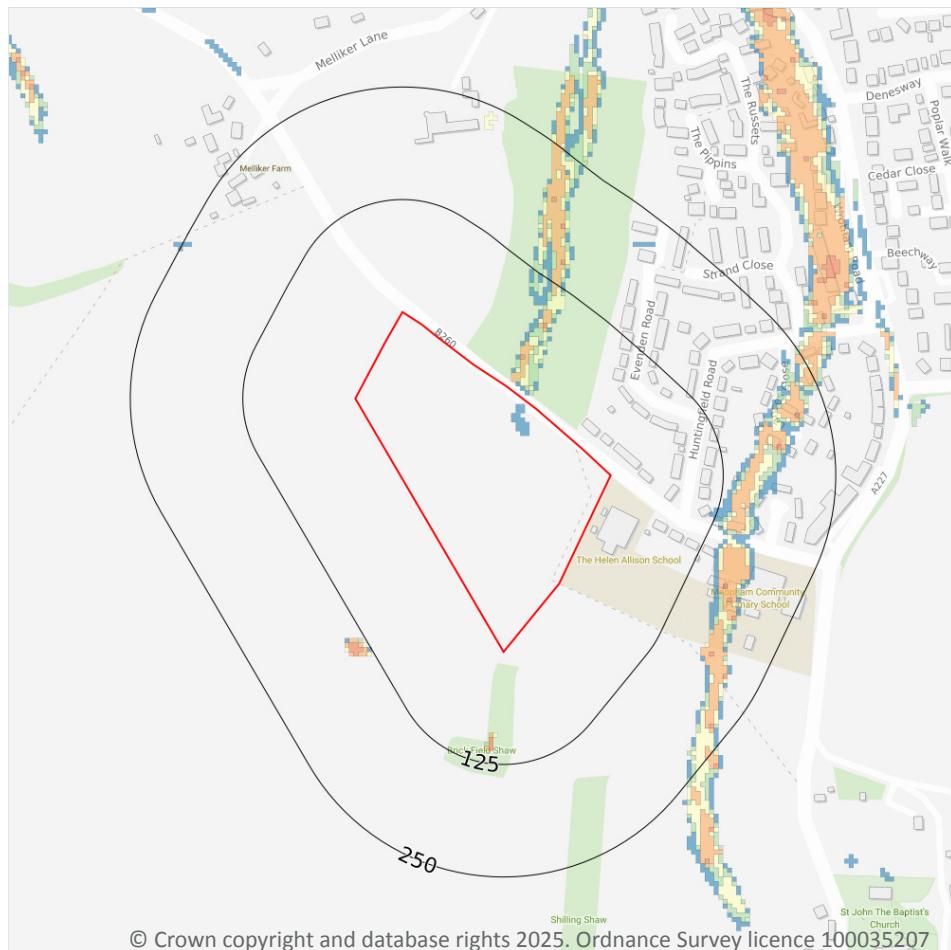
8 Surface water flooding

1 in 1000 return period

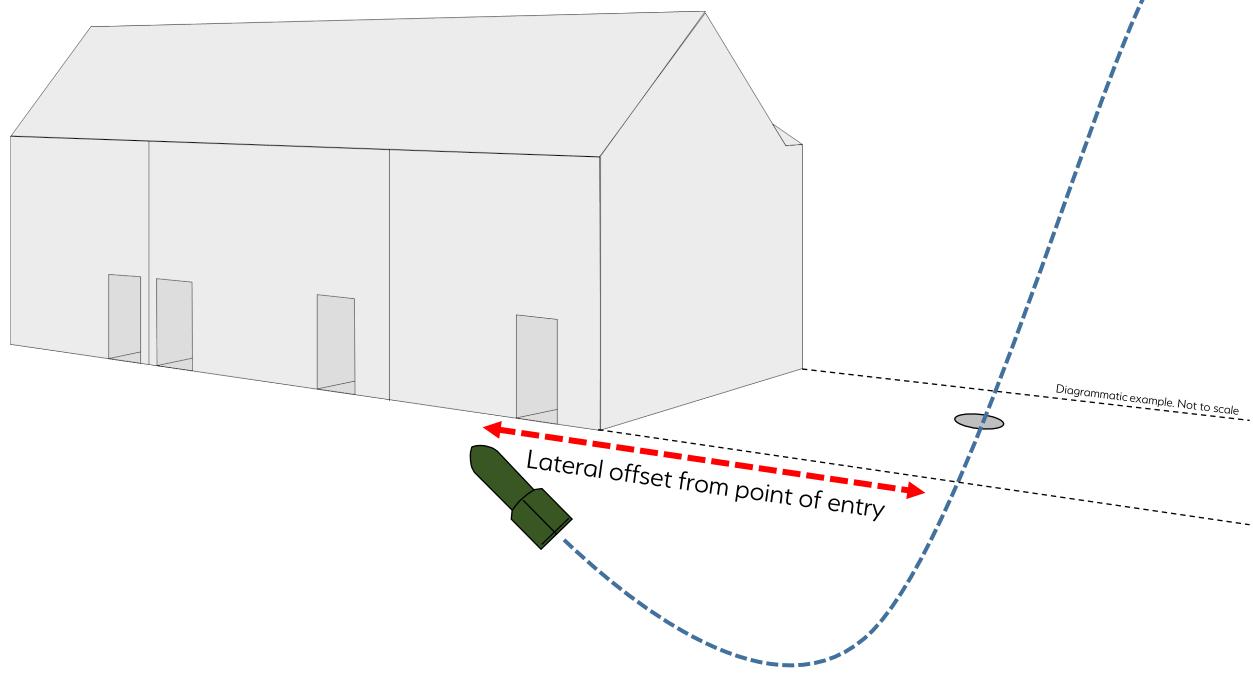
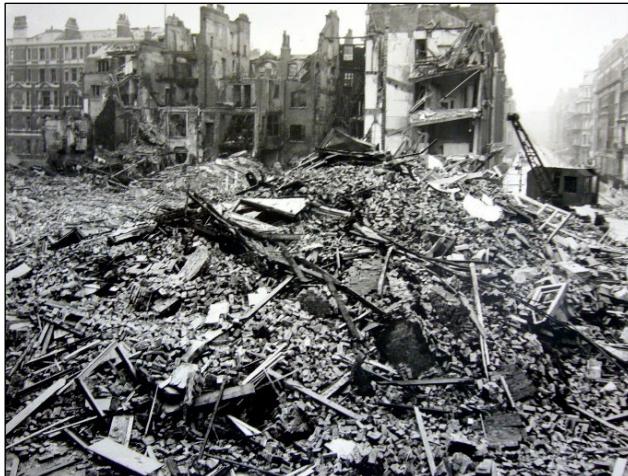
Top: J-curve Effect - Due to angle of entry, unexploded bombs would often end their trajectory at a lateral offset from point of entry, often ending up beneath adjacent extant structures/sites.

The photograph **above** shows a 250kg unexploded bomb found in Bermondsey in 2015, pointing upwards, demonstrating 'J-curve'.

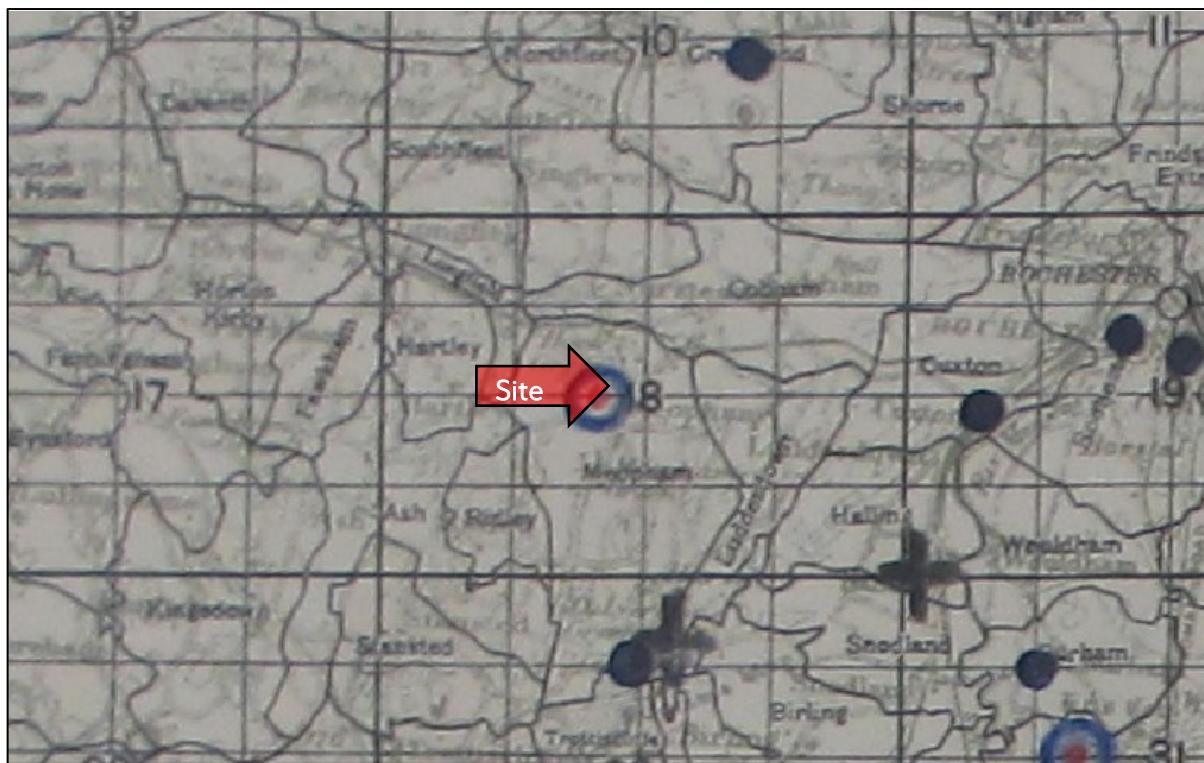
September 2nd, 1940

HE bomb strikes

Incendiary Bomb Strike

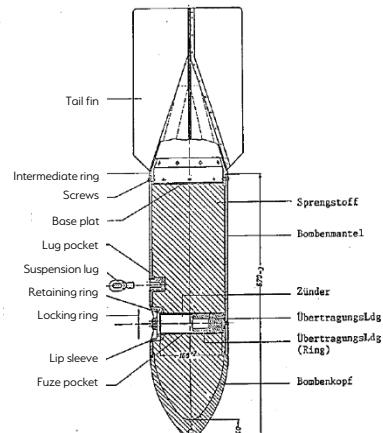
**SC 250kg High Explosive Bomb**

Bomb Weight	245-256kg (540-564lb)
Explosive Weight	125-130kg (276-287lb)
Fuze Type	Electrical impact/mechanical time delay fuze
Bomb Dimensions	1640 x 512mm (64.57 x 20.16in)
Body Diameter	368mm (14.5in)
Use	Against railway installations, embankments, flyovers, underpasses, large buildings and below-ground installations.
Remarks	It could be carried by almost all German bomber aircraft and was used to notable effect by the Junkers Ju-87 Stuka (<i>Sturzkampfflugzeug</i> , or dive-bomber).

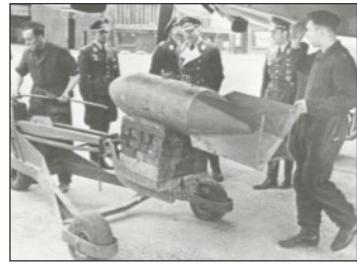
**SC 500kg High Explosive Bomb**

Bomb Weight	480-520kg (1,058-1,146lb)
Explosive Weight	250-260kg (551-573lb)
Fuze Type	Electrical impact/mechanical time delay fuze
Bomb Dimensions	1957 x 640mm (77 x 25.2in)
Body Diameter	470mm (18.5in)
Use	Against fixed airfield installations, hangars, assembly halls, flyovers, underpasses, high-rise buildings and below-ground installations.
Remarks	40/60 or 50/50 Amatol TNT, Triolene. Bombs recovered with Triolene filling have cylindrical paper-wrapped pellets, 1-15/16in. in length and diameter.

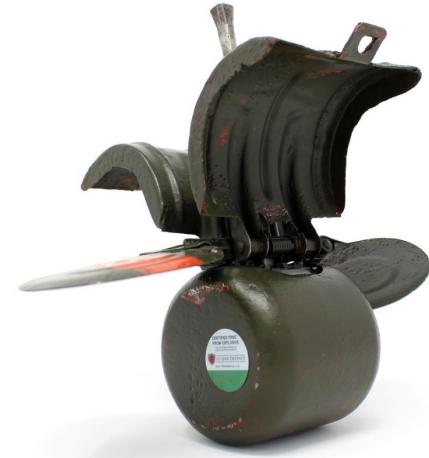
Parachute Mine (Luftmine B / LMB)

Bomb Weight	Approx. 990kg (2176lb)
Explosive Weight	Approx. 705kg (1,554lb)
Fuze Type	Impact/time delay/hydrostatic pressure fuze
Dimensions	2.64m x 0.64m (3.04m with parachute housing)
Use	Against civilian, military and industrial targets. Used as blast bombs and designed to detonate above ground level to maximise damage to a wider area.
Remarks	Deployed a parachute when dropped in order to control its descent. Had the potential to cause extensive damage within a 100m radius.

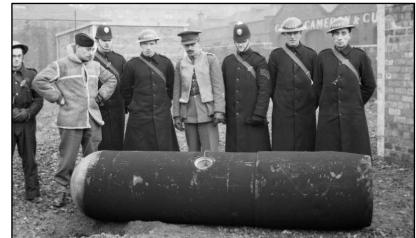
SC 1000kg High Explosive Bomb

Bomb Weight	Approx. 993-1027kg (2,189-2,264lb)
Explosive Weight	Approx. 530-620kg (1168-1367lb)
Fuze Type	Electrical impact/mechanical time delay fuze.
Filling	Mixture of 40% amatol and 60% TNT, but when used as an anti-shipping bomb it was filled with Trialen 105, a mixture of 15% RDX, 70% TNT and 15% aluminium powder.
Bomb Dimensions	2800 x 654mm (110 x 25.8in)
Body Diameter	654mm (18.5in)
Use	SC-type bombs were General Purpose Bombs used primarily for general demolition work. Constructed of parallel walls with comparatively heavy noses, they are usually of three-piece welded construction.

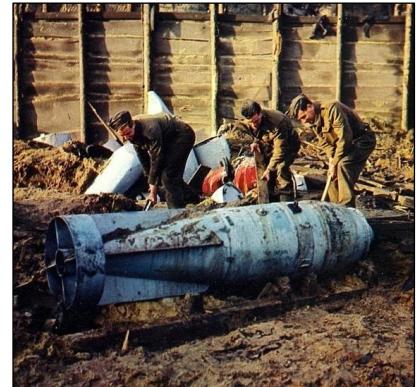
1kg Incendiary Bomb

Bomb Weight	Approx. 1.0 - 1.3kg (2.2 and 2.9lb)
Explosive Weight	Approx. 680g (1.5lb) Thermite 8-15gm Explosive Nitropenta
Fuze Type	Impact fuze
Bomb Dimensions	350 x 50mm (13.8 x 1.97in)
Body Diameter	50mm (1.97in)
Use	As incendiary – dropped in clusters on towns and industrial complexes.
Remarks	Magnesium alloy case. Sometimes fitted with high explosive charge. The body is a cylindrical alloy casting threaded internally at the nose to receive the fuze holder and fuze.

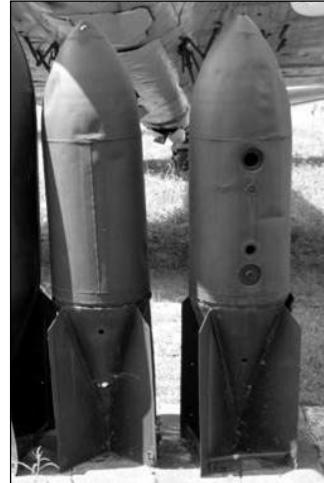
3.7 Inch QF Anti-Aircraft Projectile

Projectile Weight	28lb (12.6 kg)
Explosive Weight	2.52lbs
Fuze Type	Mechanical Time Fuze
Dimensions	3.7in x 14.7in (94mm x 360mm)
Rate of Fire	10 to 20 rounds per minute
Use	The 3.7in AA Mk 1-3 were the standard Heavy Anti-Aircraft guns of the British Army and were commonly used on the Home Front.
Ceiling	30,000ft to 59,000ft

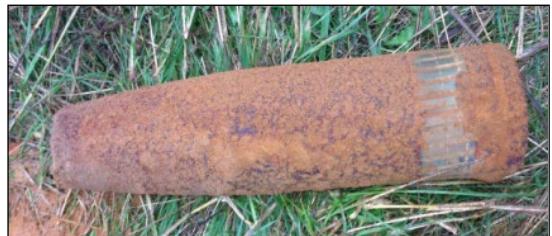
40mm Bofors Projectile

Projectile Weight	1.96lb (0.86kg)
Explosive Weight	300g (0.6lb)
Fuze Type	Impact Fuze
Rate of Fire	120 rounds per minute
Projectile Dimensions	40 x 180mm
Ceiling	23,000ft (7000m)
Remarks	Light quick fire high explosive anti-aircraft projectile. Each projectile fitted with small tracer element. If no target hit, shell would explode when tracer burnt out. Designed to engage aircraft flying below 2,000ft.

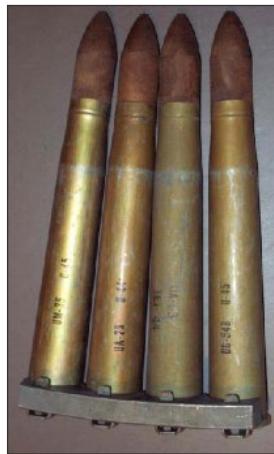
3in Unrotated Projectile (UP) Anti-Aircraft Rocket ("Z" Battery)

HE Projectile Weight	3.4kg (7.6lb)
Explosive Weight	0.96kg (2.13lb)
Filling	High Explosive – TNT. Fitted with aerial burst fuzing
Dimensions of projectile	236 x 83mm (9.29 x 3.25in)
Remarks	As a short range rocket-firing anti-aircraft weapon developed for the Royal Navy. It was used extensively by British ships during the early days of World War II. The UP was also used in ground-based single and 128-round launchers known as Z Batteries. Shell consists of a steel cylinder reduced in diameter at the base and threaded externally to screw into the shell ring of the rocket motor.

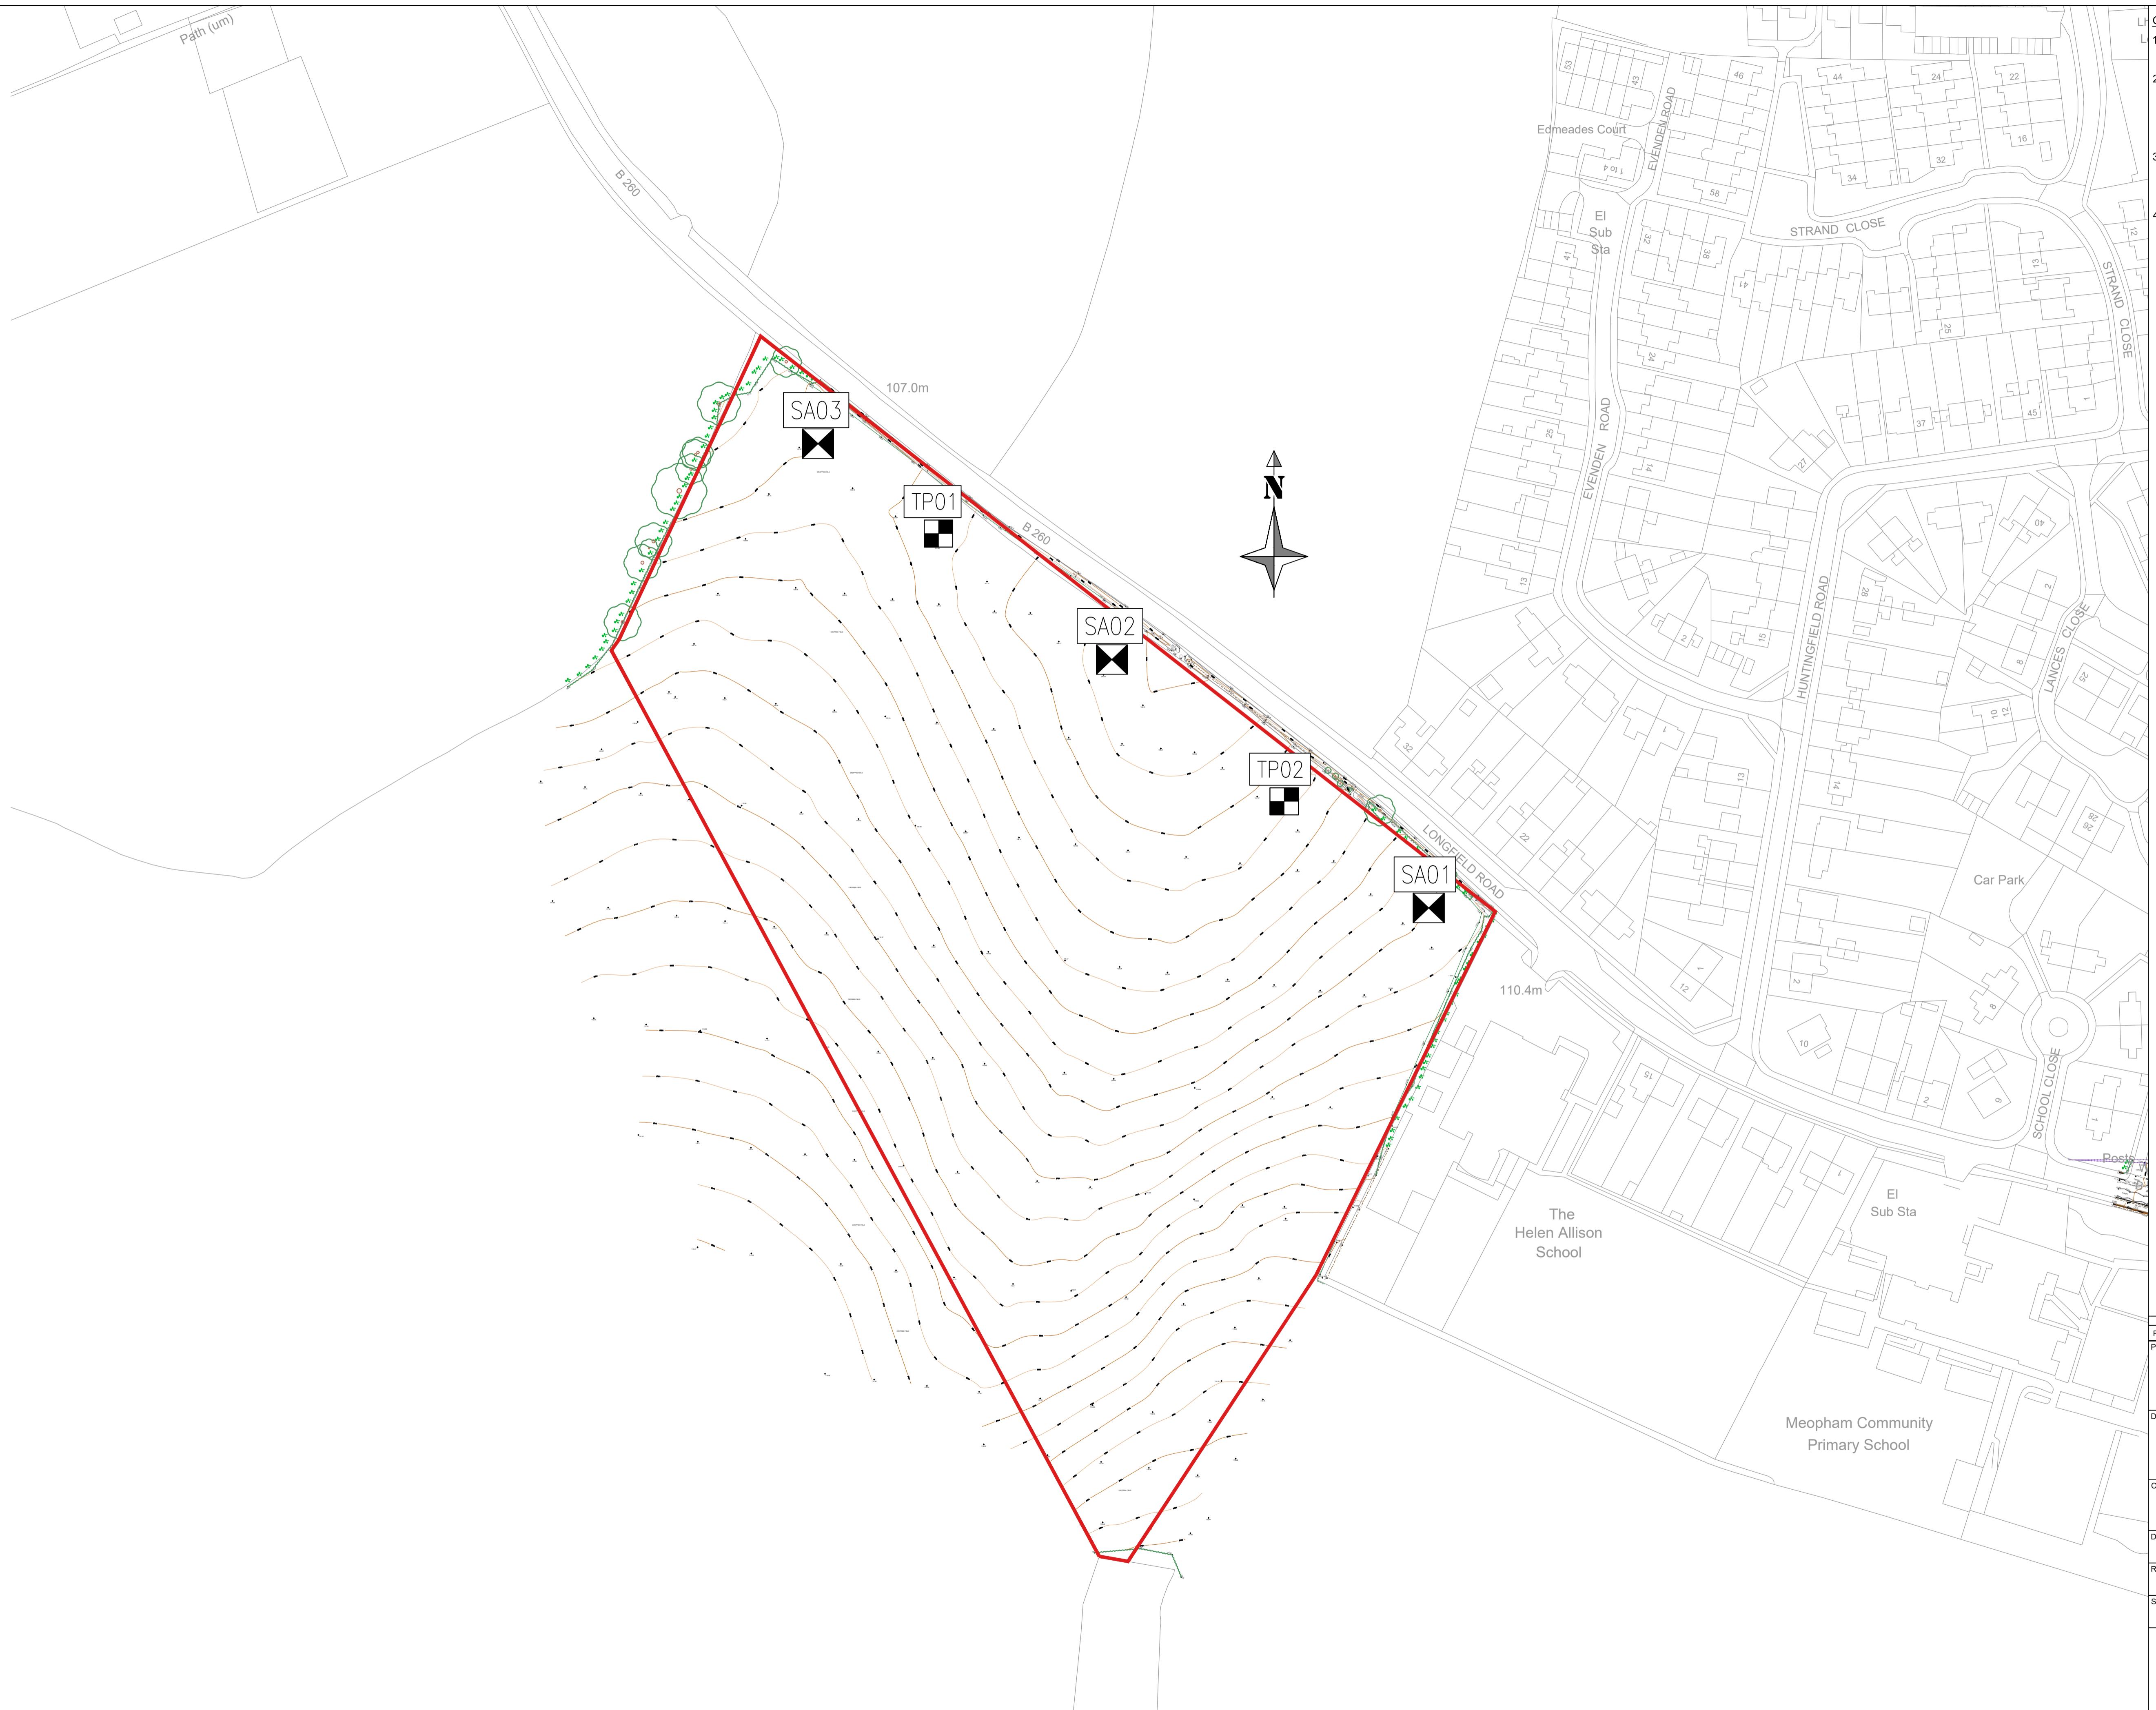
FIRST ISSUE	JM	CW	DT	08/04/25		
REV:	AMENDMENTS:	DRN:	CHK:	DATE:		
PROJECT: LAND WEST OF WROTHAM ROAD MEOPHAM						
DRAWING TITLE: EXPLORATORY HOLE LOCATION PLAN						
CLIENT: RICHBOROUGH						
DRAWING NUMBER: 29473_04_140_01.2						
REVISION: -	SHEET SIZE: A1	SCALE: 1 : 1000				
STATUS: FOR INFORMATION / APPROVAL

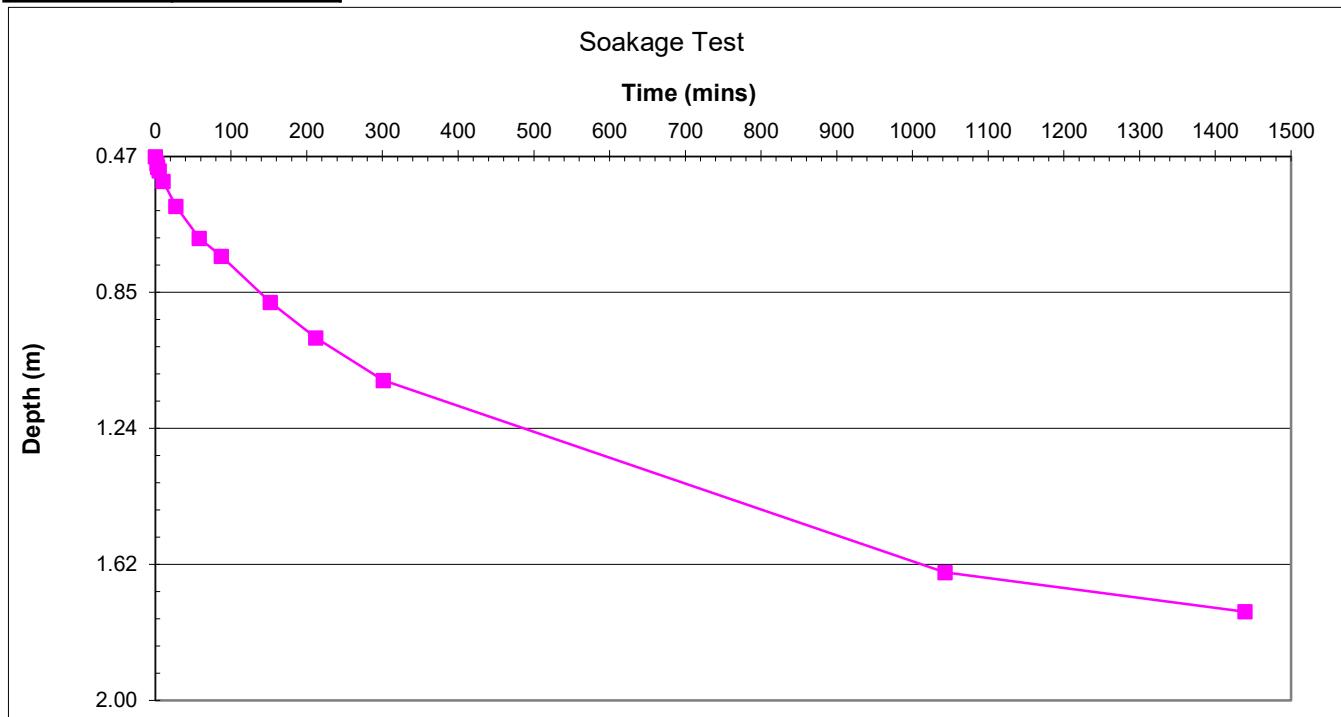
SOIL INFILTRATION RATE = 1.13E-06 m/s

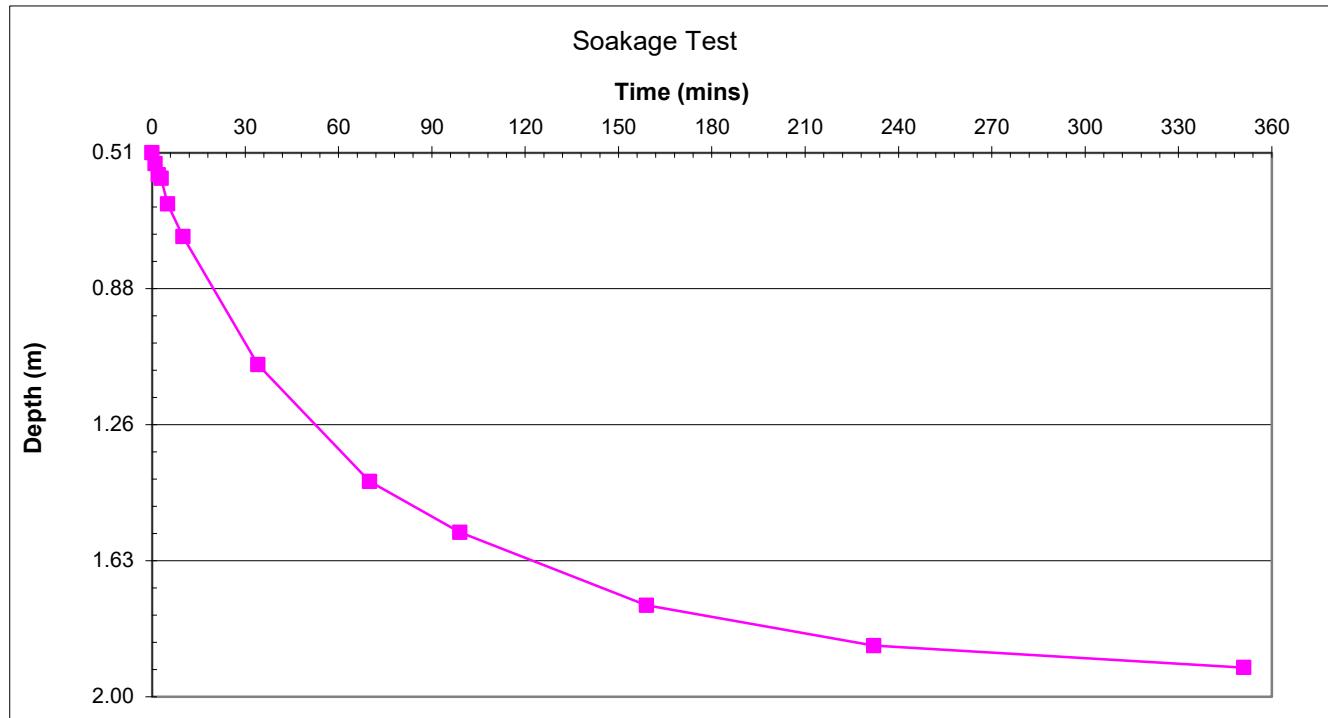
SOIL INFILTRATION RATE = 9.73E-06 m/s

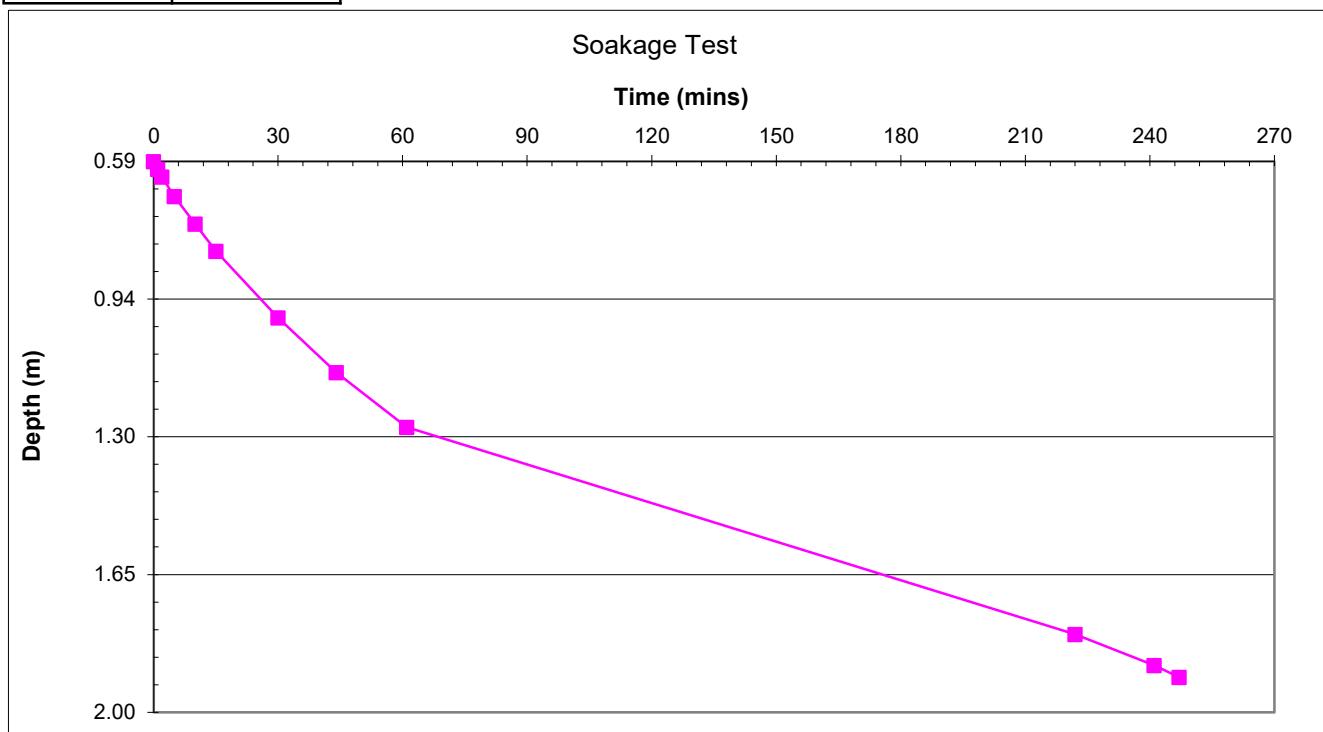
SOIL INFILTRATION RATE = 6.75E-06 m/s

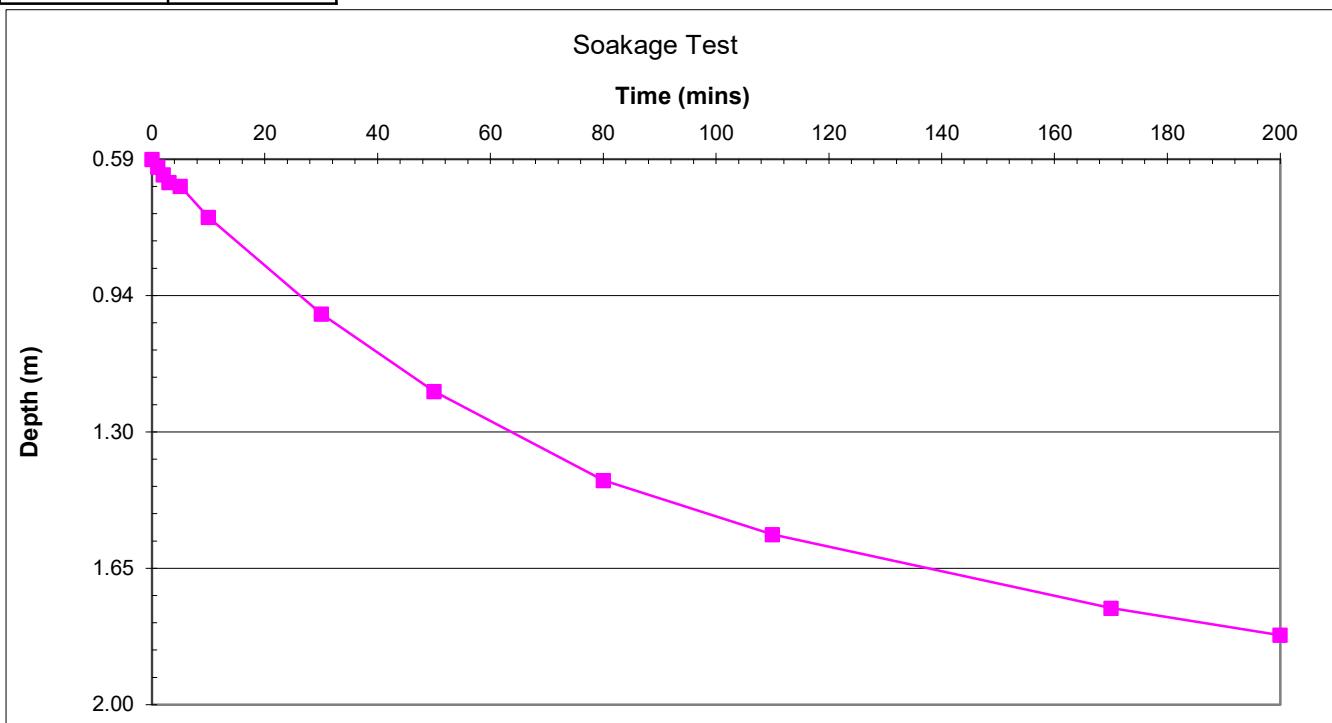
SOIL INFILTRATION RATE = 9.16E-06 m/s

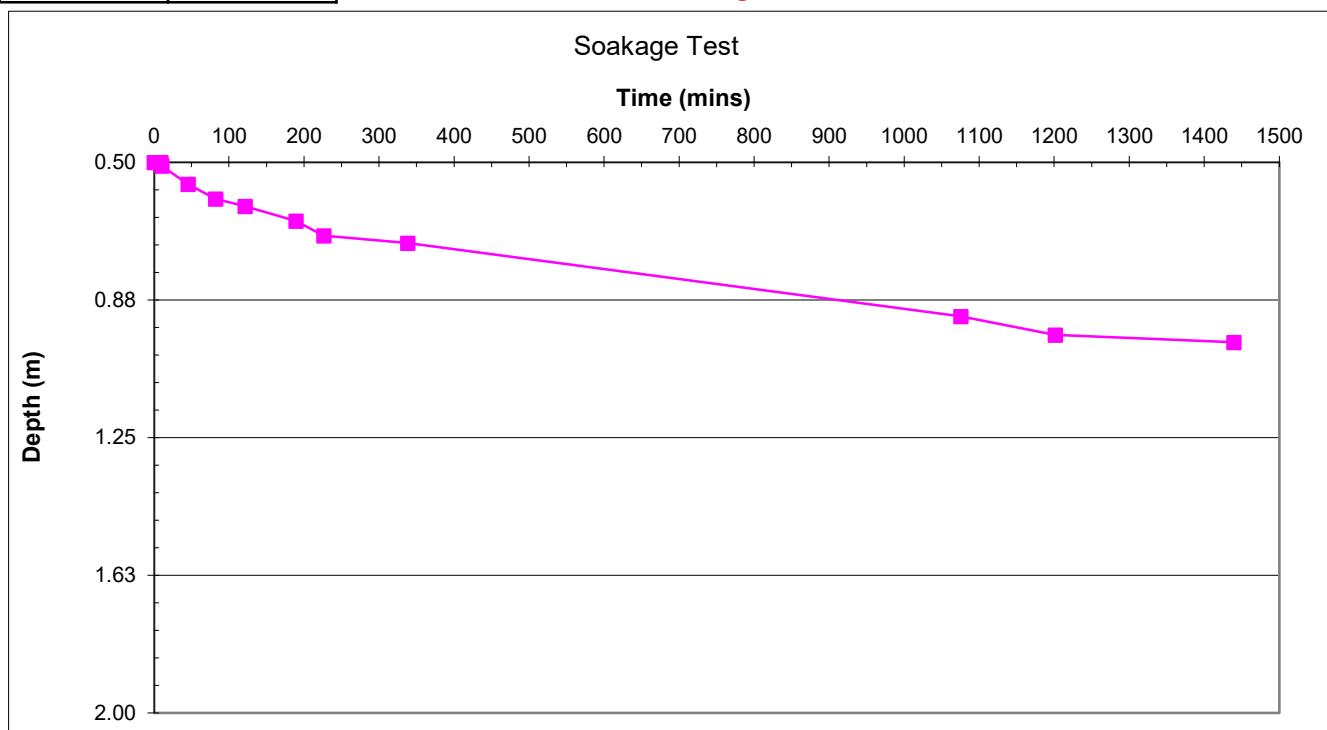
Insufficient soakage to derive an infiltration rate.
