26 King Street, Gravesend

Cornice profiles

Drwg.: KSG/0424/06 Rev. A

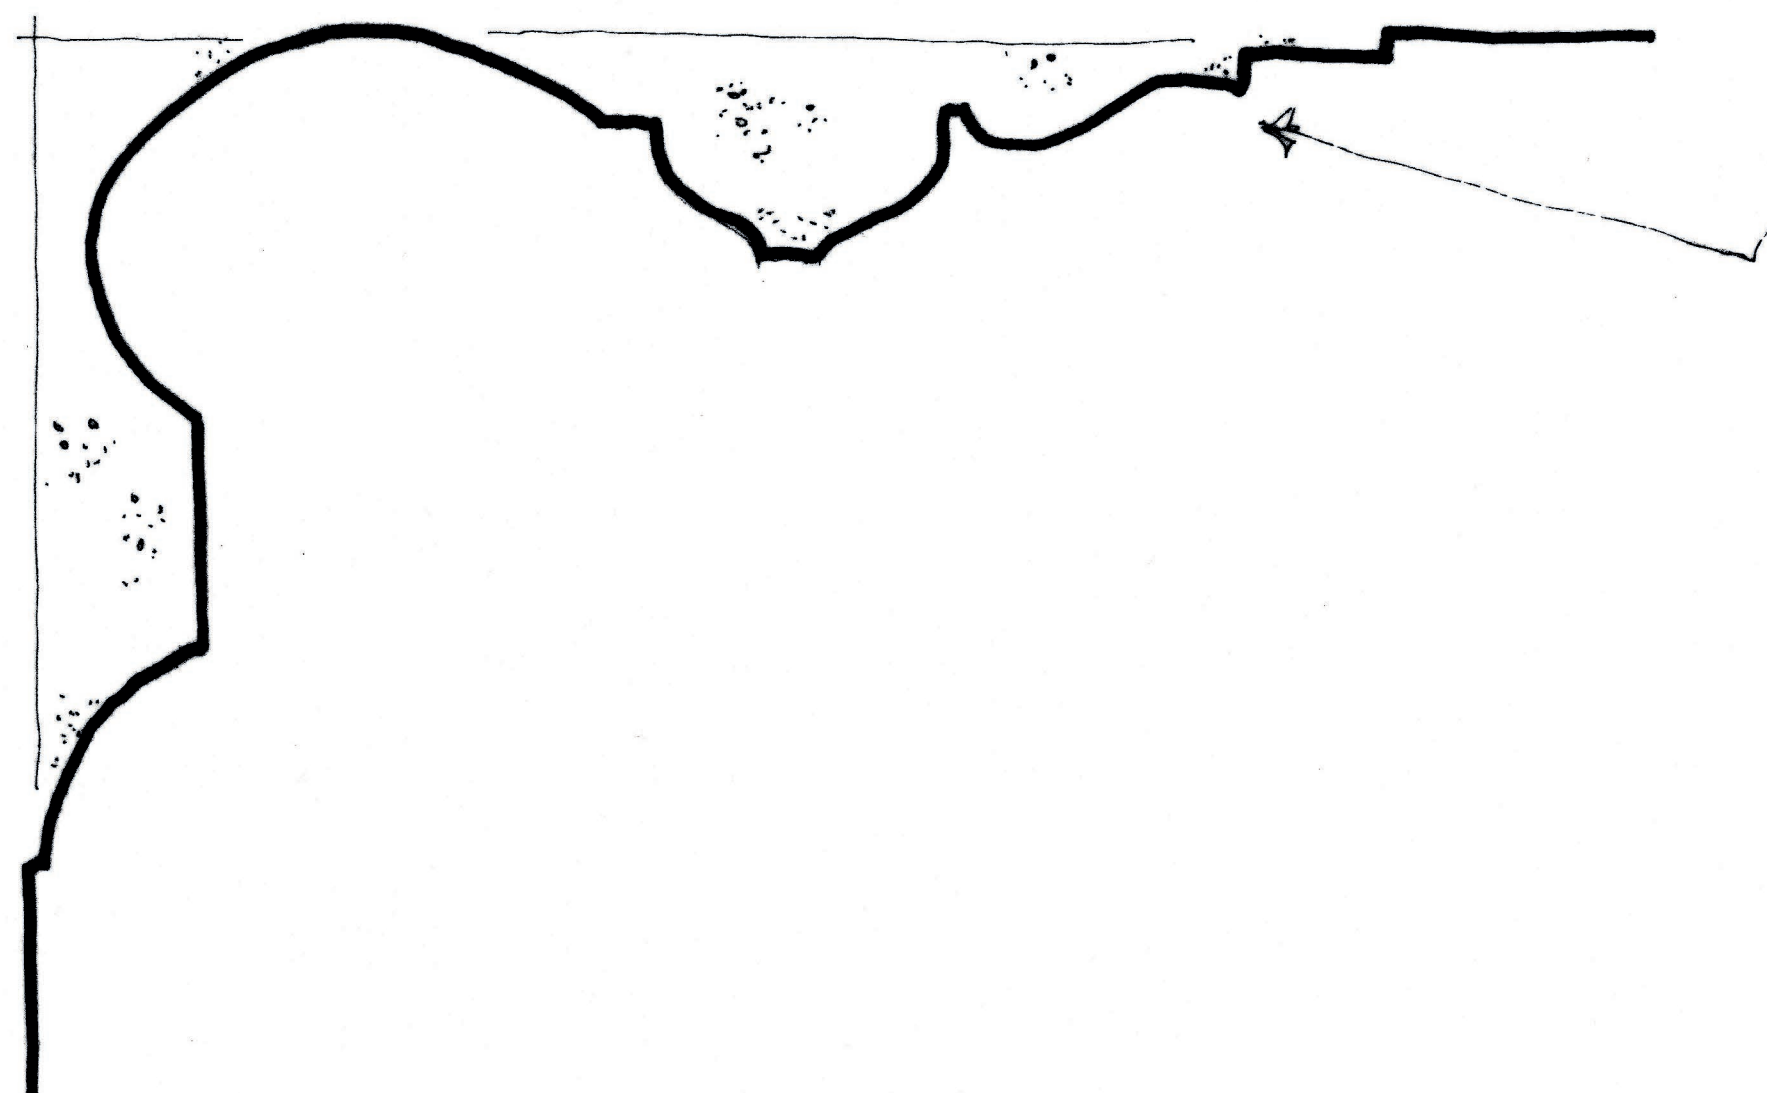
Full size cornice: Recording Studio\*

WHERE REPAIRS ARE REQUIRED, REMOVE PAINT FROM ADJACENT CORNICES WHICH ARE TO BE RETAINED TO ENABLE NEW CORNICE WORK TO PERFECTLY MATCH AT ABUTMENTS.

\*THIS IS THE ROOM ACCESSED FROM THE SOUTH-EAST DOOR OF THE FORMER COURT ROOM.

Cornice repair profiles to match existing

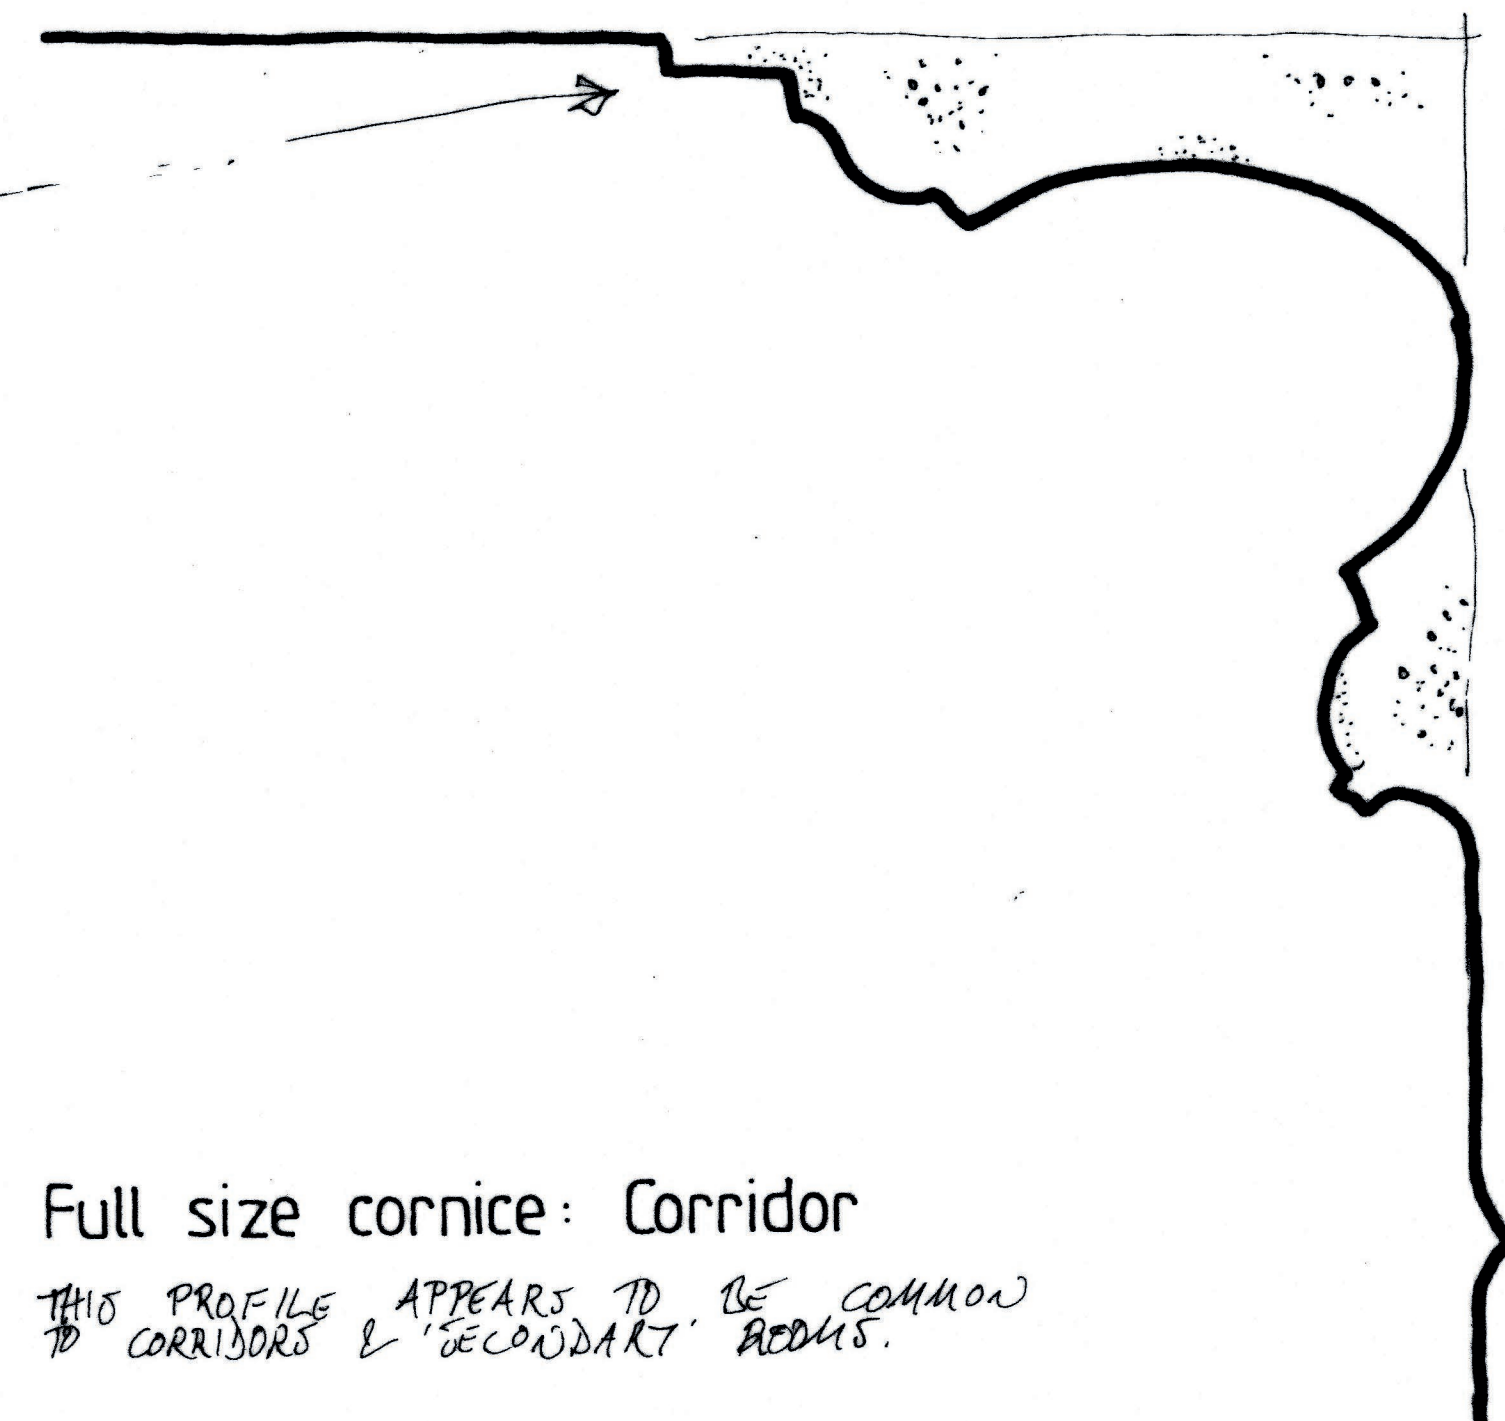
Full size cornice: Corridor

THIS PROFILE APPEARS TO BE COMMON TO CORRIDORS & SECONDARY ROOMS.
