## Archaeology and Heritage Assessment

**Huggens College  
College Road  
Northfleet, Kent  
DA11 9DL.**

**The President and Trustees of Huggens's  
College**

**April 2024**

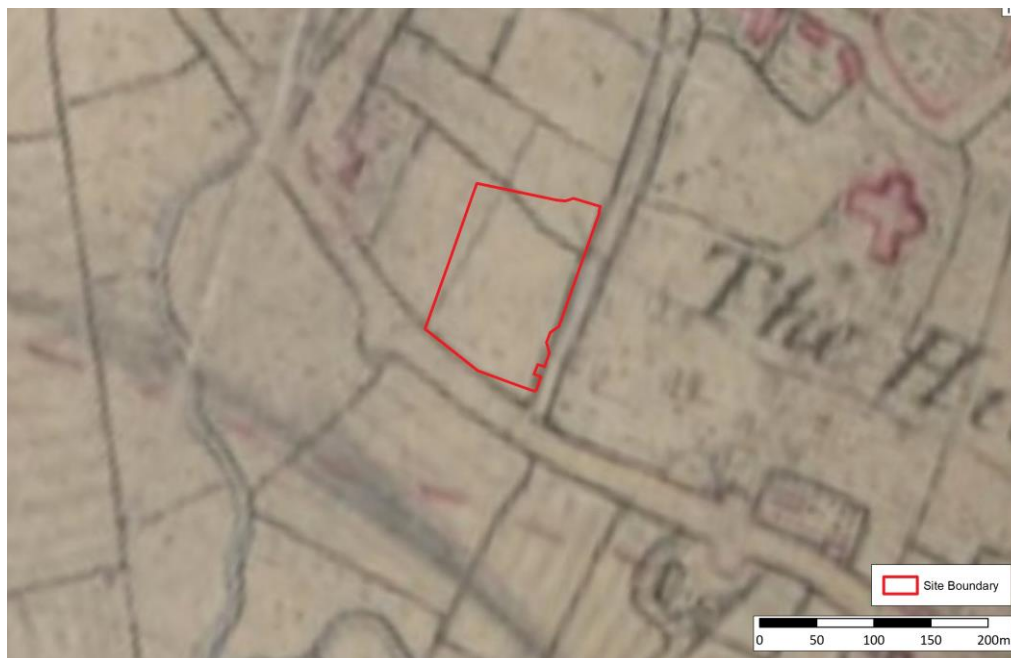
*Fig. 11: Extract from the 1799 Ordnance Survey Drawing of Dartford, Kent.  
(Reproduced by courtesy of the British Library)*

The 1799 Ordnance Survey Drawing of Dartford (*fig. 11*) suggests the site was unoccupied at this time as it is shown as undeveloped land spanning several plots at the centre of a street pattern comprising College Road, Grove Road

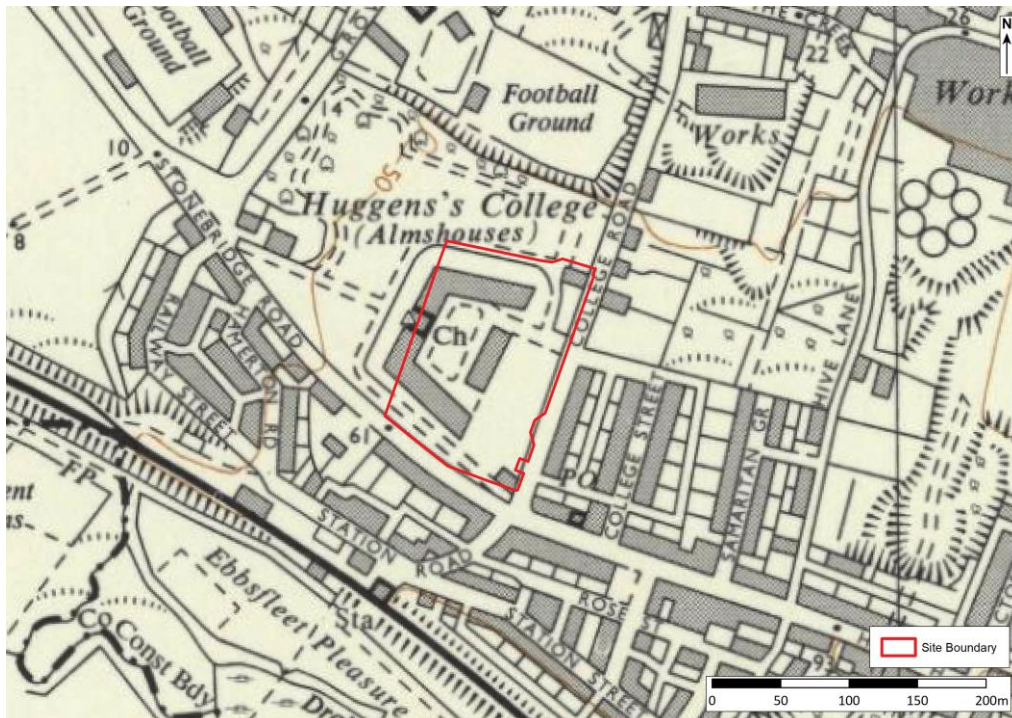
Fig. 20: Extract from the OS 1:10,000 map of 1962.  
(Reproduced courtesy of the National Archives)

The 1954 25-inch Ordnance Survey Map (*fig. 19*), 1962 1:10,000 Ordnance Survey Map (*fig. 20*) and 1966 1:10,000 Ordnance Survey Map (*fig. 15*) show little to no change.

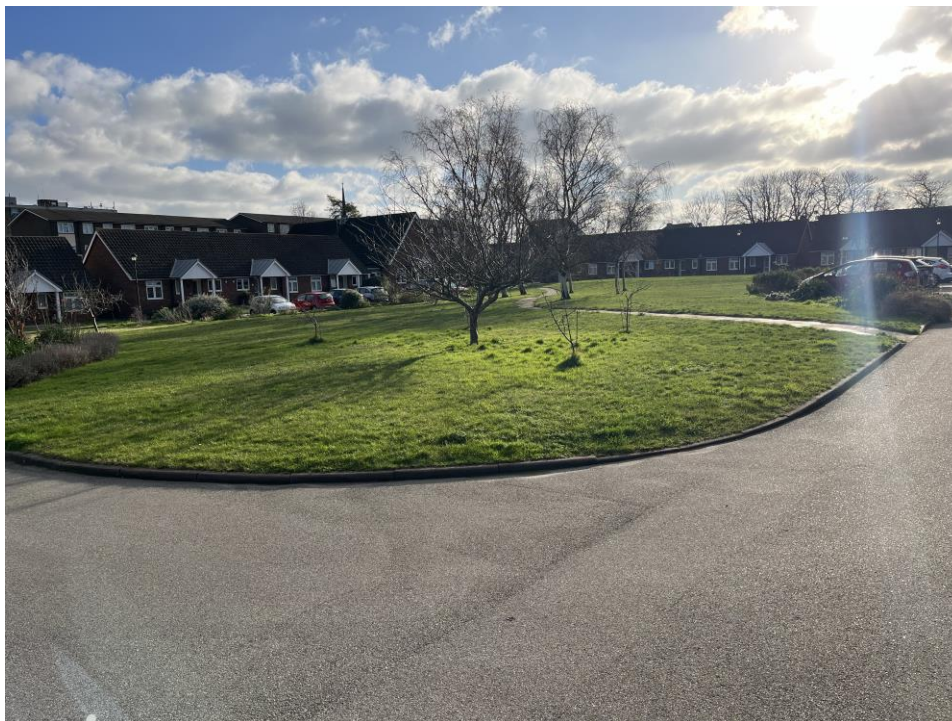
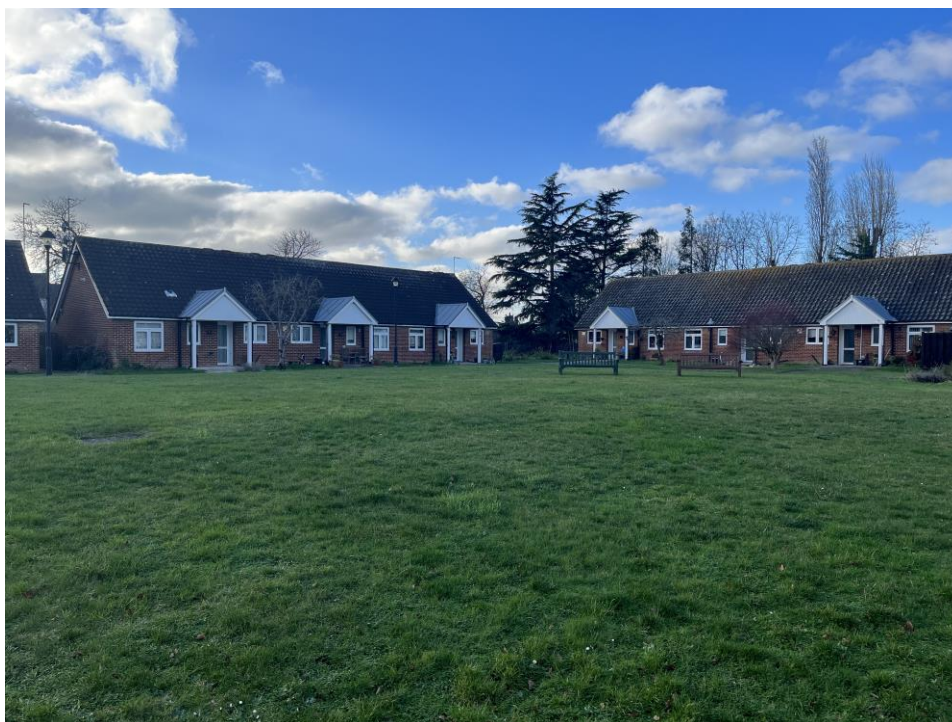
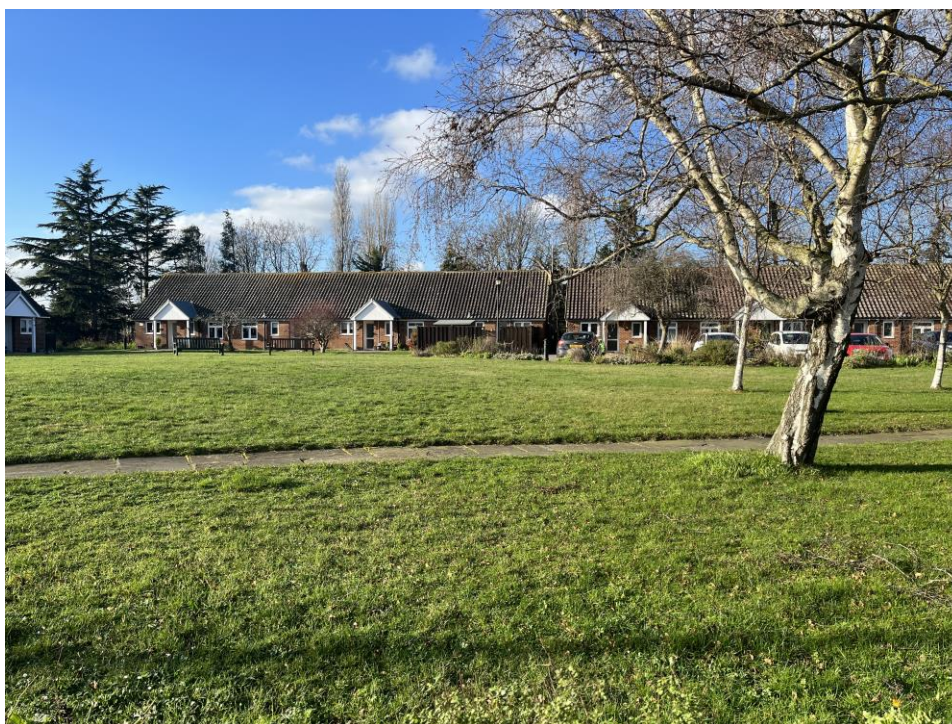
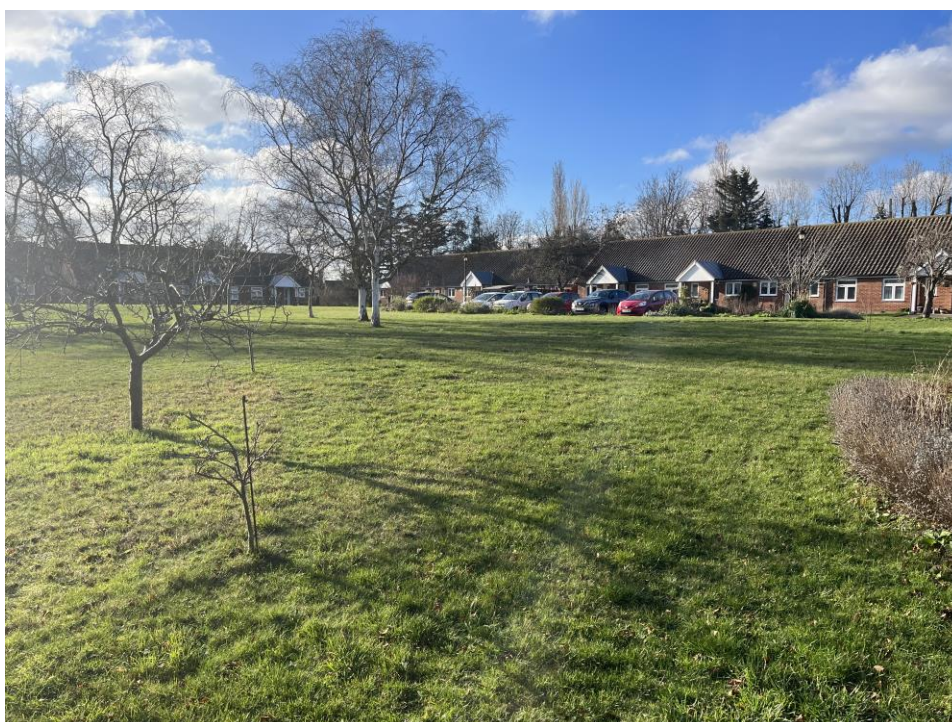
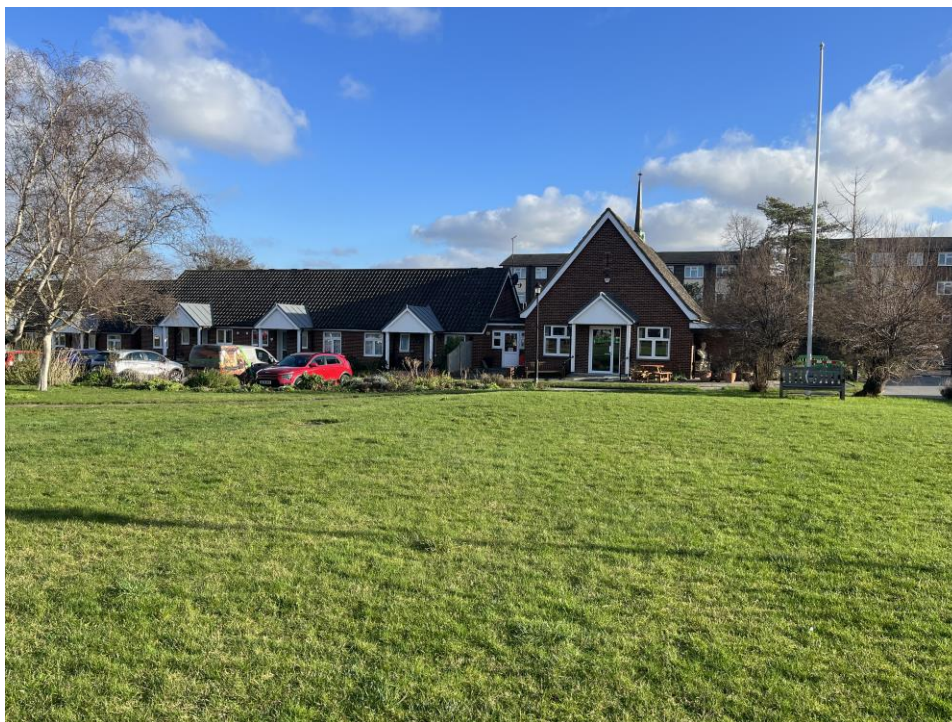
The central green of the site is uneven, being bumpy (*Plates 1-5*), and the site's other undeveloped areas are sloping (*Plates 6-8*), but there is no evidence for archaeology. Despite this, it still is considered that there may be evidence of the WWII water tank (and/or potentially an air raid shelter) which is noted to have resided on the site in the area of the central green, and that the foundations of a workshop associated with a demolished lodge house near the site's SE corner may survive. Further to this, it is possible the cobbled path which, prior to the site's redevelopment, ran along the S extent of the site to the Plough Inn, is buried beneath the grassy area and hardstanding which reside there at present.

*Plate 1: View looking SE across the central green.*

*Plate 2: View looking SW across the central green.*

*Plate 3: A view looking S across the central green.*

*Plate 4: View looking WSW across the central green.*

*Plate 5: View looking E across the central green.*

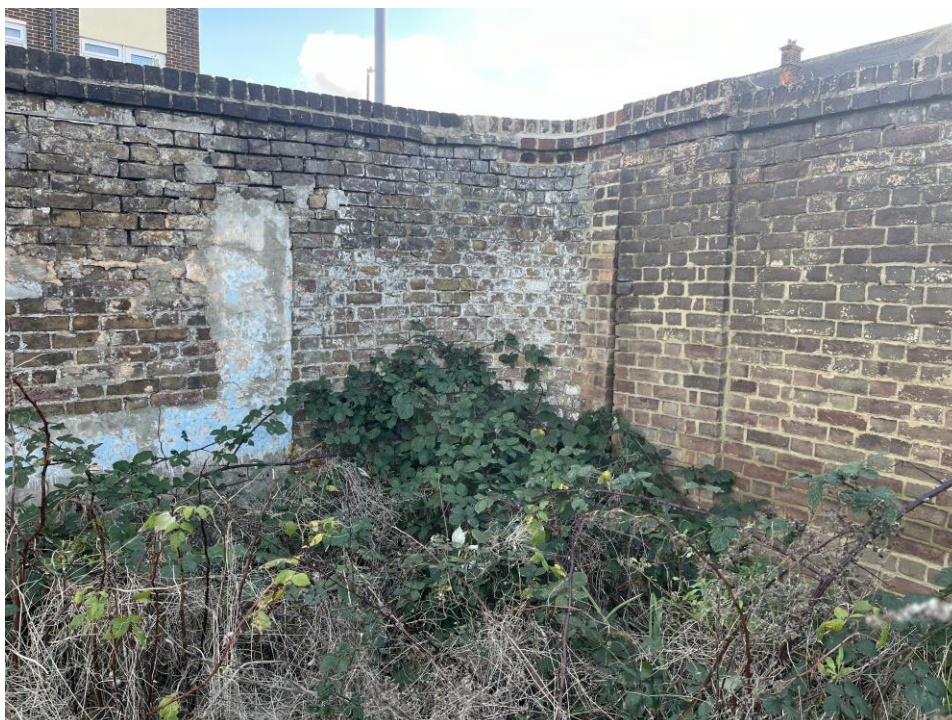
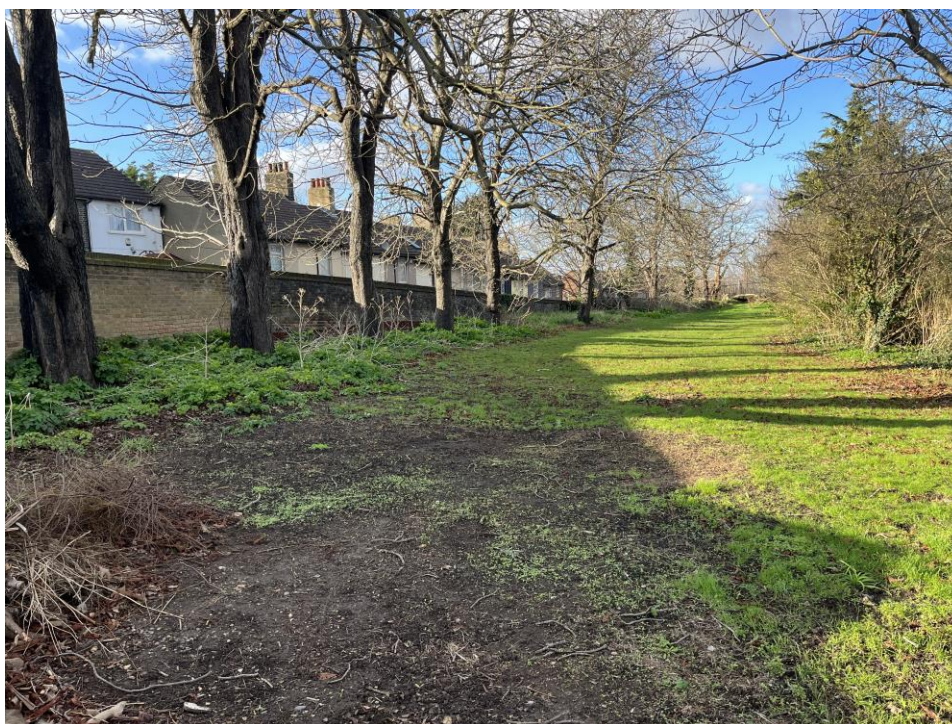
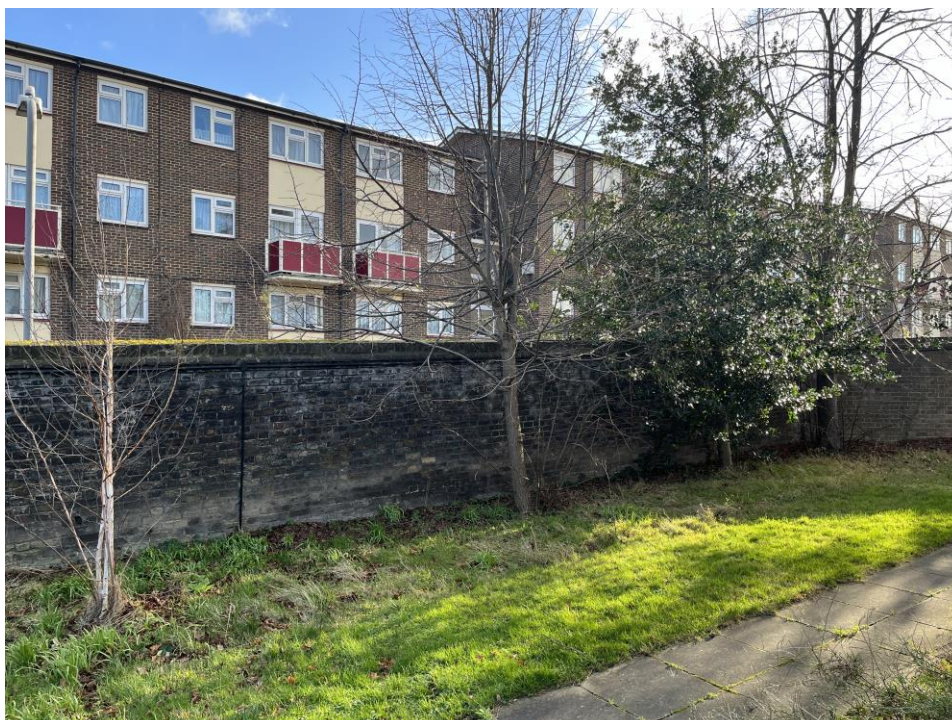
*Plate 6: View looking SE, towards the SE corner of the boundary wall.*

*Plate 7: View looking W parallel to Stonebridge Road, showing the level of the ground in relation to the wall.*

*Plate 8: View looking SE parallel to College Road, showing the level of the ground in relation to the wall*

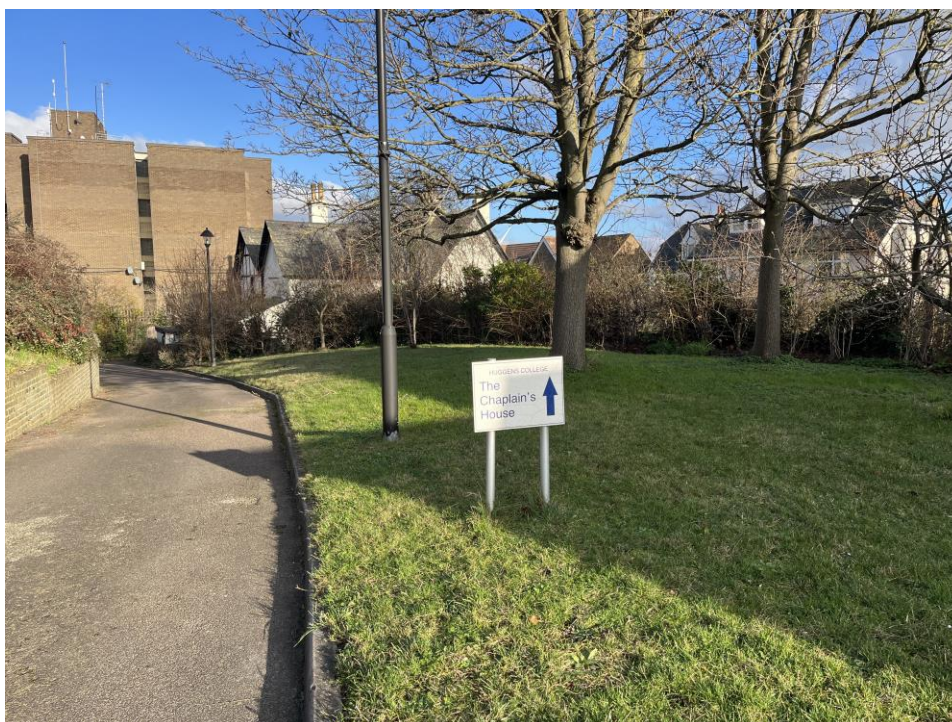
*Plate 9: View looking N, down the path to the Chaplain's House.*

The level of the site everywhere but around the Chaplain's House appears to have been built up over time, with the walls being only around 1m tall internally (*Plates 6-9*), where they are 2m tall externally. This is especially pronounced at the S end of the site (*Plates 6-7*), and is also evidenced by the path to the Chaplain's House sloping down (*Plate 9*), the level around this building potentially being the original level of the site.

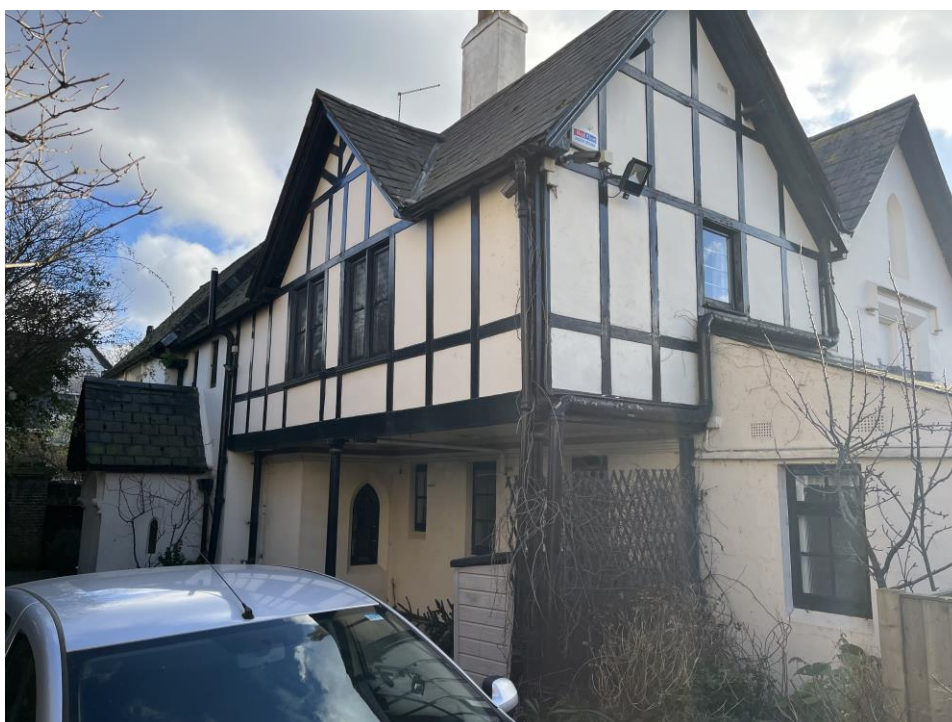
*Plate 10: View looking ESE across the N-facing elevation of the Chaplain's House.*

This end of the elevation has three casement windows on the ground floor and two on the first floor, with a W-facing lancet window beneath the overhang (*Plate 10*). Centred within the elevation is a gabled porch with ornate carved barge boards with finials, within which there is a four-centred arched door beneath a hood mould with decorative label stops (one largely destroyed) (*Plate 11*). Above the porch, at first floor level, are two windows with diamond lattice. The left side of the elevation has a set of windows at each floor beneath label moulds, both with diamond lattice glazing (*Plate 12*). The pitched roof extension has a window and two doors (*Plate 13*).

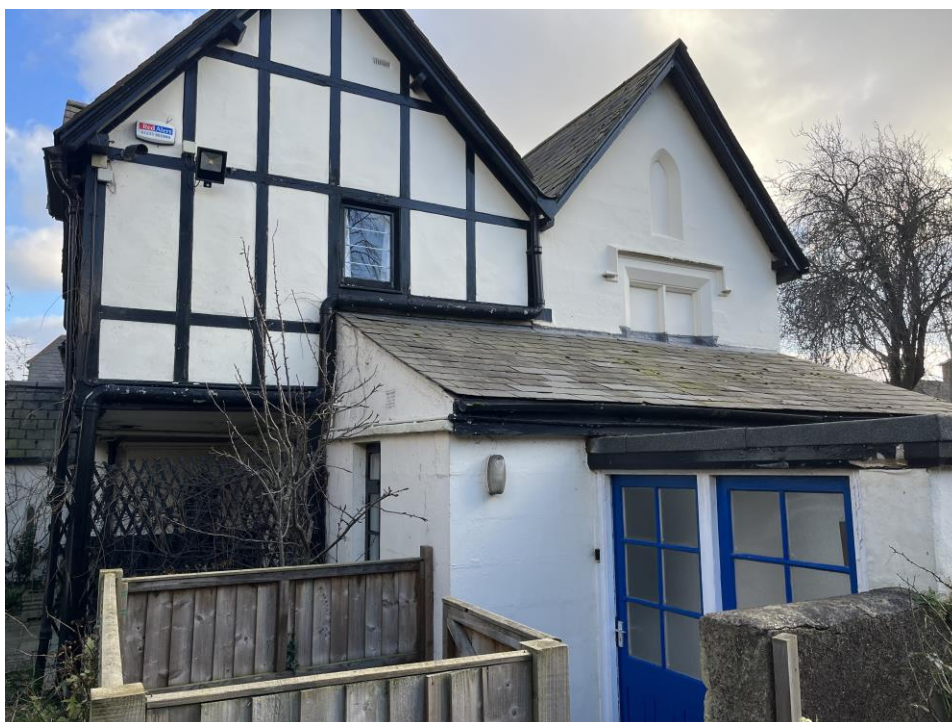
The western side of the building has a single-storey extension, which is partially beneath a pitched roof and partially under a flat roof. Photographs of the 1960s indicate the flat roof area was previously a larger, fully pitched roof extension, which has now been reduced and partly replaced.

*Plate 13: View looking ESE towards the W-facing elevation of the Chaplain's House.*

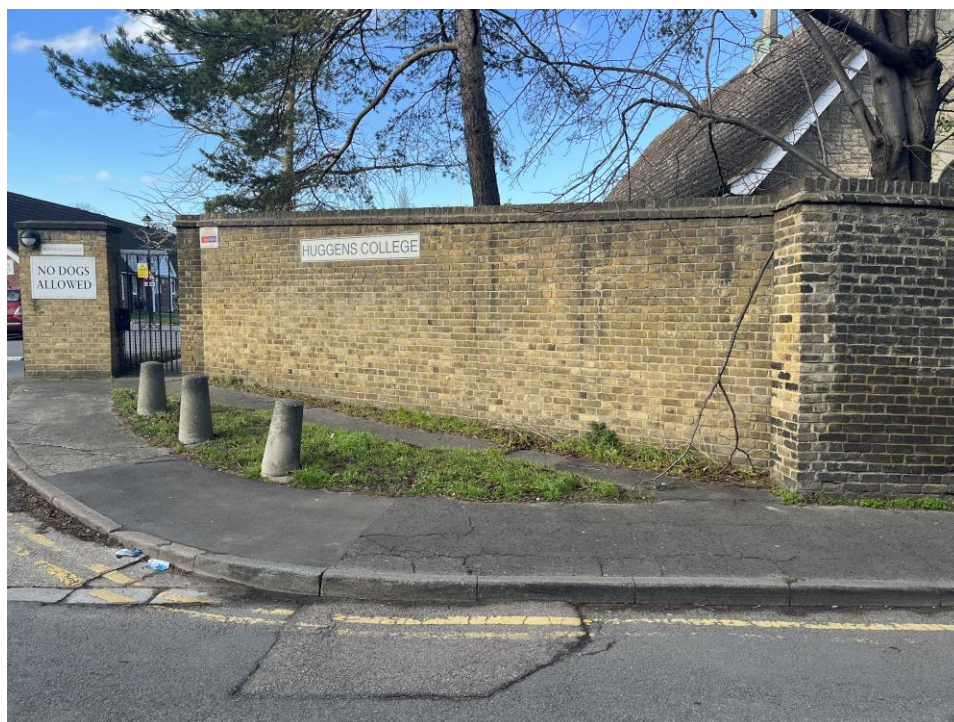
*Plate 19: View looking W towards the c.1968 entrance to Huggens College, the differing colour of the brick is apparent.*

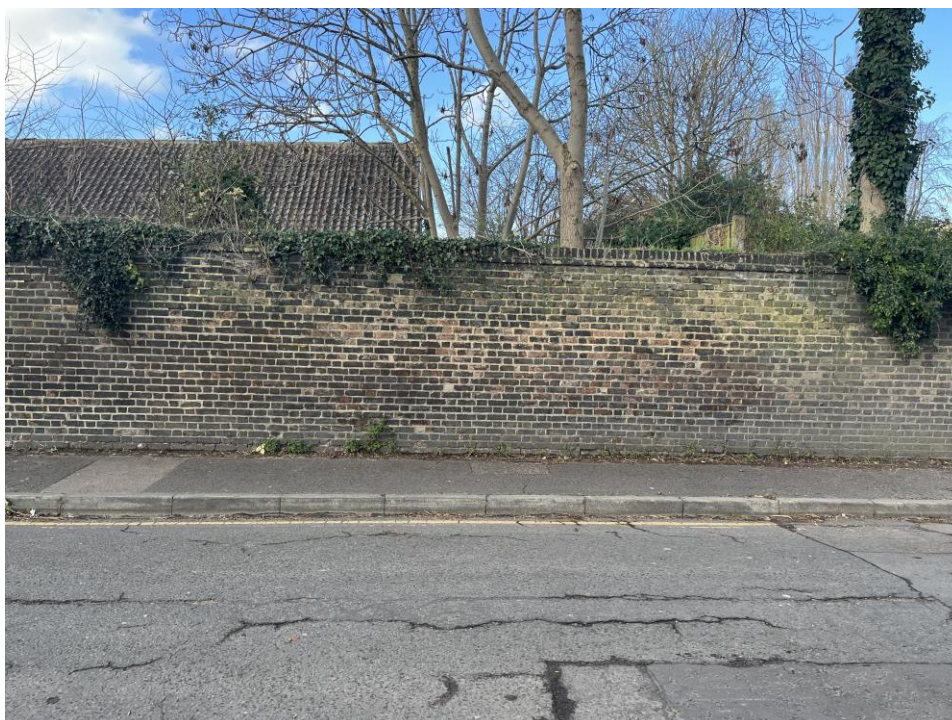
*Plate 23: View looking W towards the boundary wall in the approximated area of the proposed temporary entrance.*
