# LAND WEST OF NORWOOD LANE, MEOPHAM

## Flood Risk Assessment and Conceptual Drainage Strategy

794-ENV-HYD-22099  
Land West of Norwood Lane,  
Meopham  
004  
15<sup>th</sup> September 2025

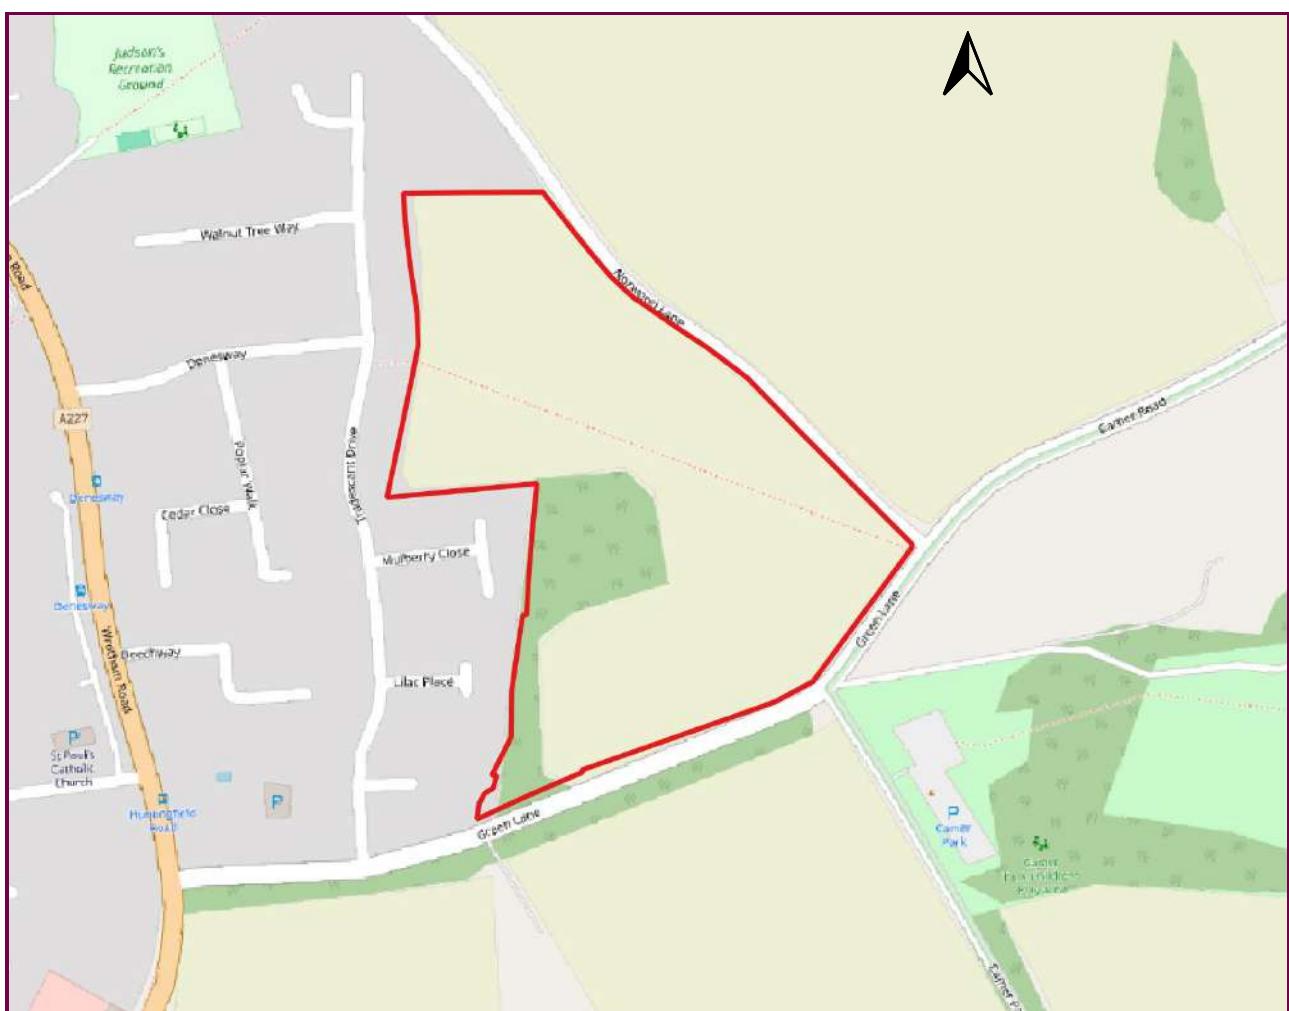
**Figure 2. EA Flood Map for Planning**

- 6.3 The EA Flood Map for Planning (updated in March 2025), which is available online, indicates that the site is located within Flood Zone 1, whereby the annual probability of flooding from fluvial or tidal sources is classified as less than 0.1%/1 in 1,000 years.
- 6.4 The EA Flood Map for Planning is provided in **Figure 2**.

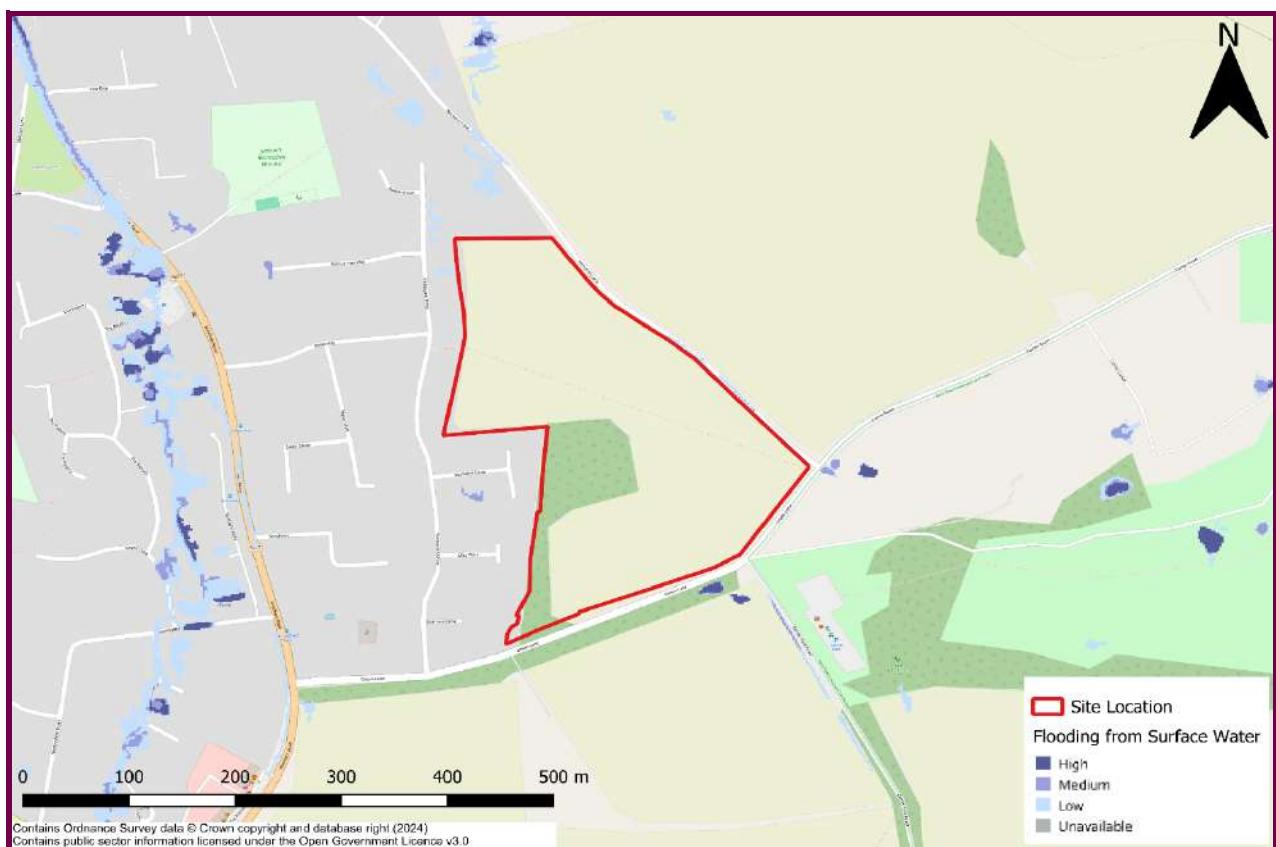
**Figure 3. Flooding from Surface Water**

6.9 There is ‘low’ risk of surface water flooding isolated in the north corner parallel to Tradescant Drive and pooling along Norwood Lane. Both areas of flooding relate to a 1% annual chance of surface water flooding; presenting flood depths of up to 0.2 metres.

6.10 The updated Flood Map for Surface Water is presented in **Figure 3**.

9.12 Extents of surface water flooding are shown to increase on the surface water plus climate change flooding map, however shallow flood depths of up to 0.20m are anticipated for both scenarios. It is expected that with development; surface water flood risk on-site will be remediated through the implementation of a positive drainage network and engineering of ground levels to direct surface water from hardstanding away from building and towards the drainage network. Due to anticipated flood depths, flood risk along Norwood Lane is not expected to cause any pedestrian or vehicular access issues.

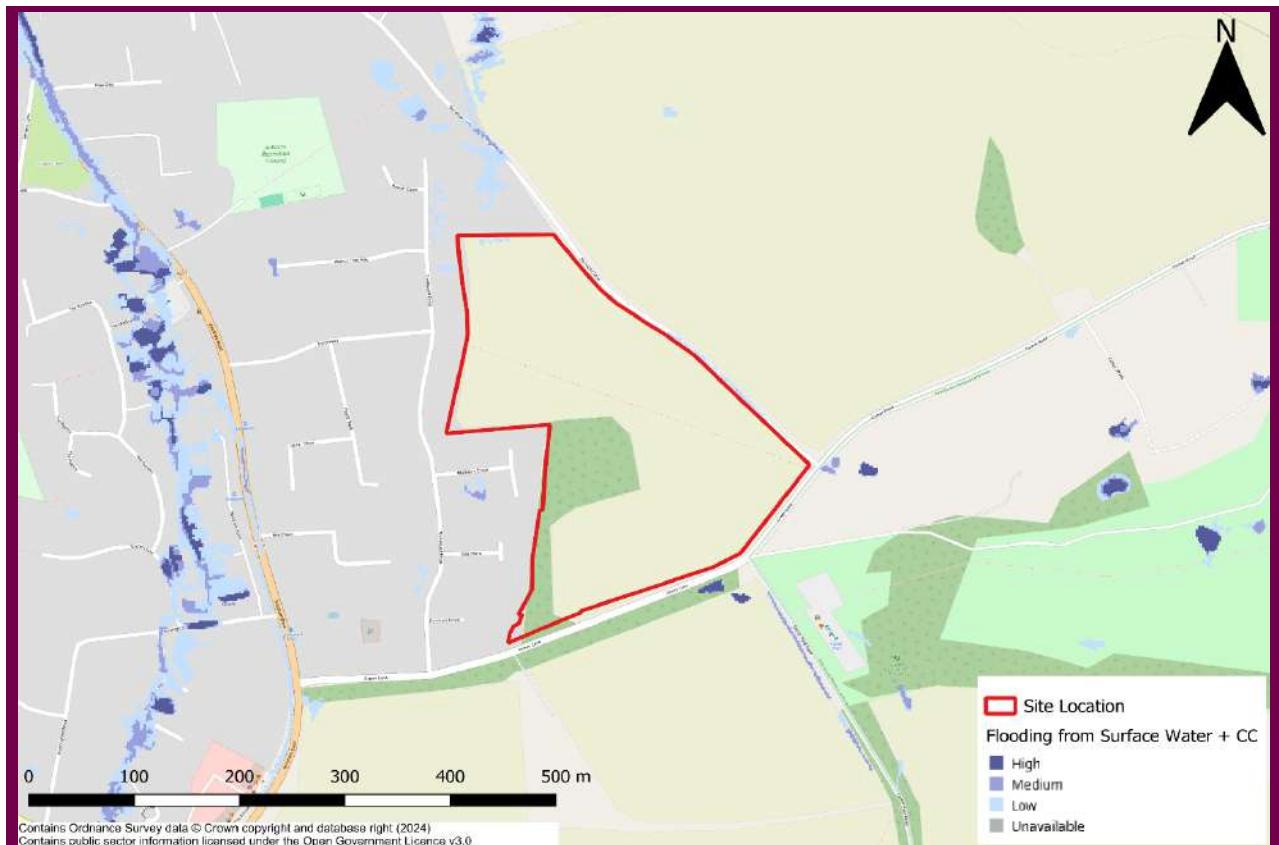
**Figure 4. Updated Flood Map for Surface Water plus Climate Change**

6.11 As of January 2025, the EA also provides data for Flood Map for Surface Water this includes the climate change extents which consider the ‘Central’ climate change allowance for the 2050s epoch (2040-2060).

6.12 Within the climate change scenario, there is a small extent of surface water flooding within the north site boundary with a ‘Low’ risk of surface water equivalent to ‘Less than 1 in 100 (1%) but greater than or equal to 1 in 1000 (0.1%) chance of flooding in any given year’, this extent cannot be seen on the EA’s surface water + climate change depth map at 0.2 metres. This can be seen below in Figure 4. Updated Flood Map for Surface Water plus Climate Change.

6.13 RPS notes that this modelling has several limitations, most significantly that it does not accurately represent the drainage capacity in urban areas. Consequently, the EA states that the maps 'are not suitable for use at an individual property level' and are instead for indicative purposes.

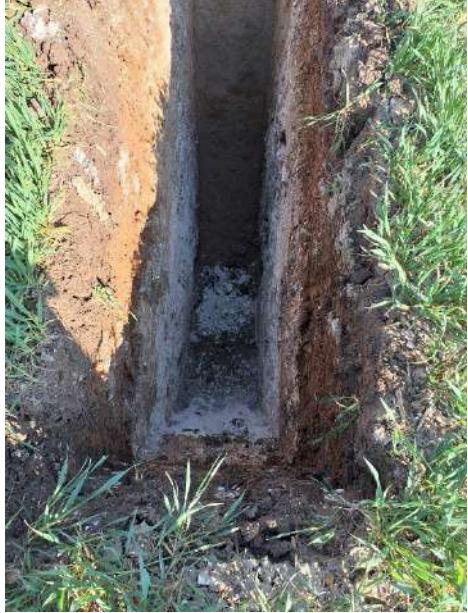
<b>Photo No.</b> <b>9</b>	<b>Date:</b> 03/0425	
	TP01	
<b>Description:</b> Photo during digging

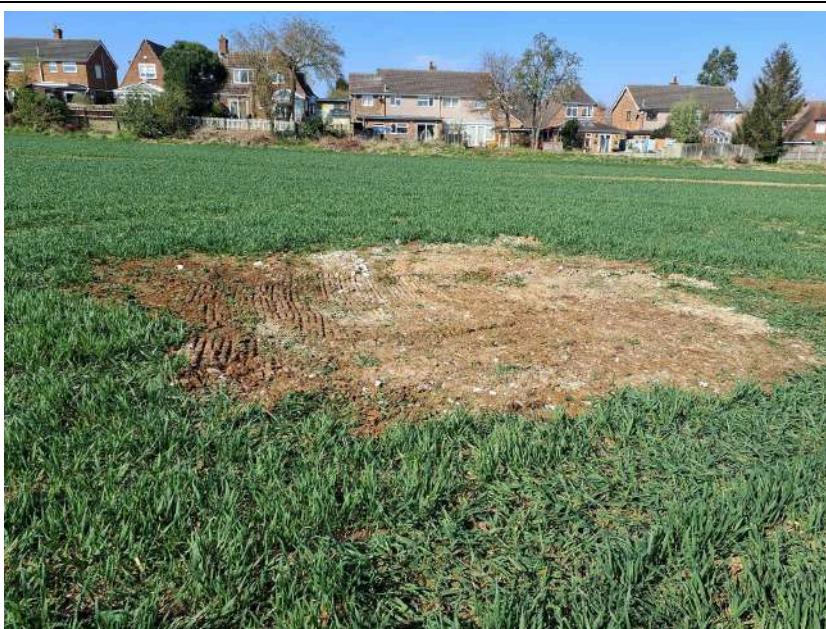
<b>Photo No.</b> <b>10</b>	<b>Date:</b> 03/0425	
	TP01	
<b>Description:</b> Photo after digging

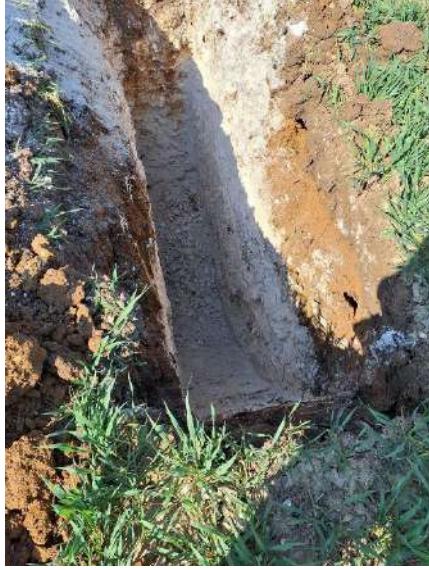
<b>Photo No.</b>	<b>Date:</b>	
11	03/0425	
<b>TP02</b>		
<b>Description:</b> Photo during digging

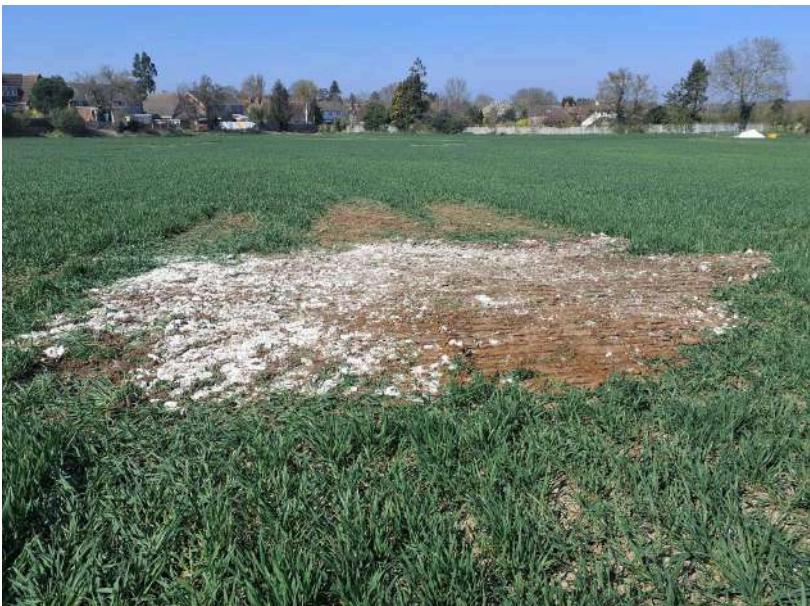
<b>Photo No.</b>	<b>Date:</b>	
12	03/0425	
<b>TP02</b>		
<b>Description:</b> Photo after digging

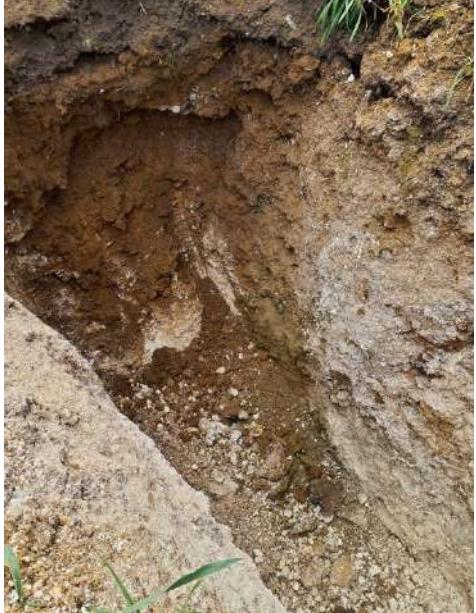
<b>Photo No.</b>	<b>Date:</b>	
<b>29</b>	26/03/25	
<b>TPSA01</b>		
<b>Description:</b> Photo during digging

Infiltration rate (m/s)		
	Test 1	Test 2	Test 3
<b>TPSA01</b>	n/a	$3.47 \times 10^{-5}$	$3.44 \times 10^{-5}$
<b>TPSA02</b>	$2.37 \times 10^{-4}$	$2.51 \times 10^{-4}$	$3.48 \times 10^{-4}$
<b>TPSA03</b>	$2.42 \times 10^{-4}$	$2.44 \times 10^{-4}$	$2.89 \times 10^{-4}$
<b>TPSA04</b>	$4.71 \times 10^{-4}$	$9.45 \times 10^{-4}$	$7.00 \times 10^{-4}$

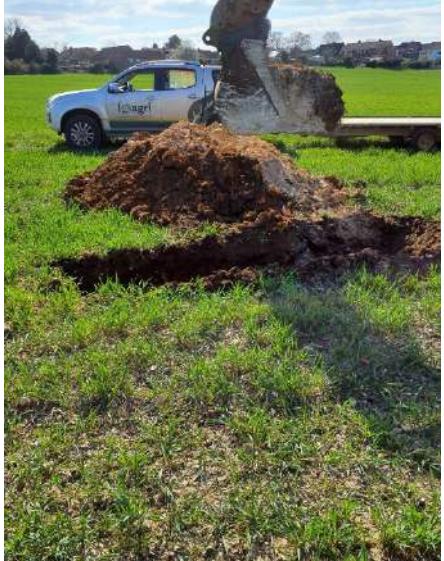
<b>Photo No.</b>	<b>Date:</b>	
<b>30</b>	26/03/25	
<b>TPSA02</b>		
<b>Description:</b> Photo during digging

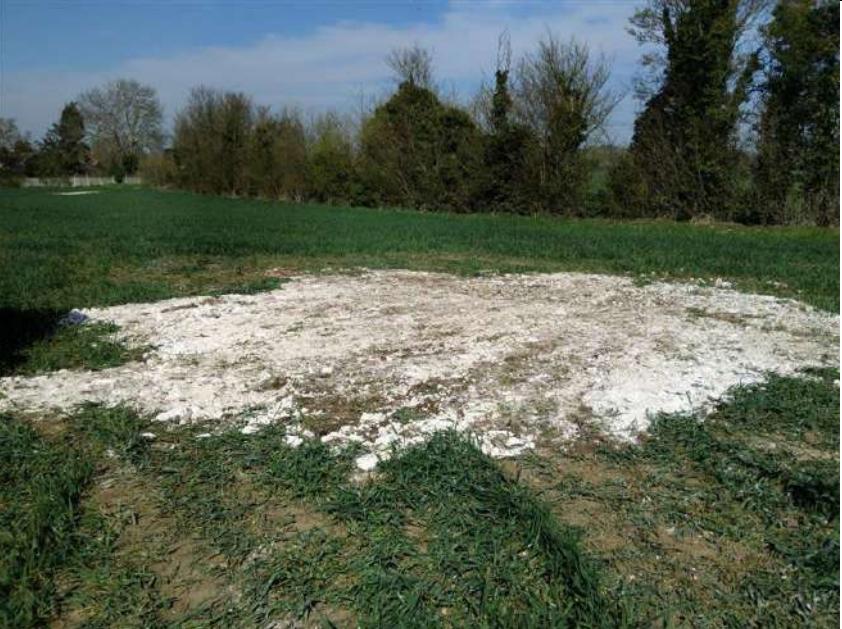
<b>Photo No.</b> <b>31</b>	<b>Date:</b> 04/04/25

<b>TPSA02</b>		
<b>Description:</b> Photo after digging

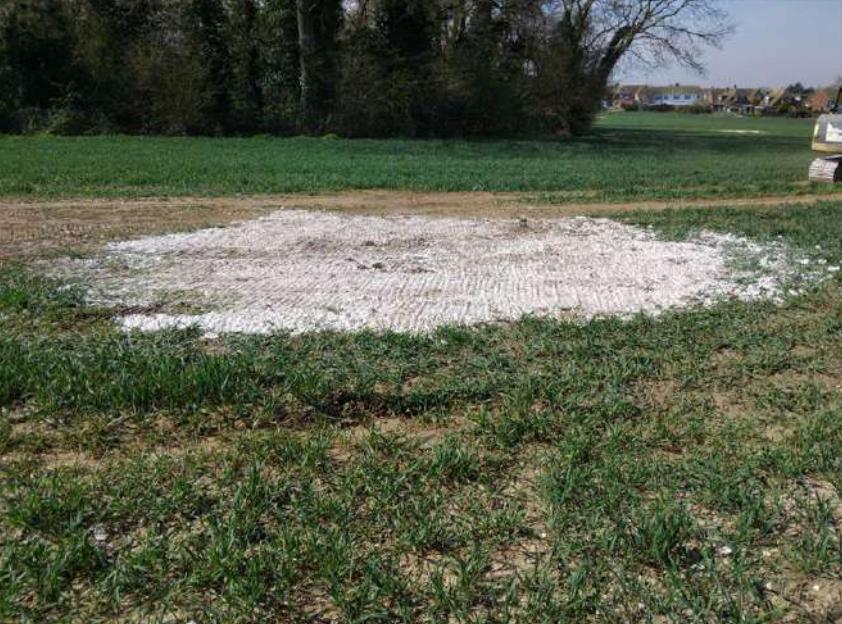
<b>Photo No.</b> <b>32</b>	<b>Date:</b> 04/04/25

<b>TPSA03</b>		
<b>Description:</b> Photo after digging

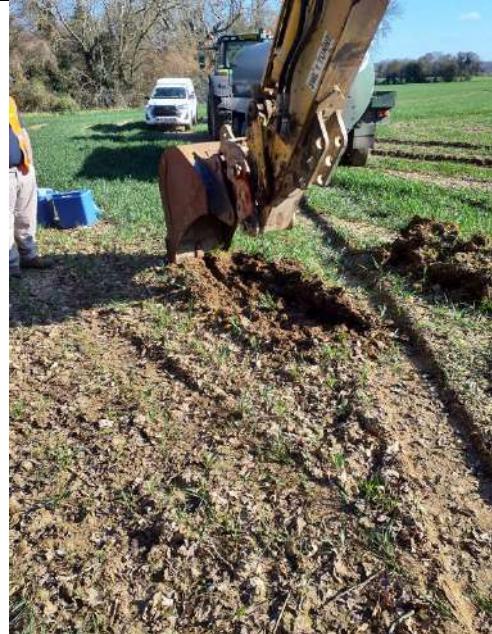
<b>Photo No.</b>	<b>Date:</b>	
33	26/03/25	
<b>TPSA04</b>

<b>Description:</b> Photo during digging

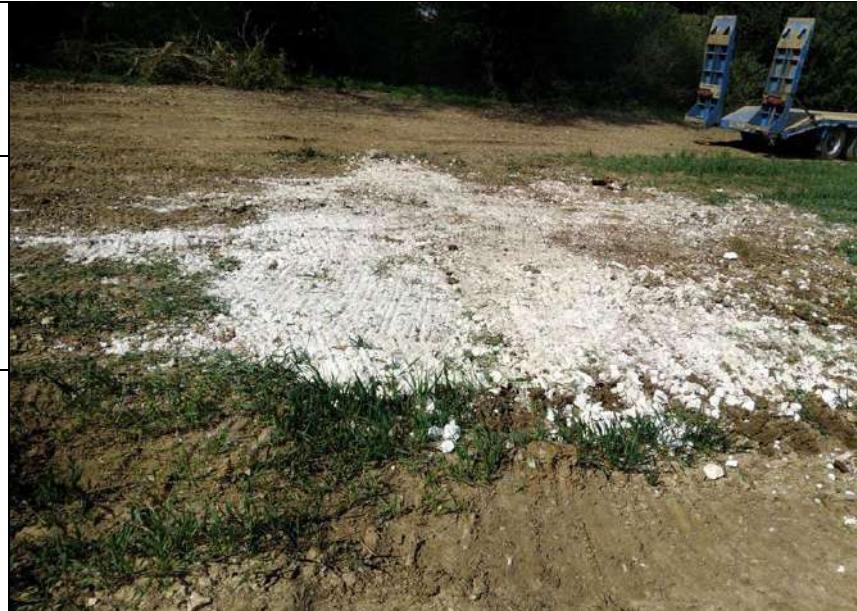
<b>Photo No.</b>	<b>Date:</b>	
34	04/04/25	
<b>TPSA04</b>

<b>Description:</b> Photo after digging
