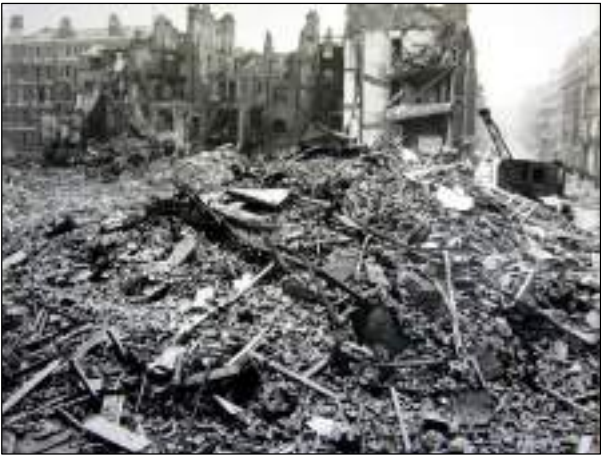
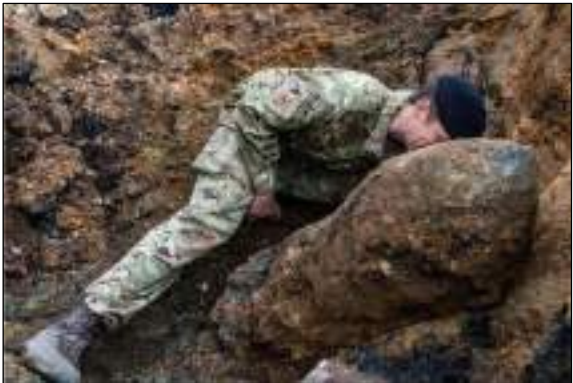
Top: J-curve Effect - Due to angle of entry, unexploded bombs would often end their trajectory at a lateral offset from point of entry, often ending up beneath adjacent extant structures/sites. The photograph above shows a 250kg unexploded bomb found in Bermondsey in 2015, pointing upwards, demonstrating 'J-curve'.

One of the most common scenarios for UXO going unnoticed was when a UXB fell into a 'bomb site' (such as the area shown Top Left), the entry hole of the bomb obscured by any debris and rubble present. Note that the entry hole of a 50kg UXB could be as little as 20cm in diameter (Left).

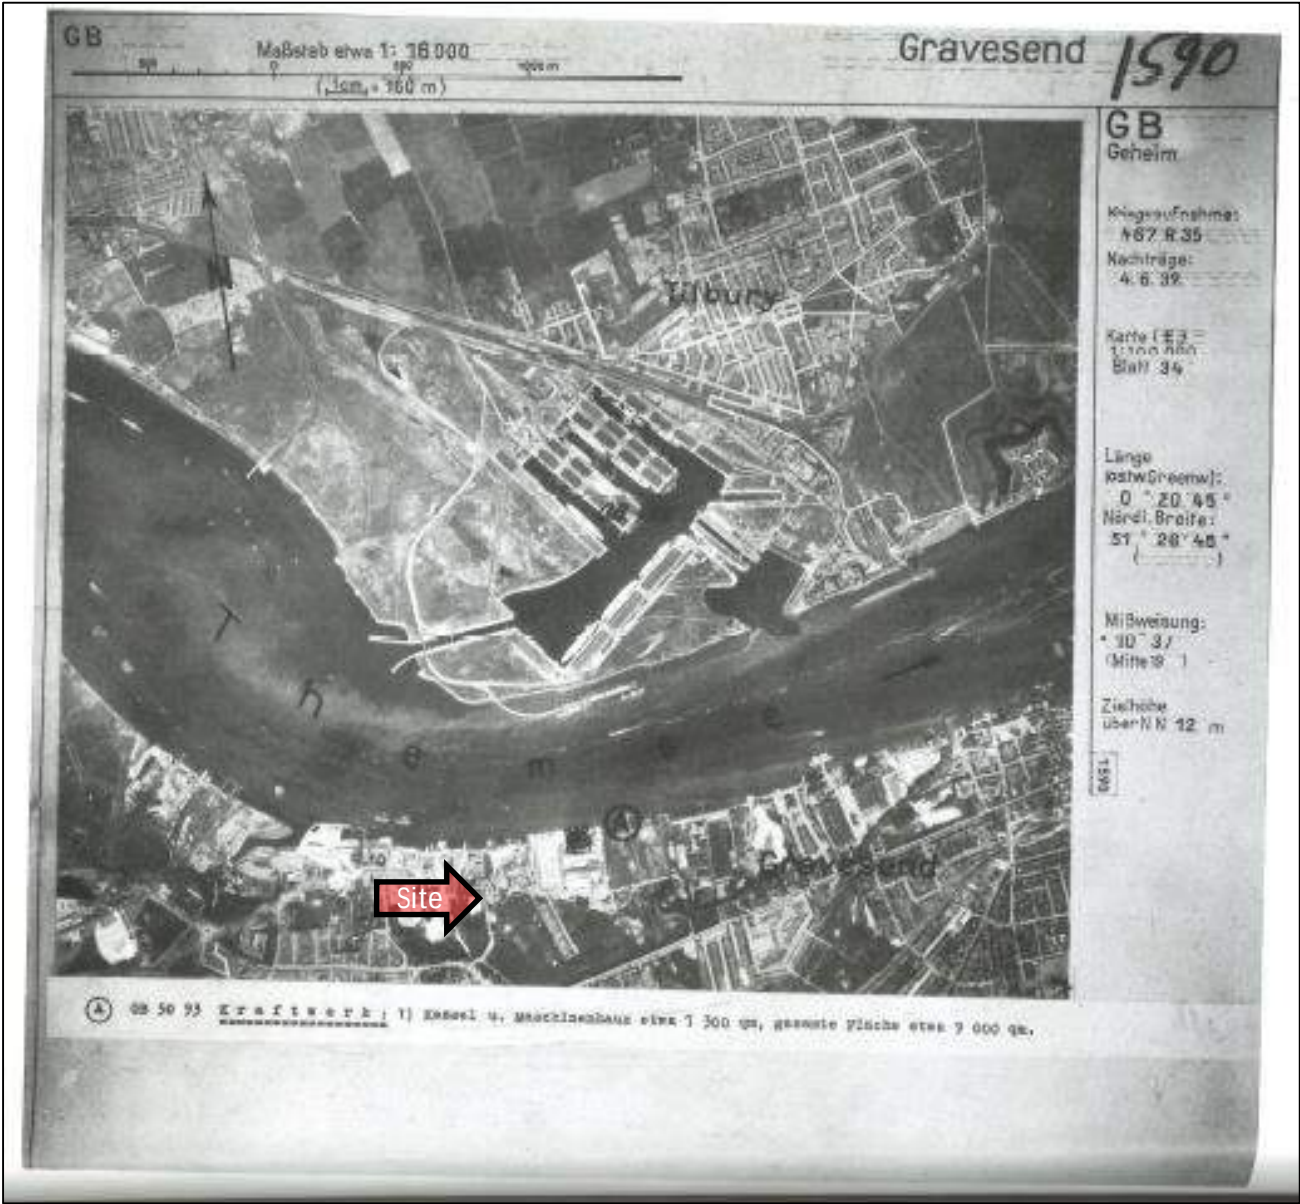
Luftwaffe Photograph, 4<sup>th</sup> June 1939

Kent Gravesend  
A) 'Kraftwerk' (Power station)– Designated Luftwaffe target
