**RSPB Higham Marshes  
Habitat Enhancement Project**

**Archaeology Gazetteer  
Planning Application Proposal Supporting Documentation  
Author: Will Tofts**

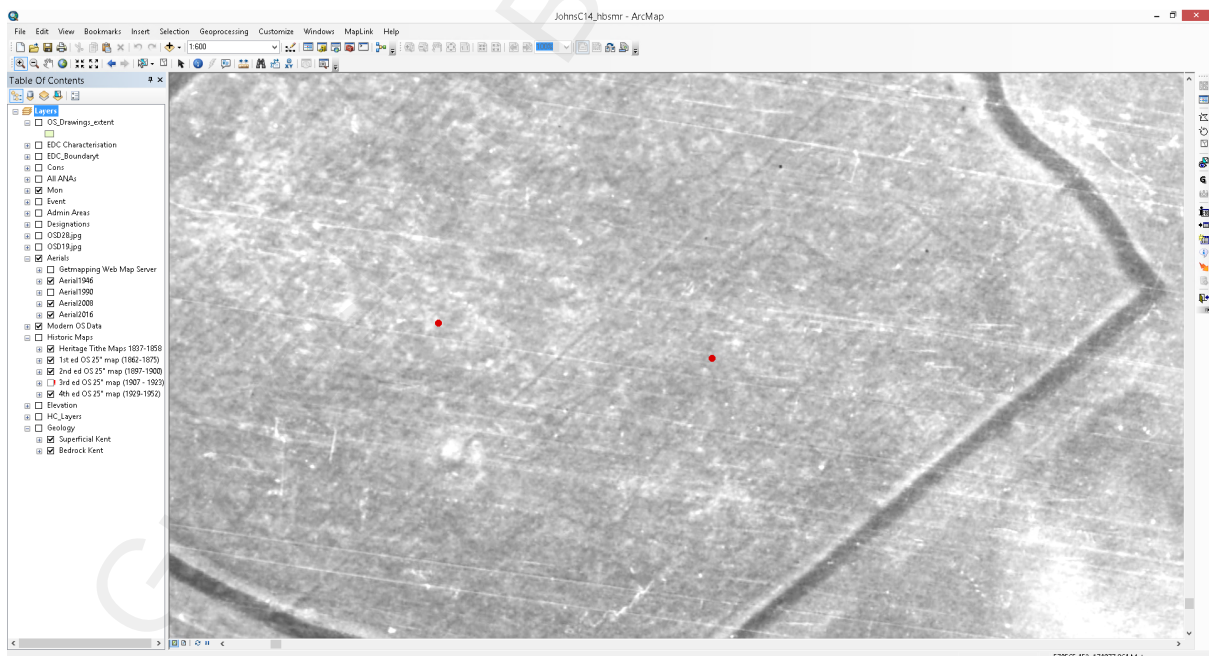
**TQ 77 NW 1269 and 1269** – these HER monument points are not presently in the gazetteer. They reference possible ring ditches and mounds or craters. They appear from the RAF 1946 photos to be similar TQ 77 NW 1038. This parcel has planned works and these will need to be subject to the archaeological watching brief.

| HMM29 | TQ 77 NW 1269<br>TQ 77 NW 1269 | Ring ditches and mounds/craters | | | <p>They reference possible ring ditches and mounds or craters. They appear from the RAF 1946 photos to be similar TQ 77 NW 1038. This parcel has planned works and these will need to be subject to the archaeological watching brief.</p> |
