# PHASE 1 DESK STUDY

**CASCADES LEISURE CENTRE,  
THONG LANE, GRAVESEND,  
KENT DA12 4LG**

**22/12488/KJC REV 1**

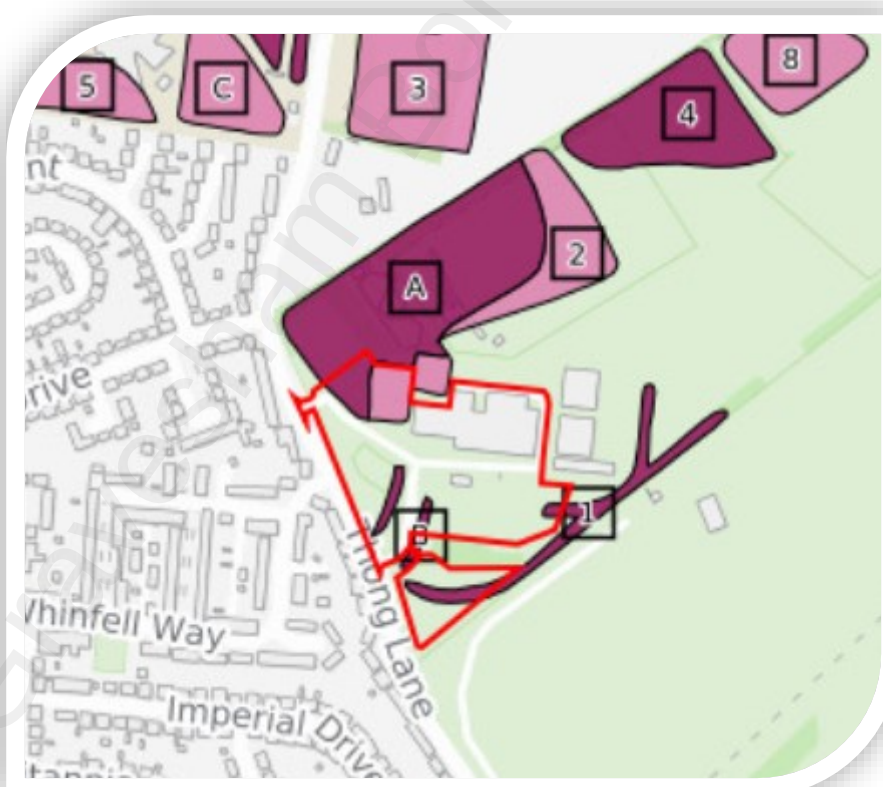
The 1:10,000 scale mapping indicates further areas of made ground and an extract is provided below:

*Extract of 1:10,000 scale BGS artificial geology mapping taken from Groundsure report*

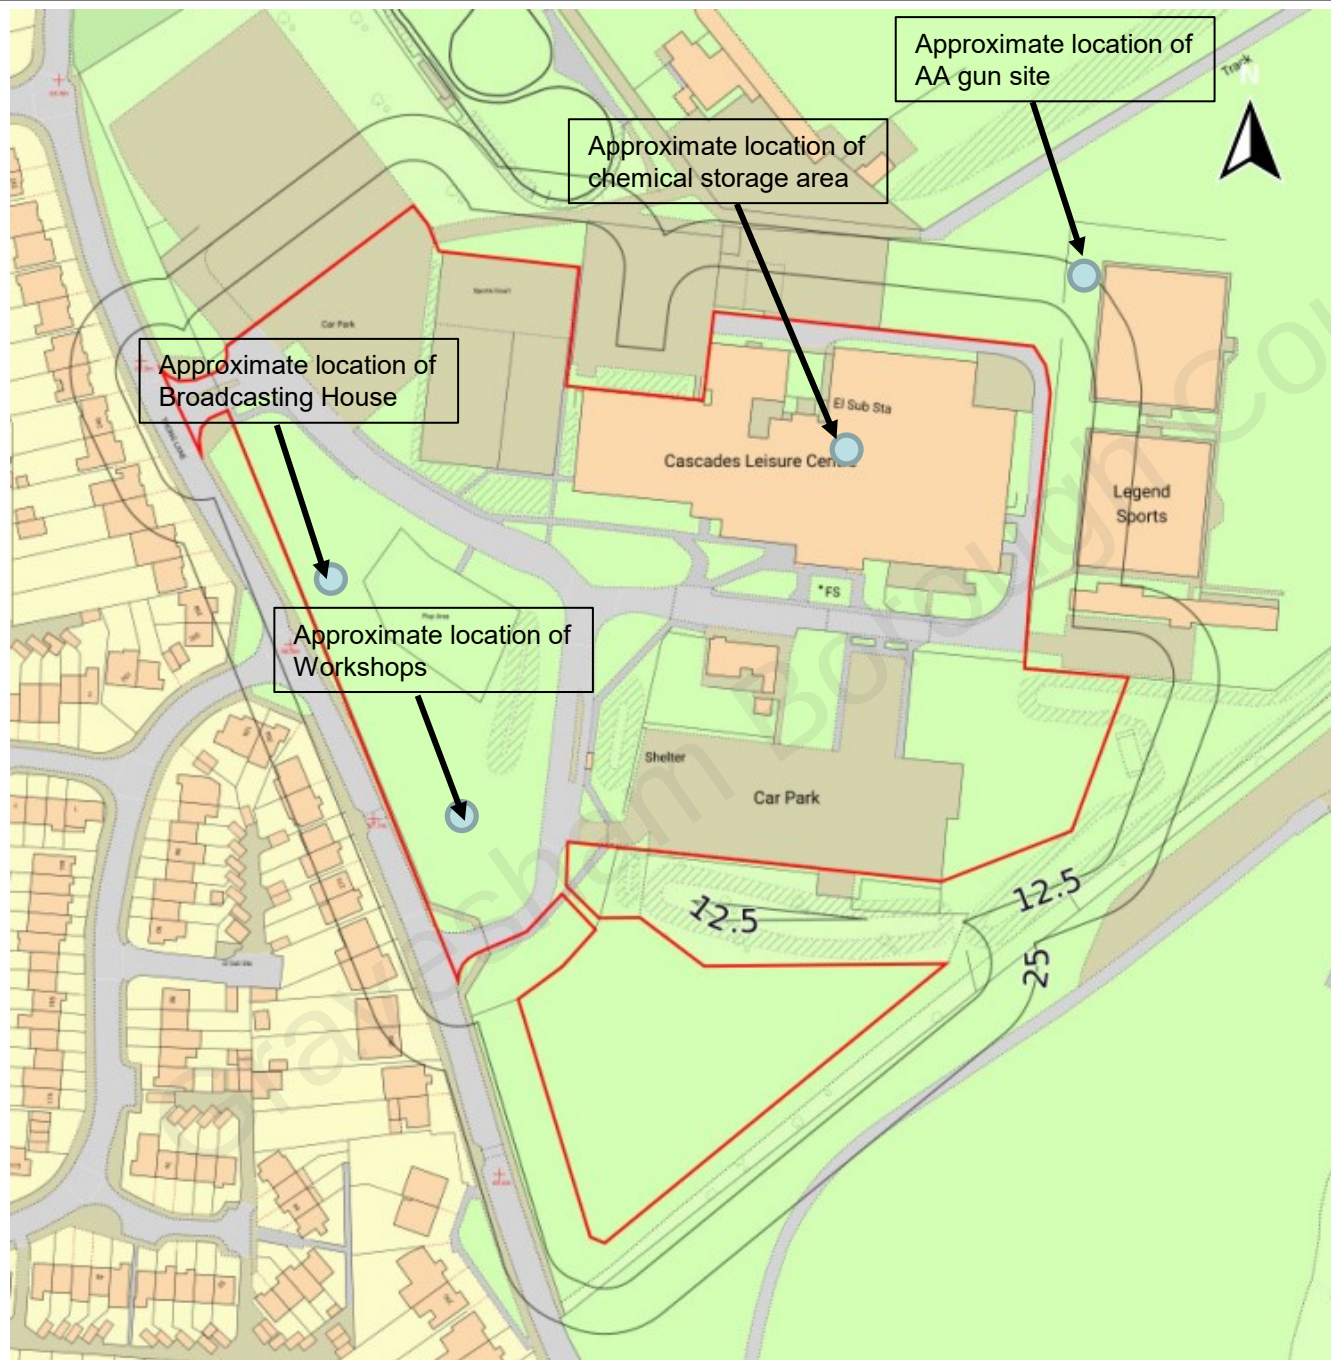
**FIGURE 1**

An examination of the layout of RAF Gravesend during WWII indicates that the perimeter taxiway traversed the development site. An anti-aircraft gun was also sited to the north east, and a broadcasting house and workshops were present on the western boundary. These three features are noted on the site plan in Figure 1.

**EXISTING LAYOUT**

Gravesham Borough Council ("the Client") proposes to demolish the existing Cascades Leisure Centre and develop a new build leisure centre on "the site". The existing site layout is included as Figure 1 and the proposed layout is shown in Figure 2.

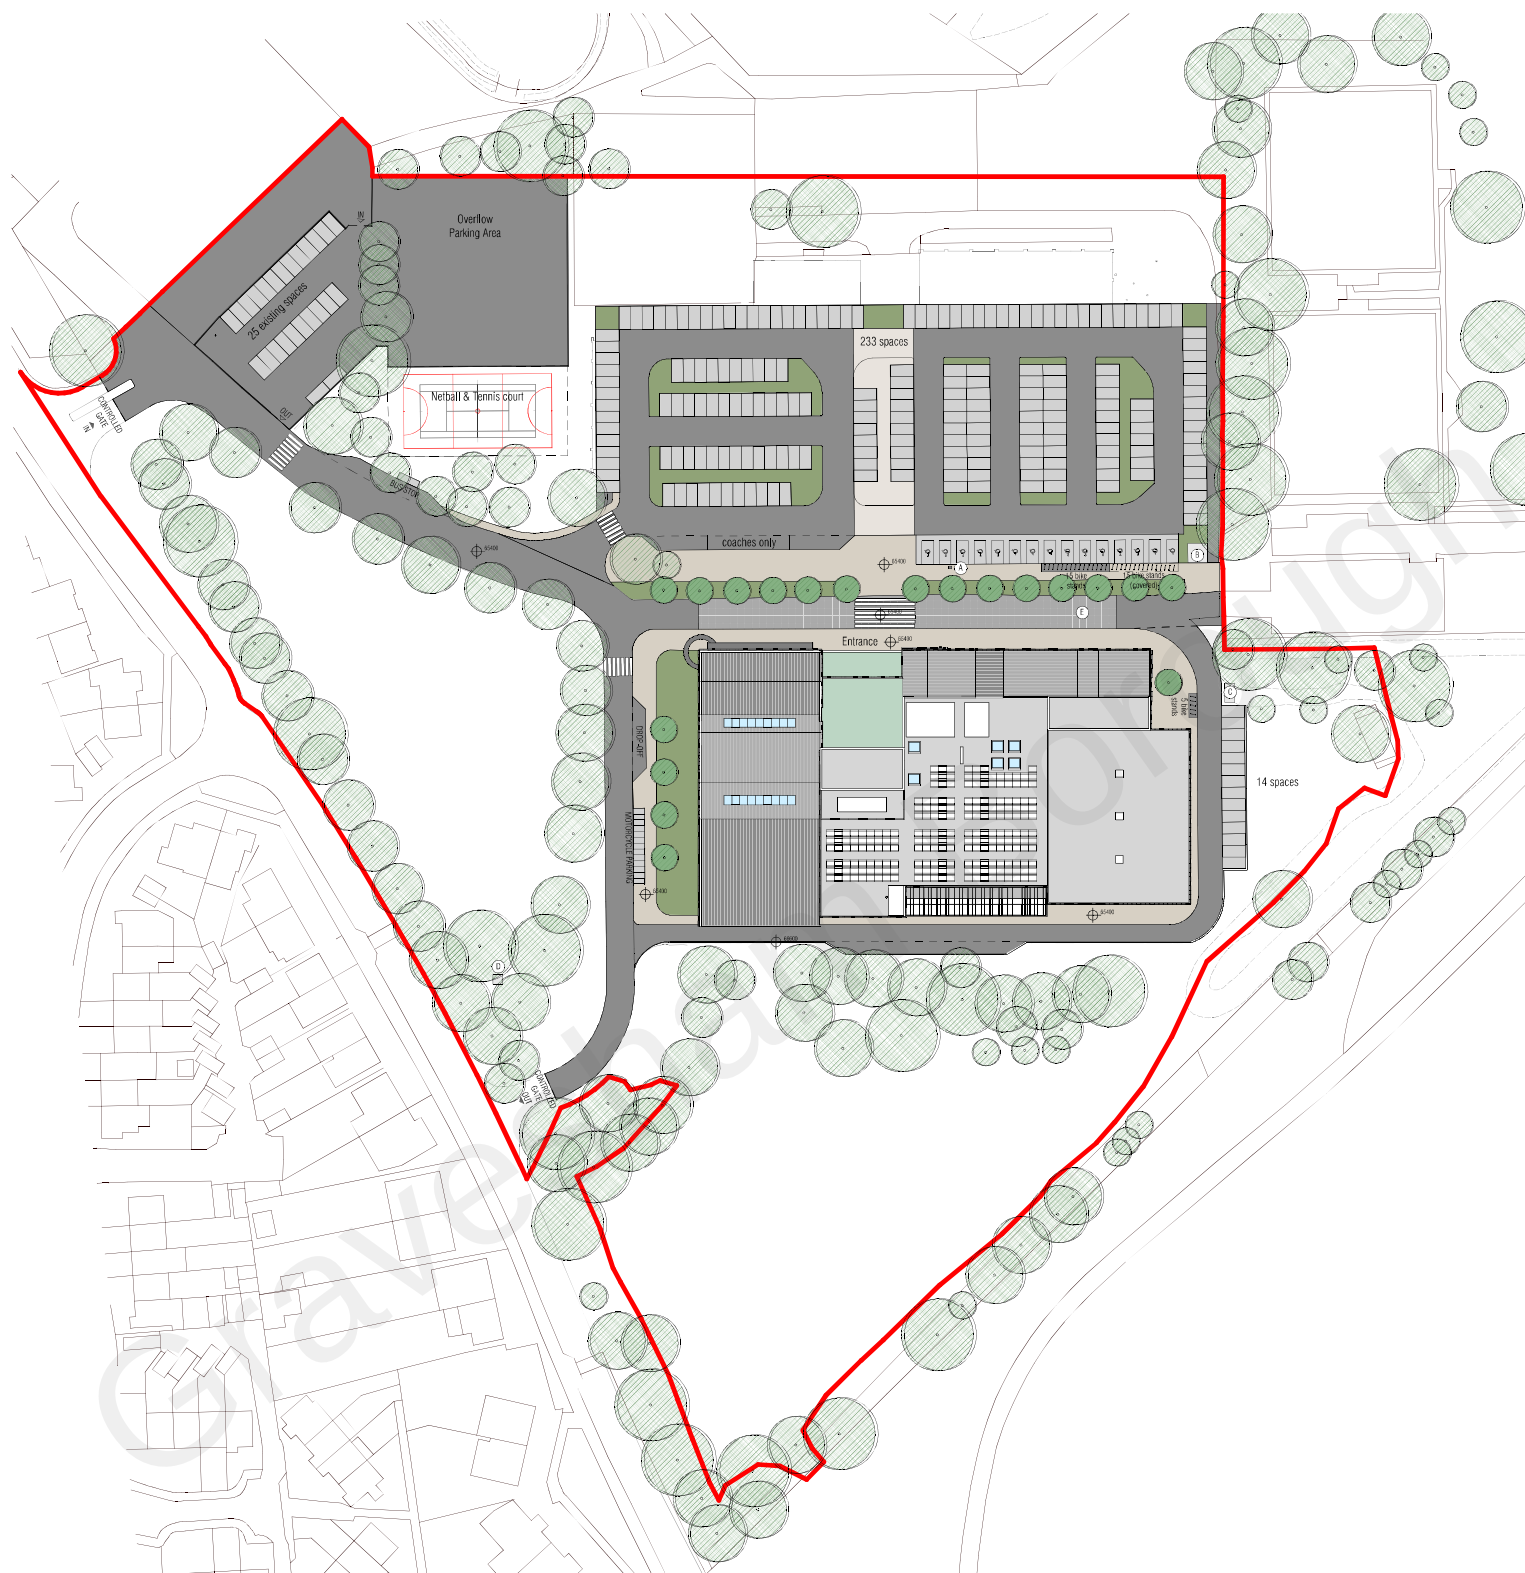
**FIGURE 2**

**PROPOSED LAYOUT**

- Property Line**
- Site Area Total - 43721.30 m<sup>2</sup>
- Parking spaces
  - Green/Vegetation spaces
  - Car access road
  - Pavement

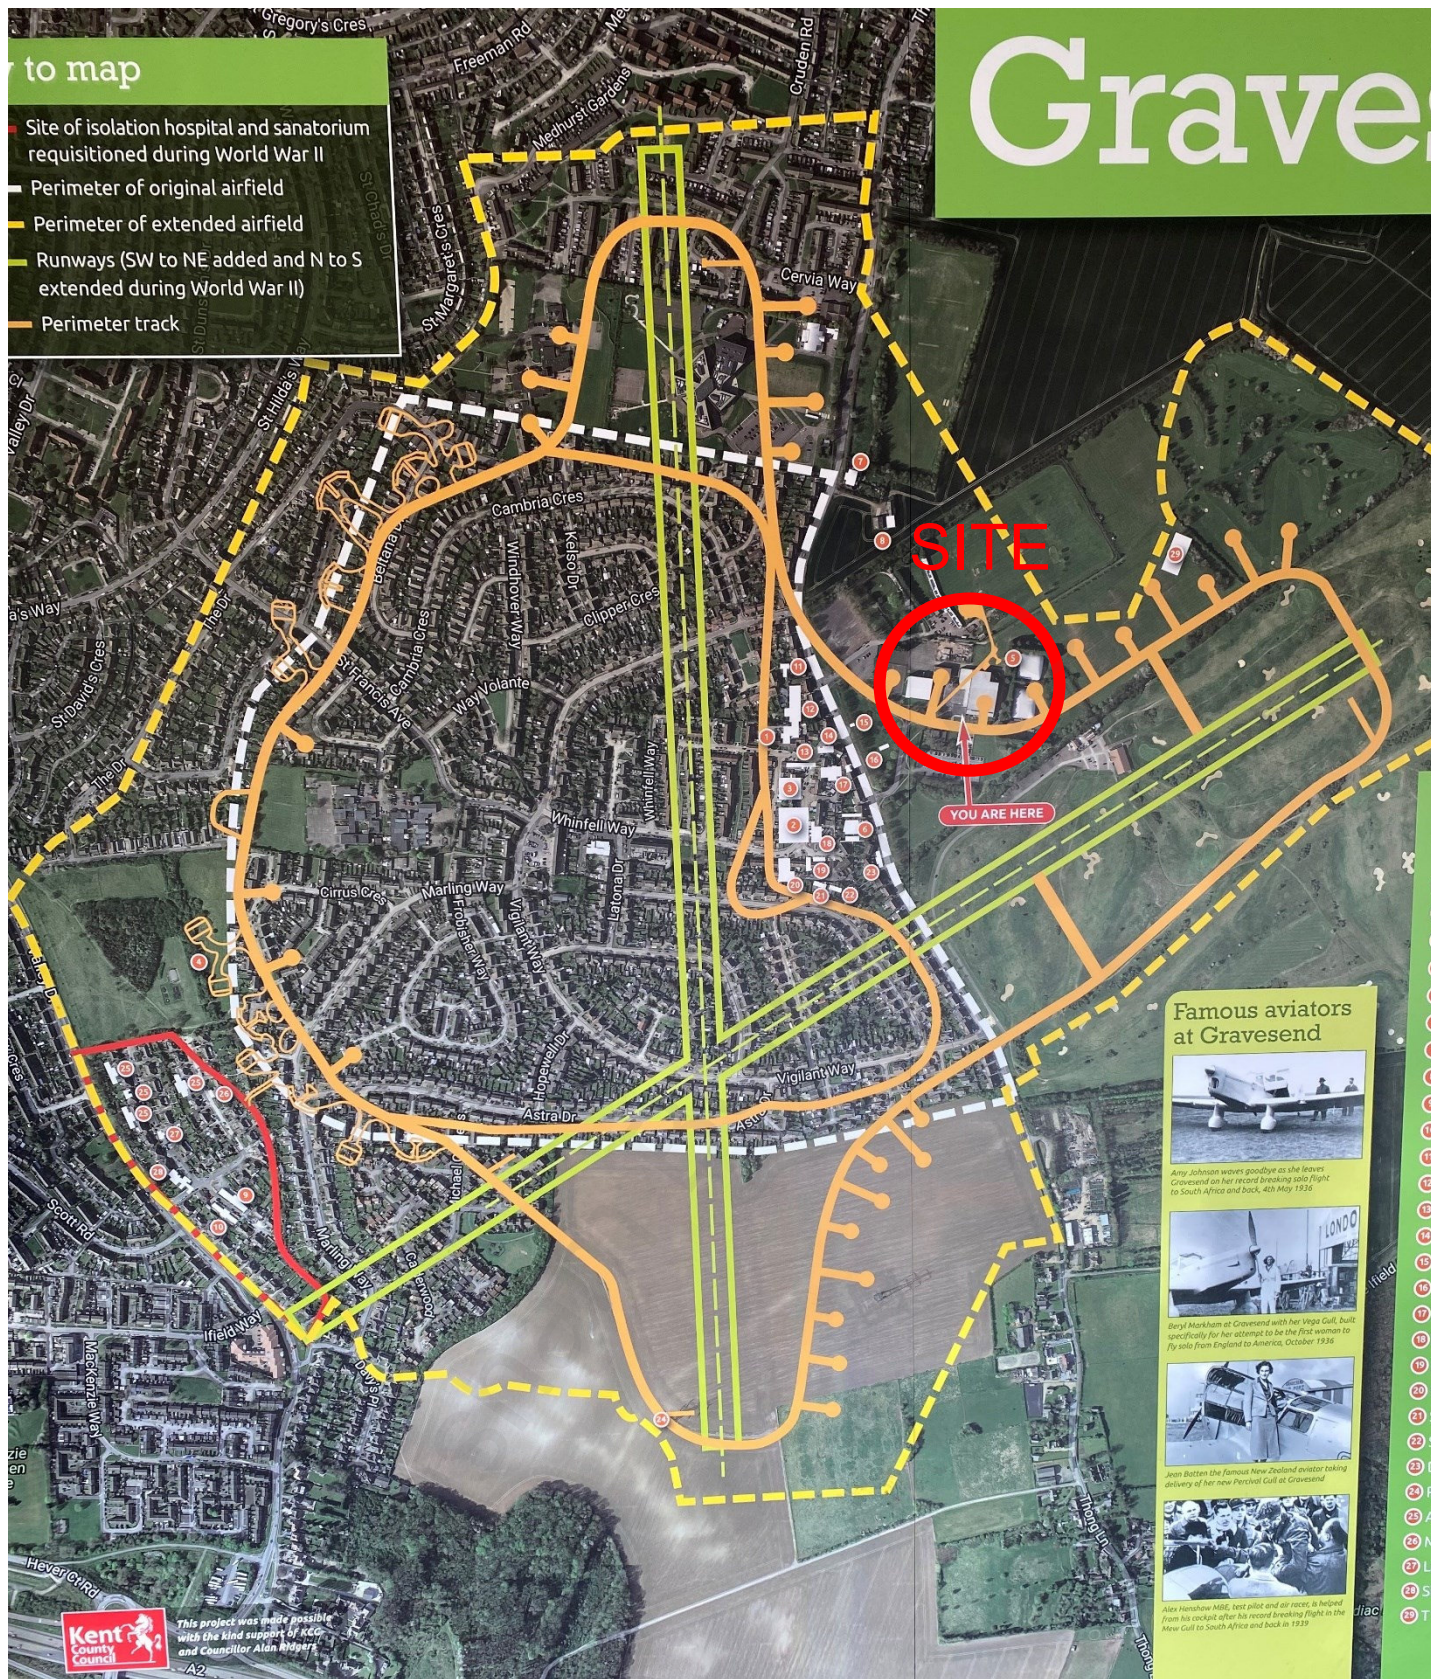
**FIGURE 3**

**AIRFIELD LAYOUT**

Title: RAF Gravesend Airfield Layout

An aerial view of the airfield forms part of an exhibition at Cascades Leisure Centre, provided by the Airfields of Britain Conservation Trust, gives further information and an extract forms Figure 3. An extract of the 1940 aerial view from Google Earth is included as Figure 4. Both images confirm that a perimeter taxiway traversed the site with a number of off shoots. The airfield had two grass runways, one to the west and the second to the south and south east of the site.

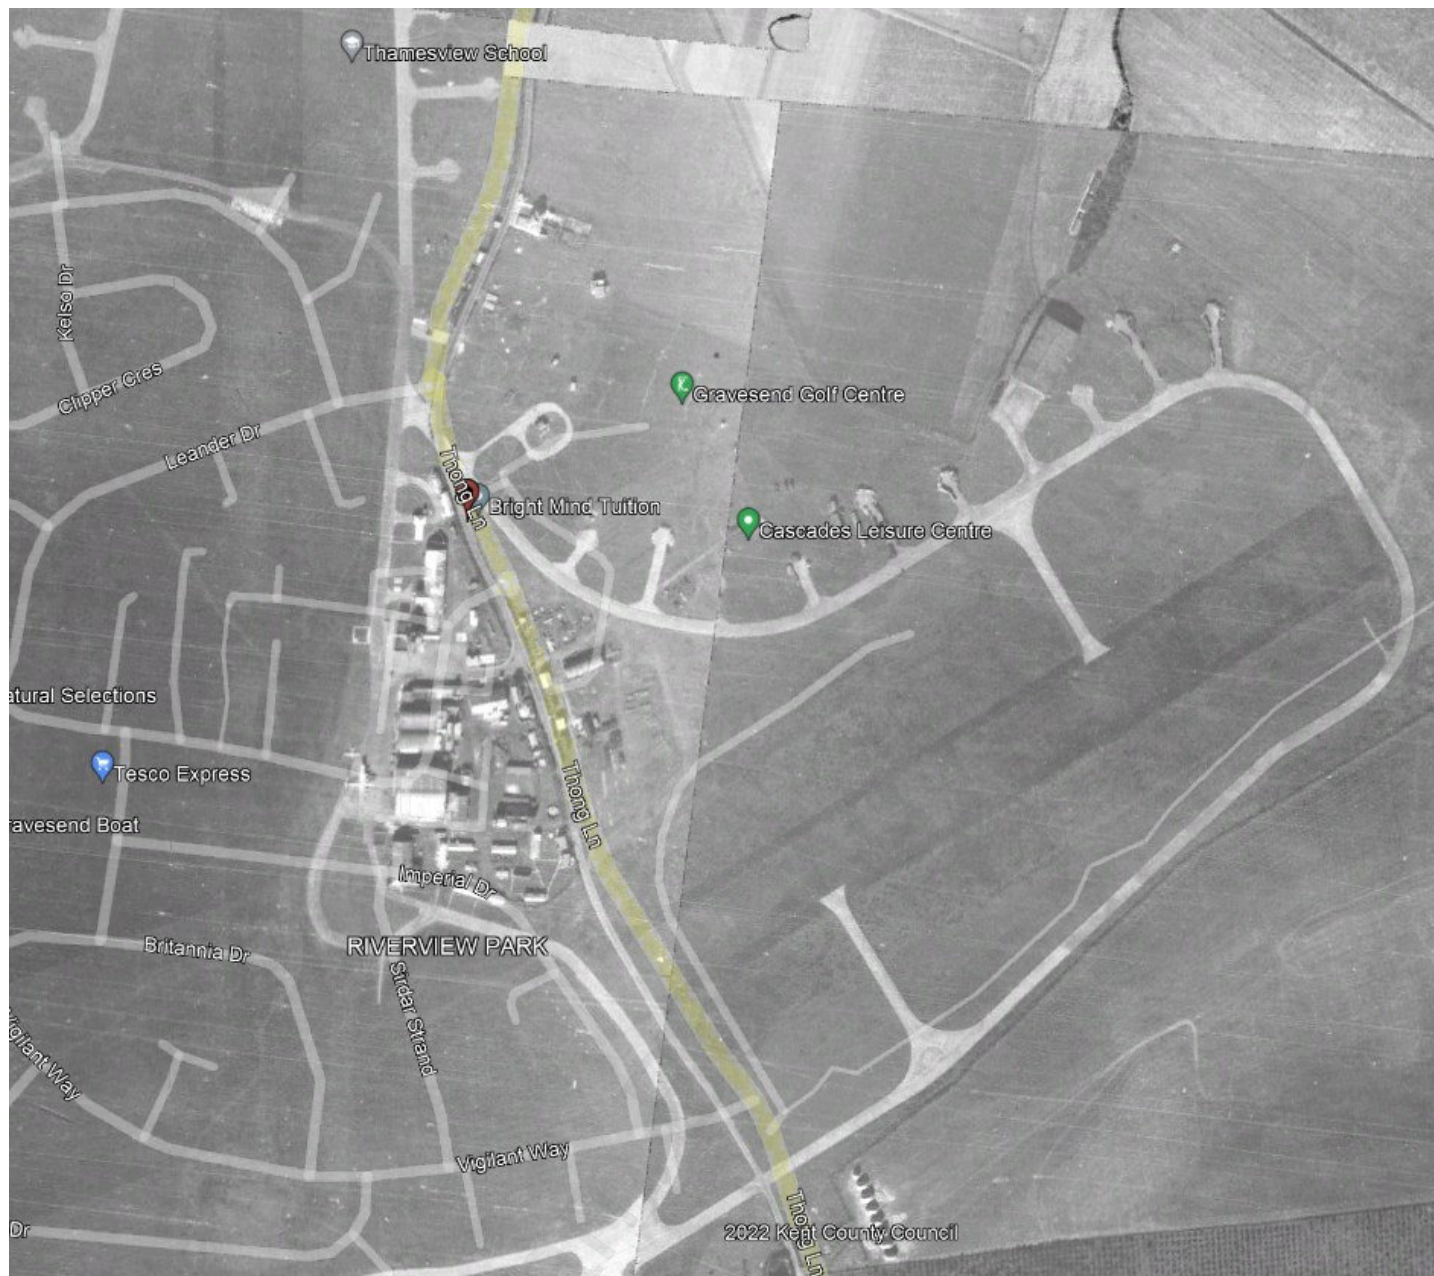
**FIGURE 4**

| Table 2 - Modern Aerials Summary | | |
|---|---|---|
| 1940 | It is apparent that a concrete taxi way associated with an airfield traverses the site with a number of spurs off the main route to the north. | Number of aircraft are present on the area to the west of Thong Lane. |

Aerial view from Google earth c1940

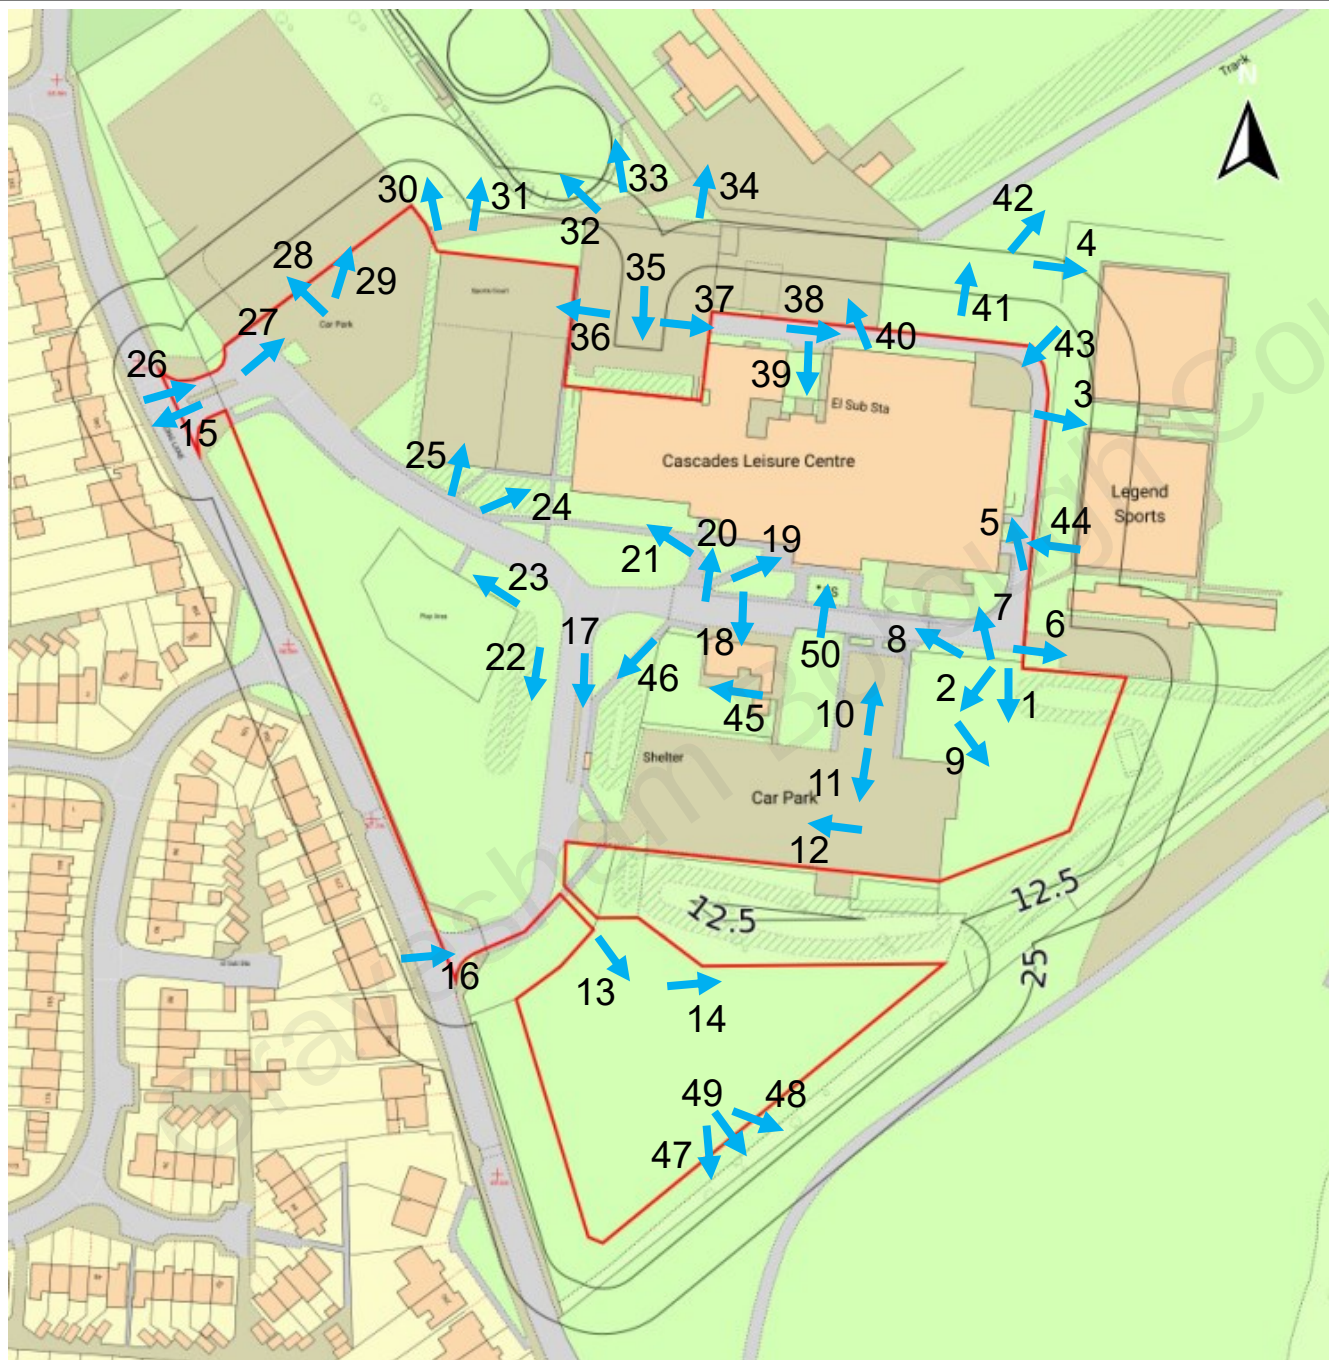
**FIGURE 5**

During the visit a number of photographs were taken, which include close ups of areas of concern. An index to the photographs taken and the photographs are presented in Figure 5 attached to this report.

Title: Photograph Index
