# Walking & Cycling Audit in support of a Residential Development

Woodlands Farm  
Wrotham Road  
Meopham  
Kent  
DA13 0RQ

**Jamie Finch FCIHT, FIHE**  
July 2026  
Revision [0]  
Job No: 6348

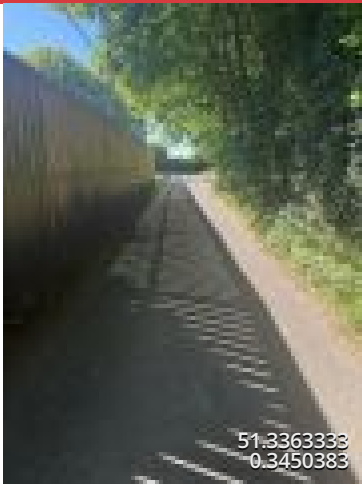
#### **ITEM 1**

Current carriageway width walking along Newlands Lane to the junction is measured at exactly 2.5 m wide

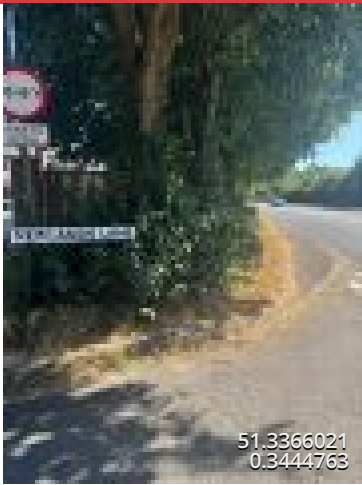
#### **ITEM 5**

There is an existing footpath which heads south out of Newlands Lane to the Royal Mail postbox outside the boundary. This footpath is approximately 1m wide and it appears to be more of a road planing footpath.

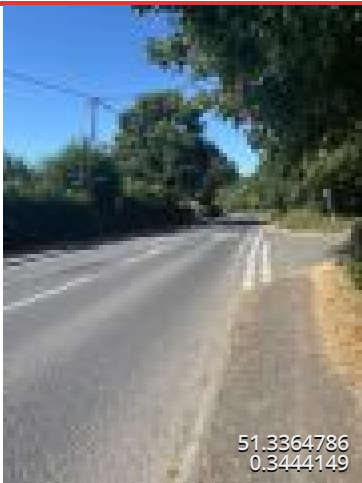
#### **ITEM 7**

Starting back from the junction of Newlands Lane now heading in a northerly direction, the footway continues on the east side of the road, whereas it terminates on the other side of the road opposite the junction of Newlands lane

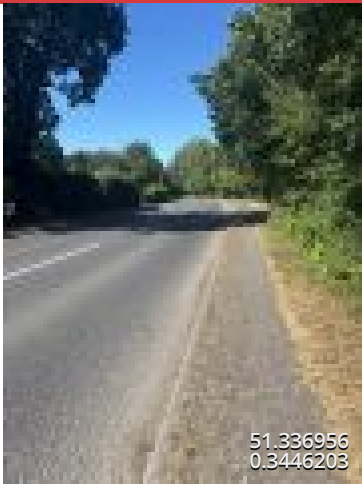
#### **ITEM 8**

Approximately 75 yards to the north there is a bus stop on the east side of the A227. This does not have the benefit of a bus shelter. The footway width remains consistent at approximately 1 m and remains as a road planings surface. However, at the point where the bus stop is this has been laid to a tarmac surface

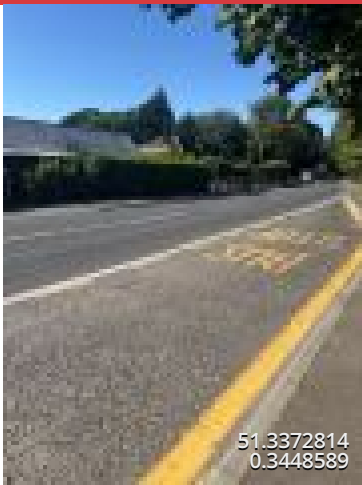
#### **ITEM 9**

Where the bus stop is located, a footpath has restarted on the west side of the road which was measured at 1.8 m wide

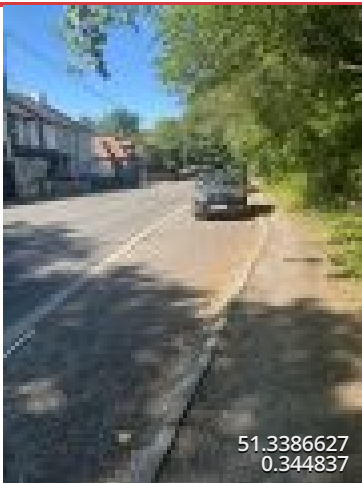
**ITEM 13**

At the same location there is a parking layby opposite the cottages. The footway width remains at approximately 1 m and is still road planings as the surface.

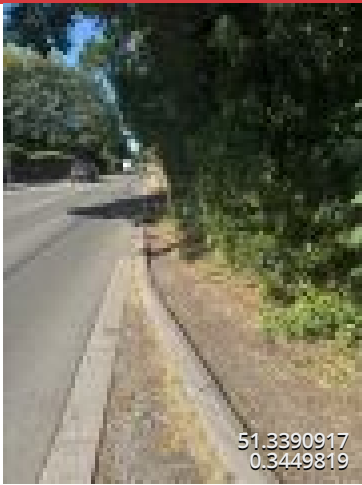
#### **ITEM 14**

| Obstructions | <del>None</del> / <del>Minor</del> / Significant | One significant obstruction being the oak tree on the east side of the A227, which blocks the current footpath. |

At the end of the layby, the footpath reduces in width significantly due to the presence of a large oak tree

Whilst an existing footway is present along Wrotham Road, a mature tree obstructs part of the route, preventing access for wheelchair users and those with pushchairs. The proposed footpath provides an alternative, accessible route, improving pedestrian permeability and encouraging sustainable travel to nearby facilities. The proposed arrangement is illustrated on Drawing RSPD 6348-04 – Proposed New 2.5m Country Footpath, included within the appendices of the transport statement which this report accompanies.

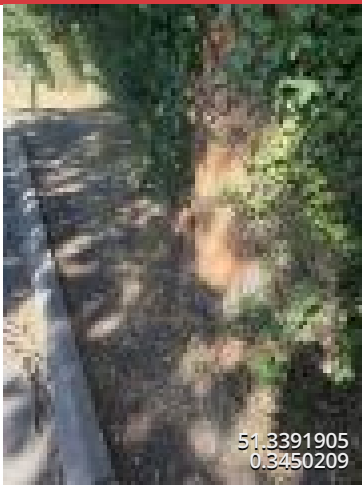
#### **ITEM 15**

This oak tree appears to have been struck several times by moving vehicles and is therefore likely to be posing as a hazard to road users

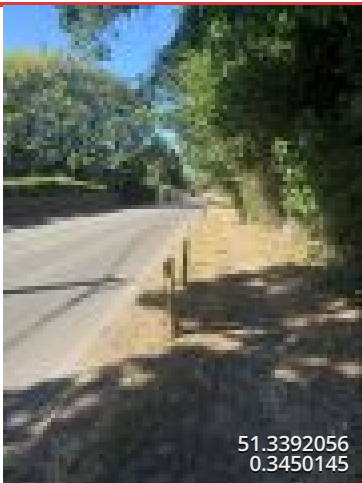
#### **ITEM 16**

Once the oak tree has been passed, the footway formed is a trodden path with no formal surface. This is loosely protected by a series of wooden posts. Whereas on the other side of the road the footway is laid to tarmac with a width of around 1.8 m wide.

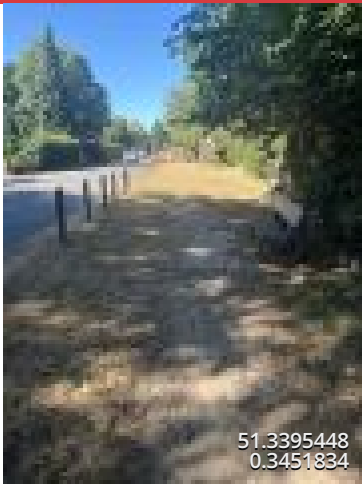
#### **ITEM 17**

Along this trodden path footway there is an existing park bench which would be suitable for people to take a short break and alongside this is a little bin which will help reduce dropped litter

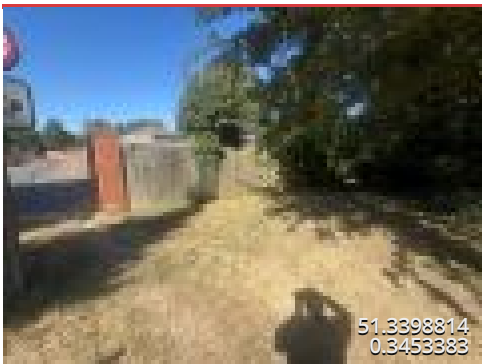
#### **ITEM 19**

At the end of this informal path there is a brick wall where a formal tarmac footpath commences which is measured at 1.8 m wide. Alternatively, there is a gateway to the right hand side which leads through to Mountfield Close

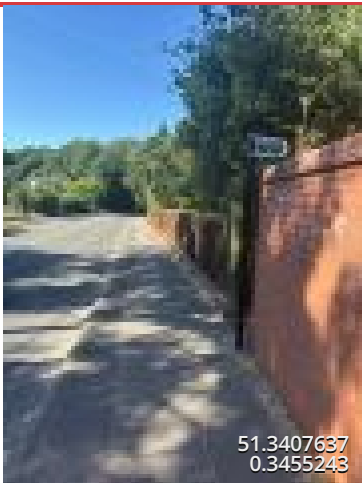
#### **ITEM 22**

Photograph showing footpath link called Carters Hill Walk

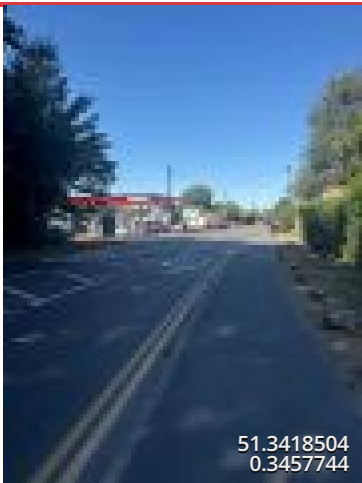
### **ITEM 25**

A fuel station is located a little further along the road which has a small convenience store which is currently partnered with co-op.

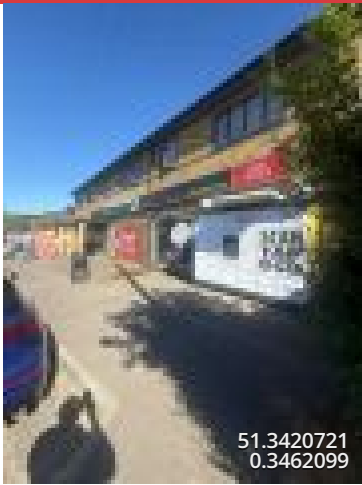
#### **ITEM 26**

On the east side of the road is a convenience store/mini supermarket which also has the benefit of a post office and 24 hour post Pickup and drop-off facility. There is parking available from a layby at the front of the shop but also a small car park at the rear.

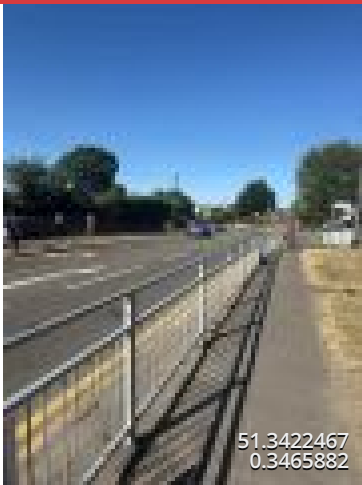
#### **ITEM 27**

It should be noted that throughout the routes observed so far in this audit there is no streetlighting present anywhere, even in the village centre.

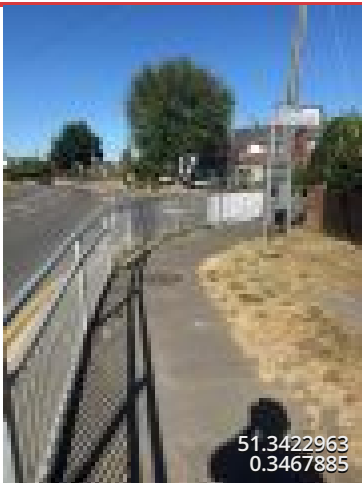
#### **ITEM 28**

Pedestrian guard rail is present on the approach to White post Lane

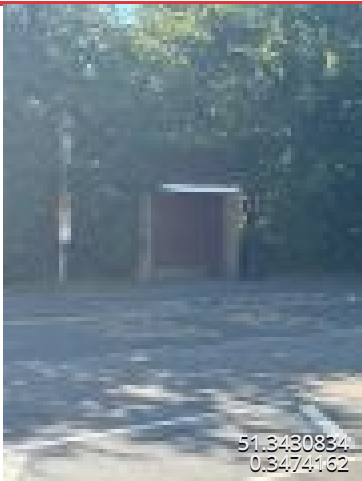
### ITEM 31

The bus stop on the west side of the road does have a bus shelter with a bench and litter bin and there is a nearby crossing point which also serves the nearby Culverstone Green Primary School

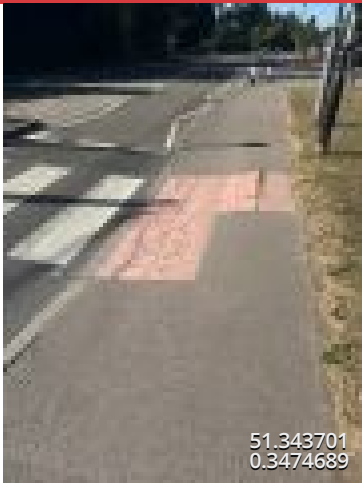
### ITEM 33

Some of the red blister tack tiles are damaged where it appears there may have been over running of HGV vehicles

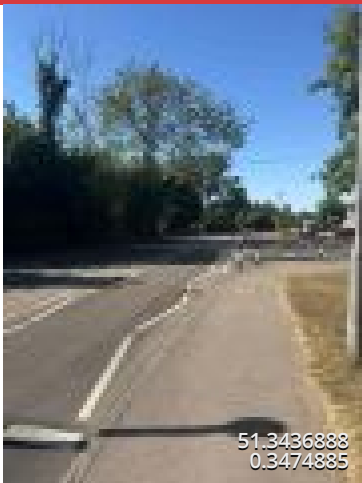
### ITEM 34

The walking and cycling audit terminate at the junction of Willow walk

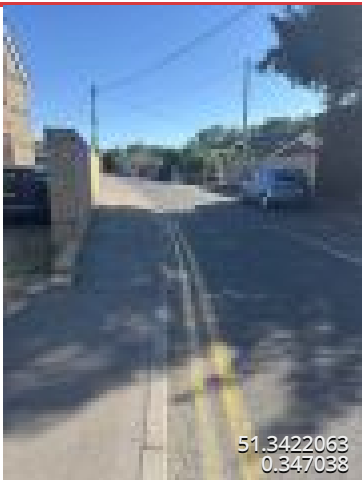
### ITEM 35

Now walking in a southerly direction along White post line footpath is only one side however is up to approximately 2.5 m in some parts

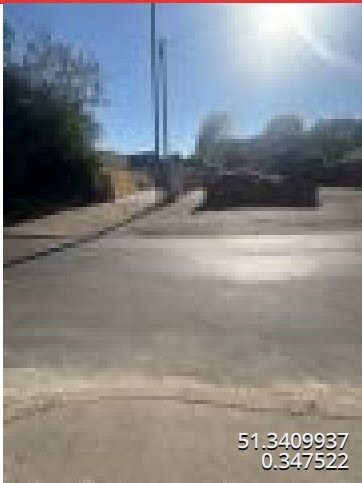
### **ITEM 36**

This shows the other end of Carters Hill walk. It is at this point that the footpath terminates outside another property called Woodlands but continues southerly along White Post Lane on the opposite side of the road. However, there is no formal pedestrian crossing point.

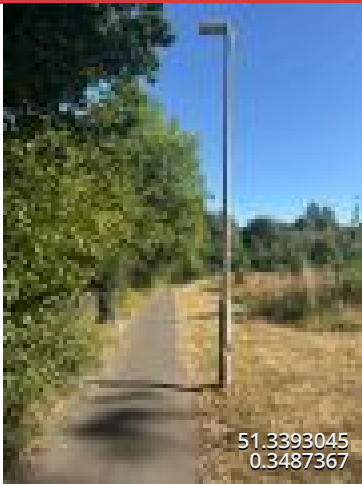
#### **ITEM 42**

This footpath appears to be the only formally lit part of the walked network that I have seen during this audit so far

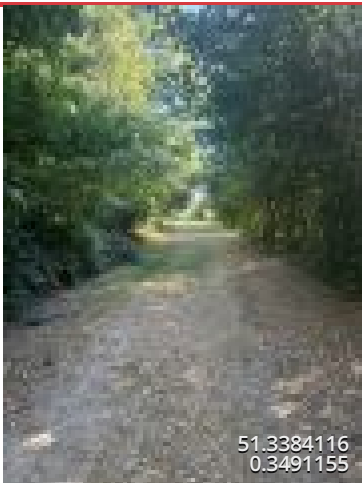
#### **ITEM 44**

Photograph shows mature trees either side of the footpath which is just one of many walked routes through this recreation ground. However, none of the routes have any formal surfacing

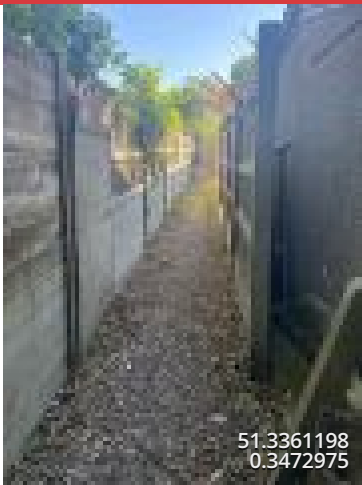
#### **ITEM 46**

This footpath NS273 leads onto a narrow but surfaced footpath which runs between houses. Surfacing material is like a type one road stone which leads out adjacent to somebody's driveway opposite Newlands farm.

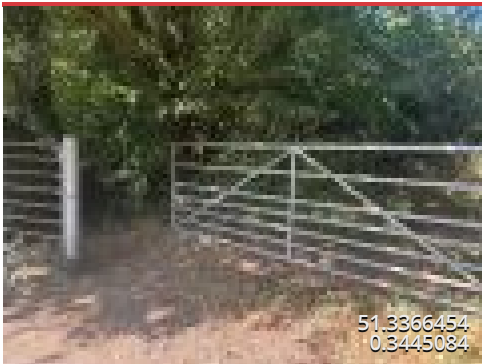
#### **ITEM 49**

Starting again at the Gateway opposite the applicants land at Woodlands farm which leads into Culverstone Green Park

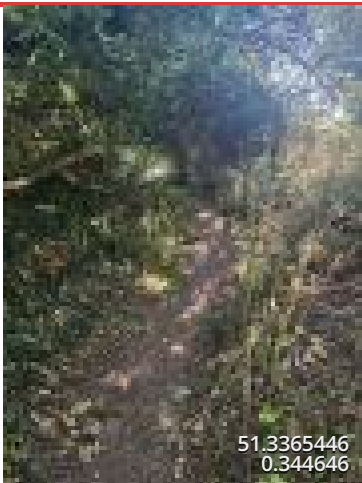
#### **ITEM 50**

Firstly, a very short section of trodden path however intentional on the basis there is a pedestrian gateway at the beginning of the route

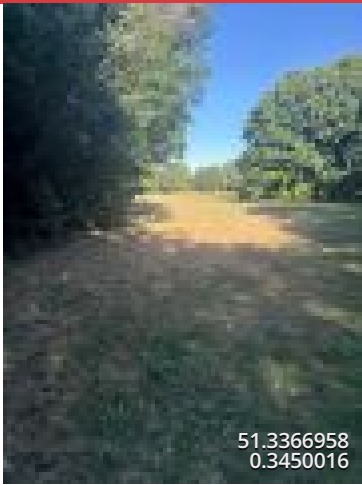
### ITEM 51

This route immediately opens out into the recreation ground

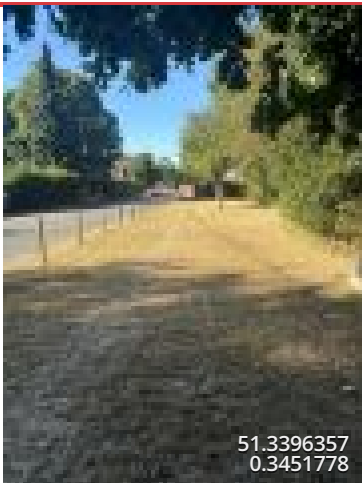
#### **ITEM 56**

To recap from item 54 the formal tarmac footway recommences almost immediately after exiting Culverstone Green Park
