# Detailed Unexploded Ordnance (UXO) Threat & Risk Assessment

Meeting the requirements of CIRIA C681 'Unexploded Ordnance (UXO)  
A guide for the Construction Industry' Risk Management Framework

| PROJECT | Thong Lane | DATE | 1 <sup>st</sup> February 2023 |

The Client has defined the Study Site as “Cascades Leisure Centre, Thong Lane, Gravesend, DA12 4LG” and it is centred on NGR 567030, 171700.

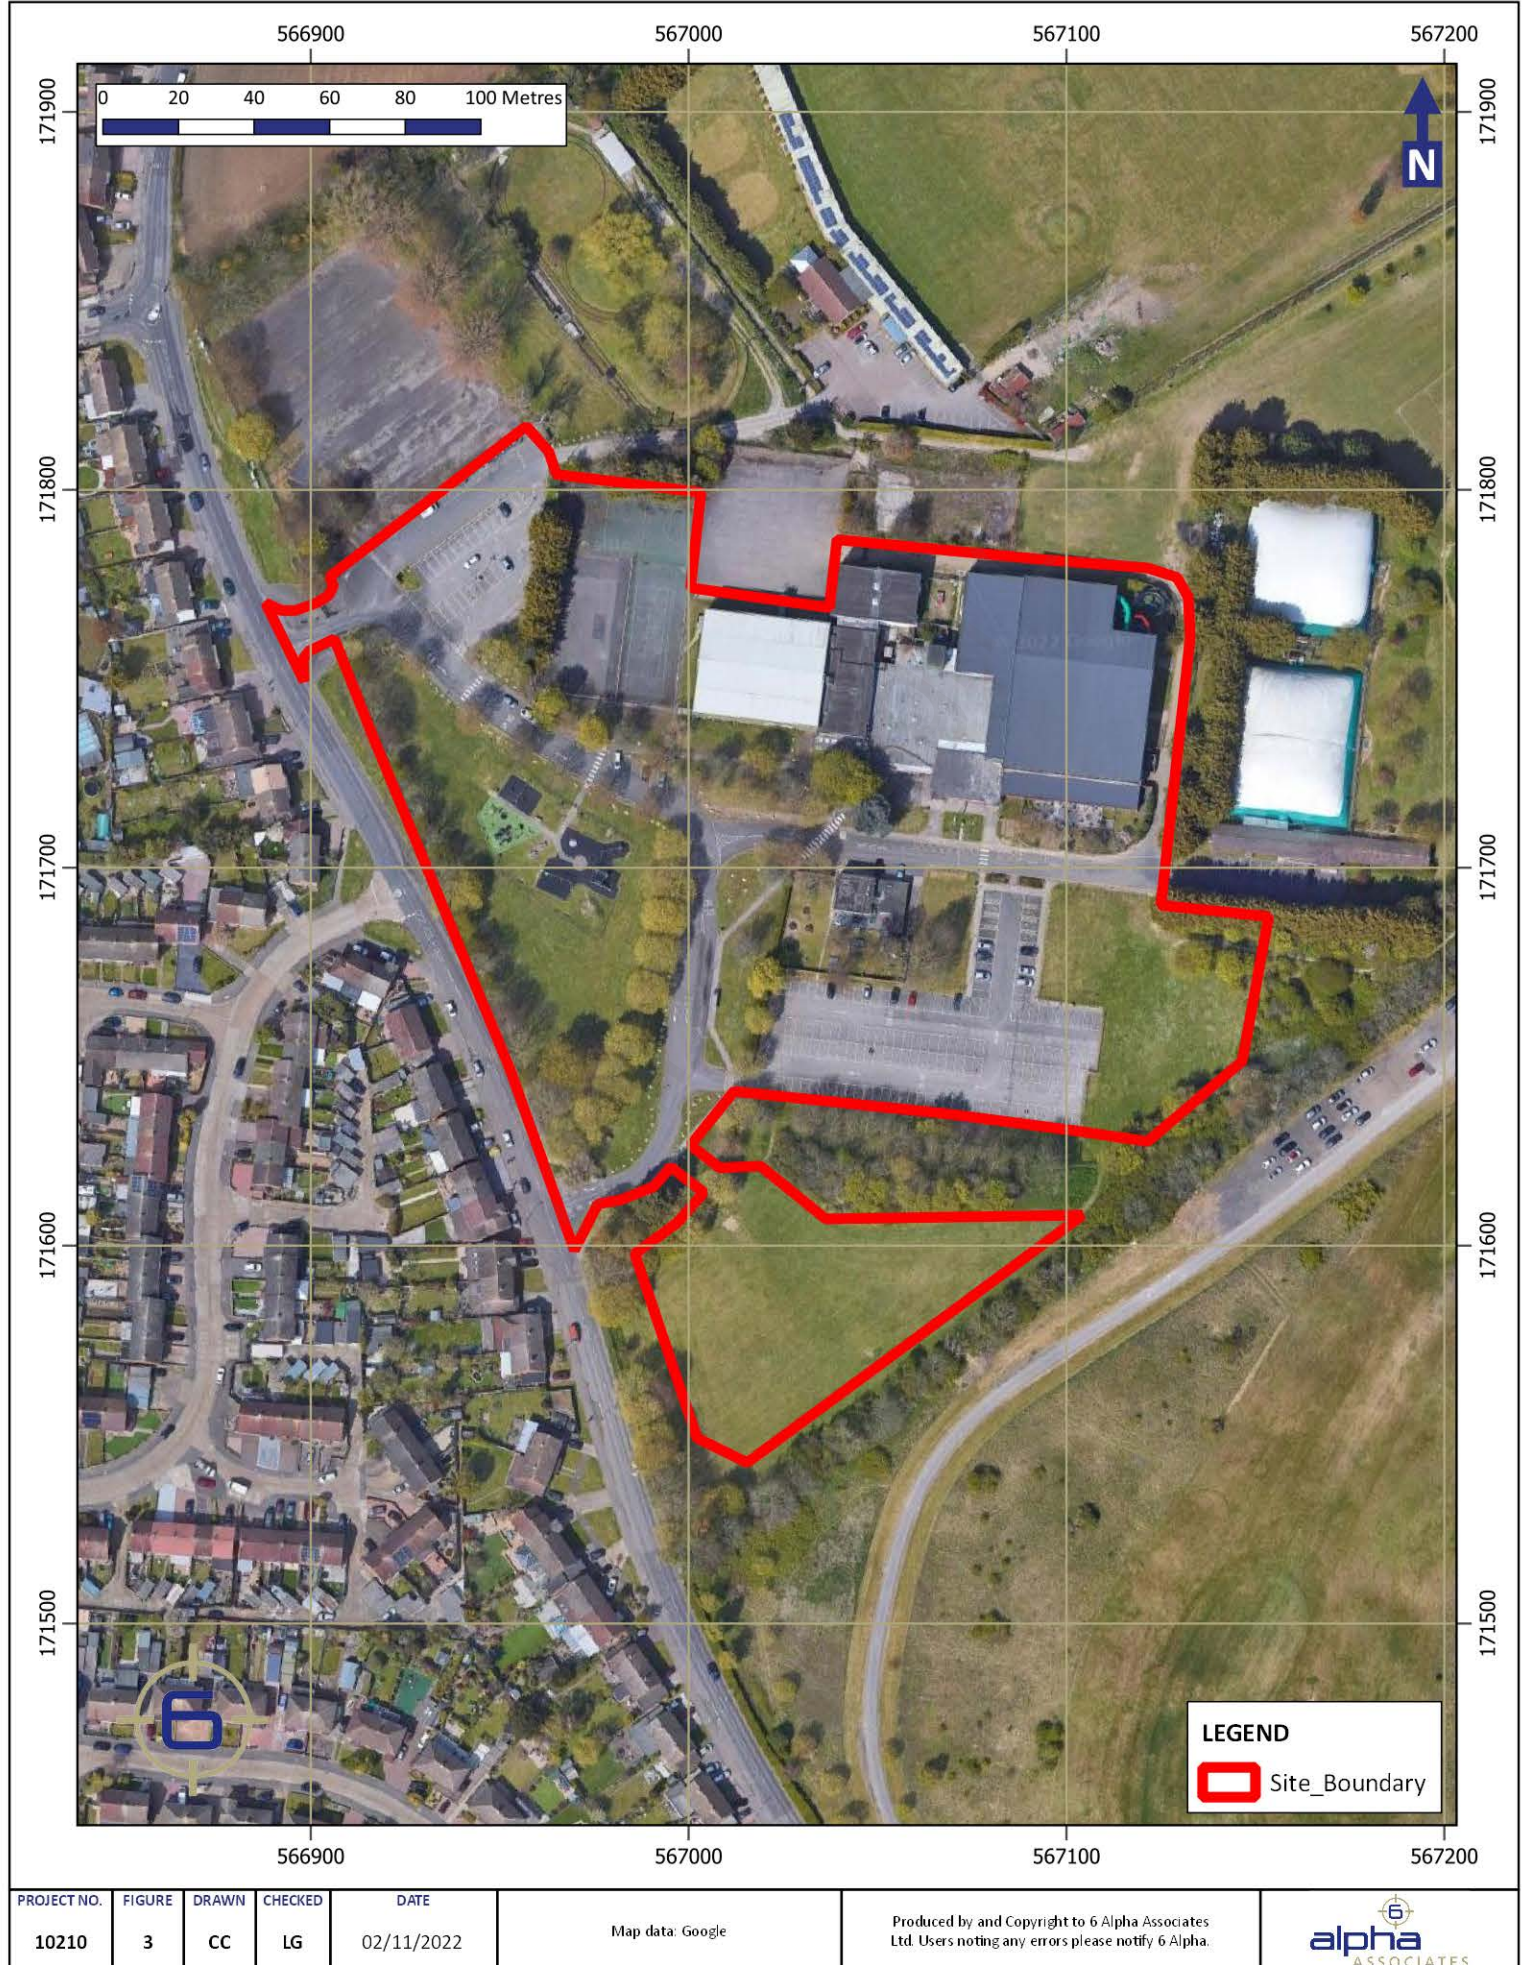
## Figure Three - Aerial Photography (2021)

Current aerial photography corroborates the information above and shows that the Study Site is situated on the outskirts of a densely developed urban area. The Study Site itself consists of multiple structures and areas of hard standing associated with *Cascades Leisure Centre*, alongside areas of undeveloped land.

### Aerial Photography (2021) (*Figure 3*)

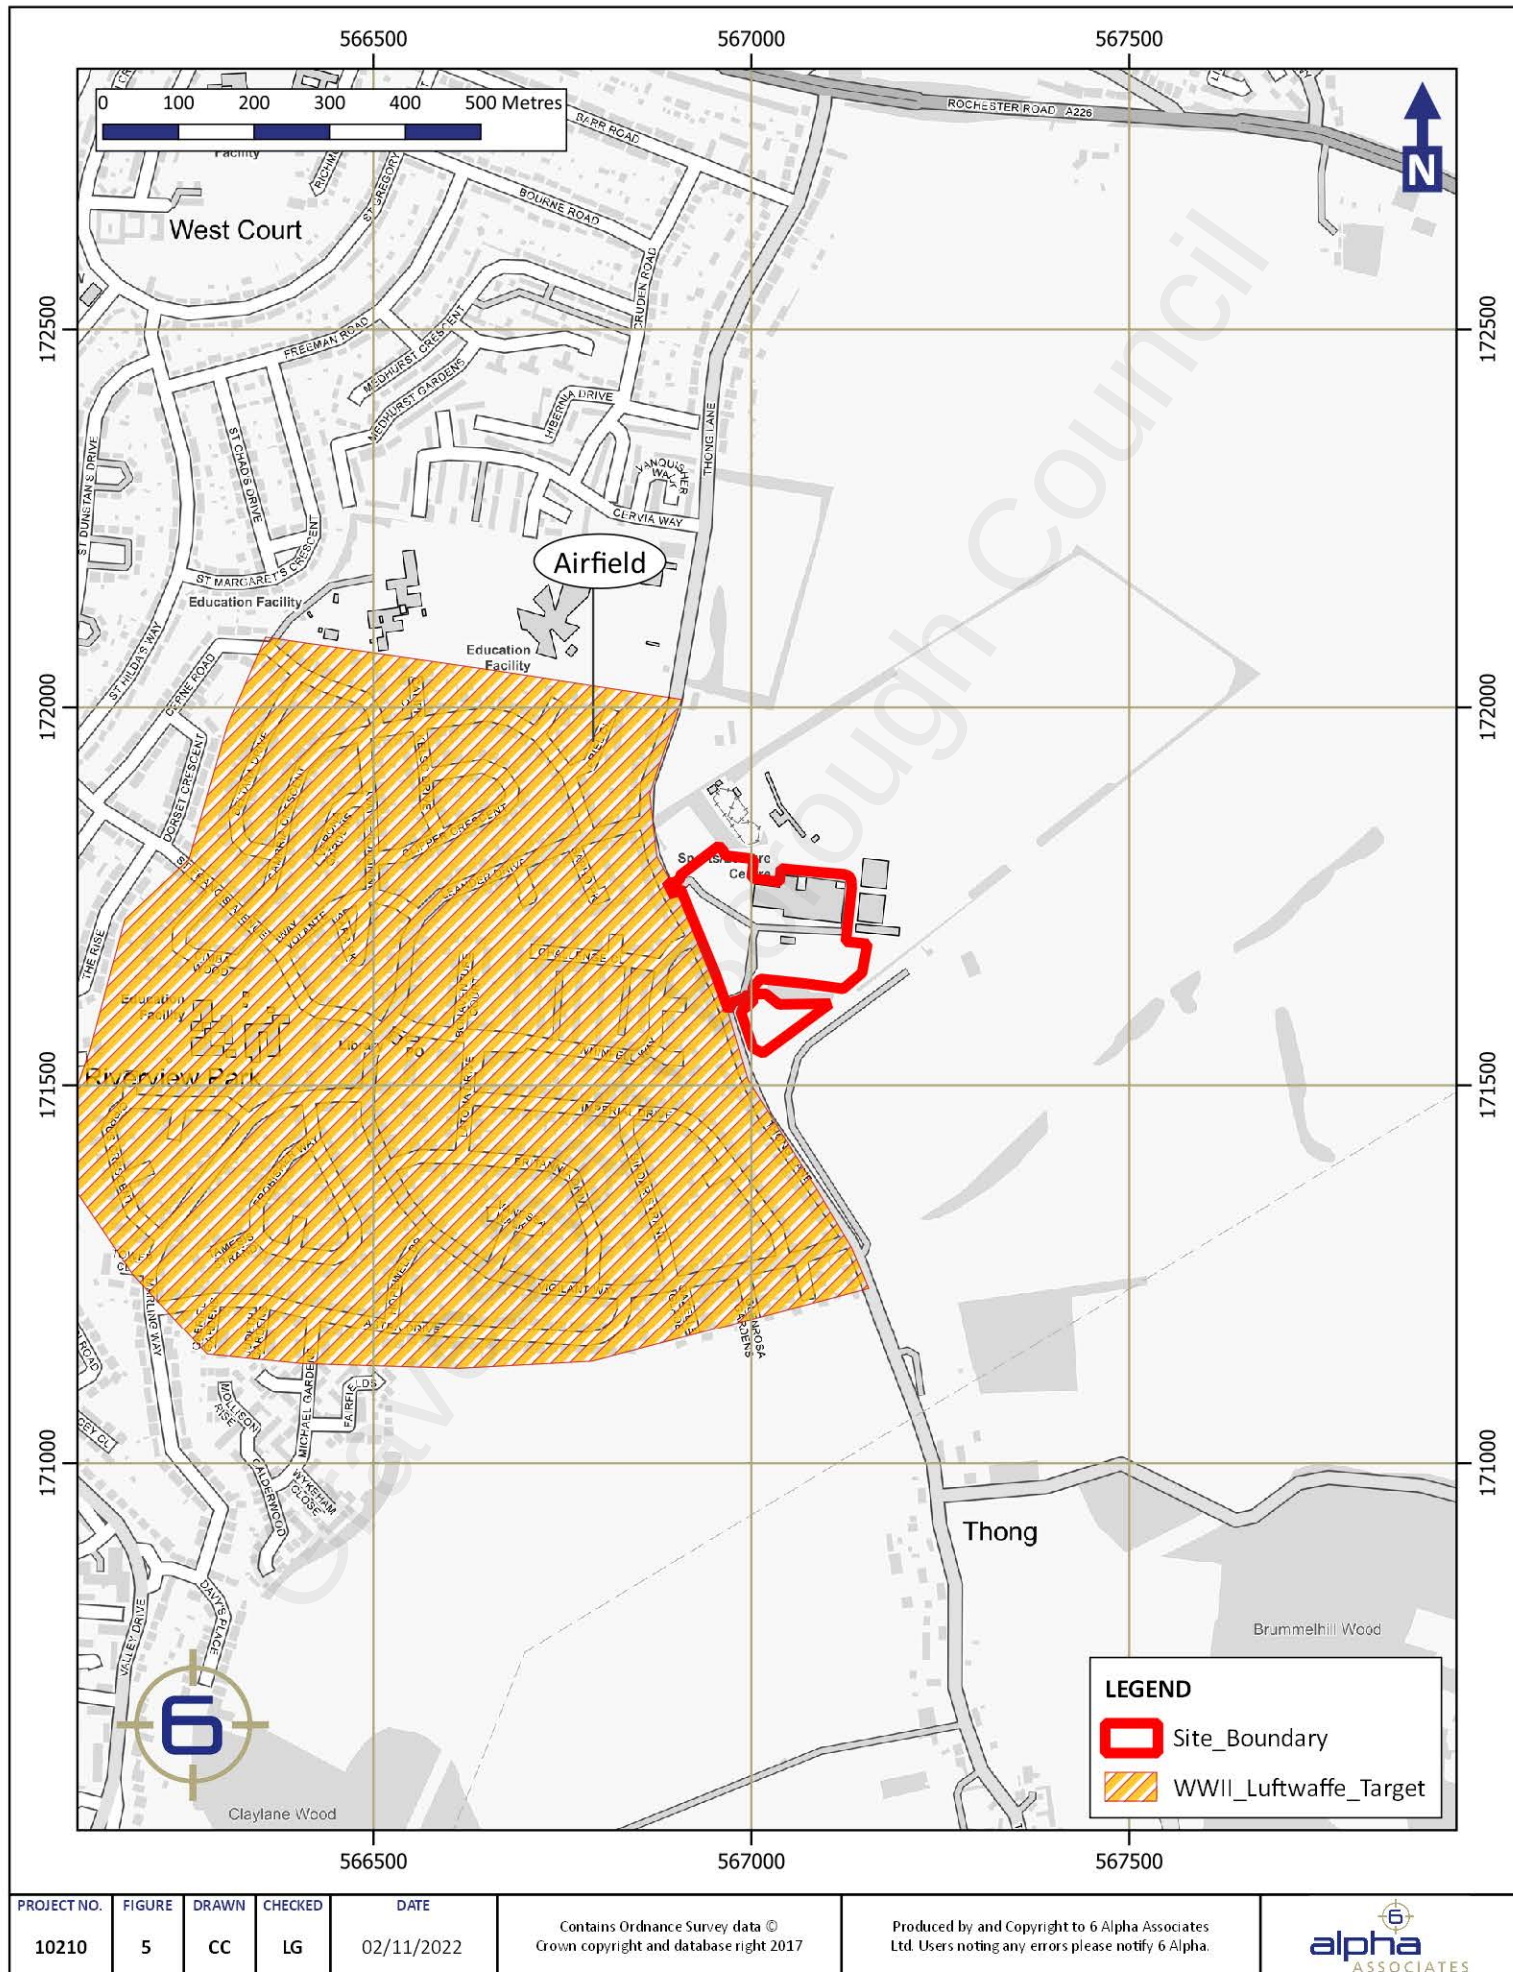
## WWII Luftwaffe Bombing Targets

*Luftwaffe* aerial reconnaissance photography associated with the Study Site identified *Gravesend Airfield* (located on-site) as a primary bombing target.

Prior to WWII, the *Luftwaffe* conducted numerous aerial photographic reconnaissance missions over *Britain*, recording key military, industrial and commercial targets for attack, in the event of war. In addition, logistics infrastructure and public services, such as railways, canals, power stations, reservoirs, water and gas works were also considered viable bombing targets.

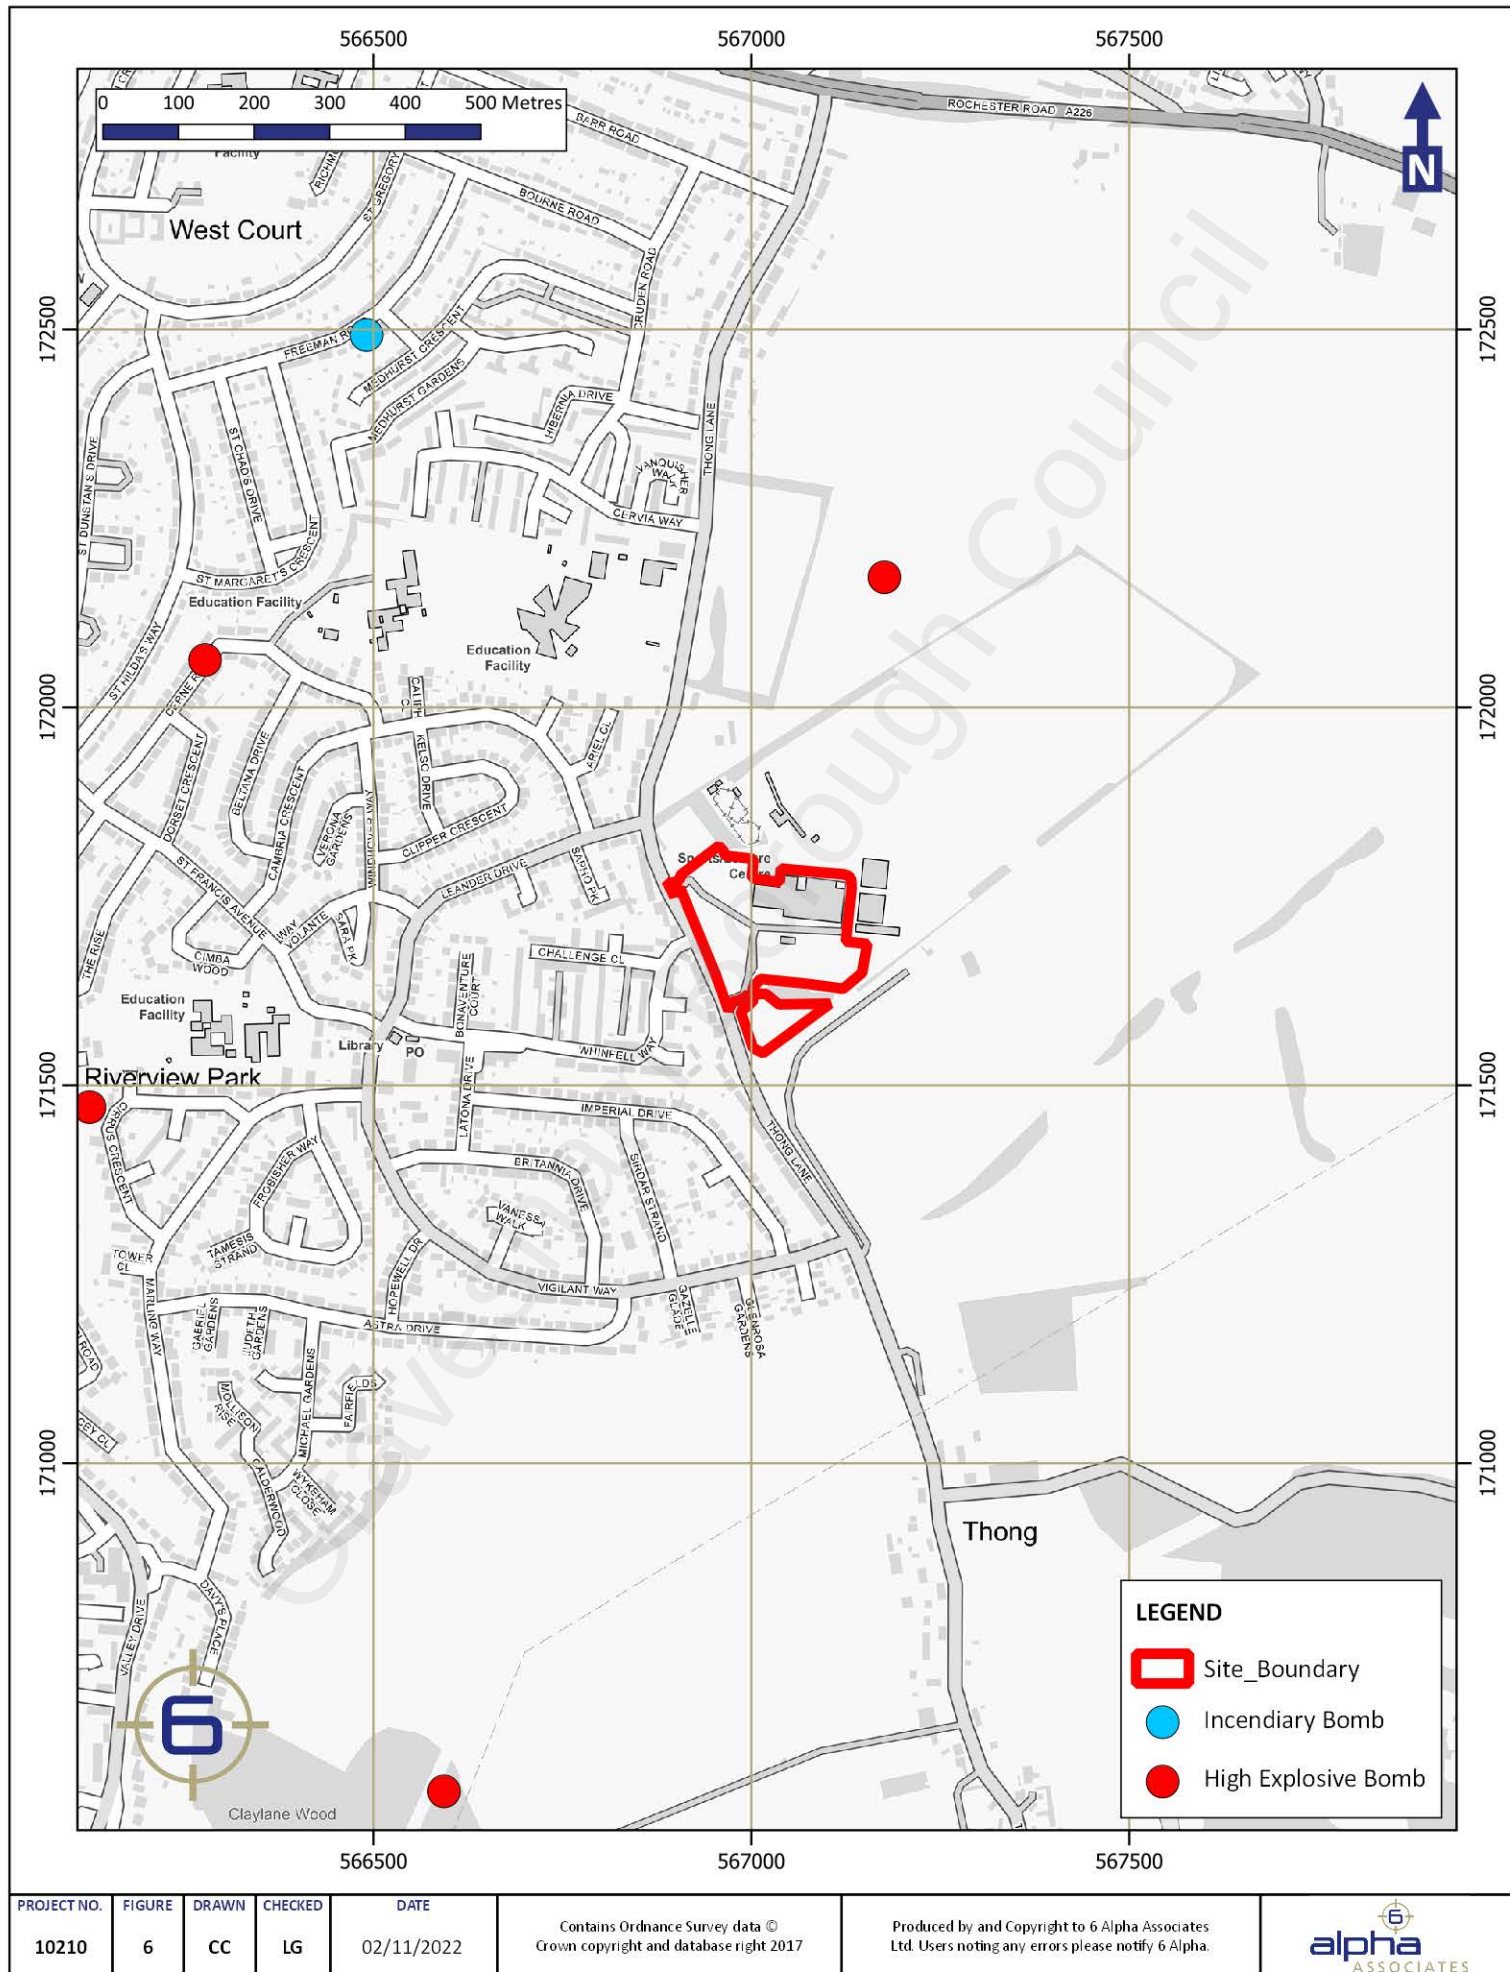
## Figure Six - WWII High Explosive Bomb Strikes

During WWII, ARP wardens compiled detailed logs of bomb strikes across their respective districts. However, ARP personnel are unlikely to have been collected for this Site given its location within a military airfield during WWII. Instead, official written military records associated with *RAF Gravesend* identified multiple 50kg and 500kg HE bomb strikes on the airfield on 21<sup>st</sup>/22<sup>nd</sup> January 1944. Whilst not all of the written entries provide a geospatial reference, 500kg HE bomb strikes were documented on the western perimeter of the airfield, and on grassland and “waste ground” around the airfield “dispersal points”. The exact locations of these bomb strikes were not mapped but it is likely they impacted either within, or in very close proximity to the Study Site – this is corroborated by the (undermentioned) proximity of “ruins” documented on post-WWII mapping near to the Study Site. Official written records also identified that three *AB 1000/2* containers (which could each contain 600 IBs) were dropped on *RAF Gravesend* during WWII; approximately 110m south-west, 110m south-west and 245m south-east of the Study Site boundary.

Furthermore, ARP records covering the Site’s wider area also recorded three bomb strikes in the vicinity; 400m to the north-north-east, 685m to the north-west and 820m to the south-west – which was corroborated by military records documenting bomb strikes at *RAF Gravesend*. These records documented multiple 50kg HE bomb strikes on residential areas around the airfield.

Official written records identified multiple 50kg and 500kg HE bomb strikes on the airfield on 21<sup>st</sup>/22<sup>nd</sup> January 1944. Whilst not all of the written entries provide a geospatial reference, 500kg HE bomb strikes were documented on the western perimeter of the airfield, and on grassland and “waste ground” around the airfield “dispersal points”. Official written records also identified that three *AB 1000/2* containers (which could each contain 600 IBs) were dropped on *RAF Gravesend* during WWII; approximately 110m south-west, 110m south-west and 245m south-east of the Study Site boundary.

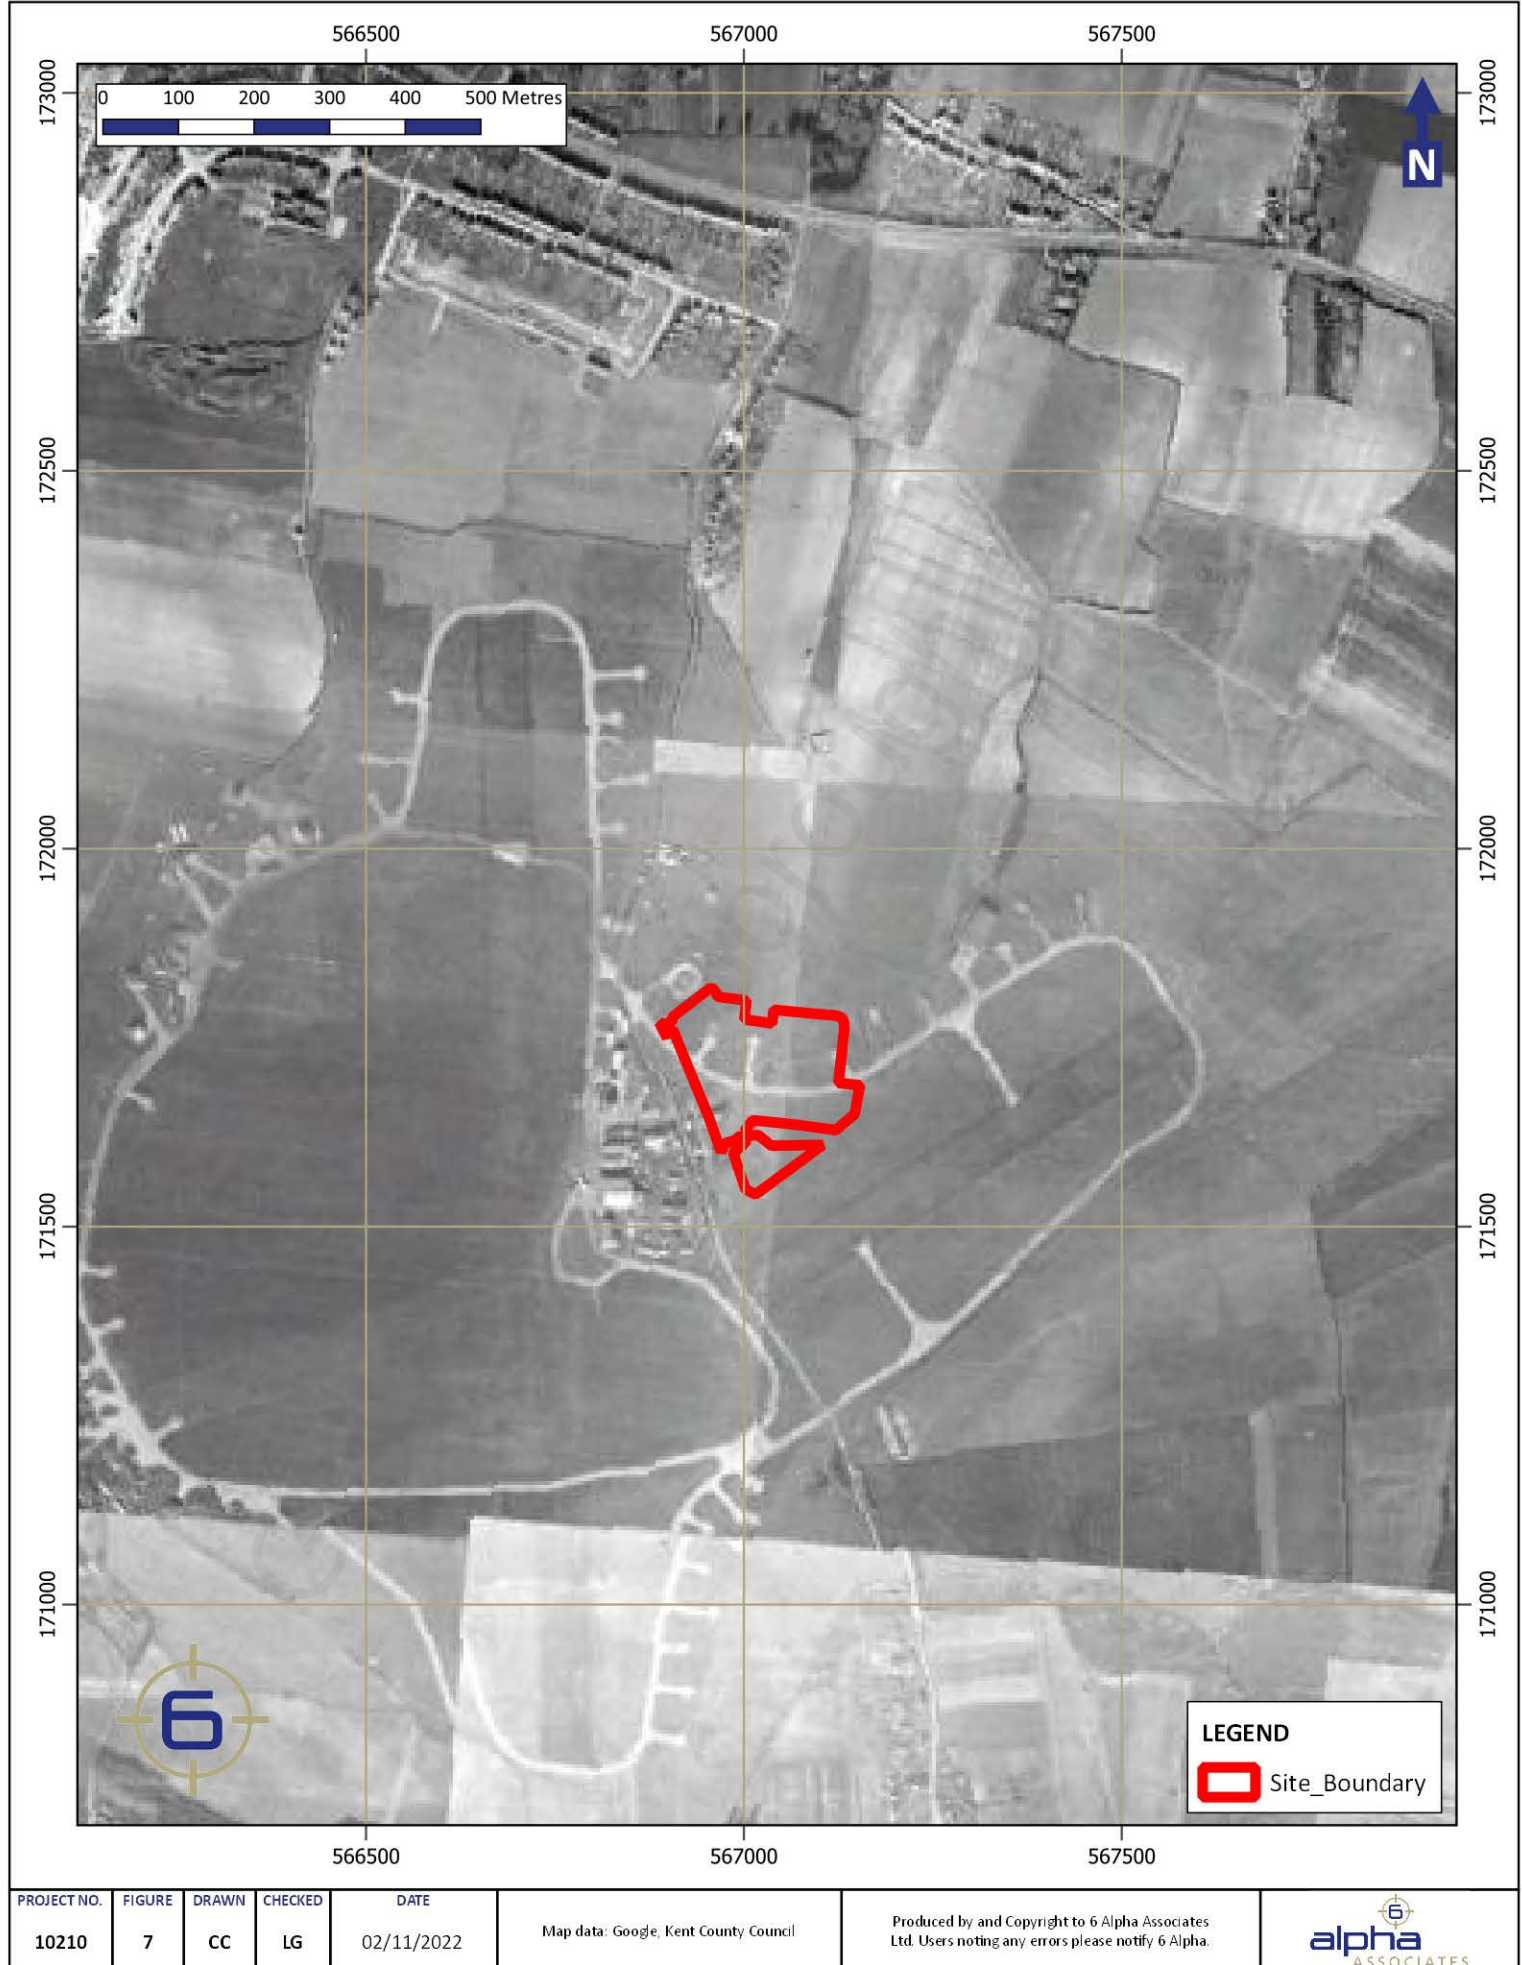
## Figure Seven – Aerial Photography (1940)

The CS mapping prior to WWII (1933-1936), 1940 aerial photography and post-WWII OS mapping (1946) shows that the Study Site was located in the rural outskirts of a developed urban area; the Study Site itself consisted undeveloped land, structures, areas of hard standing all associated with *Gravesend Airfield* (*RAF Gravesend*). Therefore, it is probable that military personnel may have inspected the Study Site for UXB entry holes following any air raids as part of any damage assessment that would have likely taken place. However, this does not preclude the potential for a UXB encounter at the Site given that extensive bomb damage was evidenced in the immediate vicinity of the Site – such damage could conceivably obscure a UXB entry hole at the Site, or in close proximity.

Pre-WWII mapping (1933-1936), 1940 aerial photography and post-war mapping (1946) associated with the Study Site shows that it was located in the rural outskirts of a developed urban area; the Study Site itself consisted undeveloped land, structures, areas of hard standing all associated with *RAF Gravesend*. Therefore, it is probable that military personnel may have inspected the Study Site for UXB entry holes following any air raids as part of any damage assessment that would have likely taken place. However, this does not preclude the potential for a UXB encounter at the Site given that extensive bomb damage was evidenced in the immediate vicinity of the Site – such damage could conceivably obscure a UXB entry hole at the Site, or in close proximity.
