## Bat Emergence and Re-Entry Surveys (BERS)

31<sup>st</sup> Gravesend Scout Hut, Hampton Crescent, Gravesend, DA12 4HZ

“The demolition of the existing building, to be replaced with a new hut.”

## Appendix 1: BERS plan

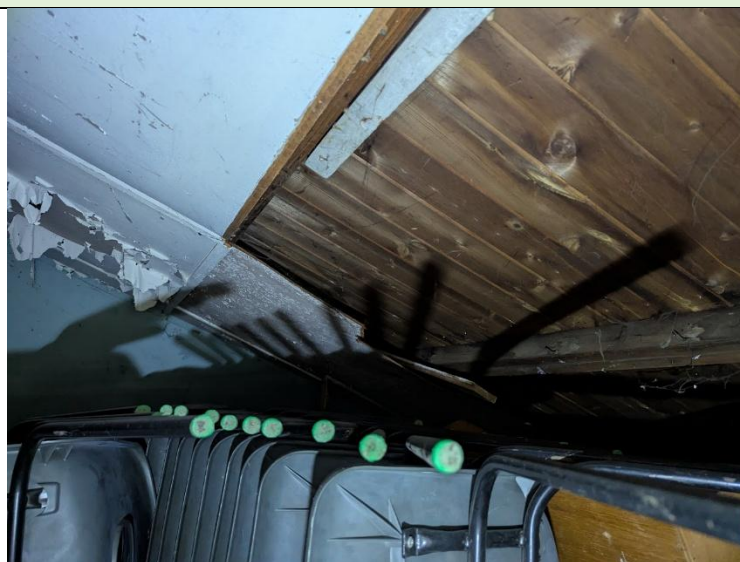
| Building inspection prior to survey | | The updated loft inspection was carried out on 19/08/025, prior to the BERS commencement by Elodie Noyes-Gouan BSc (Hons), Graduate Ecologist, accredited for class 1 techniques on a Natural England Class 2 Bat Licence. Similar to the preliminary survey, no evidence of bats was observed. | | | | |

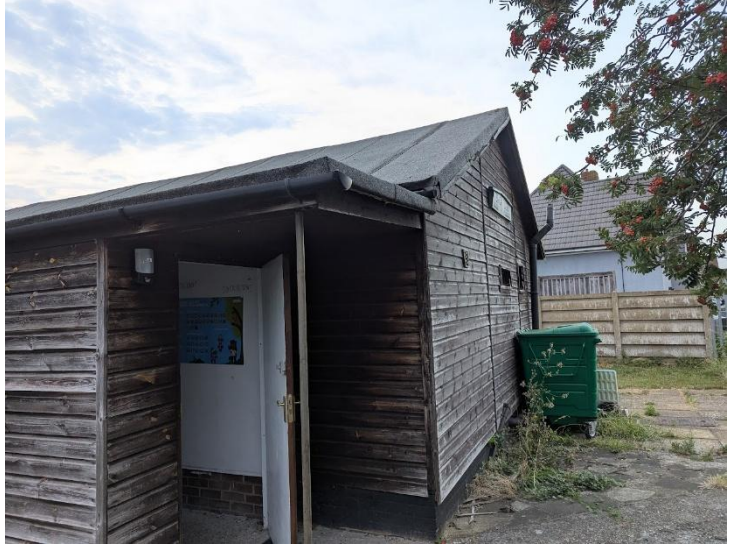
| Surveyor 1 | No emergencies observed.<br>Common pipistrelles were heard but not seen, briefly at 20:50, 20:56 and 21:06. | |

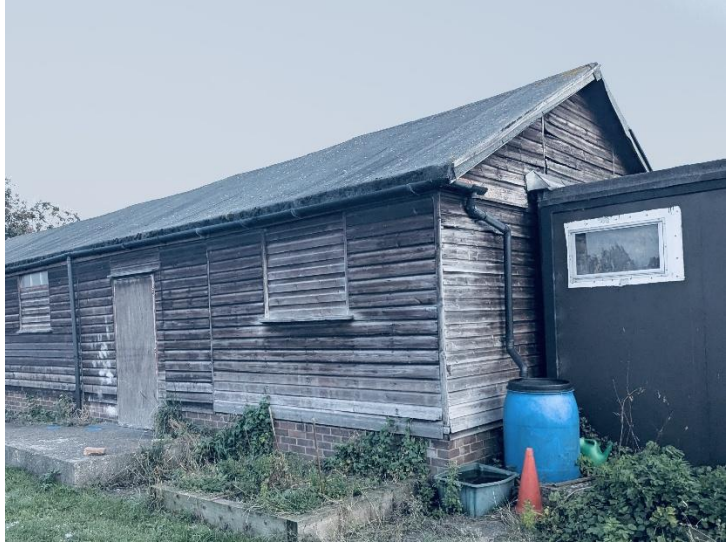
| <i>Surveyor 2</i> | No emergencies observed.<br>Four common pipistrelles were observed over the course of the survey, passing west to south and back again at 20:50, 20:56 and 21:06. | |

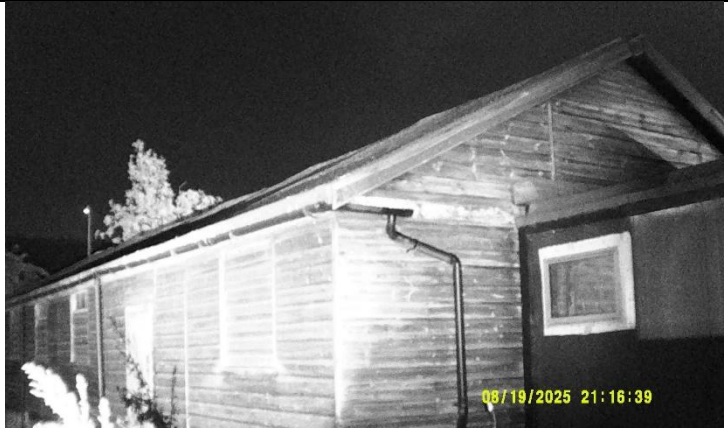
| <i>IR position 2</i><br><i>Nightfox Whisker</i><br><i>Night vision</i><br><i>binoculars + 1</i><br><i>Nightfox XB5 PRO</i><br><i>torch</i> | No emergencies were observed, and the footage was in line with the observations of surveyor 2, with no additional activity. | |

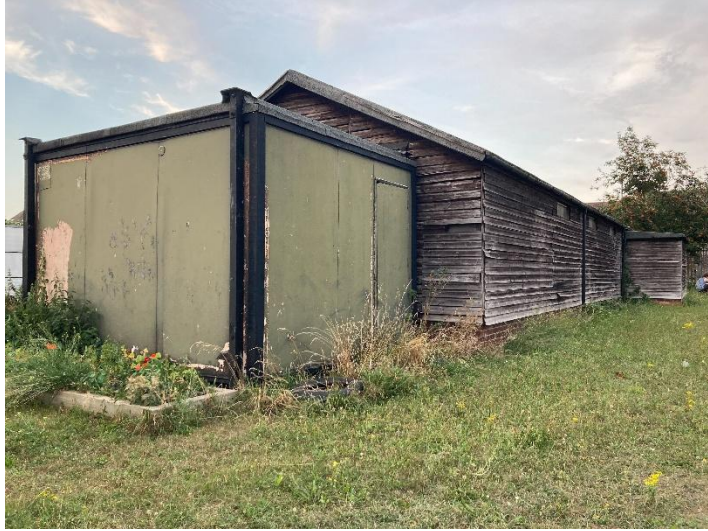
| <i>Surveyor 3</i> | No emergencies observed.<br>Four common pipistrelles were observed over the course of the survey, passing west to south and back again at 20:50, 20:56 and 21:06. | | | | | |

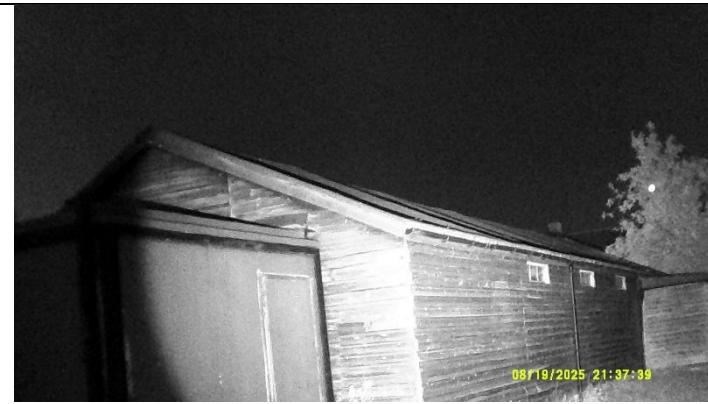
| <i>IR position 3</i><br><i>Nightfox Whisker</i><br><i>Night vision</i><br><i>binoculars + 1</i><br><i>Nightfox XB5 PRO</i><br><i>torch</i> | No emergencies were observed, and the footage was in line with the observations of surveyor 3, with no additional activity. | | | | | |

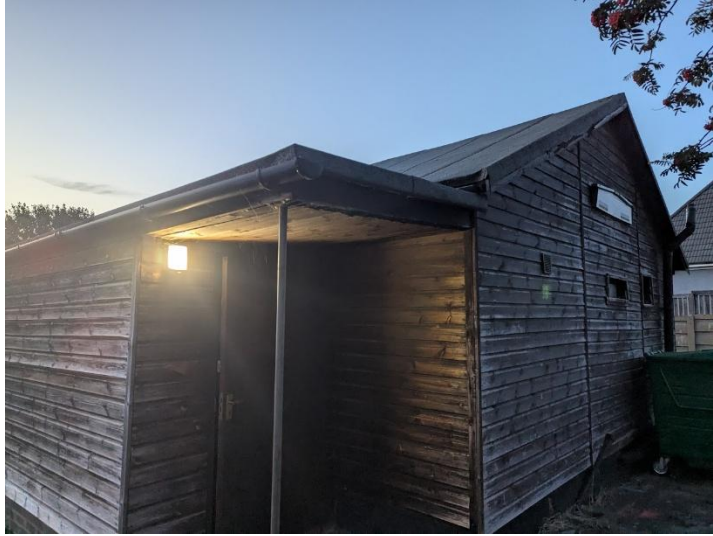
| <i>Surveyor 1 -</i> | No emergencies observed.<br>One common pipistrelle was heard but not seen at 19:36. | |

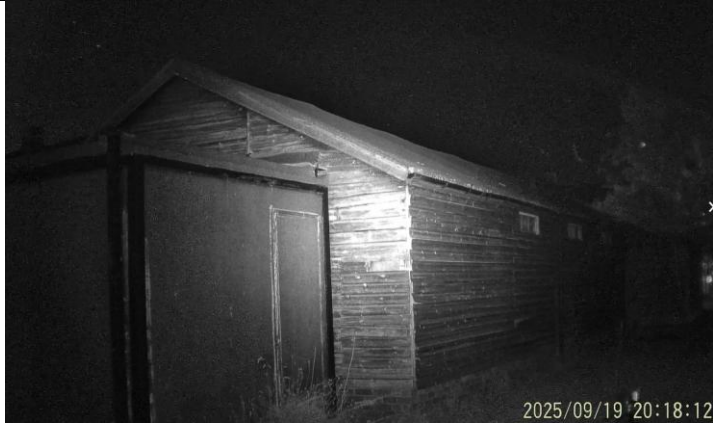
| <i>IR position 1 -<br/>Nightfox Whisker<br/>Night vision<br/>binoculars + 1<br/>Nightfox XB5 PRO<br/>torch</i> | No emergencies were observed, and the footage was in line with the observations of surveyor 1, with no additional activity. | |

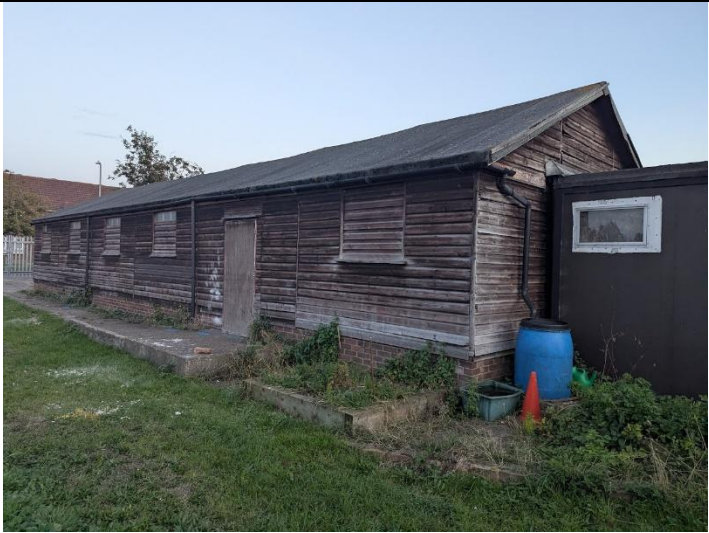
| <i>Surveyor 2 -</i> | <p>No emergencies observed.</p> <p>Common pipistrelles commuted north to south over B1 at 20:24, 20:28 and 20:32.</p> <p>The final common pipistrelle of the survey was heard but not seen at 21:10.</p> | |

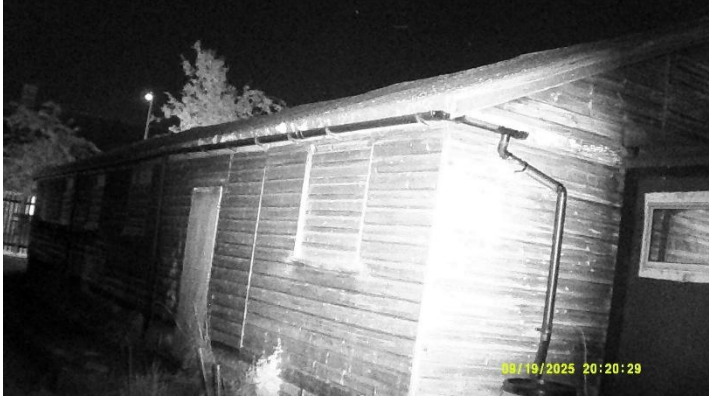
| <i>IR position 2</i><br><i>Nightfox Whisker</i><br><i>Night vision</i><br><i>binoculars + 1</i><br><i>Nightfox XB5 PRO</i><br><i>torch</i> | <p>No emergencies were observed, and the footage was in line with the observations of surveyor 2, with no additional activity.</p> | |

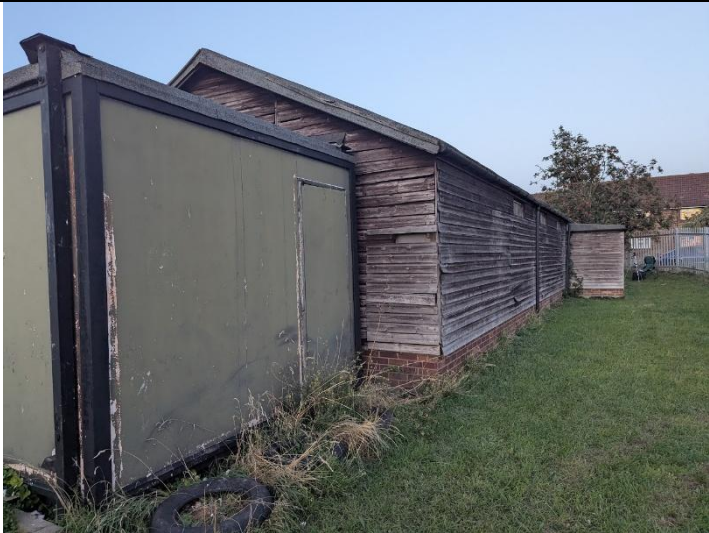
| <i>Surveyor 3 –</i> | <p>No emergences observed.</p> <p>Common pipistrelles commuted north to south over B1 and east to south throughout the local gardens, at 20:21, 20:24, 20:28, 20:32, 20:33 and 20:35.</p> <p>The final common pipistrelle of the survey was heard but not seen at 21:10.</p> | |

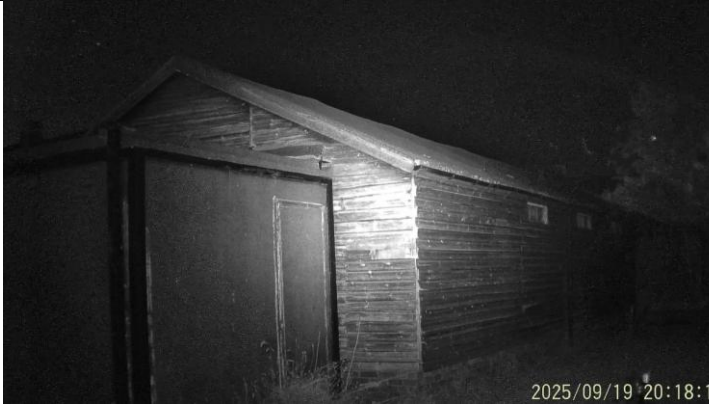
| <i>IR position 3<br/>Nightfox Whisker<br/>Night vision<br/>binoculars + 1<br/>Nightfox XB5 PRO<br/>torch</i> | <p>No emergences were observed, and the footage was in line with the observations of surveyor 3, with no additional activity.</p> | |

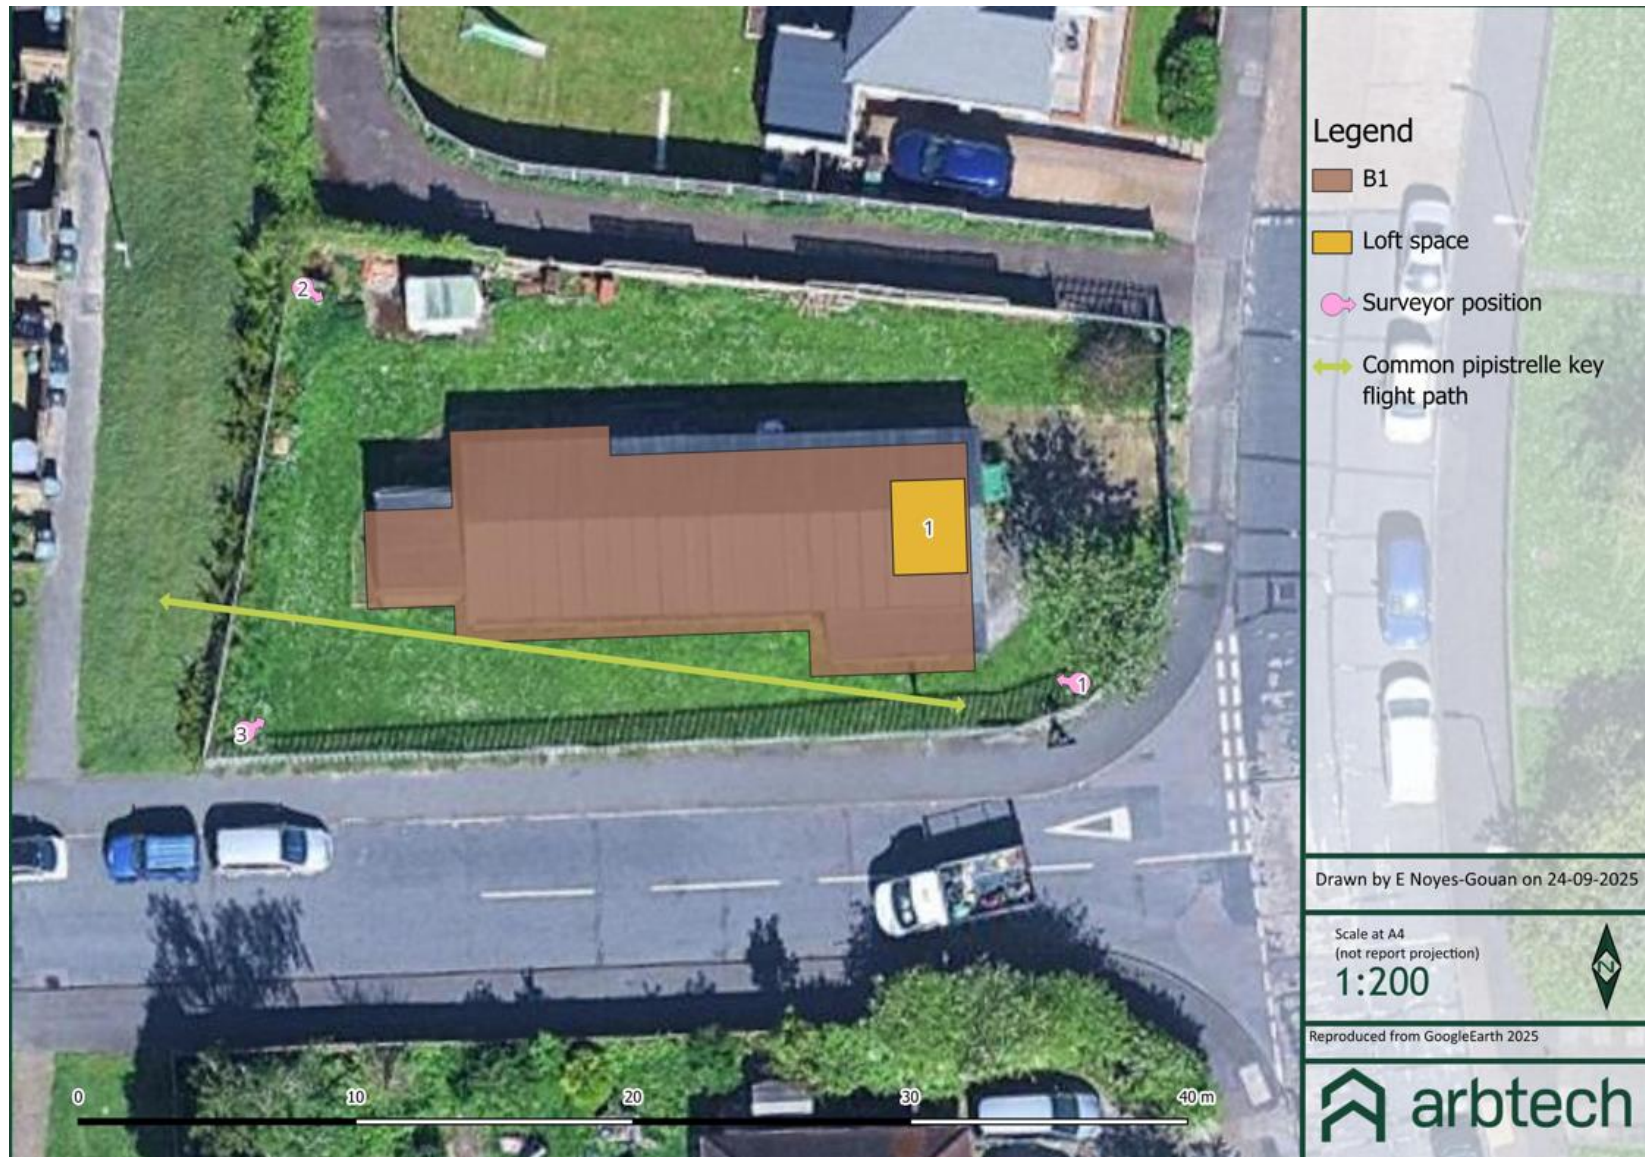
| See surveyor locations in the BERS plan in Appendix 1. | | | | | | |

| | <b>1 - Lead</b> | Elodie Noyes-Gouan | | 4 Years | | Level 2 | Observing east and part of the southeastern elevation |
| | <b>2</b> | Max Matthews | | 3 Years | | Level 1 | Observing the northern elevation and part of the western |
| | <b>3</b> | Jasmine Llewellyn | | 2 Years | | Level 1 | Observing the southern elevation and part of the western |
