**CONTRACT NO. 30510106/2B**

**SOIL VERIFICATION REPORT FOR A PROPOSED  
DEVELOPMENT AT GRAVESEND – SOFT  
LANDSCAPING AREAS**

| <b>Client:</b> | Curo Living Ltd |
| <b>Date:</b> | February 2026 |

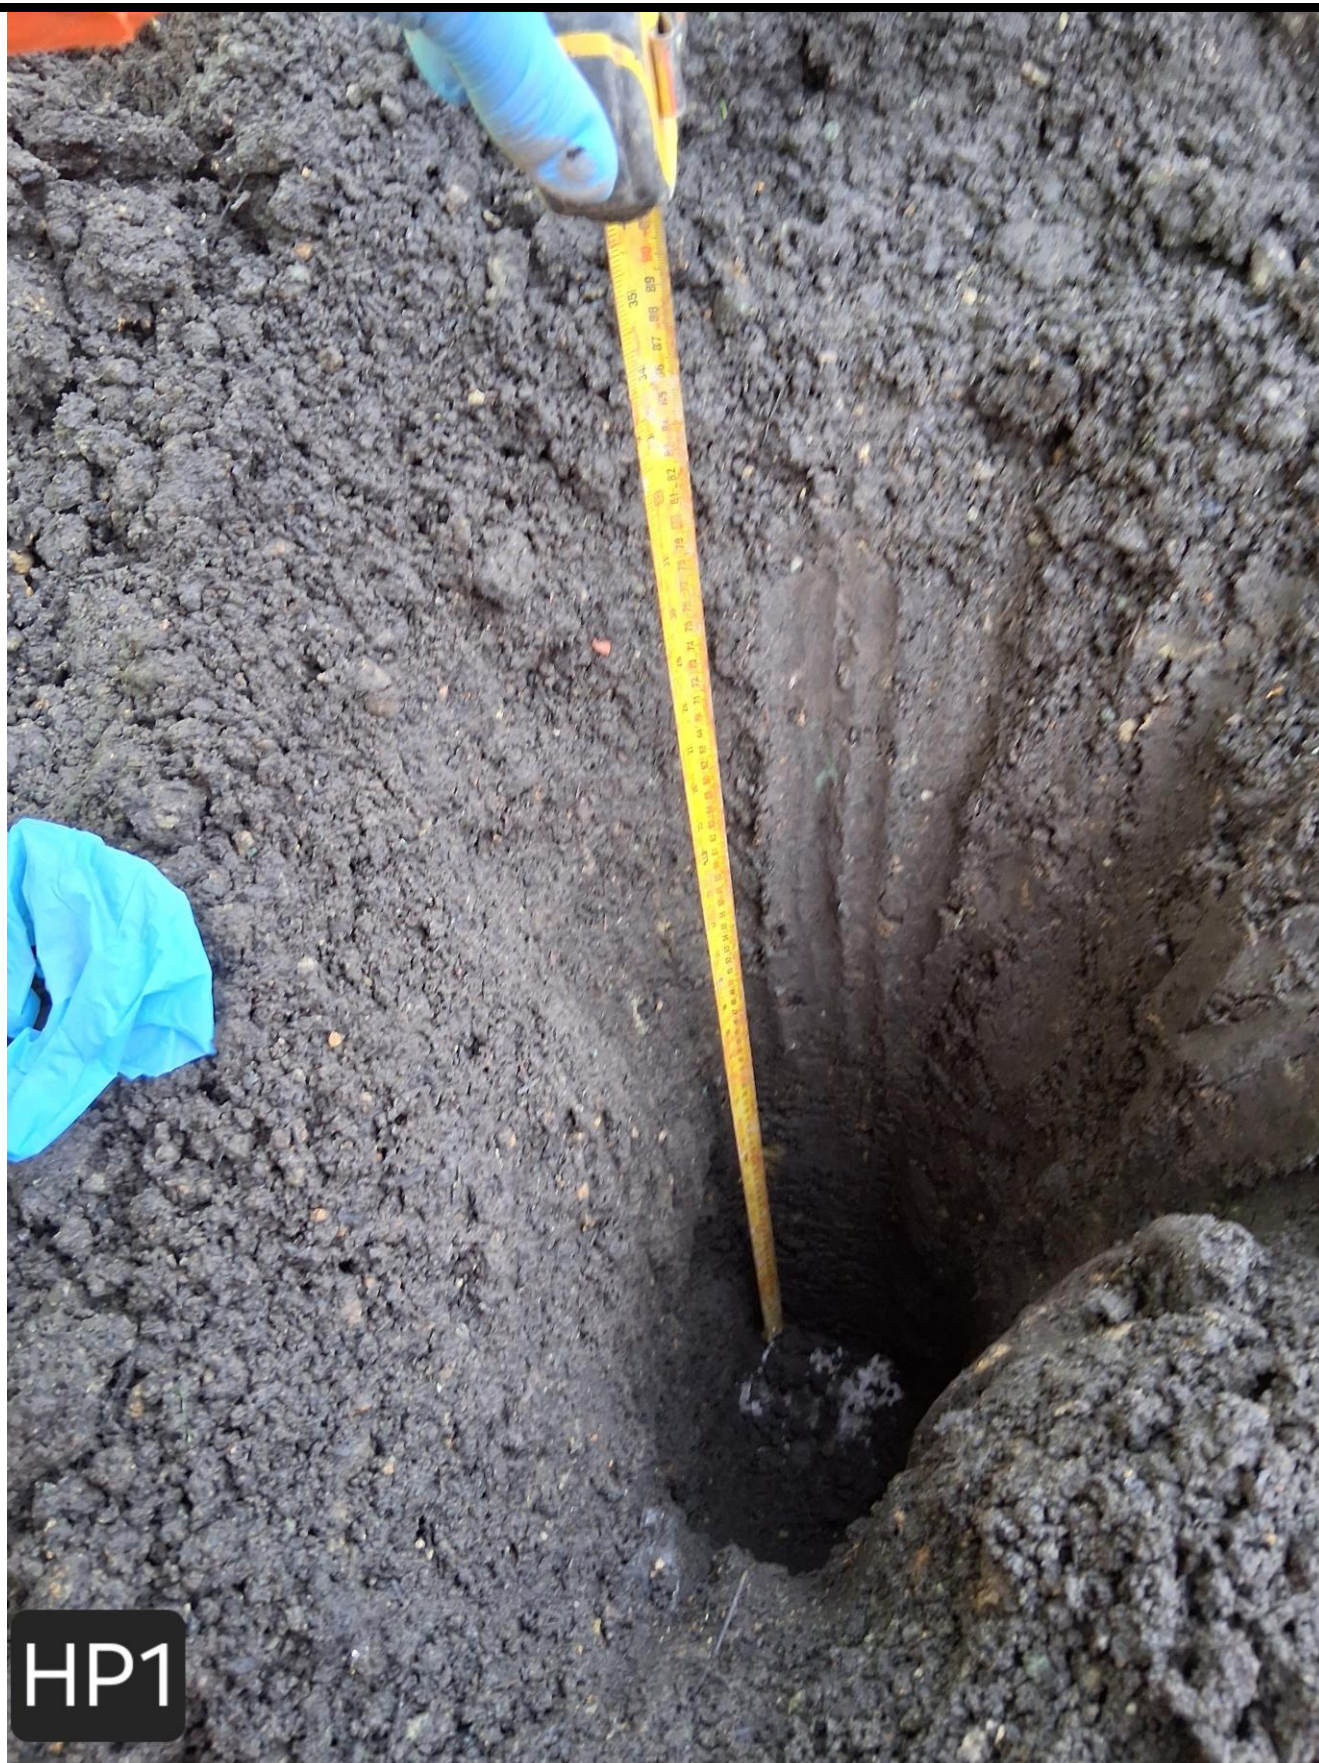
**Figure 1 Site Plan**  
Scale as shown  
30510106/2A: Gravesend  
Prepared for: Curo Living Ltd

The site is irregular in shape, covers an area of 0.8ha and consists of two multistorey residential buildings currently under construction, with associated areas of soft landscaping, as indicated in Figure 1.

Approximate verification pit locations in areas where imported soils had been placed

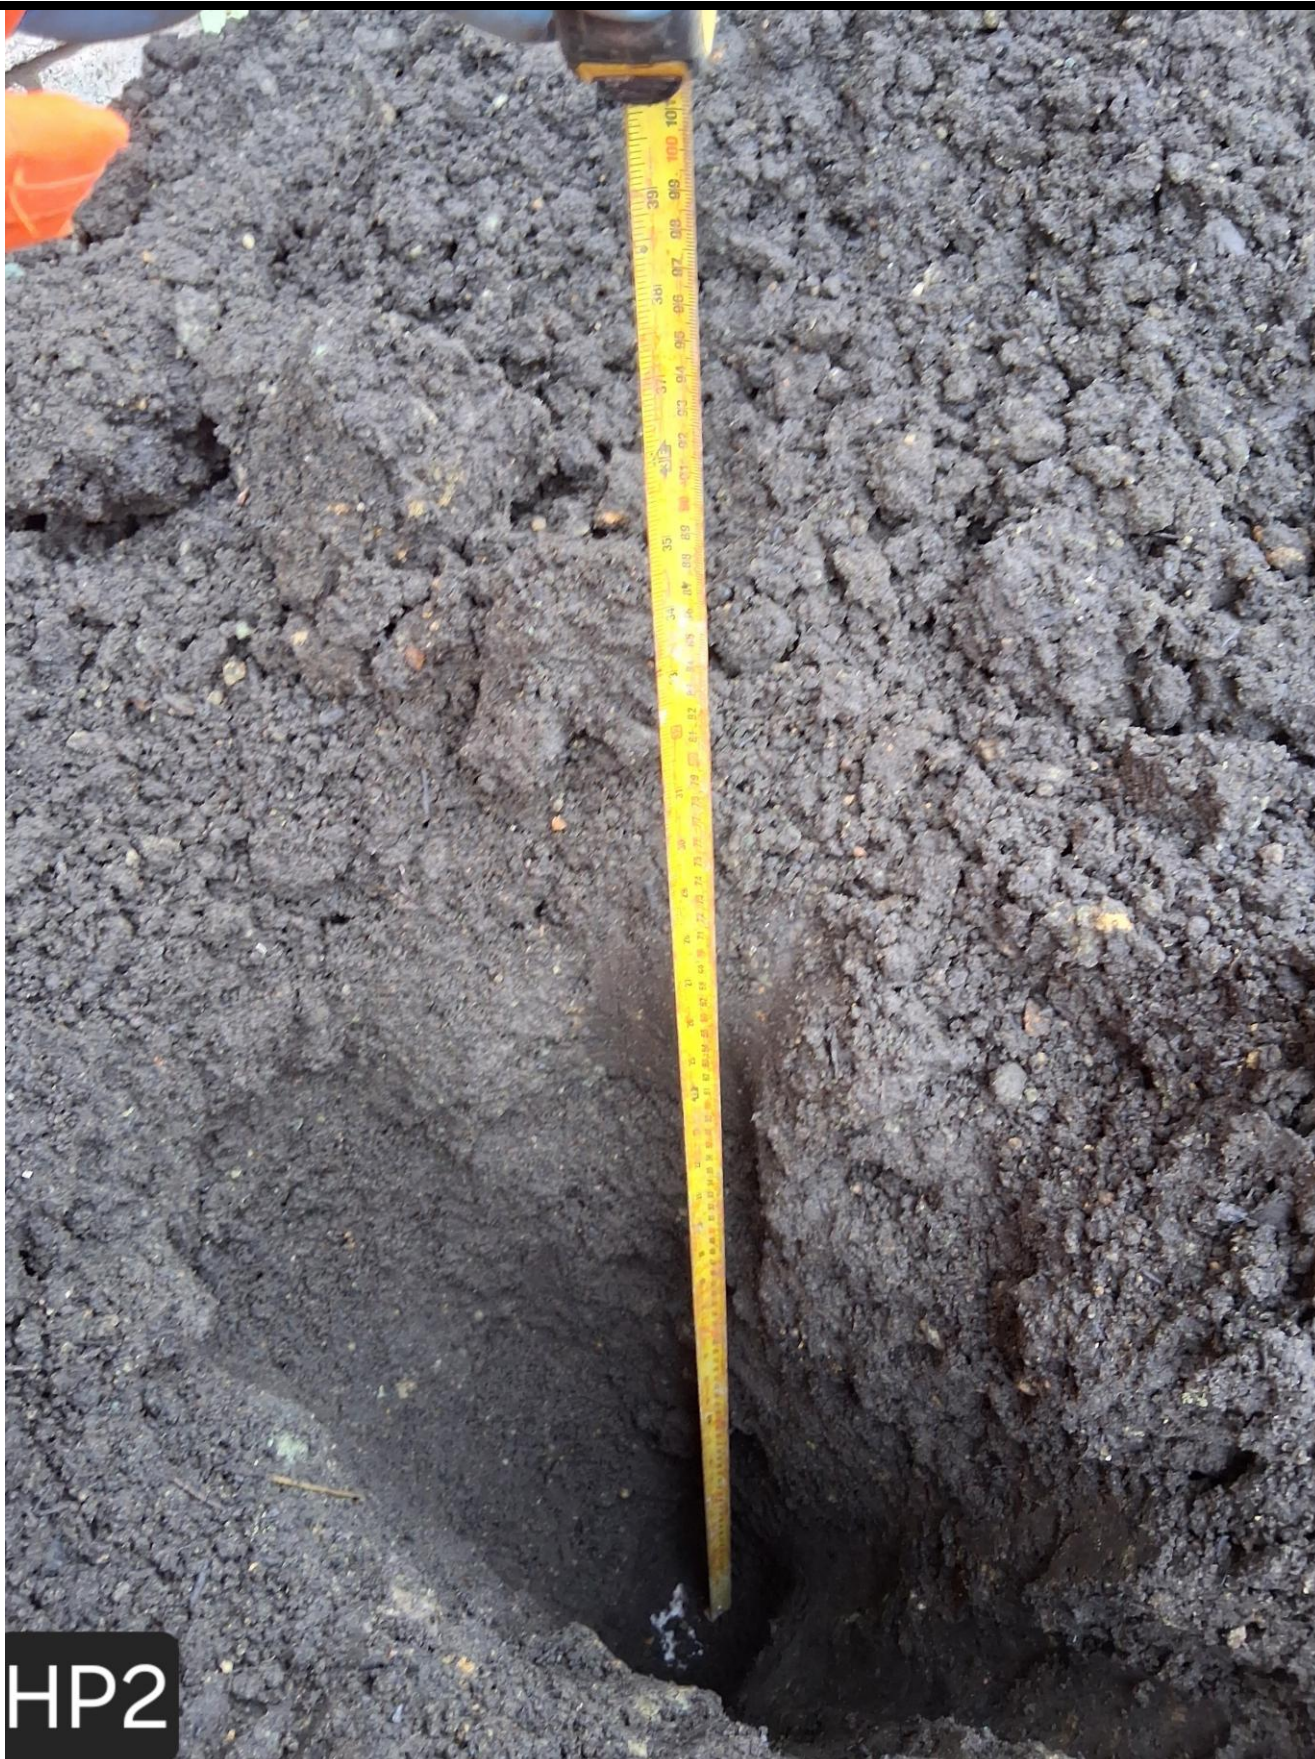
### Plate 1

Within the area of soft landscaping, four excavations were completed by hand digging to the base of the placed material (separated from the original ground by a geotextile membrane). The thickness of subsoil/topsoil at each location was in excess of the required 500mm as evidenced in Plates 1-4.

Photographic Record of HP1  
30510106/2b: Gravesend  
Prepared for: Curo Living
