# Phase 1 Desktop Survey

Outfall Cottages,  
Dering Way, Gravesend,  
DA12 2QH

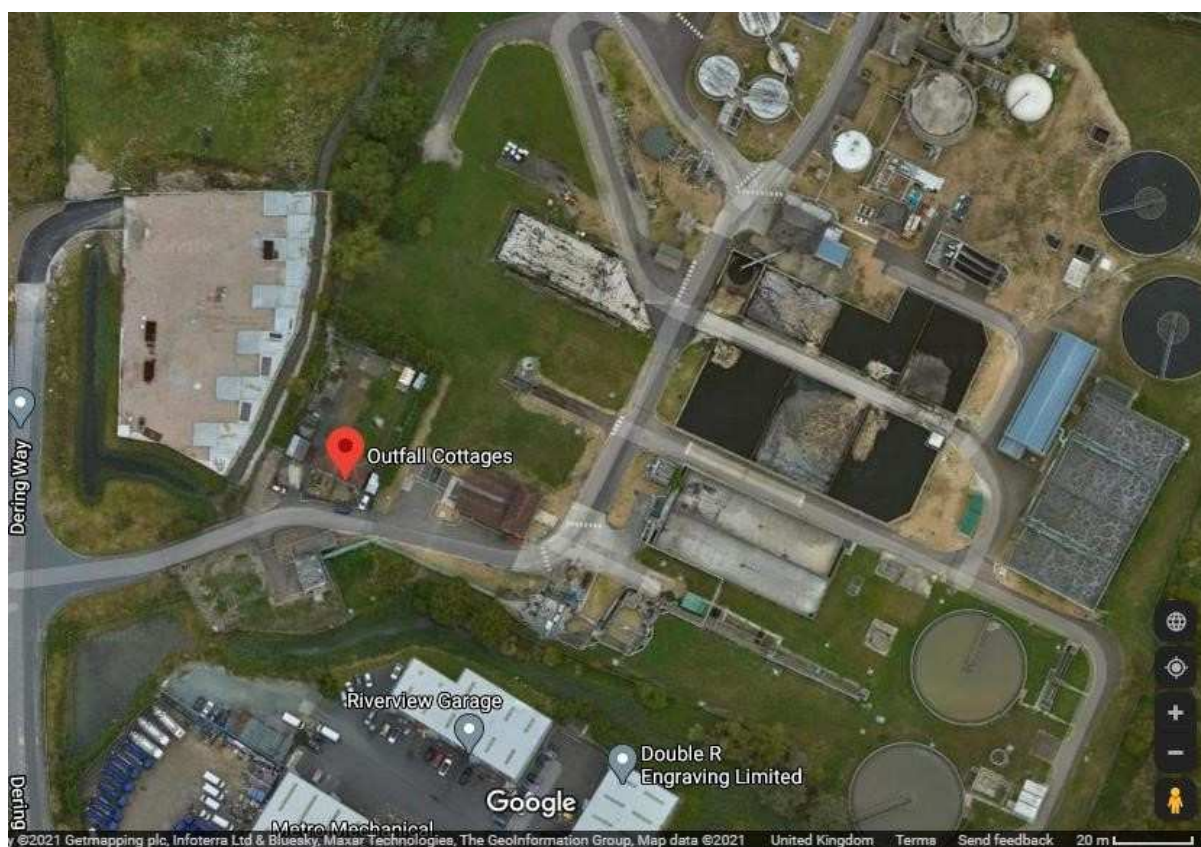
Figure 2. Ariel image showing the site of Outfall Cottages, Dering Way, Gravesend, DA12 2QH. It can be seen that the adjacent area is mostly of an industrial nature, development of this site as proposed would be in keeping with the development of the surrounding area. (Google Maps, 2021)
