## Updated Risk Assessment and Proposals

The One Architecture  
The Old School House  
School Road  
Tilmanstone  
Near DEAL  
Kent CT14 0JL

MEC Reference: 26-171

Site: Outfall Cottages, Dering Way, Gravesend, Kent DA12 2QH  
Contact Name: Clive Tidmarsh  
Telephone: 07887 503636  
Email: [clivetidmarsh@aol.com](mailto:clivetidmarsh@aol.com)

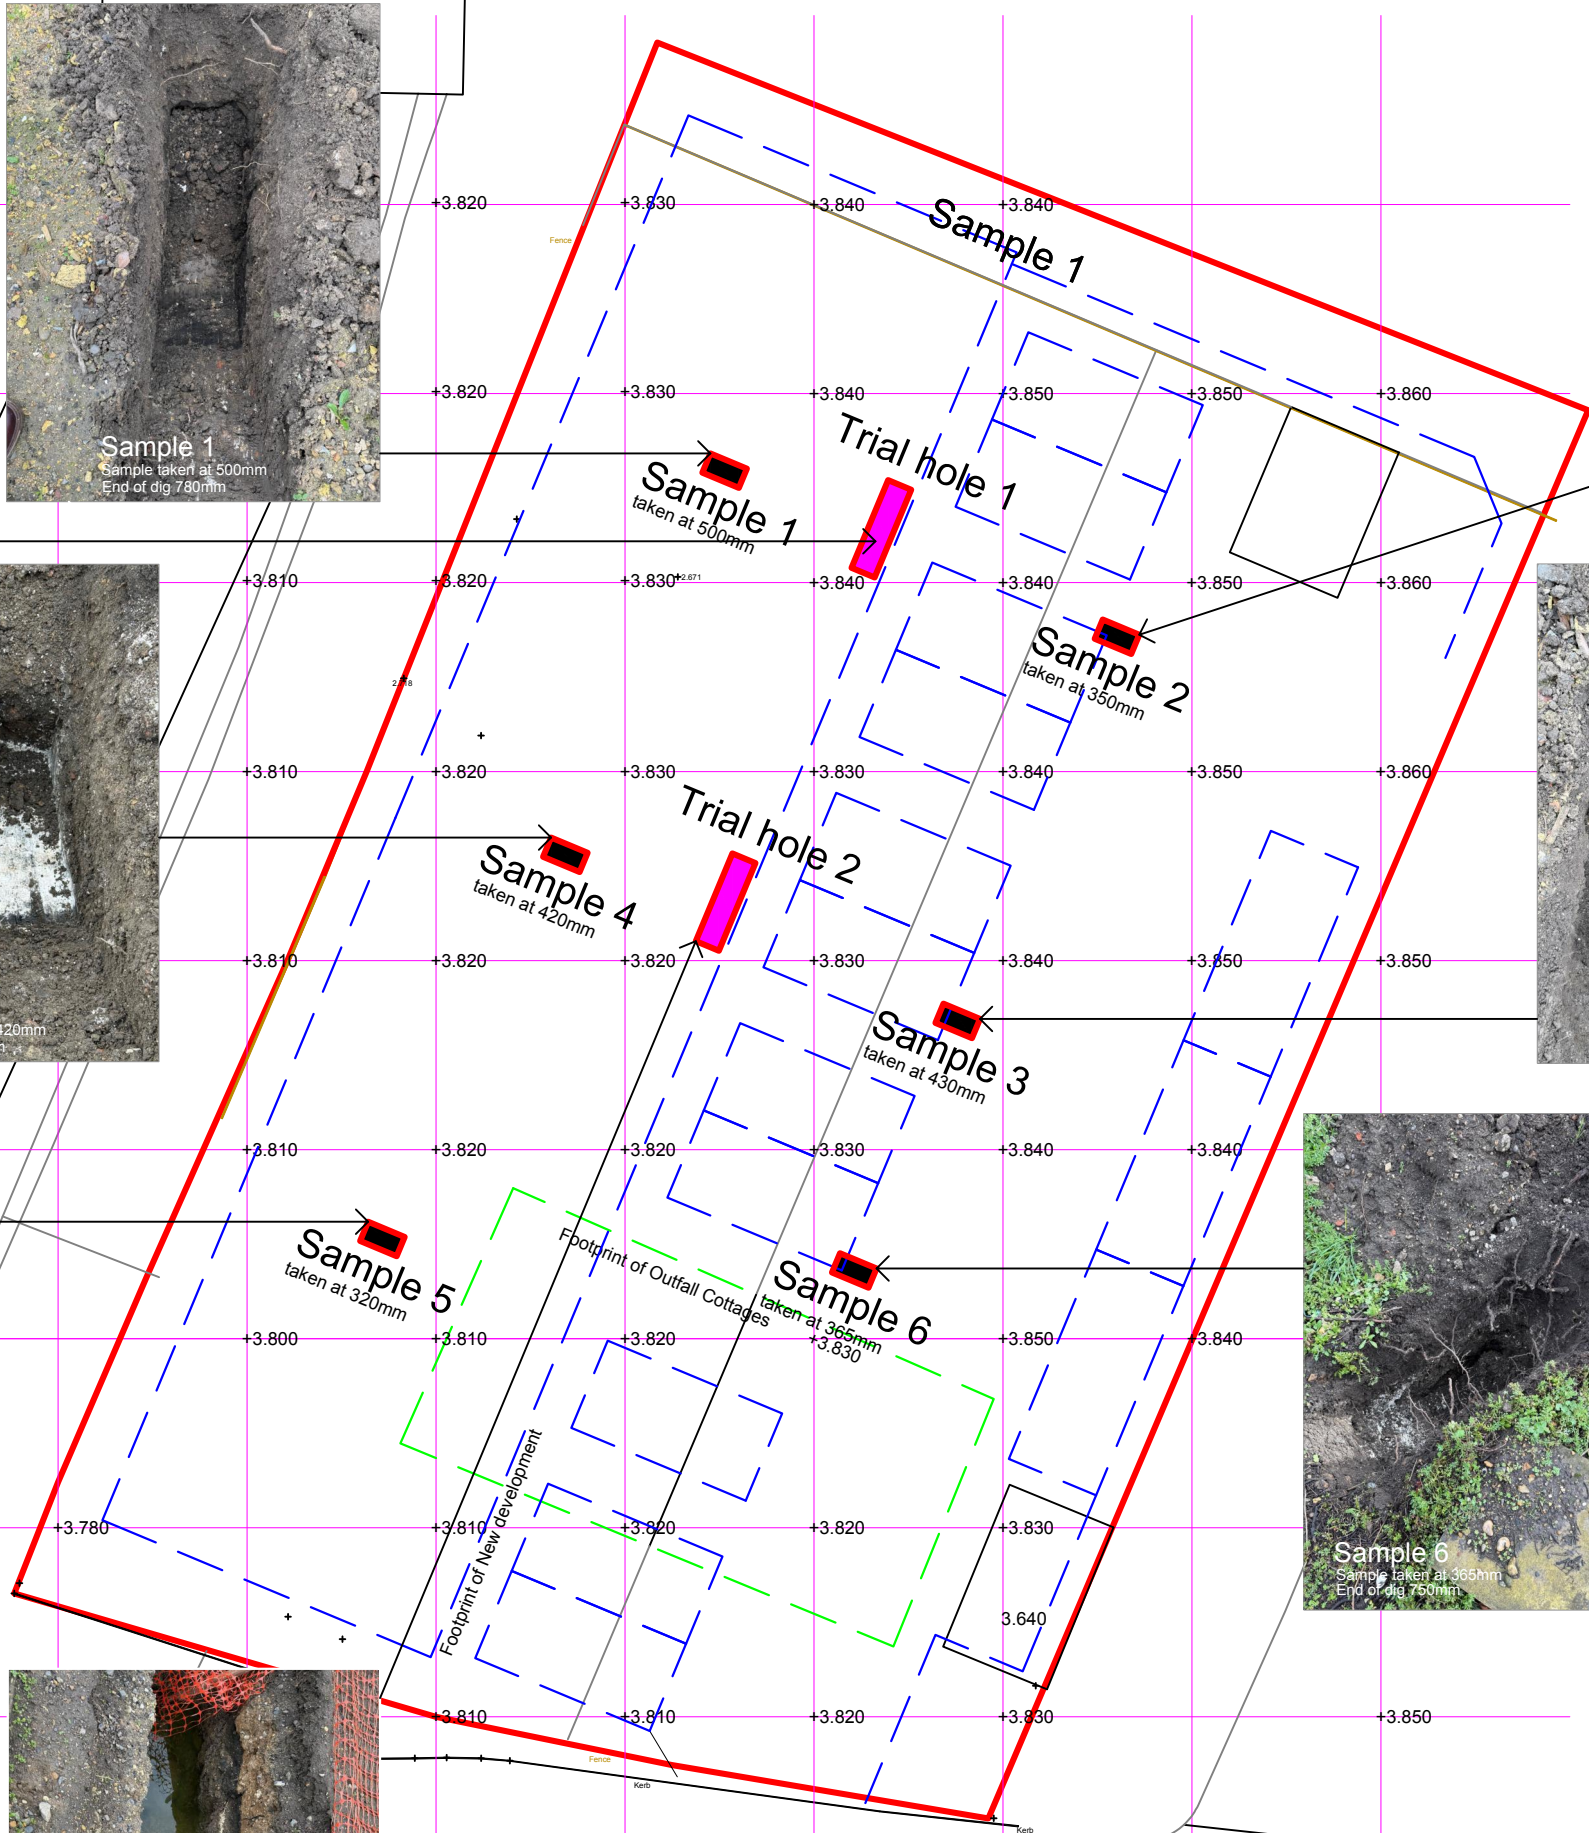
SOIL  
SAMPLING  
1/200. A3

The site was attended by TOA on 18<sup>th</sup> February 2026 under the guidance of MEC. At the time of the site investigation Outfall Cottages had been demolished with only the concrete oversite remaining. A total of six shallow exploratory trial pits were excavated for the soil sampling using a mini excavator to a maximum depth of 0.78m. Two previously excavated trial pits had also been excavated to deeper depths for geotechnical assessment. The trial pit locations and photographs are shown on the site plan in appendix 1 (p5), which also shows the depths of the samples taken for analysis.

The strata encountered at each location were dark brown/grey loamy occasionally slightly gravelly SILTY CLAY with scattered chalk pellets at all locations except sample location 5. A chalk seam was at sample location 6 at 0.4m. Chalk was encountered at 0.72m at sample location 4. Roots were within the top 0.4m at all locations and very occasional surface/near surface brick fragments were encountered at three locations. No groundwater or perched water was struck within the six shallow exploratory trial pits. Standing water was at approximately 1.0m to 1.2m within the two deeper previously excavated trial pits.

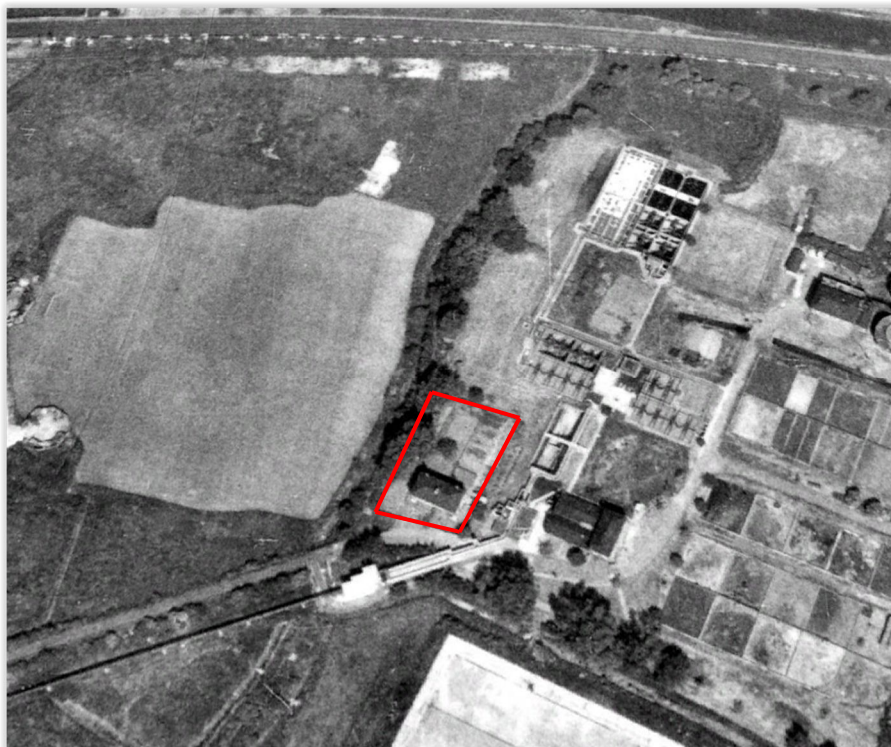
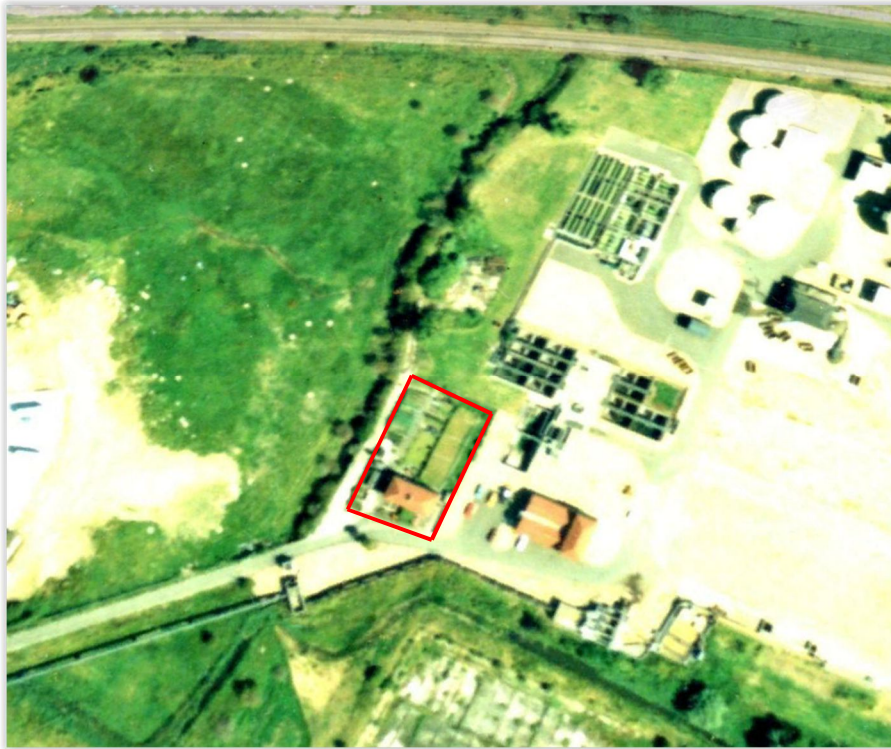
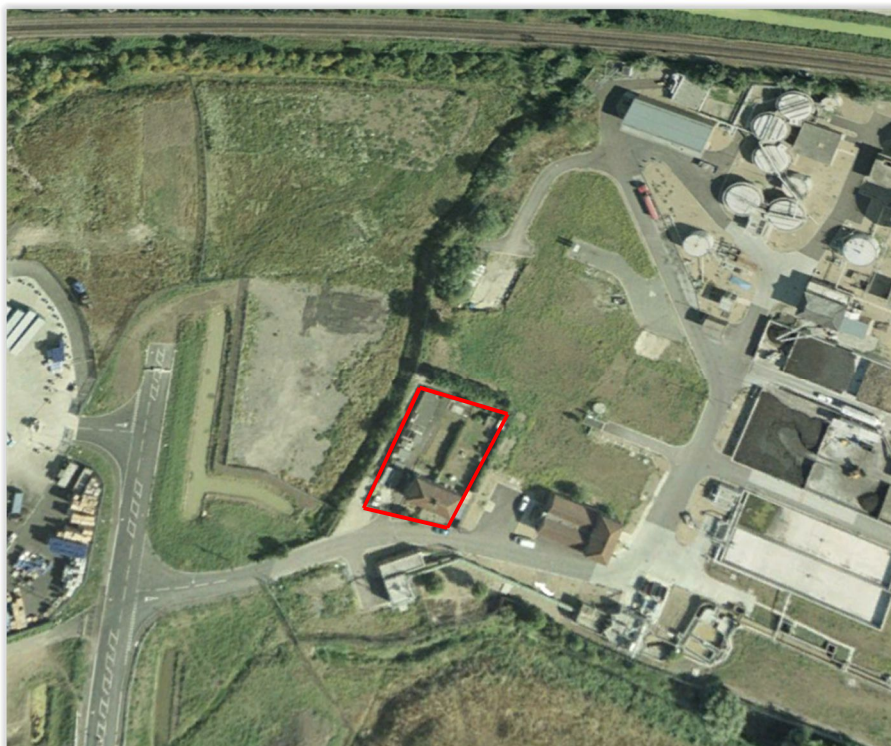
The residential cottages have been on the site since at least 1940. The historic aerial photographs show that the rear gardens were well kept up at least 2020. The historic street view photographs show that the cottages were occupied until at least 2022. The nearby Lion Business Park that is immediately to the south on the opposite side of the road was under construction in 2008. The land immediately to the west and northwest was developed between 2013 and 2020.

The site has been used for residential uses since at least 1940 and the houses appear to have been occupied until at least 2022. The adjacent sewage treatment works have also been in place since at least 1940 and the houses have been part of the sewage works site as accommodation for senior staff. Historic aerial and street view photographs of the site and houses are shown in appendix 2.
