# Detailed Unexploded Ordnance (UXO) Threat & Risk Assessment

Meeting the requirements of CIRIA C681 'Unexploded Ordnance (UXO)  
A guide for the Construction Industry' Risk Management Framework

| PROJECT | Thong Lane | DATE | 10 <sup>th</sup> November 2022 |
| UXO RISK RATING | <b>HIGH</b> - This Study Site requires further action to reduce risk to ALARP during intrusive activities. | | |

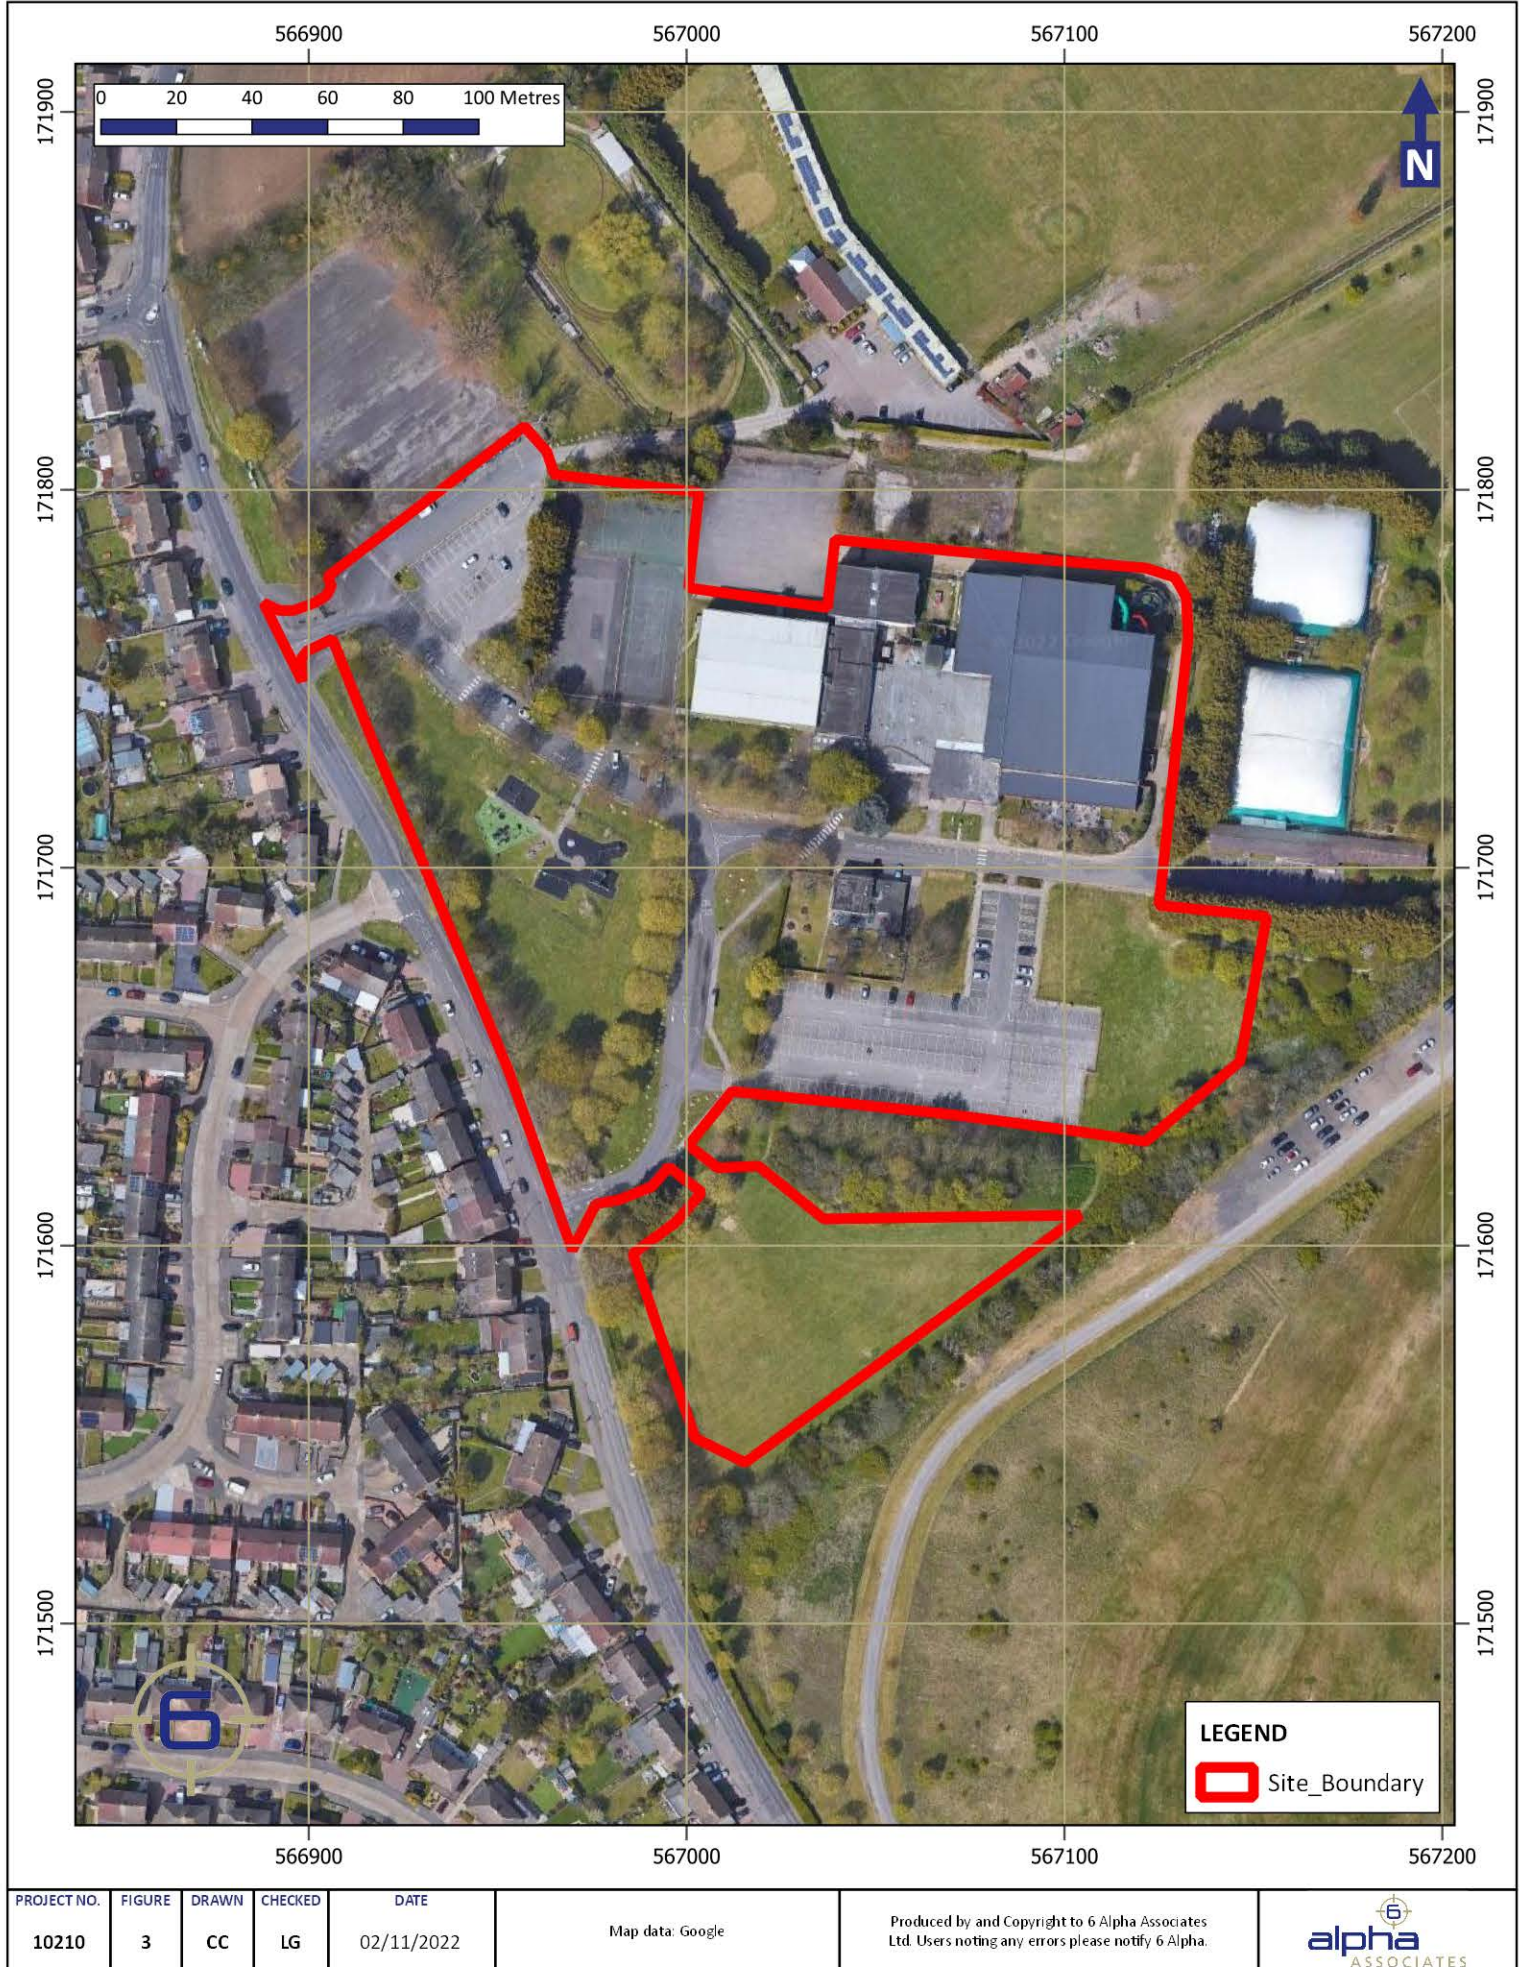
# CASCADES LEISURE CENTRE, THONG LANE, GRAVESEND, DA12 4LG Aerial Photography (2021)

Current aerial photography corroborates the information above and shows that the Study Site is situated on the outskirts of a densely developed urban area. The Study Site itself consists of multiple structures and areas of hard standing associated with *Cascades Leisure Centre*, alongside areas of undeveloped land.

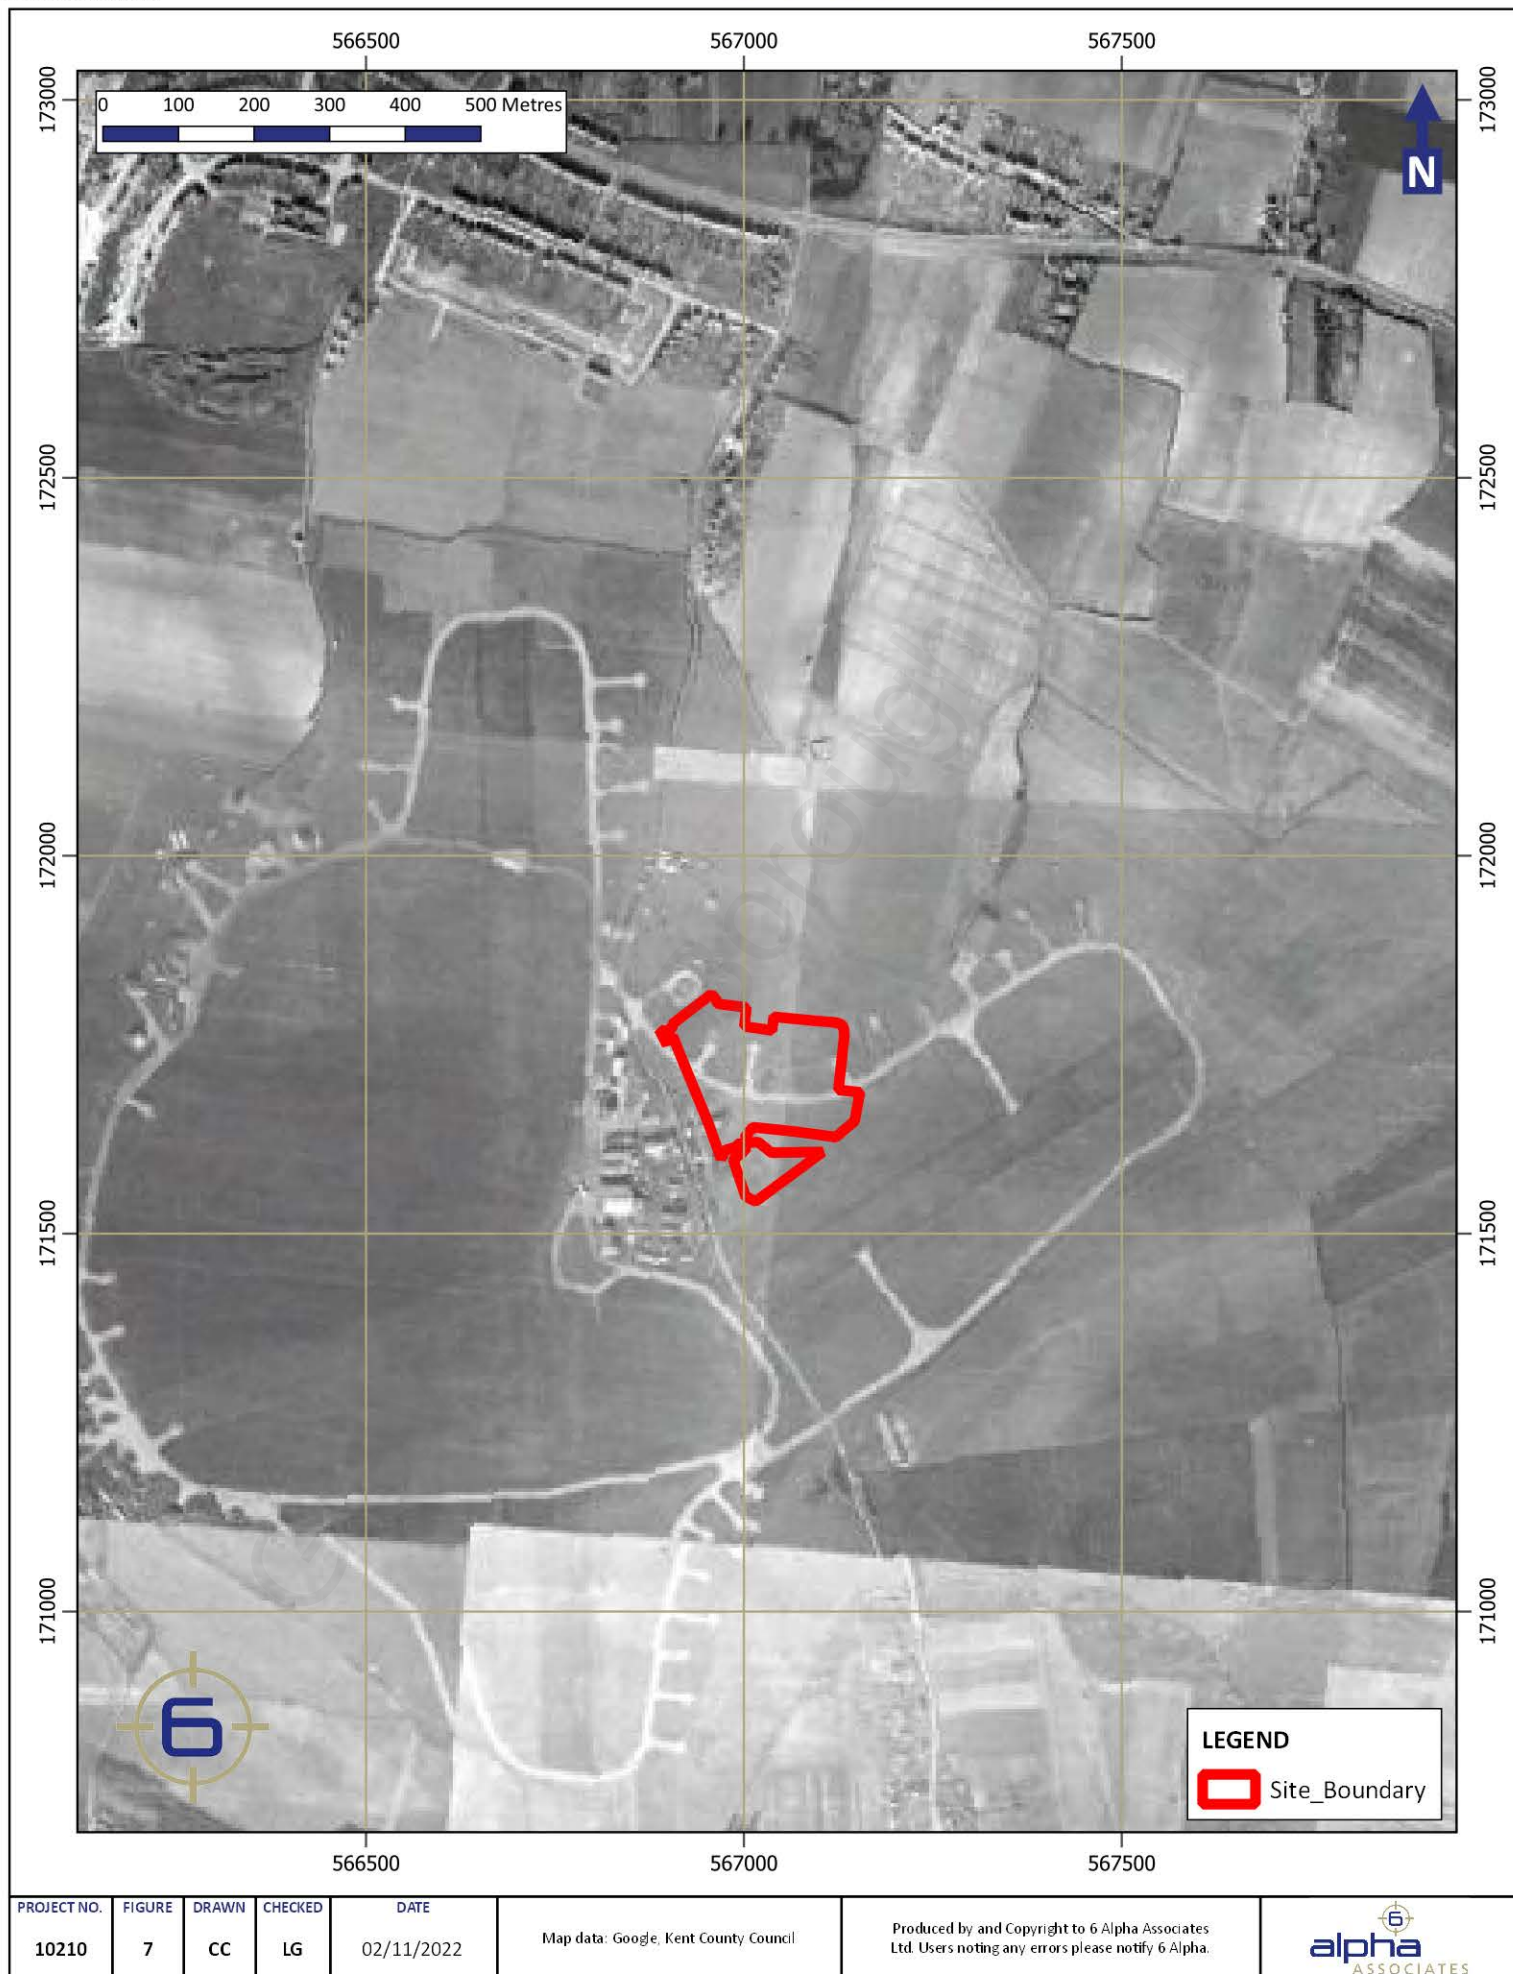
# CASCADES LEISURE CENTRE, THONG LANE, GRAVESEND, DA12 4LG Aerial Photography (1945)

The CS mapping prior to WWII (1933-1936), 1940 aerial photography and post-WWII OS mapping (1946) shows that the Study Site was located in the rural outskirts of a developed urban area; the Study Site itself consisted undeveloped land, structures, areas of hard standing all associated with *Gravesend Airfield* (*RAF Gravesend*). Therefore, it is probable that military personnel may have inspected the Study Site for UXB entry holes following any air raids as part of any damage assessment that would have likely taken place. However, this does not preclude the potential for a UXB encounter at the Site given that extensive bomb damage was evidenced in the immediate vicinity of the Site – such damage could conceivably obscure a UXB entry hole at the Site, or in close proximity.
