## Bat Emergence and Re-Entry Surveys (BERS)

Hopehill Scout Campsite, South Street, Wrotham Road, Meopham, Kent, DA13 0QJ

“The side extension of a toilet block”

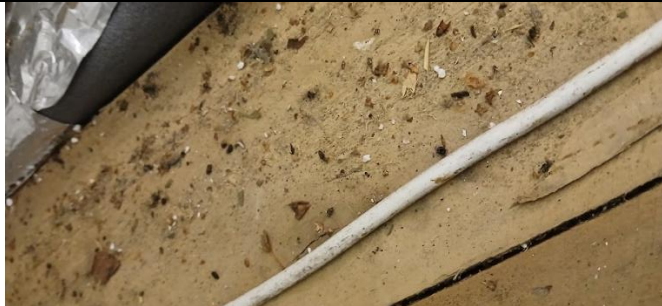
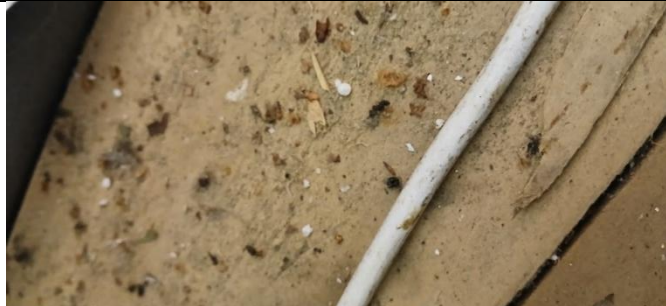
| | Approximately 30 fresh droppings were observed around the loft entrance. DNA analysis conducted in 2024 confirmed the presence of BLE, as shown in Appendix 3. | | | | | |
| B1 void: Fresh bat droppings observed. | | | | | | |

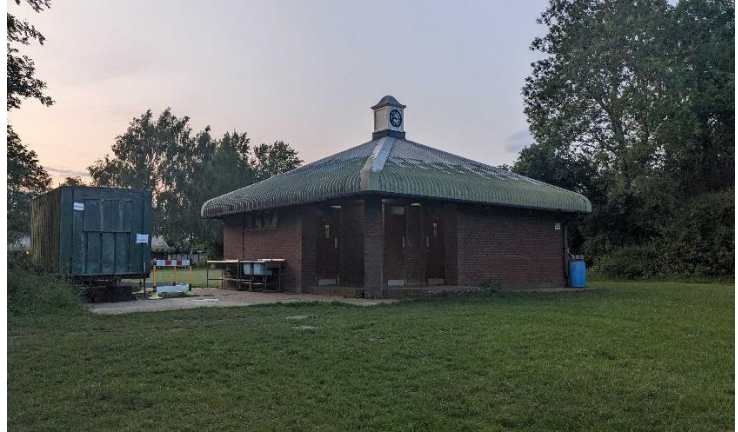
| <i>Surveyor 2</i> | No emergencies observed. Common pipistrelles were heard and observed intermittently throughout the survey. The first was heard but not seen at 21:42. Between 21:48 and 22:03, four individuals were observed commuting south to west, social calling through the vegetation to the west of the site. At 22:07, 3 individual common pipistrelles foraged within the trees to the west for approximately 15 minutes. | |

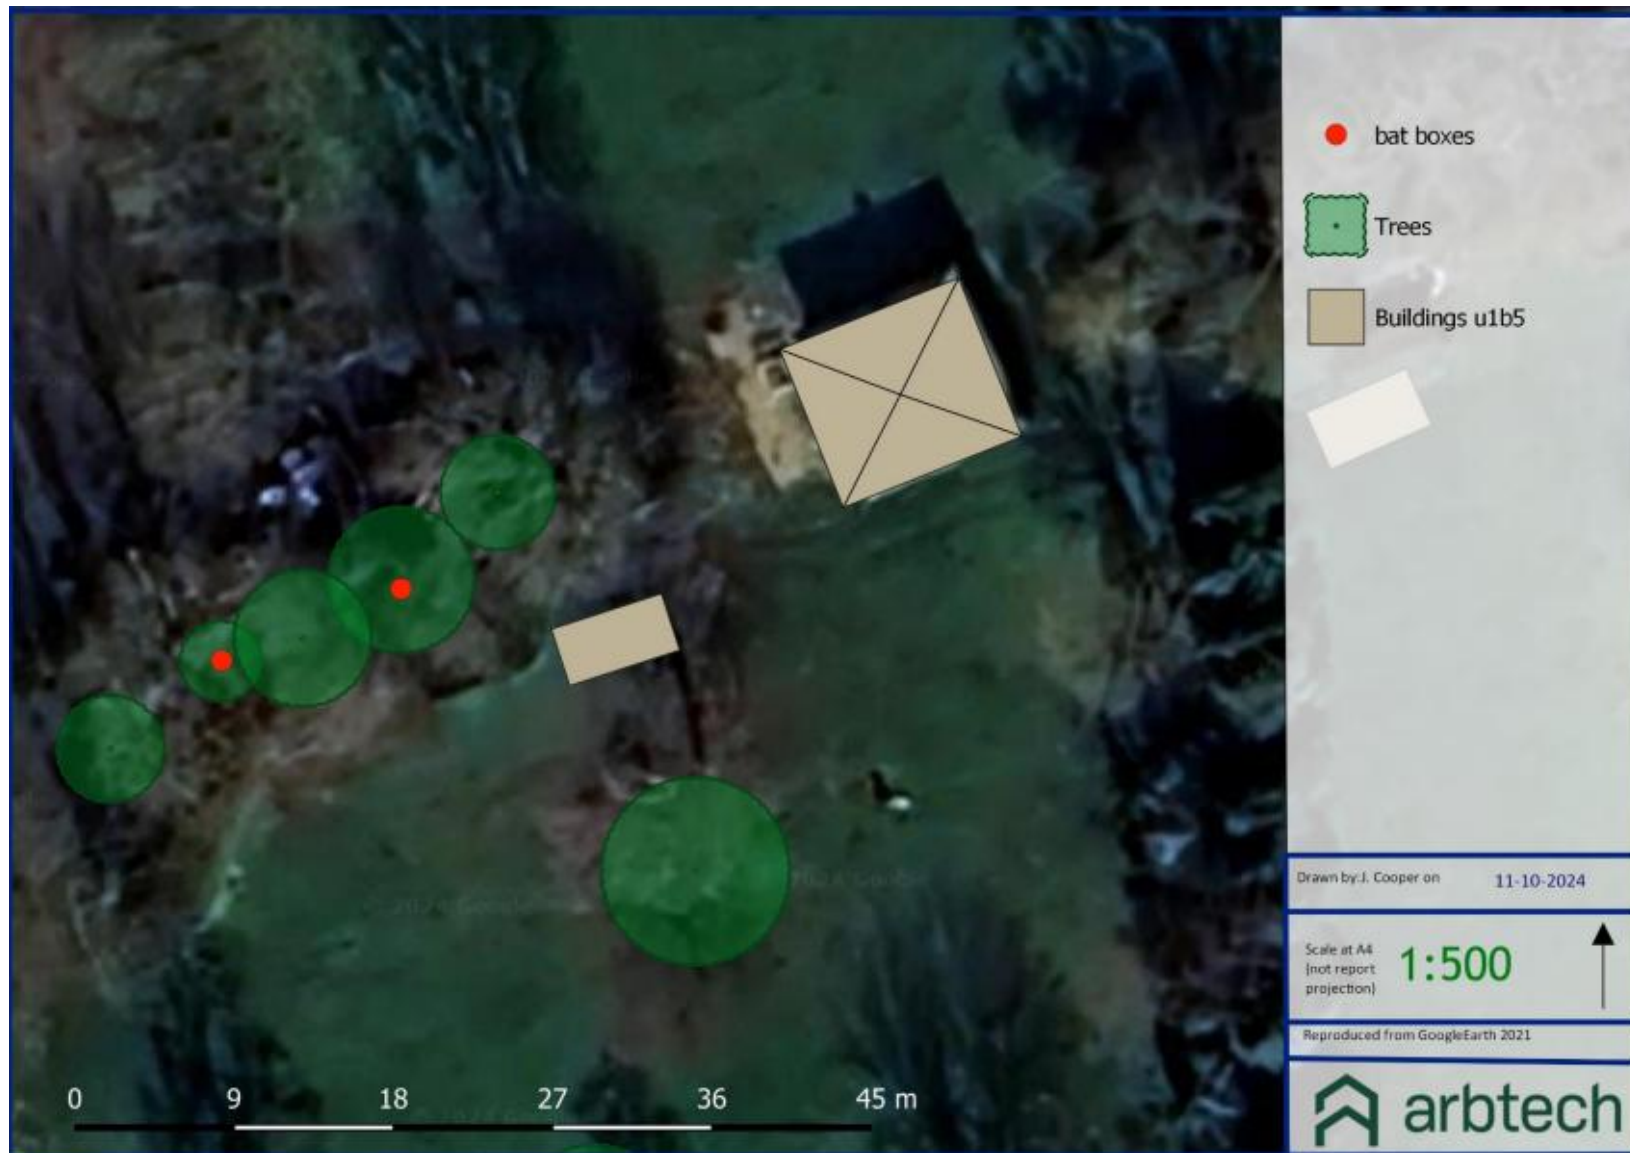
## Appendix 4: Proposed bat box locations

| <i>Enhancements</i> | <p>The installation of 2 bat boxes at the site will provide additional roosting habitat for bats. The bat boxes will be installed on trees on site (appendix 4).</p> <p>Bat boxes should be positioned 3-5m above ground level facing in a south or south-westerly direction with a clear flight path to and from the entrance, away from artificial light.</p> <p>The bat boxes will be a specification suitable for both crevice dwelling and void dwelling bats such as 1FF Schwegler Bat Box.</p> |
